# 2019 Willow Spring Breakup & Summer Monitoring & Hydrological Assessment

Prepared for:

**ConocoPhillips**  
Alaska

MSA Contract No. 296937

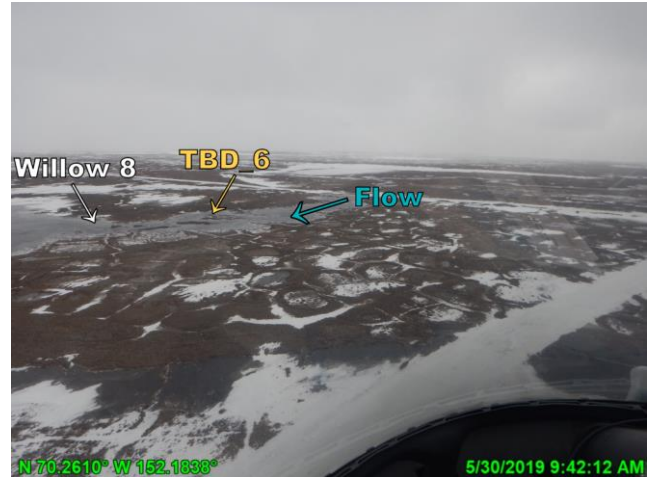
**Photo 4.66: Discharge cross-section in Willow 8 near TBD\_6, looking northeast (upstream); May 30, 2019**

Discharge was measured using a tethered ADCP at TBD\_6 on May 30 and using a HACH velocity meter attached to a wading rod at SW22 on June 1. At SW22, an exposed flow path, surrounded by drifted snow, was observed and measured upstream of the gage site (Photo 4.65). The topography of the area suggests this flow path did not capture the entirety of flow through Willow 8 as the presence of additional flow paths underneath drifted snow was likely. The quality of the measurement was classified as poor based on the inherent uncertainty of drainage patterns at this location. At TBD\_6, discharge was measured about 0.4 RM downstream of the gage station, directly downstream of the degrading ice road, as minimal snow remained in the channel and along the banks at this location. Minor overbank flooding was noted during the measurement and the reach was clear of ice (Photo 4.66). The quality of the measurement was classified as fair based primarily on the minor overbank flooding.

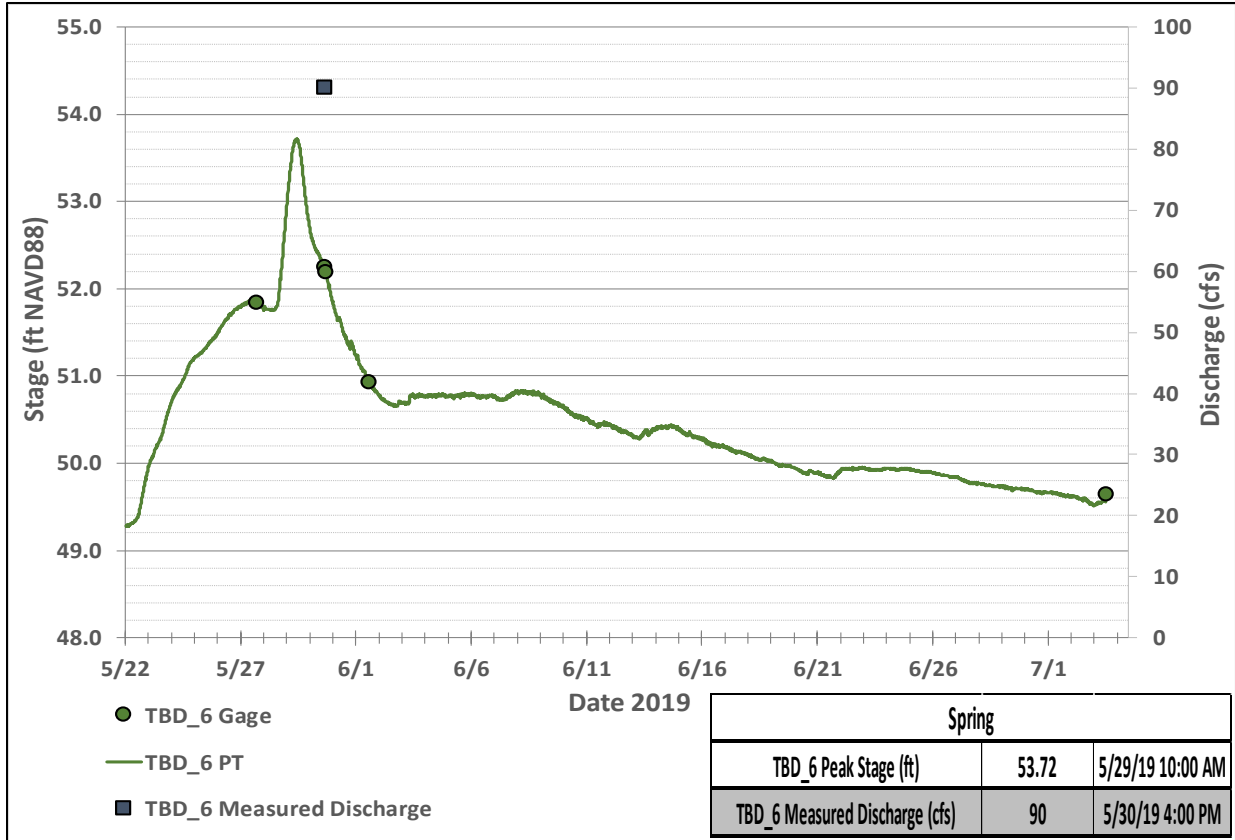
Graph 4.21: Willow 8 at TBD\_6 Spring Breakup Stage & Discharge

The TBD\_6 and SW22 stage and measured discharge data are presented in Graph 4.21 and Graph 4.22. Measured discharge data and plan and profile figures are provided in Appendix C. Elevations are referenced to NAVD88.

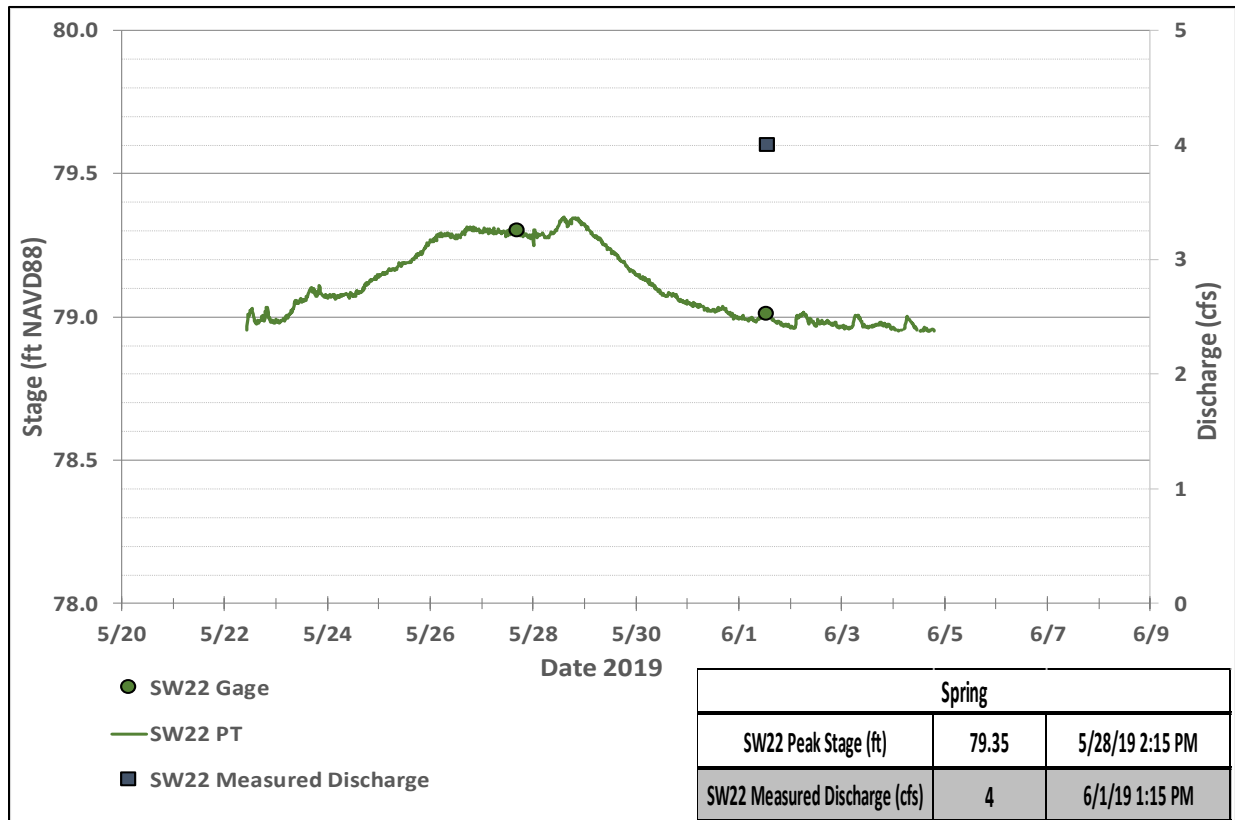
Graph 4.22: Willow 8 at SW22 Spring Breakup Stage & Discharge

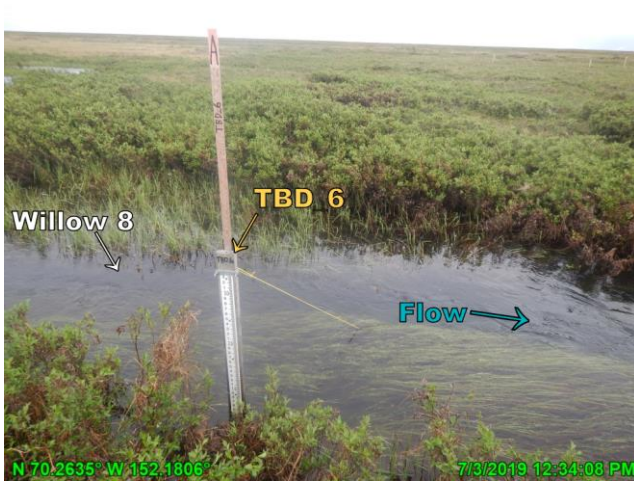
**Photo 4.67: Summer conditions at TBD\_6, looking north; July 3, 2019**

Summer stage was measured at both SW22 and TBD6. Stage fluctuations associated with summer precipitation events were recorded in the data; water levels remained well below spring breakup peak stage at all locations (Photo 4.67 and Photo 4.68). The stage increase at the end of the summer monitoring period is associated with a notable precipitation event. Summer stage at the TBD\_6 and SW22 gage sites are presented in Graph 4.23 and Graph 4.24, respectively.

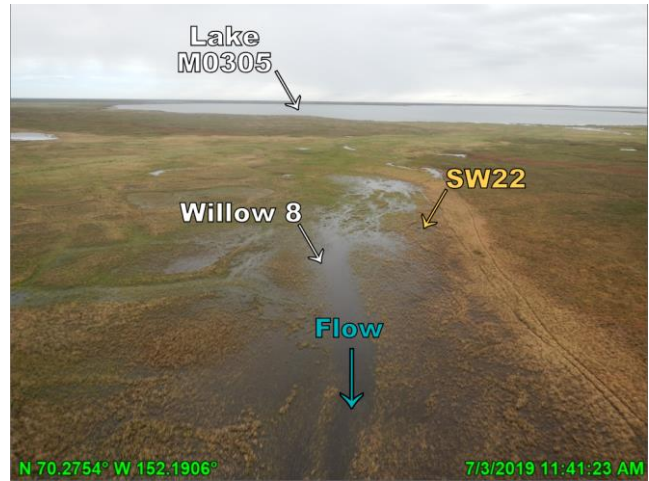
**Photo 4.68: Summer Conditions in Willow 8 near SW22, looking north (upstream); July 3, 2019**

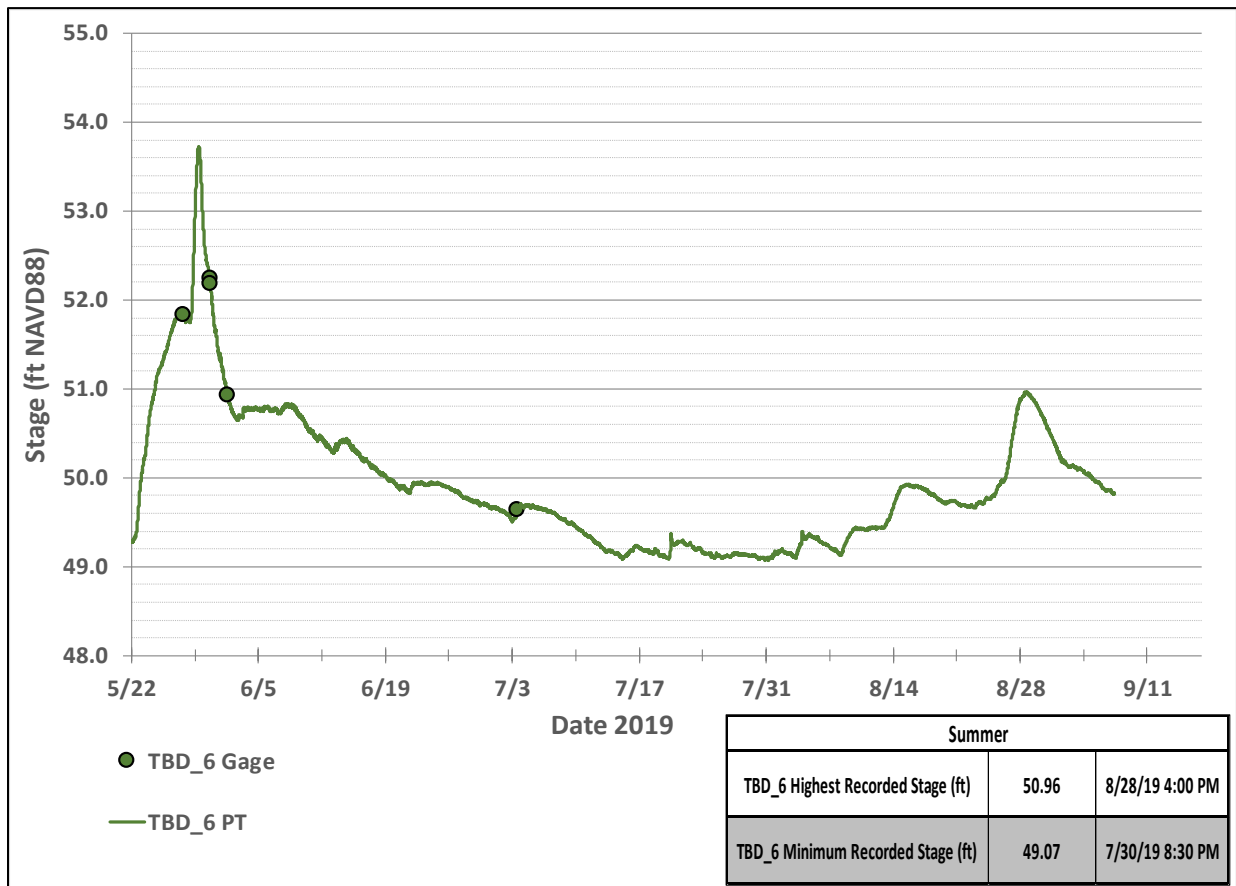
**Graph 4.23: Willow 8 at TBD\_6 Spring and Summer Stage**

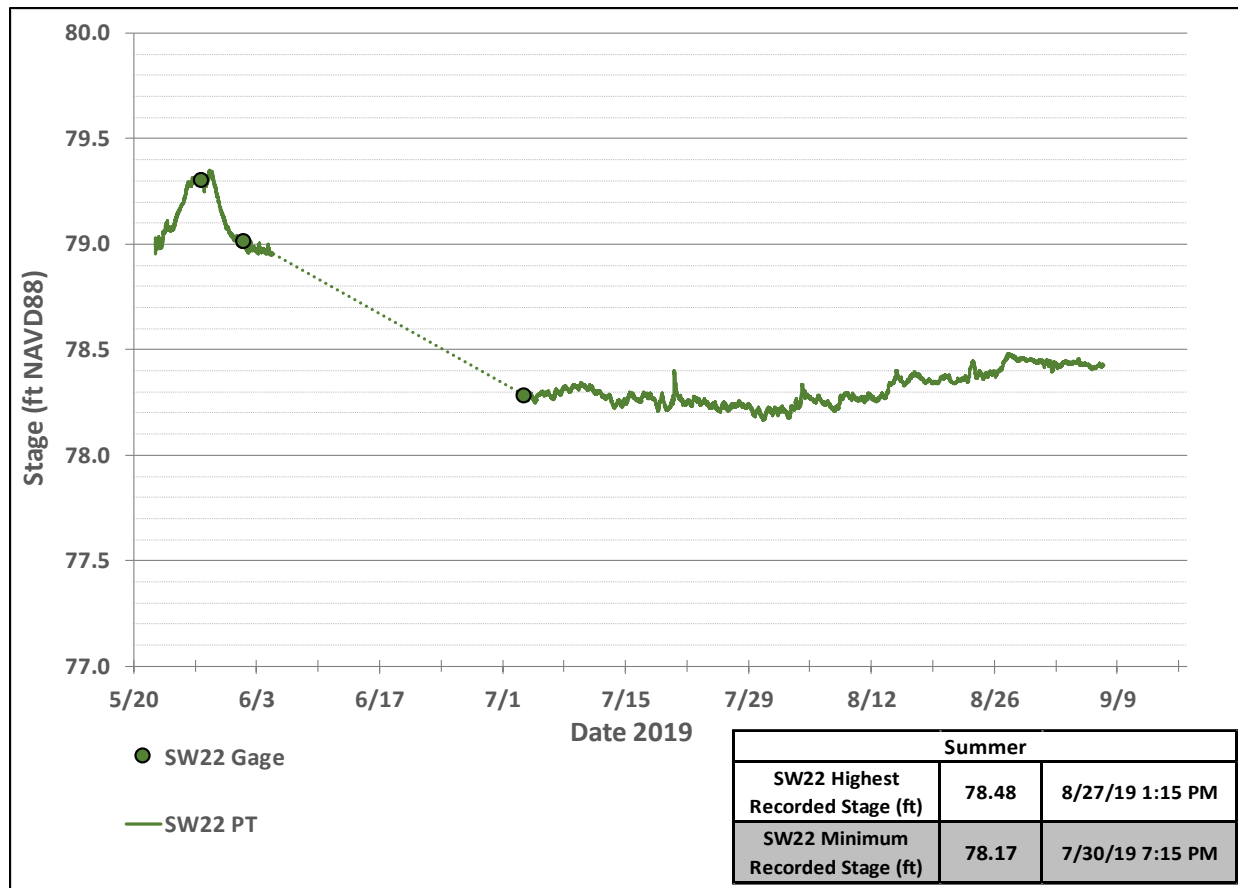
Graph 4.24: Willow 8 at SW22 Spring and Summer Stage

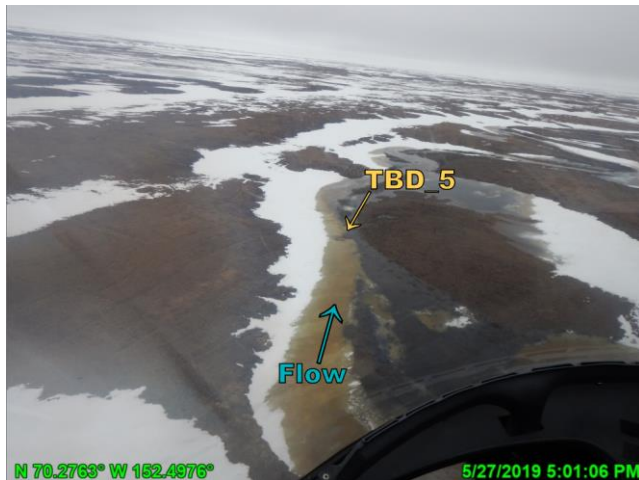
**Photo 4.69: Bottom-fast ice and saturated snow near TBD\_5, looking northeast (downstream); May 27, 2019**

The TBD\_5 drainage was filled with wind-driven snow at the onset of spring breakup. Initial meltwater was recorded on the site PT on May 21. Stage increased at a relatively consistent pace until peak stage occurred on May 27. Site observations first occurred on May 27, coincidentally one hour before peak stage. On this day, large quantities of drifted snow were observed in the channel and along the banks. Stage was elevated by saturated snow, and overbank flooding was present in low-lying areas. Snow and bottom-fast ice were observed across the entire width

of the channel near TBD\_5 (Photo 4.69). A slotted ice road intersecting the drainage and located approximately 1 RM downstream of TBD\_5 appeared to not inhibit the passage of meltwater (Photo 4.70).

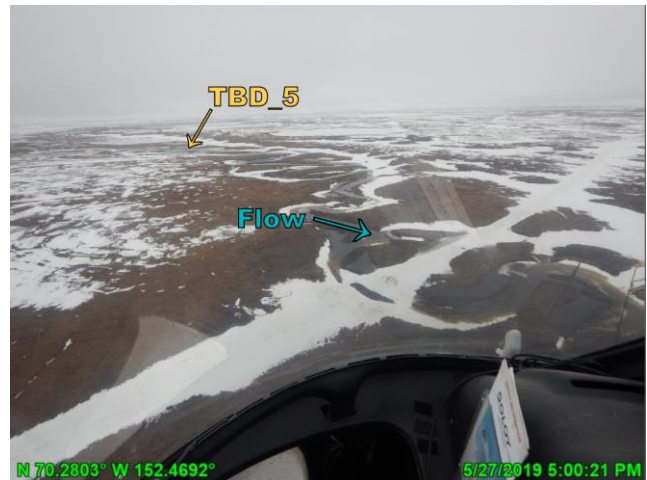
**Photo 4.70: Slotted ice road near TBD\_5, looking west (upstream); May 27, 2019**

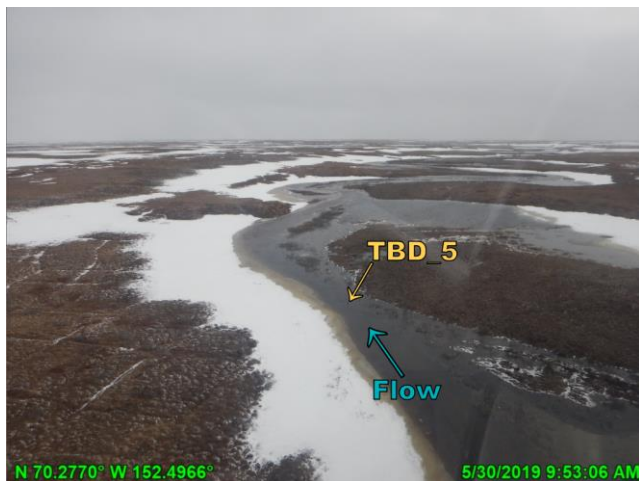
**Photo 4.71: Overbank flooding near TBD\_5, looking northeast (downstream); May 30, 2019.**

On May 30, aerial observations revealed saturated snow present in the channel and along the banks. Stage was still elevated above bankfull, and flooding was observed in low-lying areas (Photo 4.71). The condition of the slotted remained relatively unchanged from May 27. The snow cover on the surrounding tundra was approximately 10 percent. On June 1, stage had receded but was still above bankfull. Bottom-fast ice was present in the channel and saturated snow remained along the banks (Photo 4.72). PT data indicates that stage remained elevated after peak and did not begin to recede below elevated breakup stage levels until June 6.

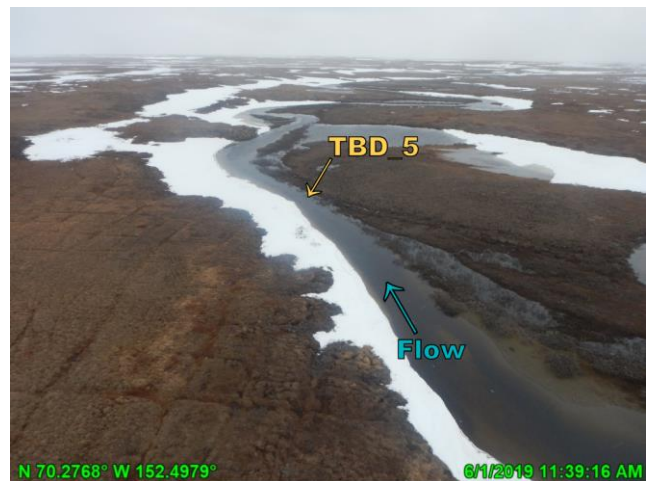
**Photo 4.72: TBD\_5 drainage five days after peak stage, looking northeast (downstream); June 1, 2019**

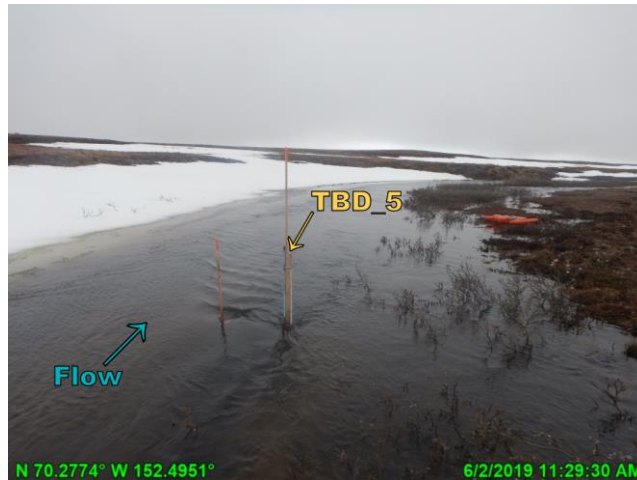
**Photo 4.73: Conditions during TBD\_5 discharge measurement, looking north (downstream); June 2, 2019**

Discharge was measured using a tethered ADCP at TBD\_5 on June 2 as stage was about 0.5-ft below recorded peak stage on May 27. Conditions at the time of measurement included overbank flooding, saturated snow along the banks, and bottom-fast ice across nearly the entire width of the channel (Photo 4.73). Discharge was measured in an area where flow was generally well-confined to the channel. Based on conditions at the time of the measurement, the overall quality of the discharge measurement was considered fair.

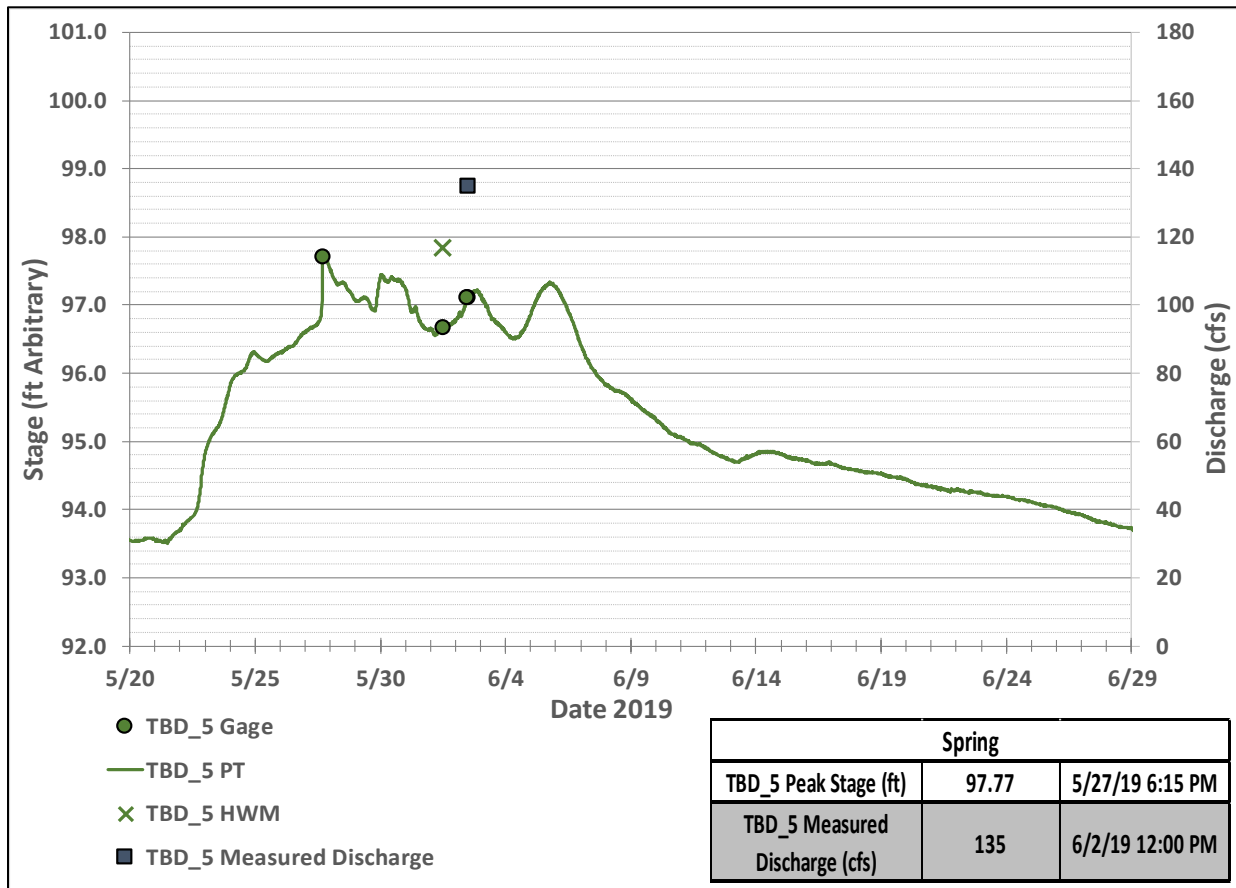
**Graph 4.25: TBD\_5 Spring Breakup Stage & Discharge**

The TBD\_5 spring breakup stage and measured discharge data are presented in Graph 4.25. Measured discharge data and plan and profile figures are provided in Appendix C. Elevations are arbitrary.

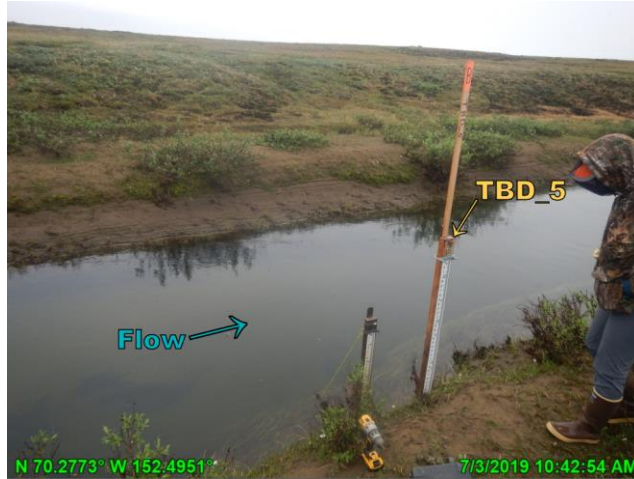
Photo 4.74: Summer conditions at TBD\_5, looking north (downstream); July 3, 2019

Summer stage was measured at TBD\_5. Stage fluctuations associated with summer precipitation events were recorded in the data; water levels remained well below spring breakup peak stage (Photo 4.74). During a late summer precipitation event, stage crested at levels observed near the end of spring breakup. Summer stage at TBD\_5 gage site is presented in Graph 4.26.

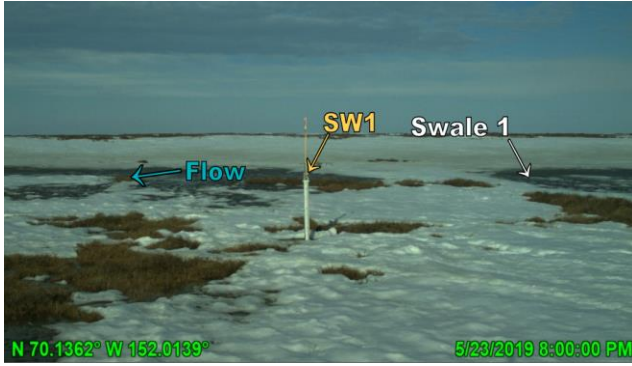
Photo 4.75: Game camera image of initial meltwater near SW1, looking east; May 23, 2019

Local melt was first observed near SW1 from game camera images on May 23 (Photo 4.75). Stage increased until peak stage conditions were observed on May 26. On May 27, site observations revealed hydraulically connected meltwater between the two unnamed lakes through the swale and the SW1 gage. Widespread meltwater was observed near the low-relief areas associated with the two unnamed lakes on either end of the swale (Photo 4.76). An area of channelized flow was present for about 150 feet between these areas of widespread meltwater. Discharge was measured at SW1 on May 29. Aerial observations revealed similar conditions to those observed on May 27. PT data indicates that stage had receded slightly. Saturated snow present on the eastern outer extent of both unnamed lakes did not appear to confine flow (Photo 4.77). Snow cover on the surrounding tundra was approximately 10 percent. On June 2, widespread meltwater persisted across the low-relief areas and ice still covered each unnamed lake (Photo 4.78). By early July, water was confined to beads within the drainage path, adjacent low-lying areas were dry, and no flow was observed (Photo 4.79).

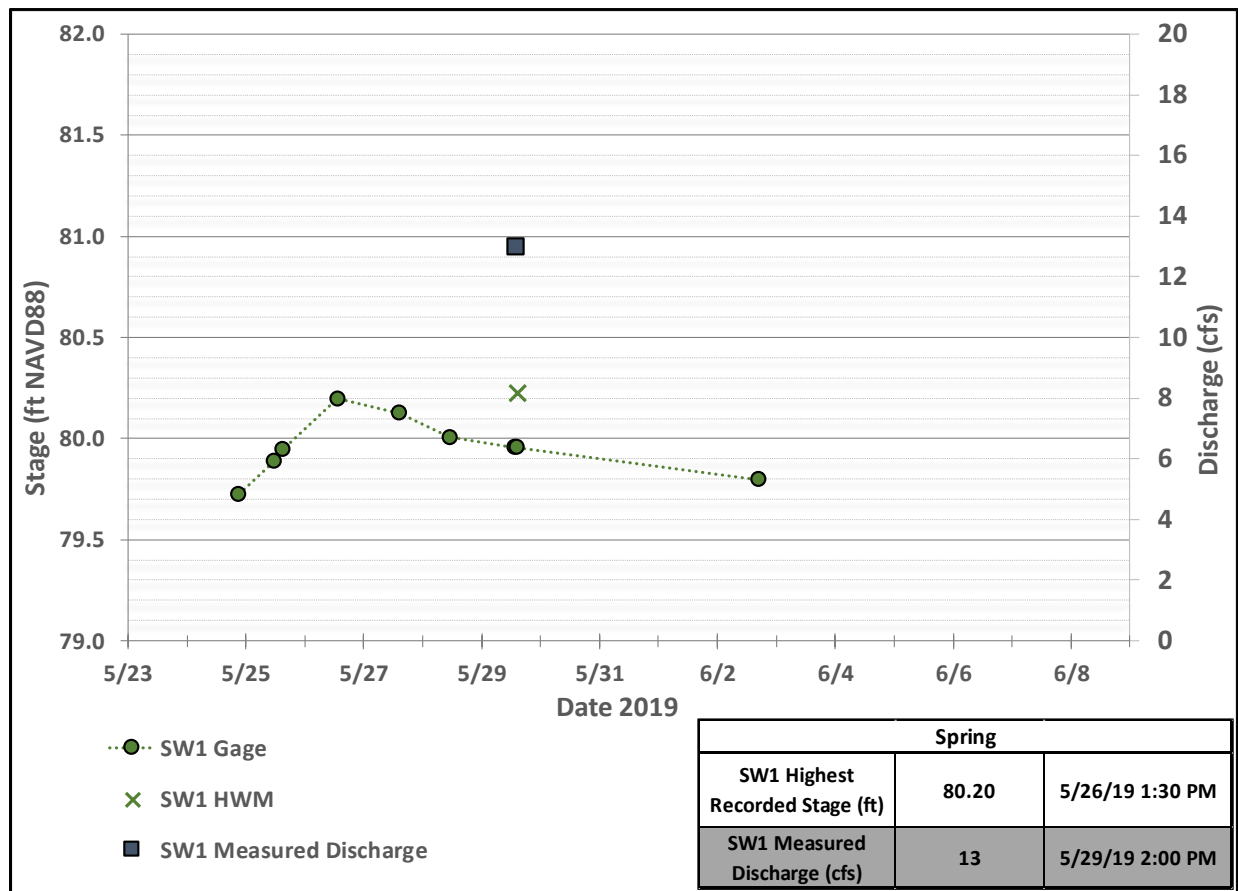
Graph 4.27: Swale 1 Spring Breakup Stage & Discharge

Swale 1 at SW1 spring breakup stage and measured discharge data are presented in Graph 4.27. Measured discharge data and plan and profile figures are provided in Appendix C. Elevations are referenced to NAVD88.

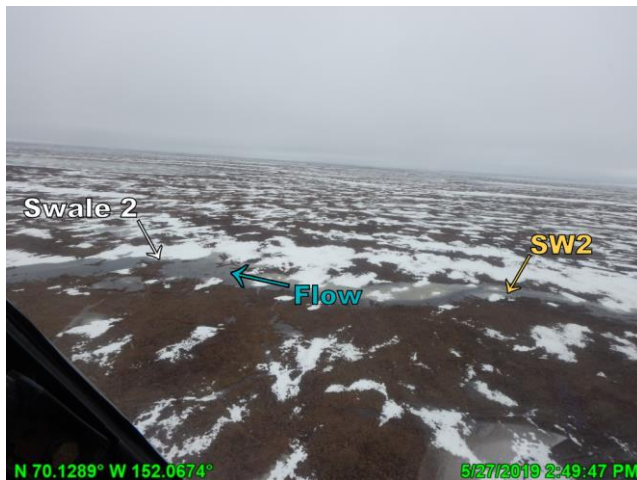
**Photo 4.80: Peak stage conditions at SW2, looking east; May 27, 2019**

Initial meltwater was first recorded on the SW2 PT on May 22. Stage increased until peak stage conditions were observed on May 27. Site observations from this day coincided with peak stage and revealed bankfull stage with flow over the top of saturated snow (Photo 4.80). On May 29, stage was still bankfull but less saturated snow was present in the channel (Photo 4.81). The PT data indicated that stage had receded about 0.7-ft from peak stage. Snow cover on the surrounding tundra was estimated at 10 percent. Discharge was measured on May 30 at a location about 200 feet upstream of the gage station (Photo 4.82). During the discharge measurement, flow was confined to a single flow path and minimal snow remained in the swale and along the banks. As a result, the quality of the discharge measurement was classified as good. By June 3, stage continued to recede, and minimal snow remained in the drainage area (Photo 4.83).

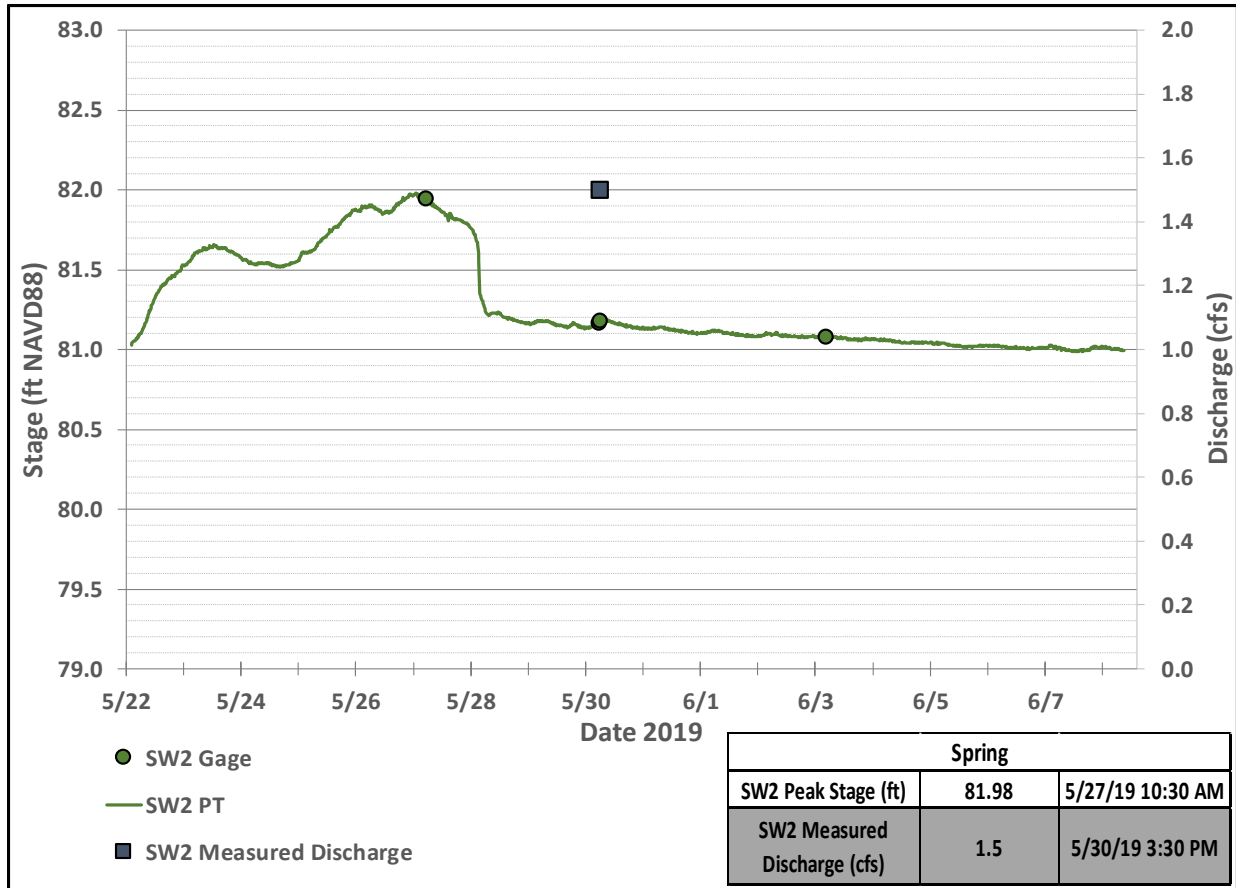
Graph 4.28: Swale 2 Spring Breakup Stage & Discharge

Swale 2 spring breakup stage and measured discharge data are presented in Graph 4.28. Measured discharge data and plan and profile figures are provided in Appendix C. Elevations are referenced to NAVD88.

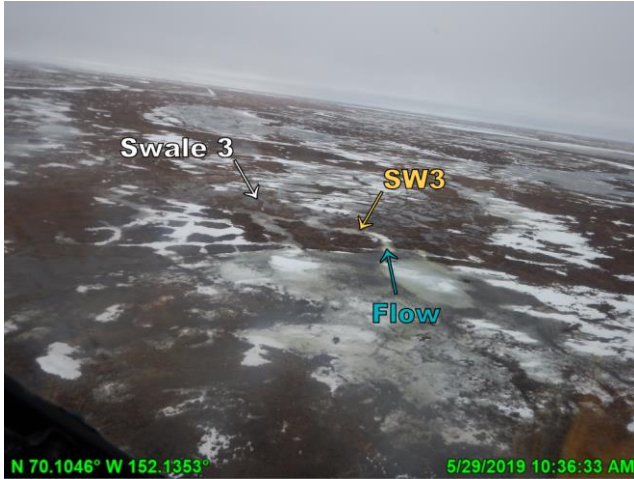
Photo 4.84: Snow-filled channel of the SW3 drainage, looking northeast (downstream); May 29, 2019

Site observations from May 29 reveal meltwater flowing north through saturated snow at SW3. Aerial observations show the Swale 3 drainage filled with bottom-fast ice and snow (Photo 4.84). Snow cover on the surrounding tundra was approximately 20%. Peak stage is estimated to have occurred near this time, based on site observations of bankfull stage and the presence of ice and snow in the channel. Discharge was measured at SW3 on June 2 as most of the snow and ice had cleared the channel (Photo 4.85). Aerial photos from June 2 reveal multiple flow paths associated with this drainage (Photo 4.86). A bifurcation was noted upstream of the gage station and discharge cross-section; however, this reach of the swale was still noted as the best location for measuring the largest proportion of flow. As a result of the multiple flow paths, the quality of the discharge measurement was classified as poor.

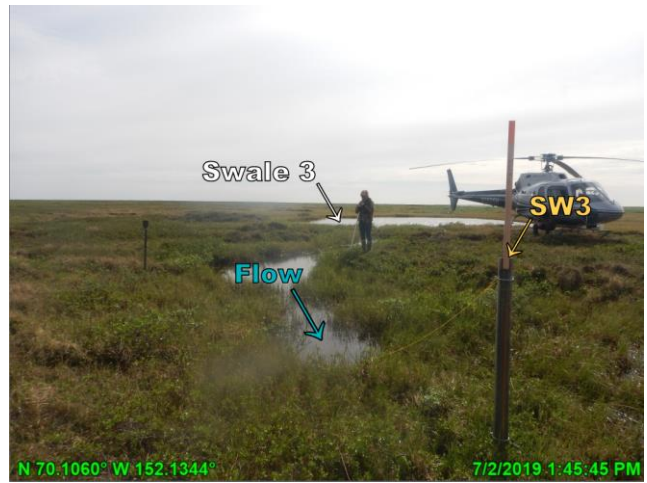
Photo 4.87: Summer conditions at SW3, looking south (upstream); July 2, 2019

Summer stage was measured at SW3. Stage fluctuations associated with summer precipitation events were recorded in the data; water levels remained well below spring breakup peak stage (Photo 4.87). The stage increase at the end of the summer monitoring period is associated with a significant precipitation event. Swale 3 spring

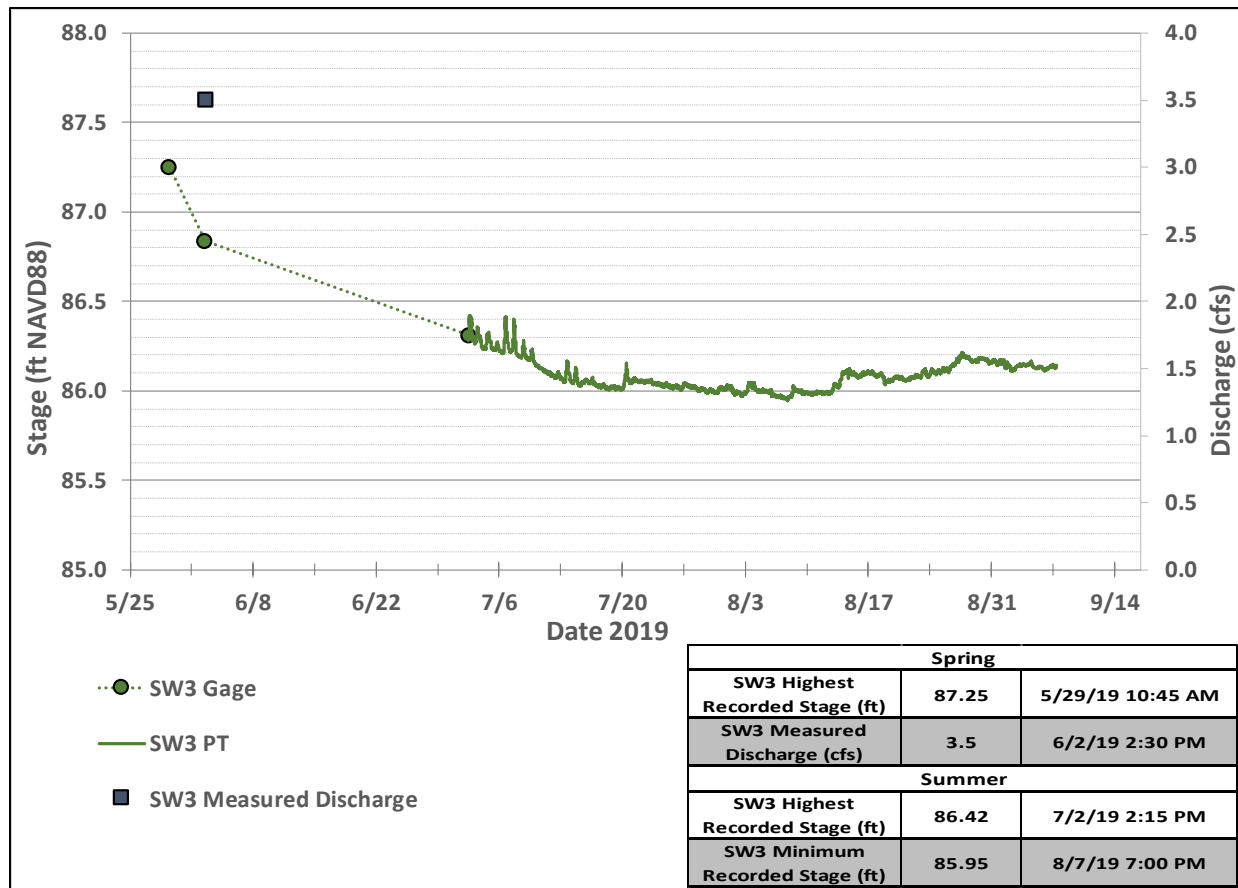
Graph 4.29: Swale 3 Spring Breakup Stage and Discharge, and Summer Stage

breakup stage and measured discharge, and summer stage data are presented in Graph 4.29. Measured discharge data and plan and profile figures are provided in Appendix C. Elevations are referenced to NAVD88.

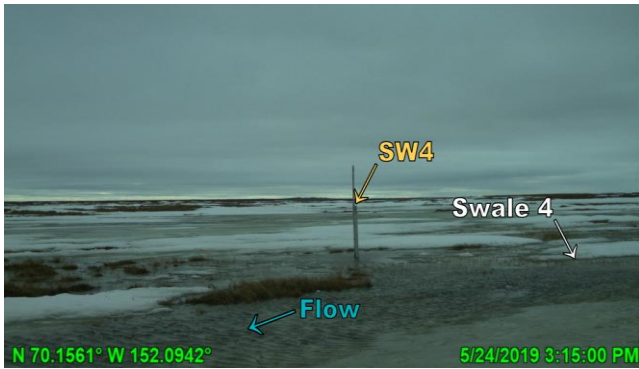
Photo 4.88: Game camera image of peak stage at SW4, looking south (upstream); May 24, 2019

Initial meltwater was first measured at SW4 on May 23 through game camera images. Stage increased until peak stage conditions were reached on May 24. Game camera images from this day show widespread ponded water in low-lying areas and polygon troughs around SW4 (Photo 4.88). On May 27, a site visit revealed meltwater in the Swale 4 drainage was hydraulically disconnected from Judy Creek. Aerial observations revealed saturated snow present in the drainage, particularly along the higher-situated polygon troughs (Photo 4.89). On May 30, stage in the SW4 drainage had receded and meltwater was still disconnected from Judy Creek, although it did appear to be connected to Lake M1523 to the west (Photo 4.90). By June 1, stage continued to decrease, and minimal snow remained in the drainage. Discharge was measured on June 1 in a narrow area of channelized flow through a polygon trough in an otherwise slow-moving, dispersed drainage pattern (Photo 4.91). The widespread nature of this drainage creates challenges in measuring discharge, and the resulting quality classification was rated as poor. During breakup, minimal stage fluctuations were recorded, and only local, disconnected meltwater was observed through aerial observations.

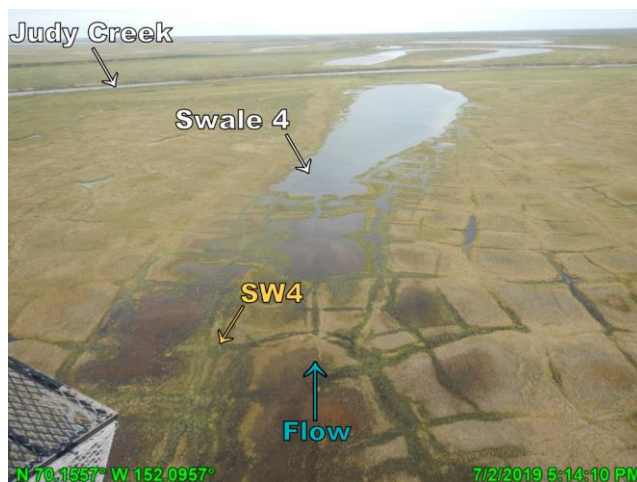
Photo 4.92: Summer conditions in the SW4 drainage, looking northeast (downstream); July 2, 2019

Summer observations at SW4 were limited to a site visit on July 2. At this time, stagnant water was observed in low-lying areas around the poorly defined drainage and no flow was observed (Photo 4.92).

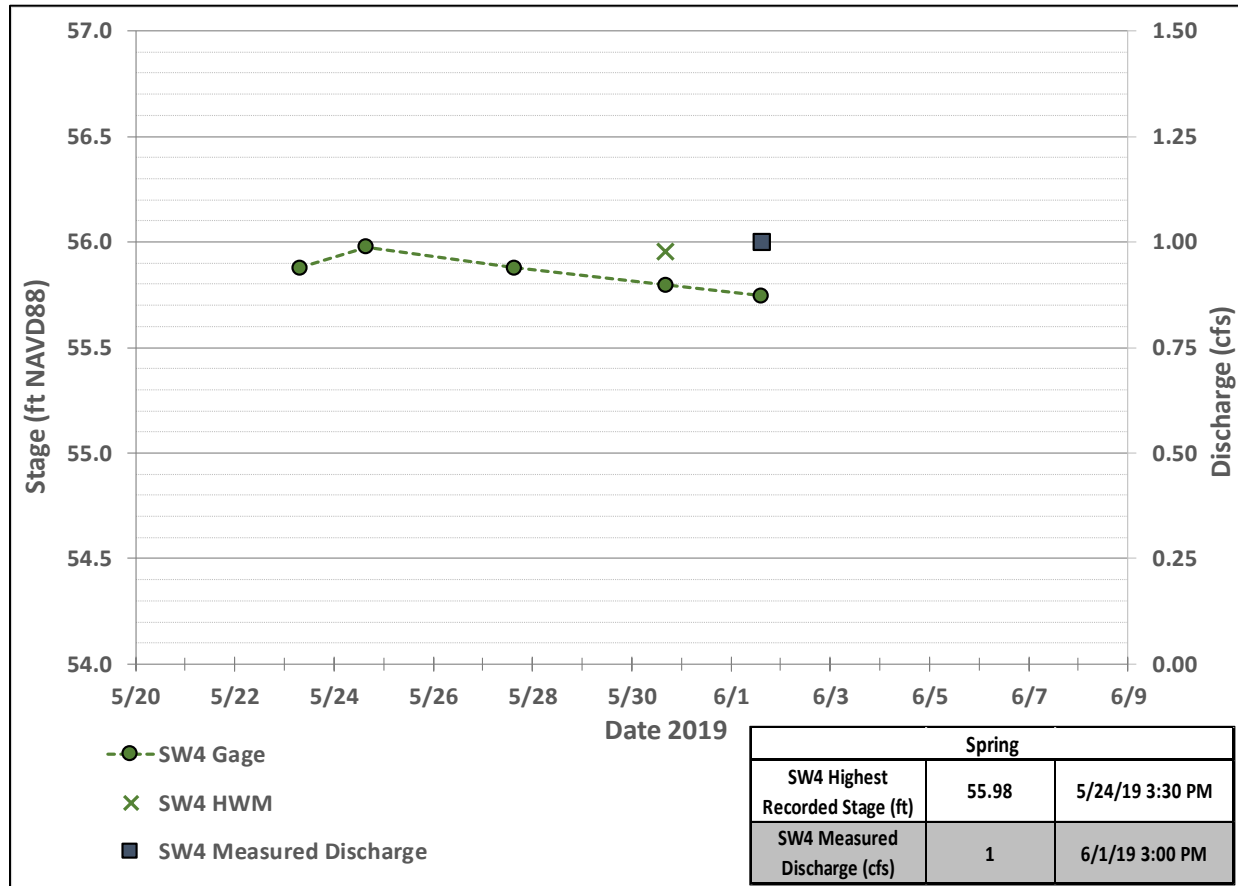
Graph 4.30: Swale 4 Spring Breakup Stage & Discharge

Swale 4 spring breakup stage and measured discharge data are presented in Graph 4.30. Measured discharge data and plan and profile figures are provided in Appendix C. Elevations are referenced to NAVD88.

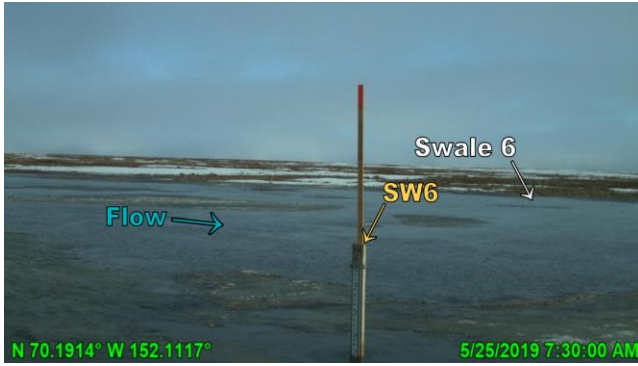
Photo 4.93: Game camera image of peak stage at SW6, looking northwest (upstream); May 25, 2019

Initial meltwater was first observed from the SW6 game camera on May 23. Stage increased until peak stage conditions were reached on the morning of May 25. During peak stage, game camera images revealed apparent stagnant meltwater overtopping polygon crests around the SW6 gage station (Photo 4.93). After peak, stage rapidly decreased, and polygon crests were again visible by the afternoon on May 25. On May 27, aerial observations revealed meltwater in low-lying areas and polygon troughs in the swale depression (Photo 4.94). Meltwater had cut a path through a nearby ice road downstream of the gage station. By June 1, stage continued to recede and meltwater within polygon troughs was becoming disconnected from other troughs (Photo 4.95). Summer observations from July 2 show stagnant, disconnected meltwater in a series of polygon troughs and low-centered polygon depressions (Photo 4.96).

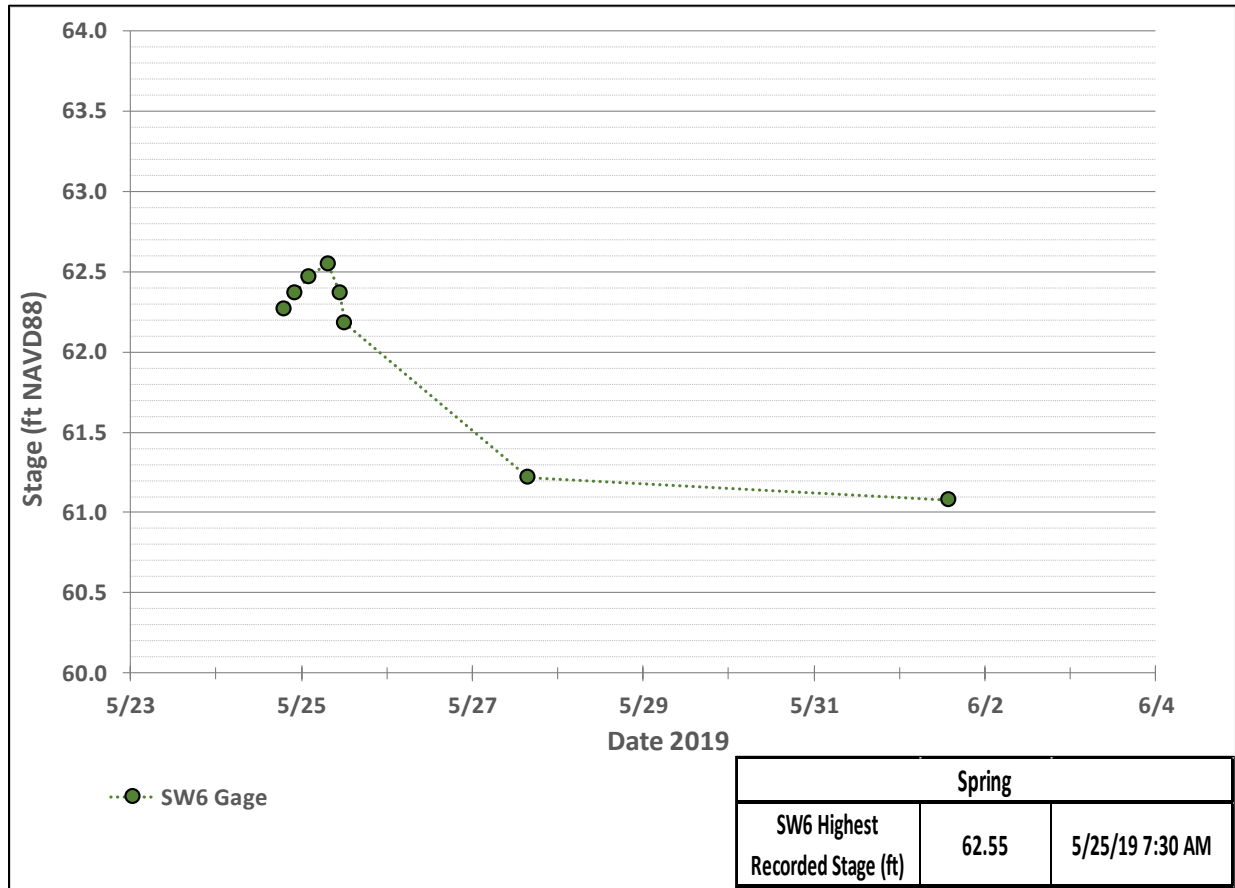
Graph 4.31: Swale 6 Spring Breakup Stage

Swale 6 spring breakup stage data is presented in Graph 4.31. Elevations are referenced to NAVD88.

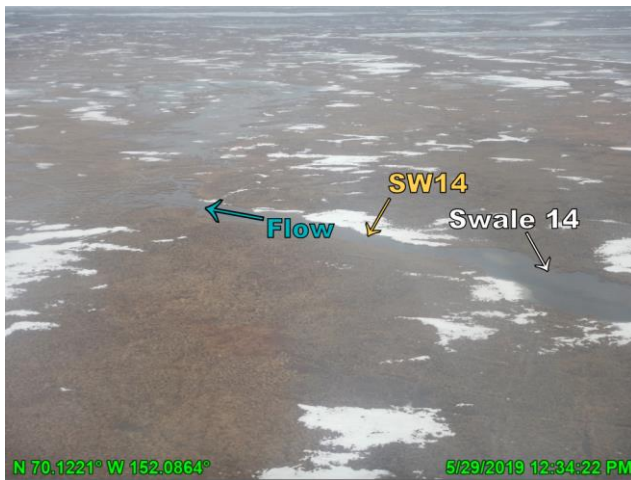
**Photo 4.97: SW14 drainage four days after peak stage, looking northwest (downstream); May 29, 2019**

Initial meltwater was recorded at SW14 on May 22. Stage peaked on May 25 and remained elevated at peak levels until May 28. Site observations from May 29 reveal stage below bankfull at SW14 (Photo 4.97). Snow and ice had cleared from the swale while some saturated snow was noted along the bank. No overbank flooding was observed. Discharge was measured about 20 feet downstream of SW14 on May 29 (Photo 4.98). The quality of the discharge measurement was classified as good based on the conditions described above. On June 2, aerial observations revealed minimal saturated snow along the banks. The stage condition was similar to that noted on May 29 (Photo 4.99). Snow cover on the surrounding tundra was approximately 5 percent. By July 2, flow was confined to the narrow, shallow, grass-lined beaded stream near SW14 (Photo 4.100).

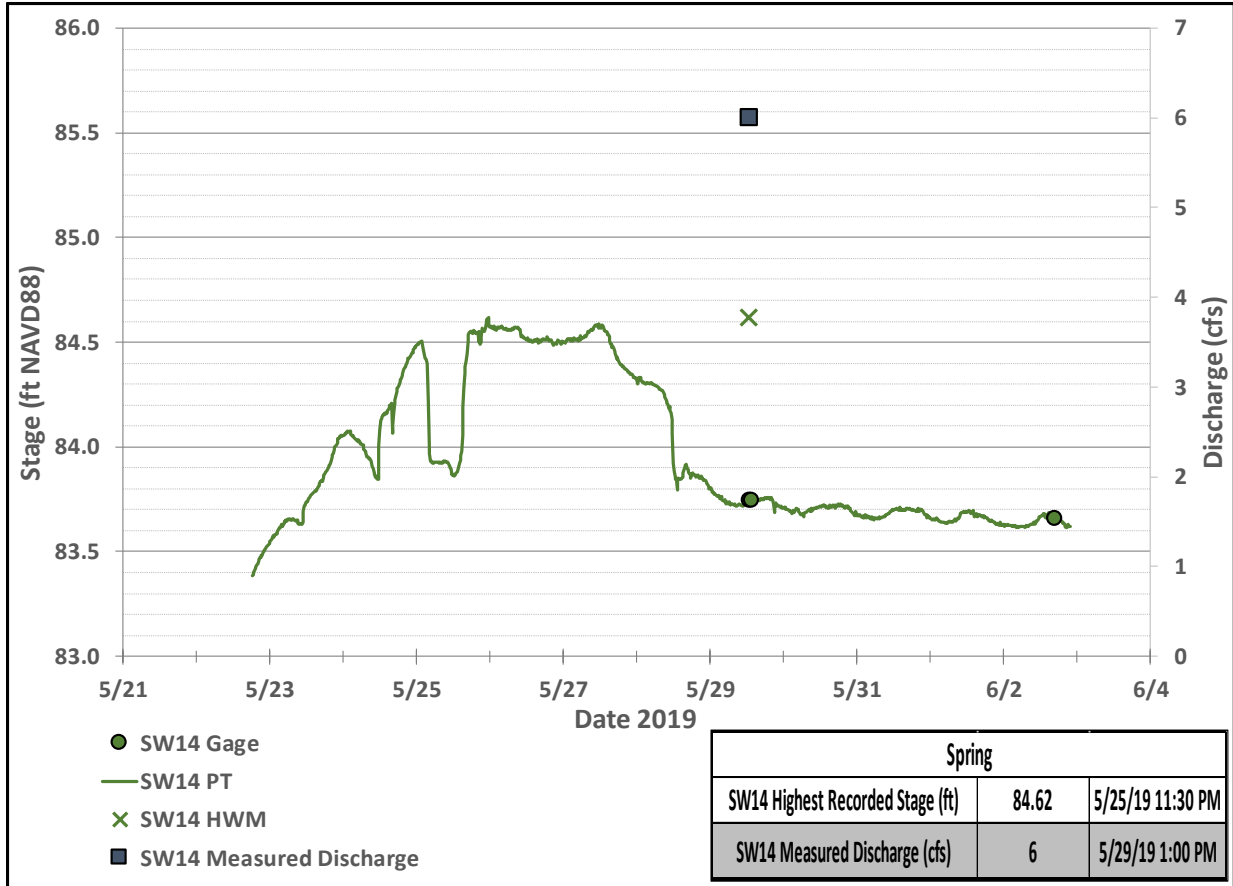
Graph 4.32: Swale 14 Spring Breakup Stage & Discharge

Swale 14 spring stage and measured discharge data are presented in Graph 4.32. The SW14 summer stage data is presented in Graph 4.33. Measured discharge details and plan and profile figures are provided in Appendix C. Elevations are referenced to NAVD88.

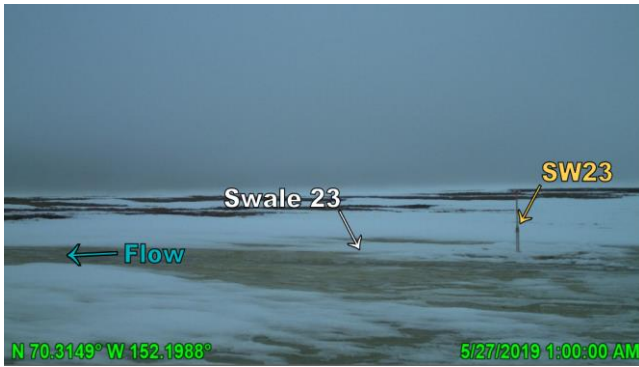
Photo 4.101: Game camera image of peak stage at SW23, looking west (downstream); May 27, 2019

Ponded local meltwater first appeared in Swale 23 at SW23 on May 26, based on game camera footage. Peak stage conditions occurred on May 27 (Photo 4.101). Stage remained near peak levels until a sudden drop was observed on May 28 around 3:00 PM. After this drop, stage remained below levels observed on May 26 through May 28. Game camera footage suggests meltwater was stagnant during the period of elevated stage from May 26 to May 28, then began to flow as stage dropped. Aerial observations from May 27 reveal meltwater in the main channel through Swale 23, based on the coloration of dark saturated snow (Photo 4.102). Site observations on May 27 confirm that meltwater near SW23 was stagnant. Aerial observations on May 31 show flowing meltwater had cut a path through snow. Minor overbank flowing was observed in low-lying areas around SW23 (Photo 4.103). Snow cover on the surrounding tundra was approximately 25 percent.

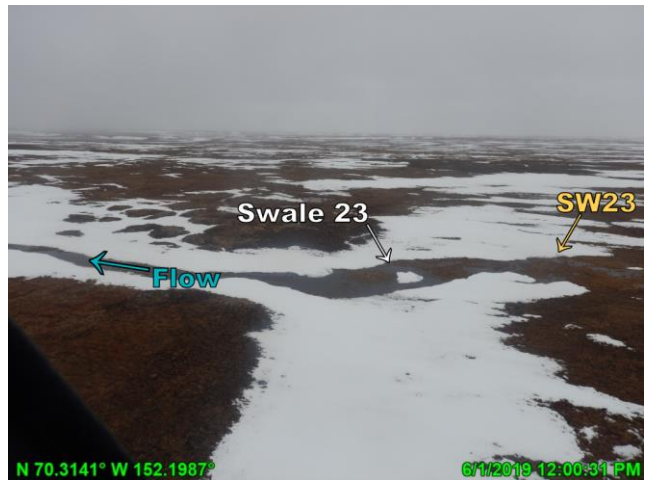
Photo 4.104: Conditions in the SW23 drainage during the discharge measurement, looking north; June 1, 2019

Discharge was measured on Swale 23 upstream of gage station SW23, near the swale's outlet from an unnamed lake, on June 1. At this location, flow was confined to a single flow path through saturated snow along the banks. Snow and ice were present in the channel (Photo 4.104). The overall quality of the discharge measurement was classified as fair based on the presence of saturated snow along the banks. By July 3, water was confined to small, disconnected pools within the swale (Photo 4.105).

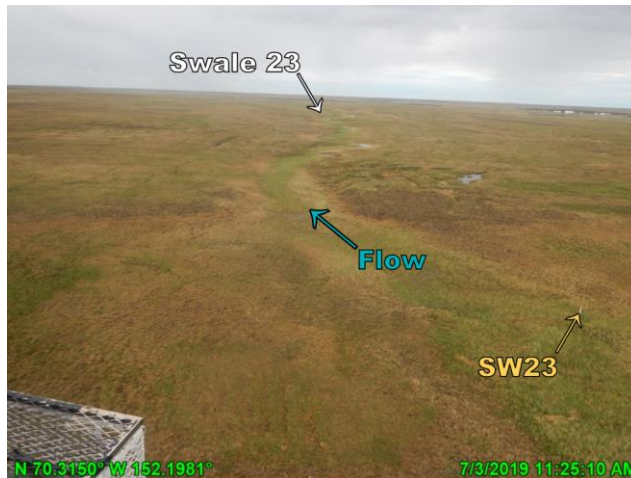
Photo 4.105: Summer conditions in the SW23 drainage, looking west (downstream); July 3, 2019
