# 2019 Willow Spring Breakup & Summer Monitoring & Hydrological Assessment

Prepared for:

**ConocoPhillips**  
Alaska

MSA Contract No. 296937

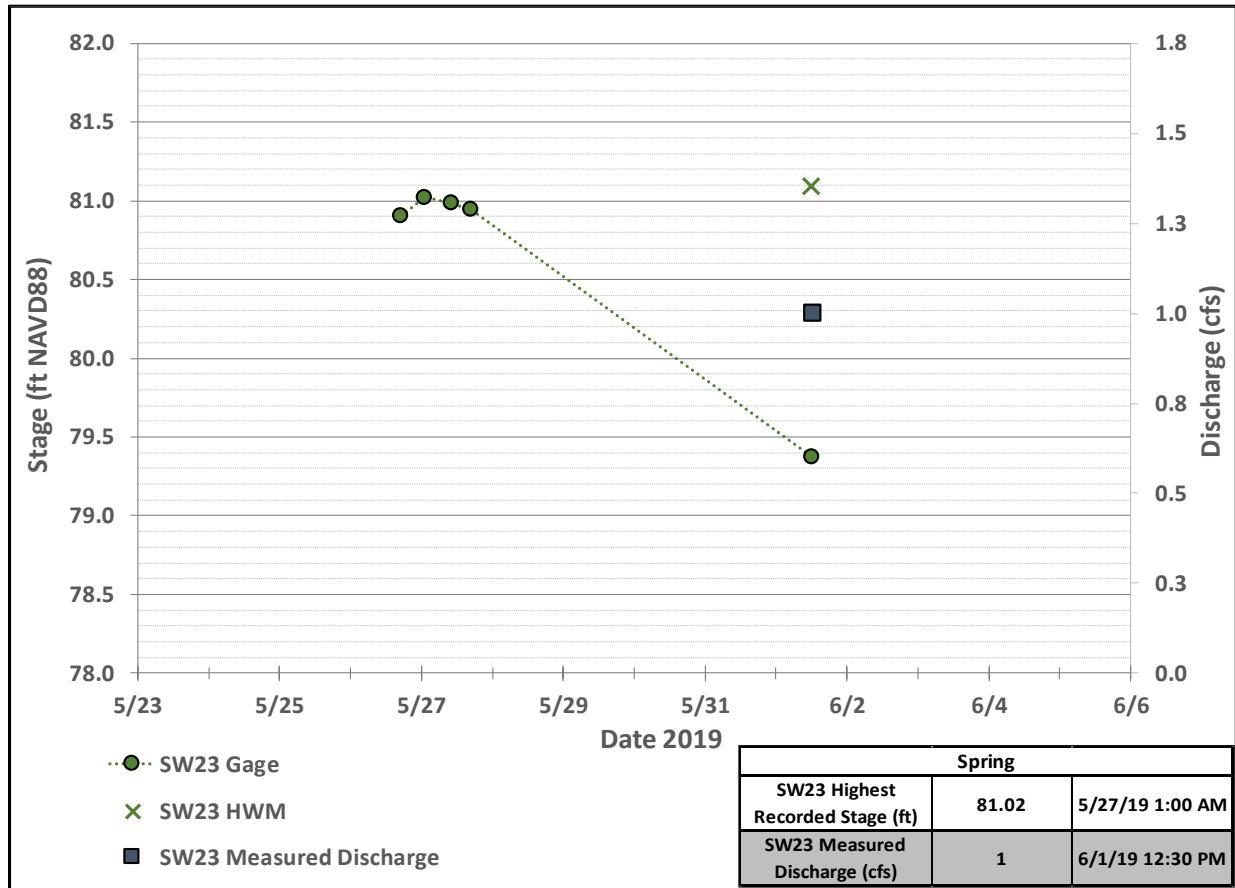
Graph 4.34: Swale 23 Spring Breakup Stage & Discharge

Swale 23 spring stage and measured discharge data are presented in Graph 4.34. Measured discharge data and plan and profile figures are provided in Appendix C. Elevations are referenced to NAVD88.

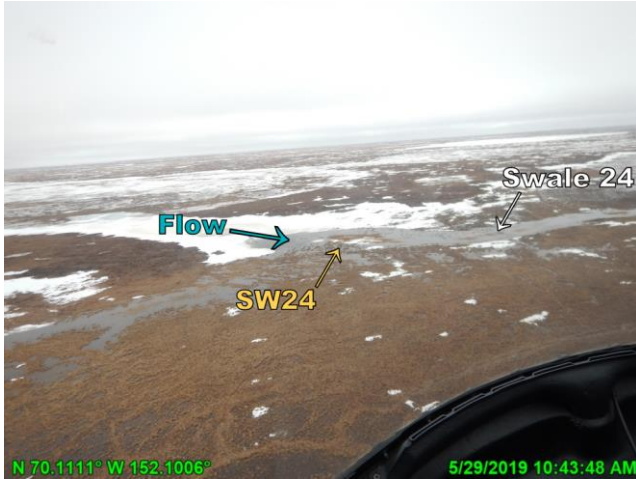
Photo 4.106: Meltwater in the SW24 drainage, looking northeast (upstream); May 29, 2019

On May 29 site observations revealed meltwater flowing out of the unnamed lake past SW24. Snow and ice were present in the drainage, particularly on the unnamed lake, but the channel was clear (Photo 4.106). Stage appeared near bankfull. This section of the swale was predominantly shallow and wide with a grass-lined bottom. Discharge was measured near SW24 on May 29 (Photo 4.107). The overall quality of the discharge measurement was classified as good based on the open-channel conditions present. An HWM captured on May 29 recorded peak stage as 85.35 ft.

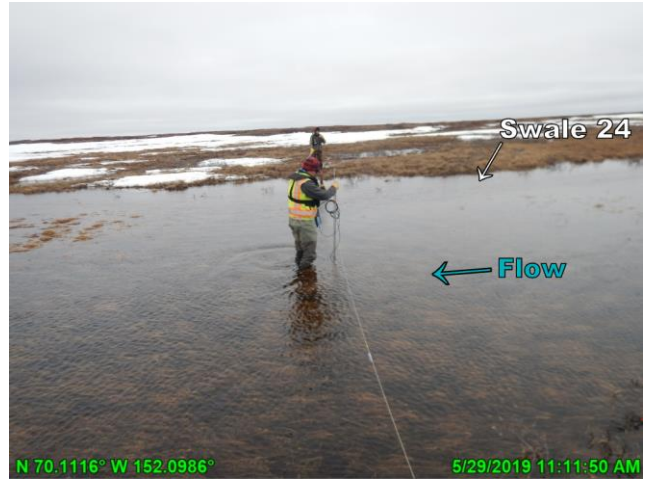
Photo 4.107: Measuring discharge near SW24, looking south; May 29, 2019

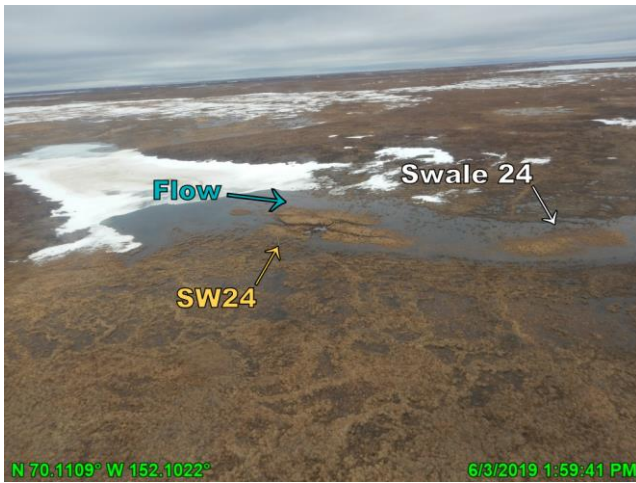
Photo 4.108: Receding stage near SW24, looking northeast (upstream); June 3, 2019

Aerial observations from June 3 show bankfull stage and minimal snow in the channel and along the banks (Photo 4.108). The unnamed lake was still covered with ice. Snow cover on the surrounding tundra was approximately 5 percent. By July 2, water was noted as widespread and stagnant across the swale depression (Photo 4.109).

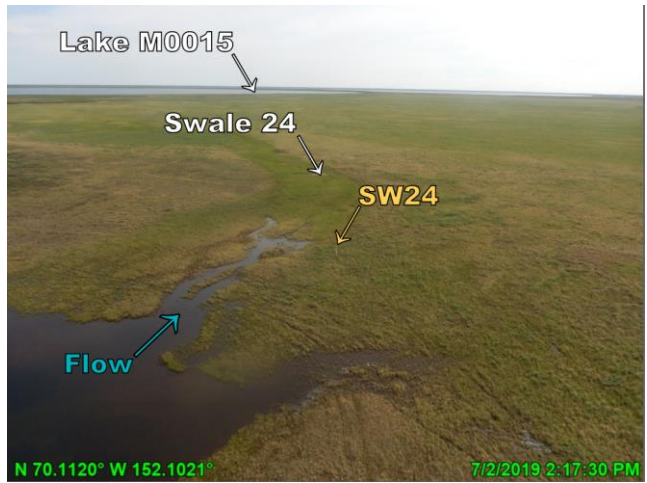
Photo 4.109: Summer conditions at SW24, looking south (downstream); July 2, 2019

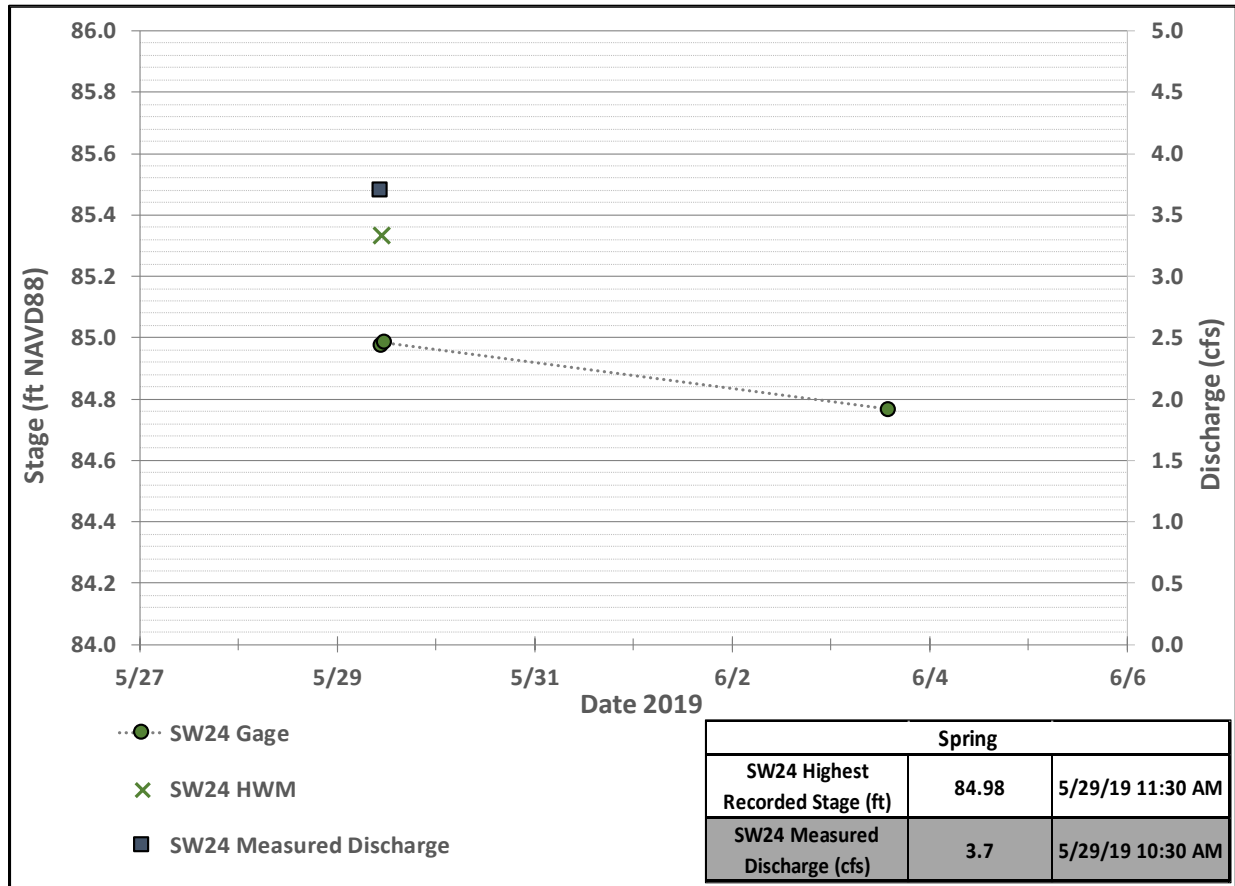
Graph 4.35: Swale 24 Spring Breakup Stage & Discharge

Swale 24 stage and measured discharge data are presented in Graph 4.35. Measured discharge data and plan and profile figures are provided in Appendix C. Elevations are referenced to NAVD88.

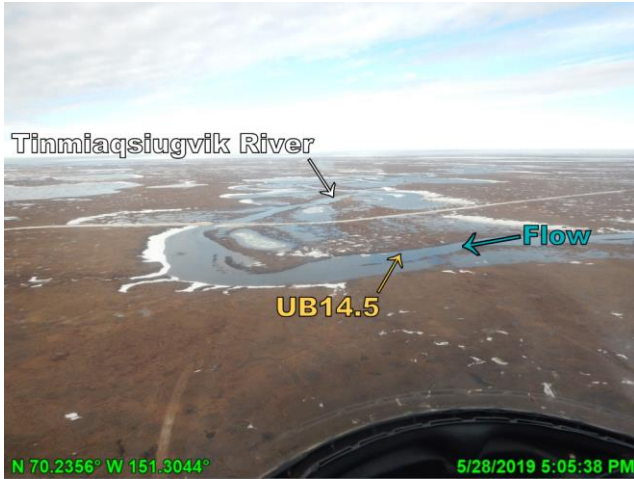
Photo 4.110: Bankfull conditions in the Tinmiaqsiugvik River near UB14.5, looking north (downstream); May 28, 2019

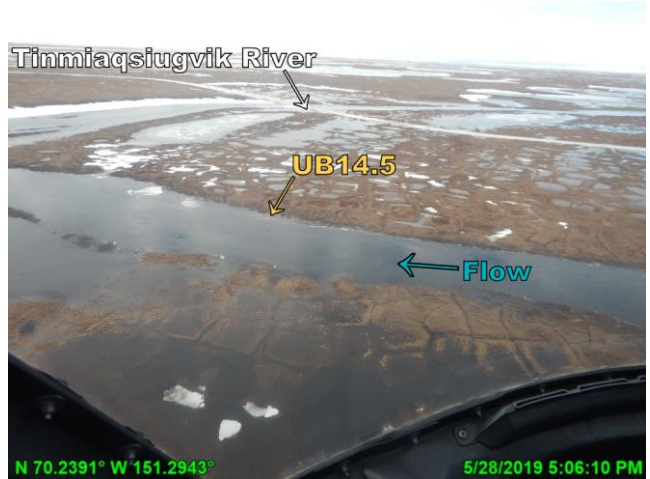
Photo 4.111: Stranded ice near UB14.5, looking west (downstream); May 28, 2019

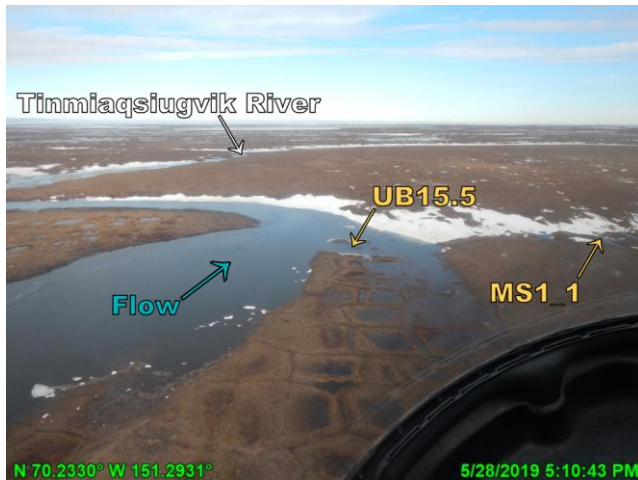
Photo 4.112: Overbank flooding near UB15.5; looking east (downstream); May 28, 2019

Initial meltwater was first recorded on PTs at both sites on May 22. Stage increased until peak stage conditions occurred at UB15.5 on May 26. Peak at UB14.5 also likely occurred on May 26, but a PT malfunction at this site prevented a conclusive determination of peak stage magnitude and timing. Site observations on May 28 reveal stage above bankfull at UB14.5, with minor overbank flooding in low-lying areas particularly along the west bank (Photo 4.110). Stranded ice was observed along the channel banks and overbanks near UB14.5, suggesting peak stage had exceeded bankfull and was now decreasing (Photo 4.111). At UB15.5, overbank flooding was observed near the low-lying area near the gage station (Photo 4.112). Drifted snow was observed in the MS1\_1 swale. Stranded ice was also observed near UB15.5.

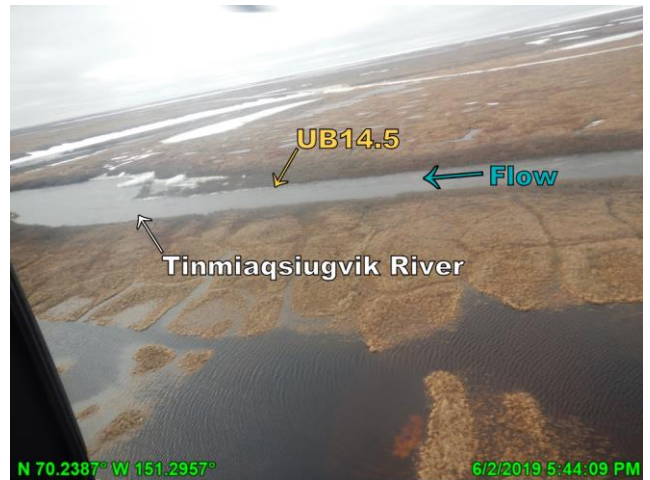
Photo 4.113: Discharge cross-section in the Tinmiaqsiugvik River near UB14.5, looking north (downstream); June 2, 2019

On June 2, discharge was measured using a tethered ADCP, slightly upstream of the UB14.5 gage station. At the time of the discharge measurement, stage had receded nearly 5 feet from peak conditions and was below bankfull. Stranded ice and wood debris were observed in the overbank in various locations within the monitoring reach (Photo 4.113). Ice floes were observed periodically flowing through the reach during the discharge measurement, but the channel was otherwise clear of ice and snow. The overall quality of the discharge measurement was classified as good based on these conditions. By June 3, stage had receded to below bankfull at UB15.5 (Photo 4.114). Drifted snow was observed along the banks and snow cover on the surrounding tundra was approximately 5%.

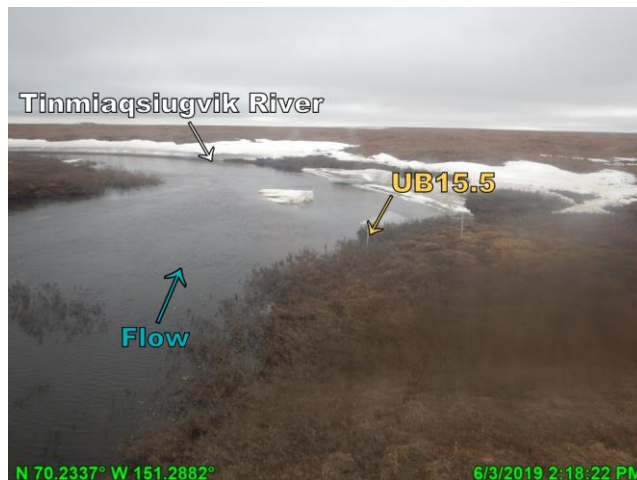
Photo 4.114: Receding stage in the Tinmiaqsiugvik river, looking east (downstream); June 3, 2019

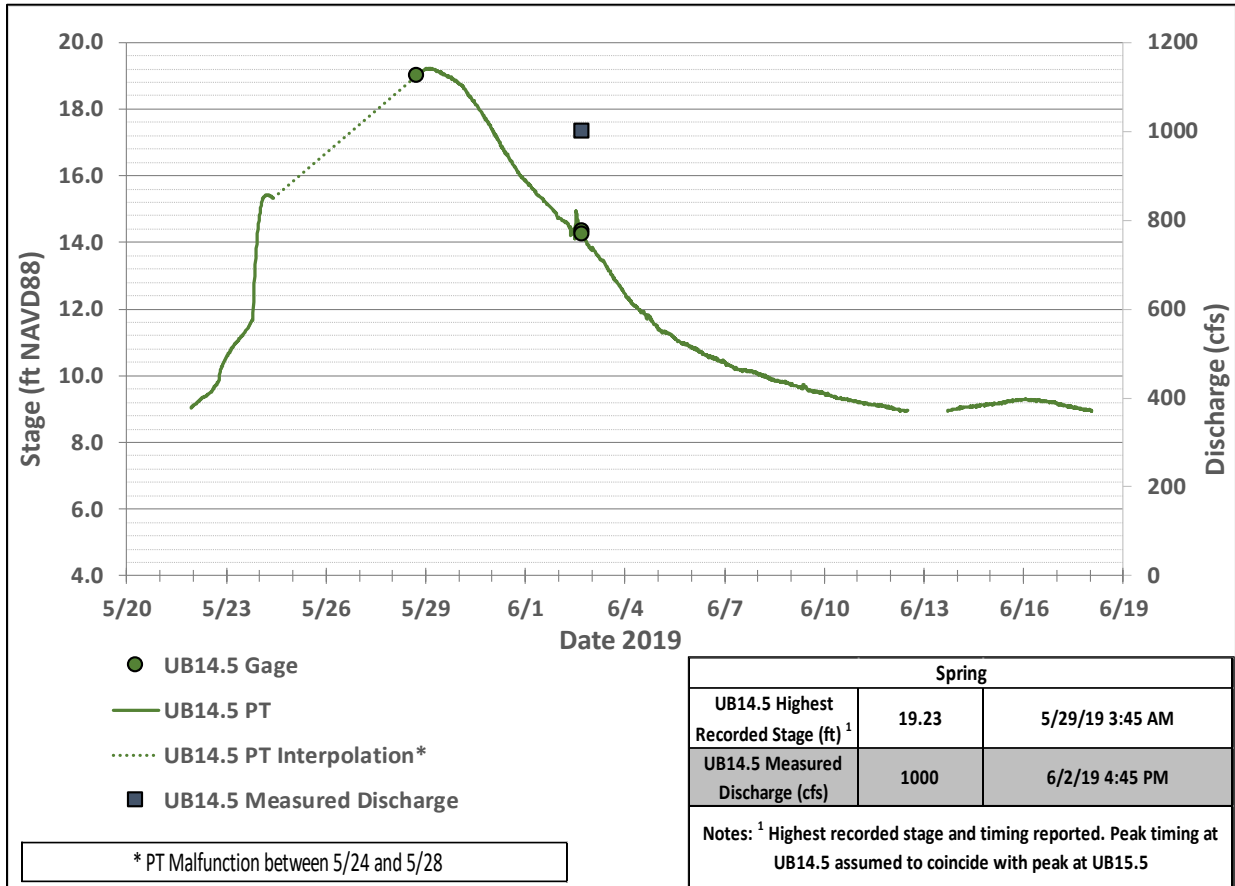
Graph 4.36: UB14.5 Spring Breakup Stage and Discharge

The UB14.5 and UB15.5 stage and measured discharge data are presented in Graph 4.36 and Graph 4.37, respectively. Measured discharge data and plan and profile figures are provided in Appendix C. Elevations are referenced to NAVD88.

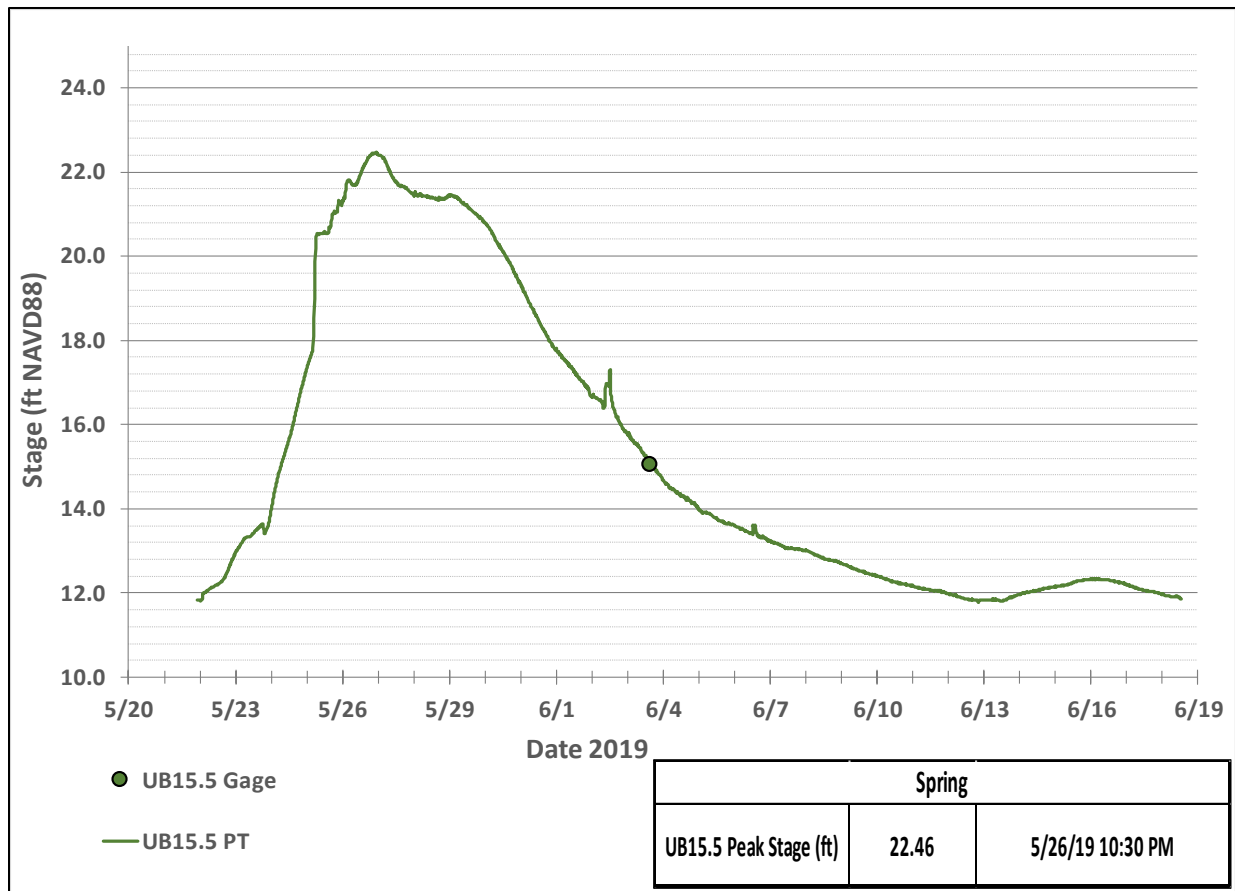
Graph 4.37: UB15.5 Spring Breakup Stage

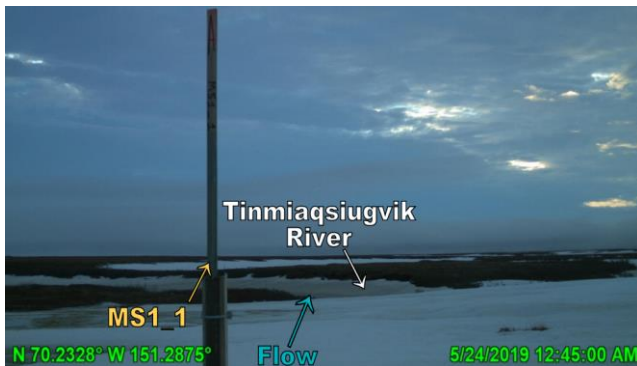
**Photo 4.115:** Game camera image of peak stage at MS1\_1, looking northwest (downstream); May 24, 2019

Initial meltwater was first recorded on the MS1\_1 PT on May 23. Game camera images from this day show meltwater, confined by saturated snow, accumulating around the gage station. Peak stage occurred early morning on May 24 and was likely the result of disconnected local melt (Photo 4.115). Meltwater appeared to break through the saturated snow and connect with the Tinmiaqsiugvik River in the afternoon of May 24, corresponding with a sharp drop in stage. On the afternoon of May 25, increasing localized meltwater was observed at MS1\_1 through game camera images. Peak stage on the Tinmiaqsiugvik River at UB15.5 occurred on May 26 (Photo 4.116).

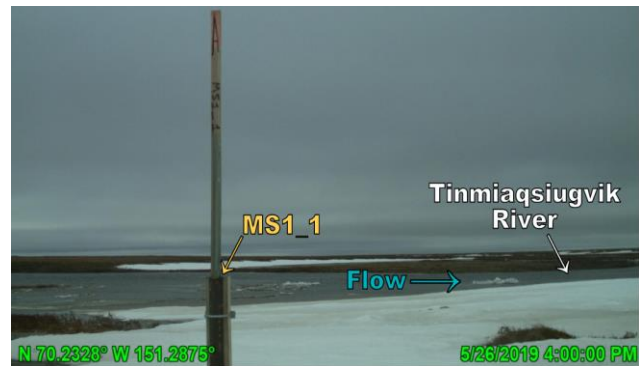
**Photo 4.116:** Game camera image of peak stage at UB15.5 from the MS1\_1 gage, looking northwest (downstream); May 26, 2019

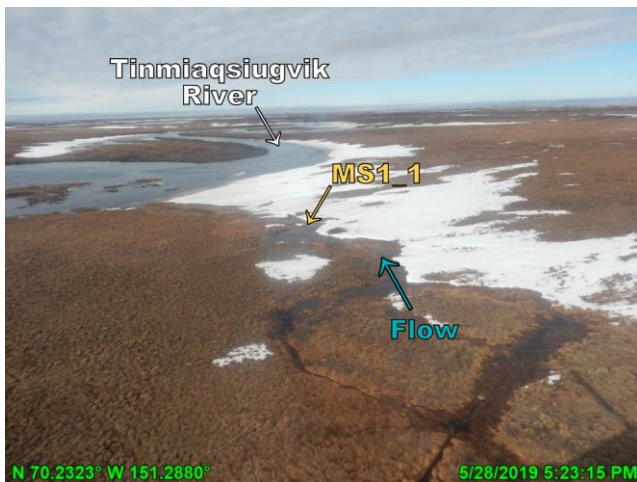
**Photo 4.117:** Meltwater flowing over exposed tundra near MS1\_1, looking north (downstream); May 28, 2019

On May 28, site observations at MS1\_1 reveal meltwater flowing over exposed tundra and into the Tinmiaqsiugvik River. Snow present along the east bank of the swale did not appear to confine flow. Multiple flow paths within polygon troughs were noted around the gage site (Photo 4.117). Snow cover on the surrounding tundra was approximately 5 percent, not including drifted snow within the swale drainage. Overbank flooding was still seen at the nearby UB15.5 gage station. By June 3, stage had receded to near summer levels and minimal snow remained in the MS1\_1 drainage (Photo 4.118). Summer stage did not reach the spring PT elevation during summer monitoring.

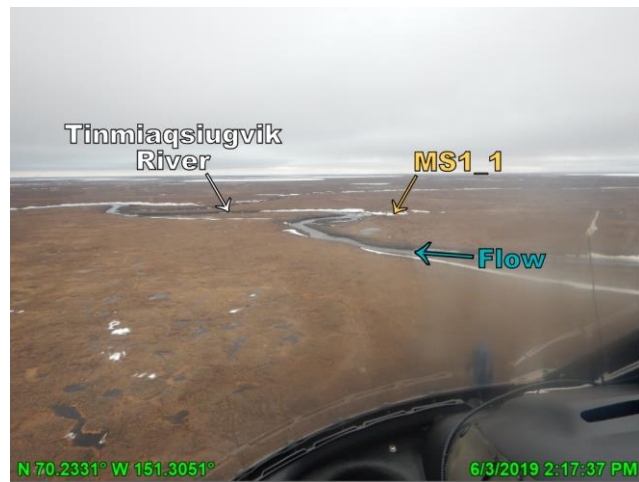
**Photo 4.118:** Receding stage in the Tinmiaqsiugvik River near MS1\_1, looking east (downstream); June 3, 2019

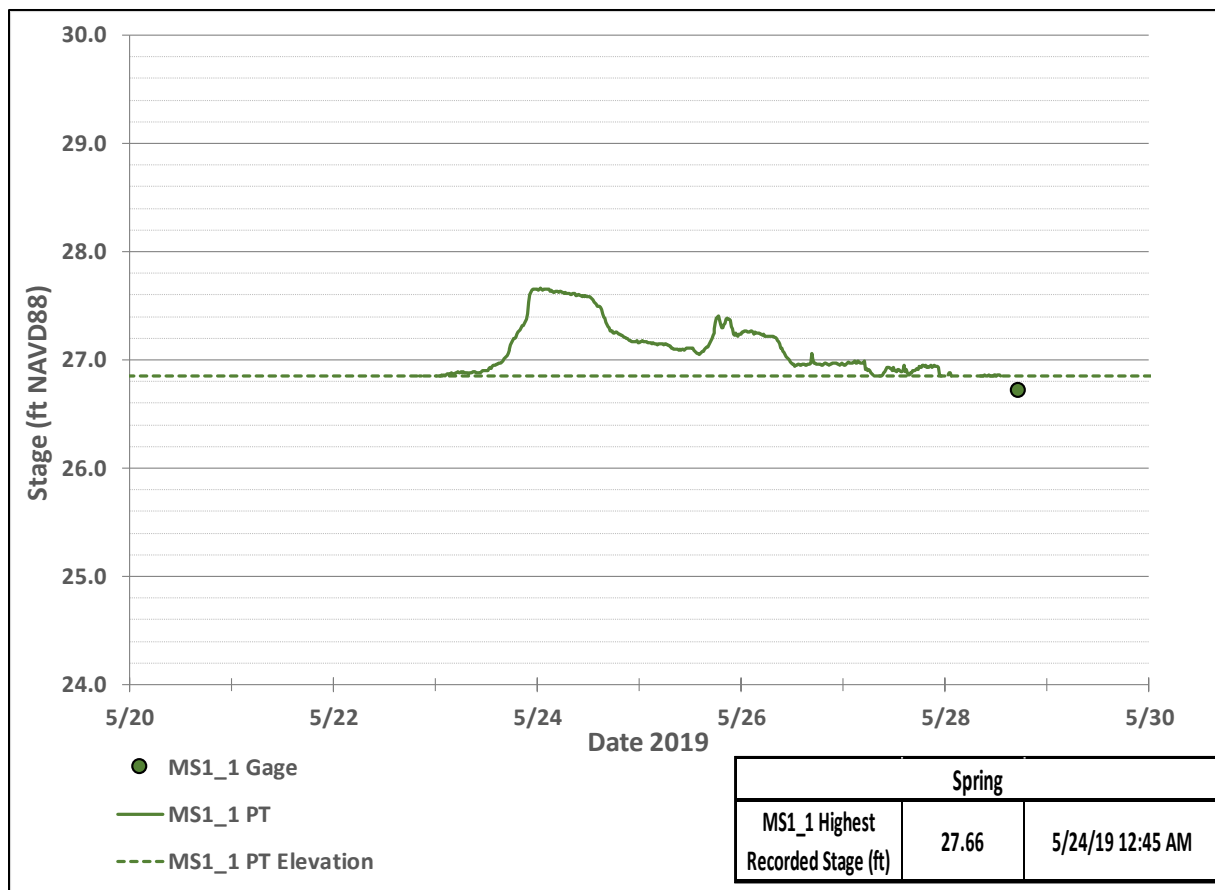
Graph 4.38: MS1\_1 Spring Breakup Stage

MS1\_1 stage data are presented in Graph 4.38. Elevations are referenced to NAVD88.

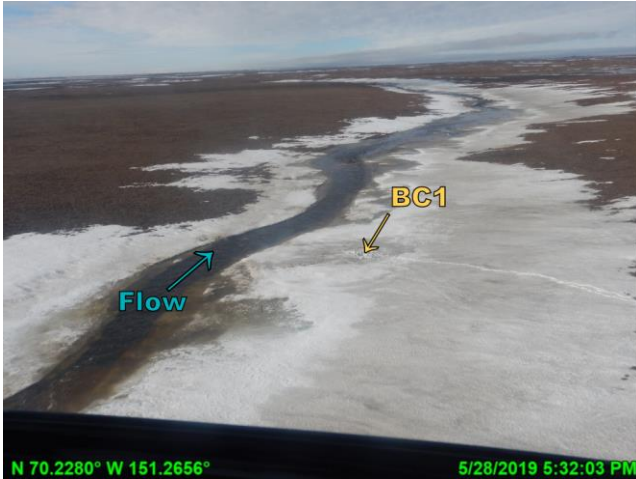
Photo 4.119: Meltwater flowing over saturated snow near BC1, looking north (downstream); May 28, 2019

Initial meltwater was first recorded at BC1 on May 19. Stage increased until peak conditions occurred on May 23. On May 28, site observations revealed meltwater flowing with high velocity overtop of drifted snow in the channel (Photo 4.119). No overbank flooding was noted as flow was confined to the defined channel. Snow cover on the surrounding tundra was approximately 5 percent. Stage decreased until the end of the spring monitoring period on June 3. On June 3, snow was present in the drainage and still appeared to confine meltwater (Photo 4.120).

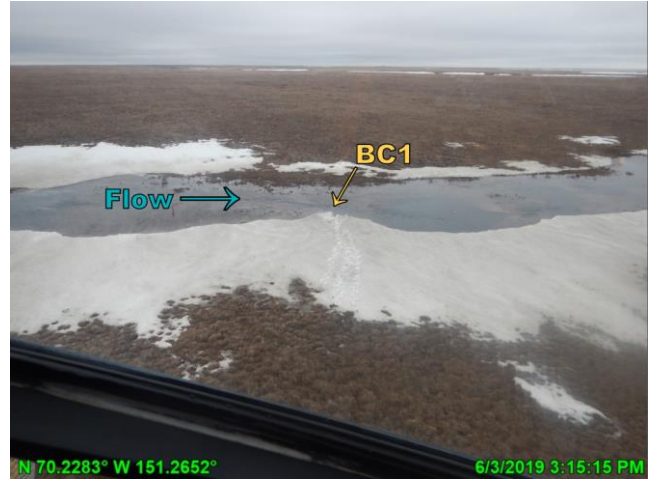
Photo 4.120: Receding stage at BC1, looking west; June 3, 2019

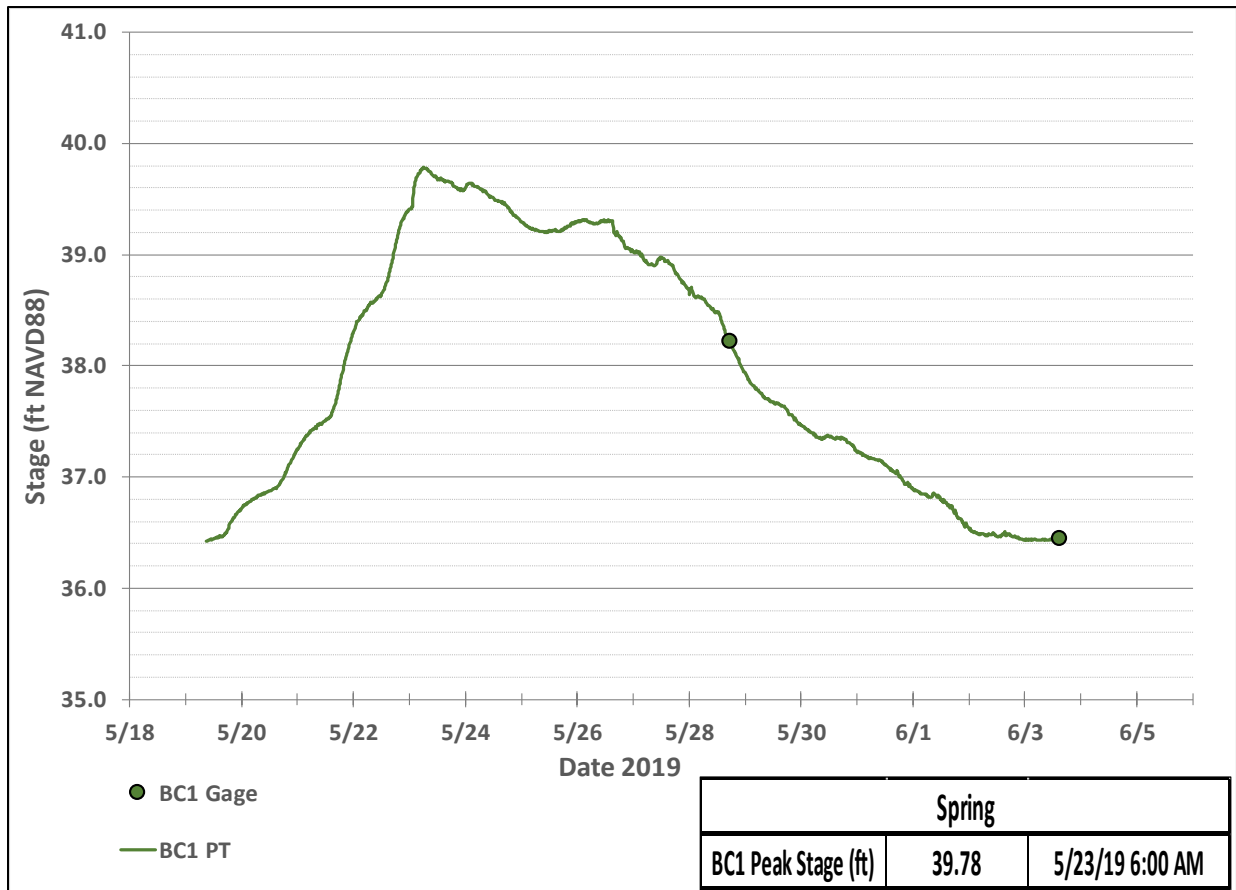
Graph 4.39: BC1 Spring Breakup Stage

The BC1 spring stage data are presented in Graph 4.39. Elevations are referenced to NAVD88.

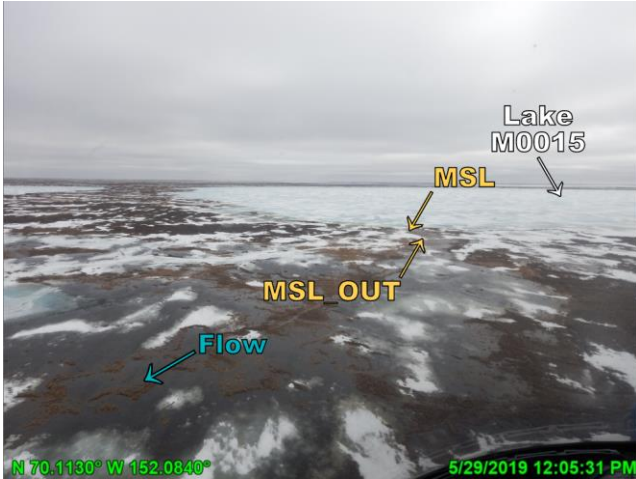
Photo 4.121: MSL drainage one day prior to peak stage, looking southeast (upstream); May 29, 2019

Meltwater was initially recorded on the MSL PT on May 28. On May 29, stage at MSL and MSL\_OUT began to rise concurrently, culminating in peak stage conditions at each site on May 30. Site observations conducted on May 29 show an open water lead near MSL, and saturated snow with minor overbank flooding near MSL\_OUT. Aerial photographs show integrated flow was confirmed as meltwater was seen extending from M0015 to the W3S reach (Photo 4.121). At both MSL and MSL\_OUT, overbank flooding was observed, and the main outlet channel was difficult to identify.

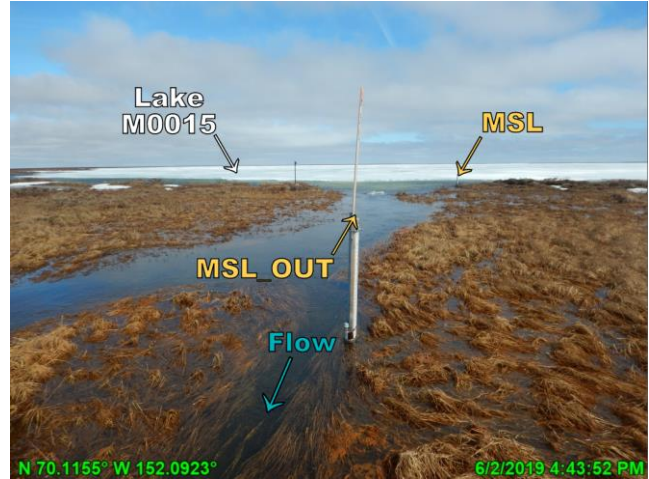
Photo 4.122: Meltwater near MSL & MSL\_OUT, looking southeast (upstream); June 2, 2019

On June 2, site observations revealed channelized flow between MSL and MSL\_OUT with stage slightly exceeding bankfull. Minor overbank flooding was observed in low-lying areas around the channel. Gage MSL\_OUT is situated in a well-defined, but very small (about 1-ft across) grass lined channel which bifurcated from the main channel about 30 feet to the north (Photo 4.122). This fork converges with the main channel about 100 feet downstream of MSL\_OUT. From there, the channel is well-defined for another 200 feet, then opens into the poorly defined, low-relief drainage area associated with W3S. No saturated snow was observed in the drainage near the MSL and MSL\_OUT gage station and lake M0015 was still covered with ice. The PT data indicates that stage leveled off at both sites around June 10.

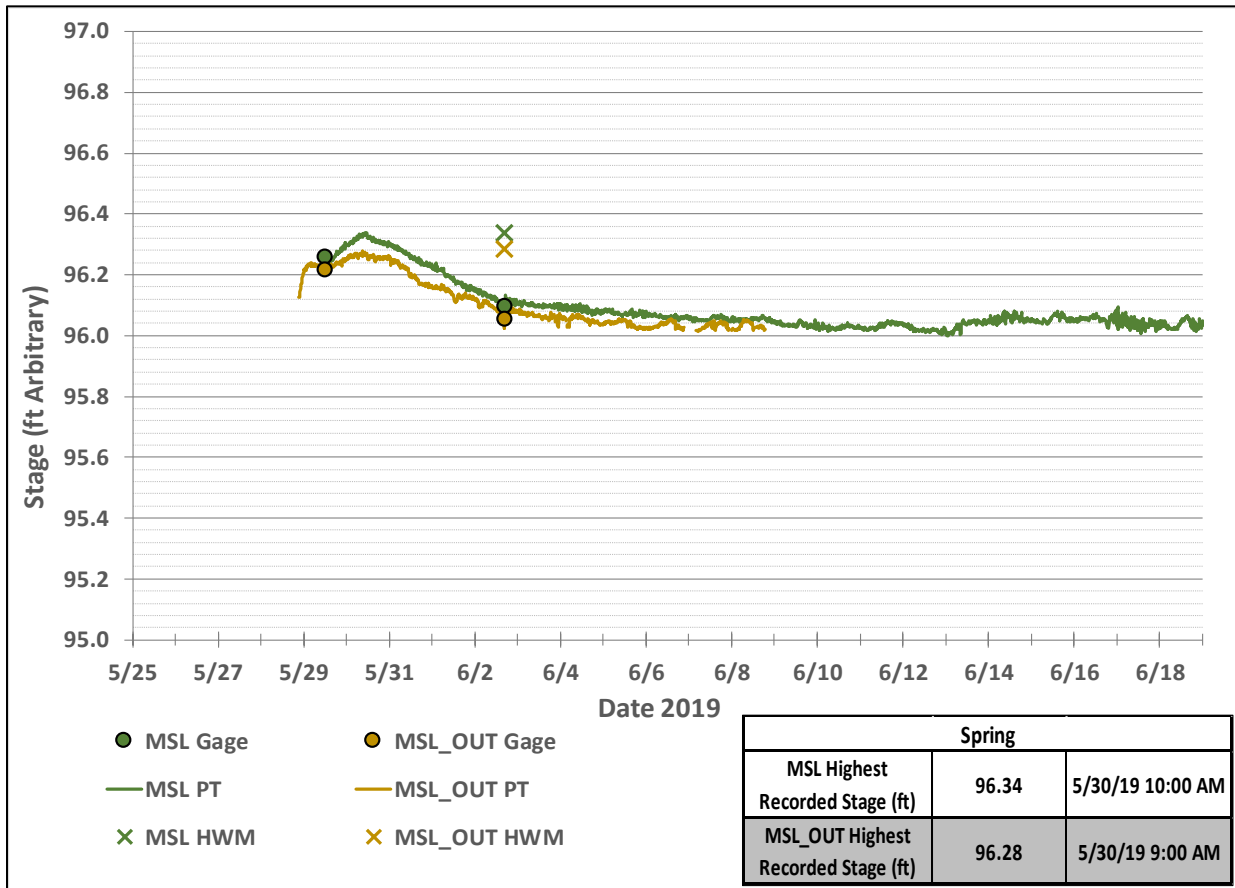
Graph 4.40: Middle Snowman Lake at MSL & MSL\_OUT Spring Breakup Stage

Gage stations MSL and MSL\_OUT stage and is presented in Graph 4.40. Elevations are referenced to an arbitrary datum based on a local control point.

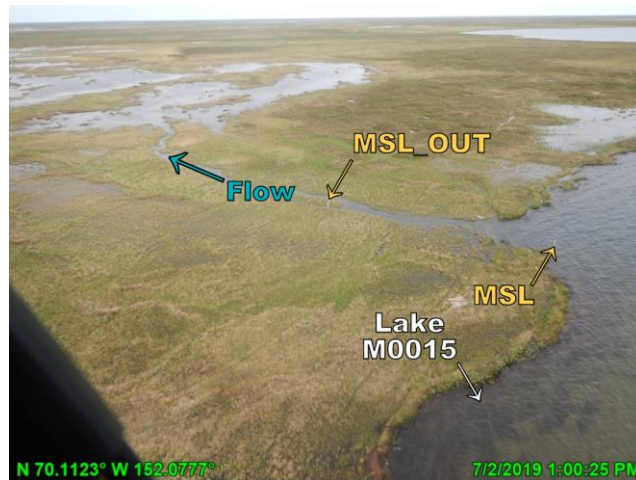
**Photo 4.123: Summer conditions at MSL & MSL\_OUT, looking north (downstream); July 2, 2019**

Summer stage was measured at both MSL and MSL\_OUT. Small stage fluctuations associated with summer precipitation events were recorded in the data; water levels remained below spring breakup peak spring stage (Photo 4.123). During the summer observation period, no flow was present, although standing water around the gage was observed. Summer stage at MSL and MSL\_OUT is presented in Graph 4.41.

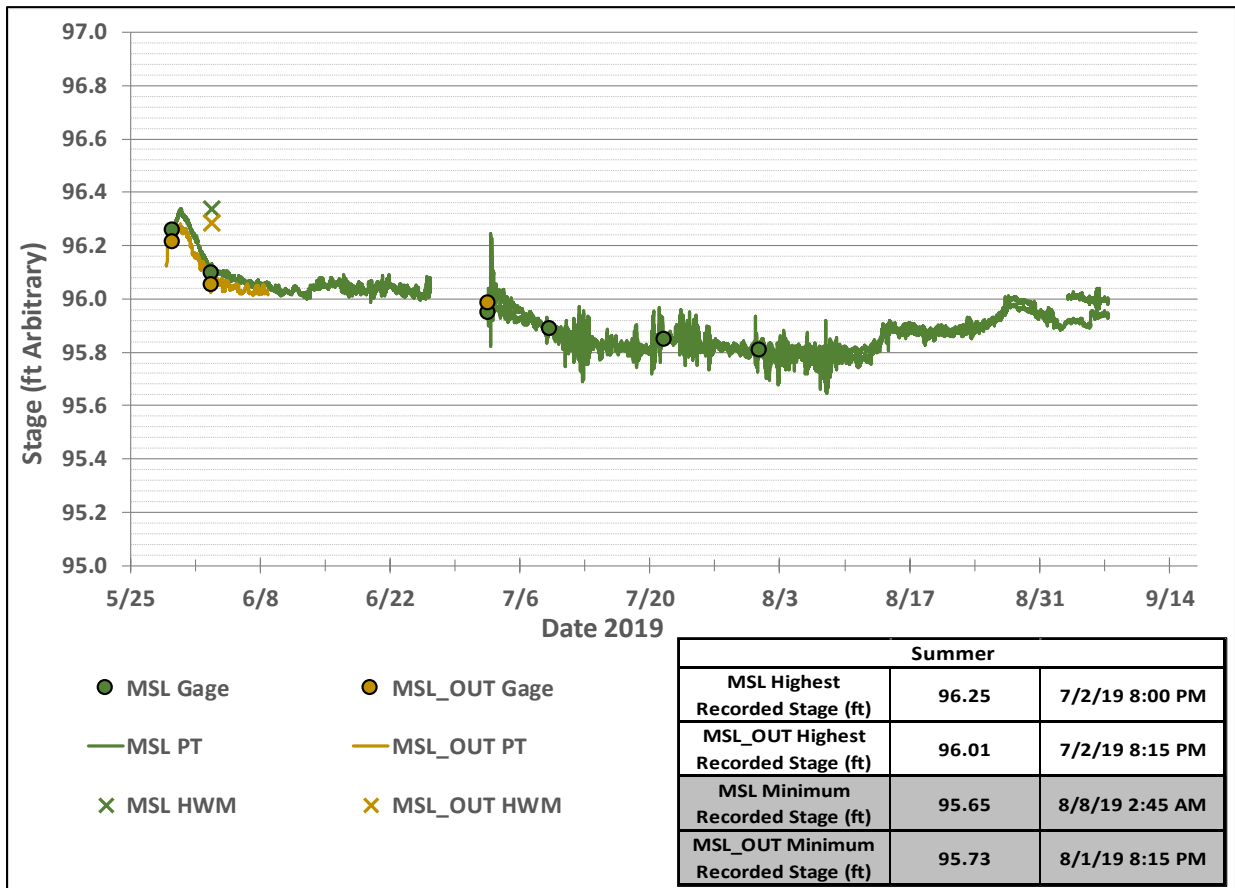
**Graph 4.41: Middle Snowman Lake at MSL & MSL\_OUT Summer Stage**

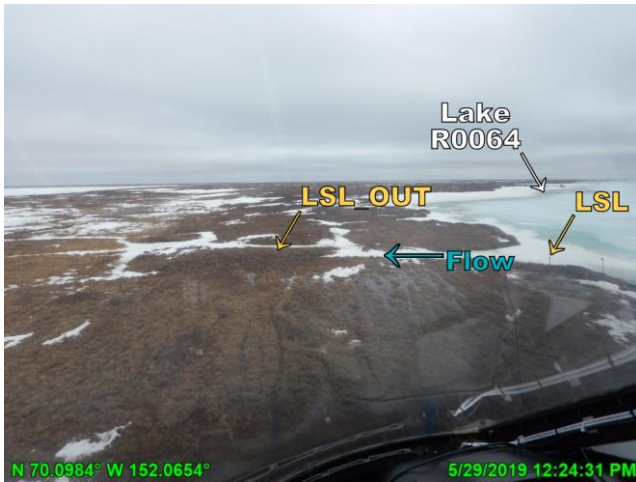
Photo 4.124: Snow-filled drainage near LSL & LSL\_OUT, looking east; May 29, 2019

Meltwater was first recorded on the LSL PT on May 19 and was likely the result of isolated local melt. From May 19 to May 29, the LSL PT recorded the largest daily stage fluctuations in the monitoring period. After May 29, stage remained steady with fluctuations less than 0.1-ft. The LSL\_OUT PT recorded stage following a similar, steady trend after water reached the PT on June 1. Site observations at LSL and LSL\_OUT on May 29 showed local meltwater from lake R0064 reaching LSL but not LSL\_OUT. Aerial observations on this day confirmed that integrated flow had not yet developed as the swale was filled with snow (Photo 4.124). Disconnected local meltwater was present in low-lying areas to the west of the LSL outlet.

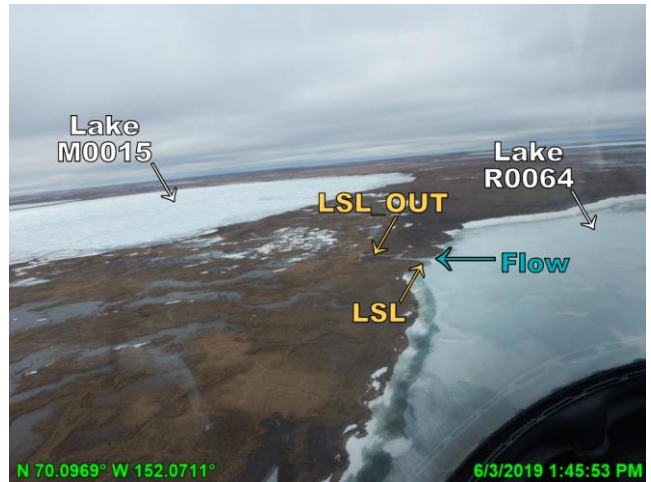
Photo 4.125: Meltwater between R0064 and M0015, looking northeast (downstream); June 3, 2019

By June 3, aerial observations showed a well-defined channel conveying flow from Lake R0064 north, past the LSL and LSL\_OUT gage stations, then across a poorly defined low-lying area, and eventually emptying into the south end of Middle Snowman Lake (Lake M0015) (Photo 4.125). Minimal snow remained in the area on this day. The flow-path observed upstream of the gage was well-defined with multiple 90-degree bends along polygon features. A bifurcation was observed at gage station LSL\_OUT, with two distinct channels each conveying flow into a low-lying area about 200 feet downstream of LSL\_OUT. Overbank flooding was observed in the low-lying areas closer to M0015, while flow was confined to the defined channels around the gage sites where bankfull conditions were observed. The lake was still covered with ice on June 3.

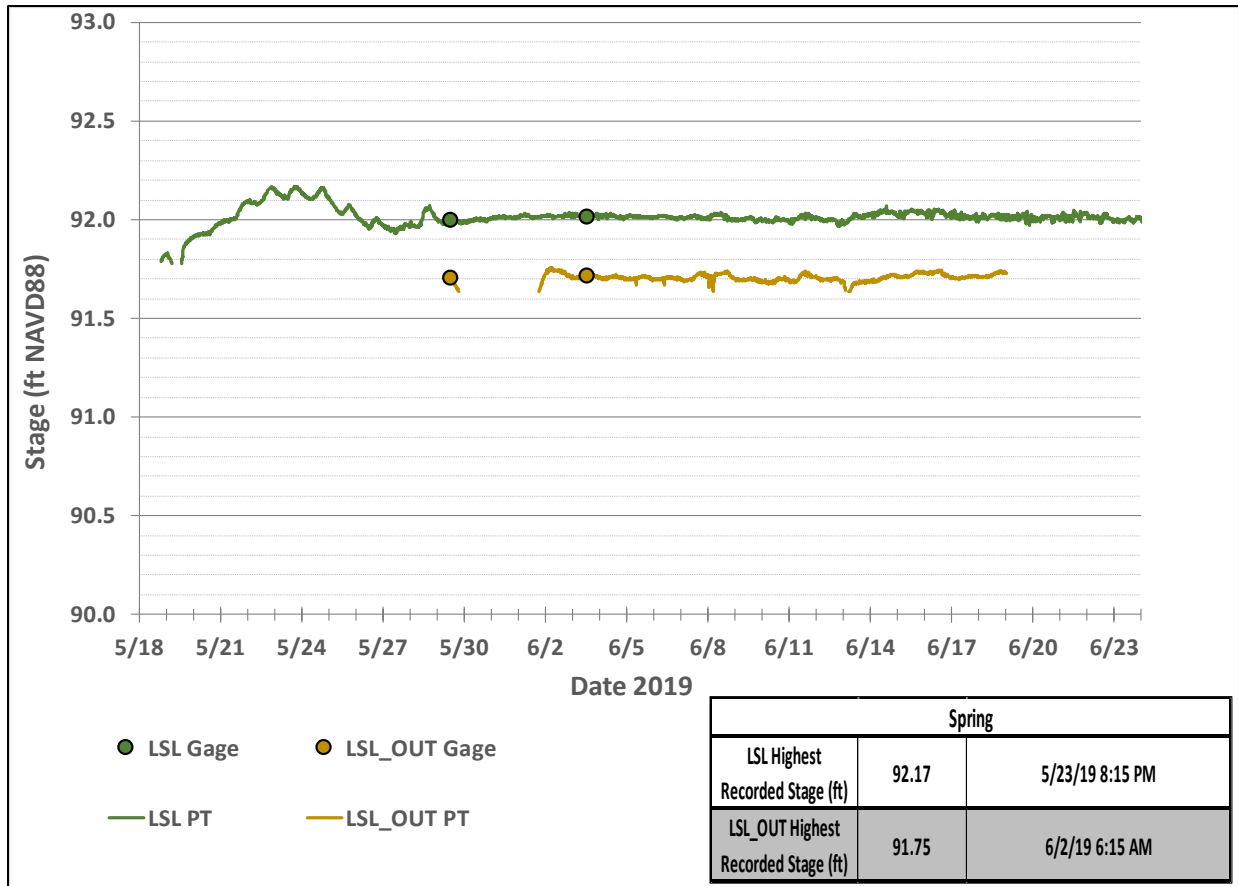
Graph 4.42: Lower Snowman Lake at LSL & LSL\_OUT Spring Breakup Stage

LSL and LSL\_OUT stage and is presented in Graph 4.42. Elevations are referenced to NAVD88.

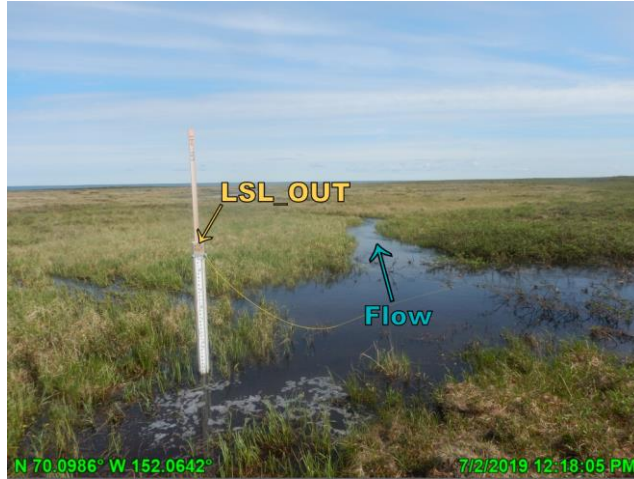
Photo 4.126: Summer conditions at LSL\_OUT, looking north (downstream); July 2, 2019

Small stage fluctuations associated with summer precipitation events were recorded in the data; water levels remained below spring breakup peak spring stage (Photo 4.126). During the summer observation period, no flow was present, although standing water around the gage was observed. Summer stage at LSL and LSL\_OUT is presented in Graph 4.43.

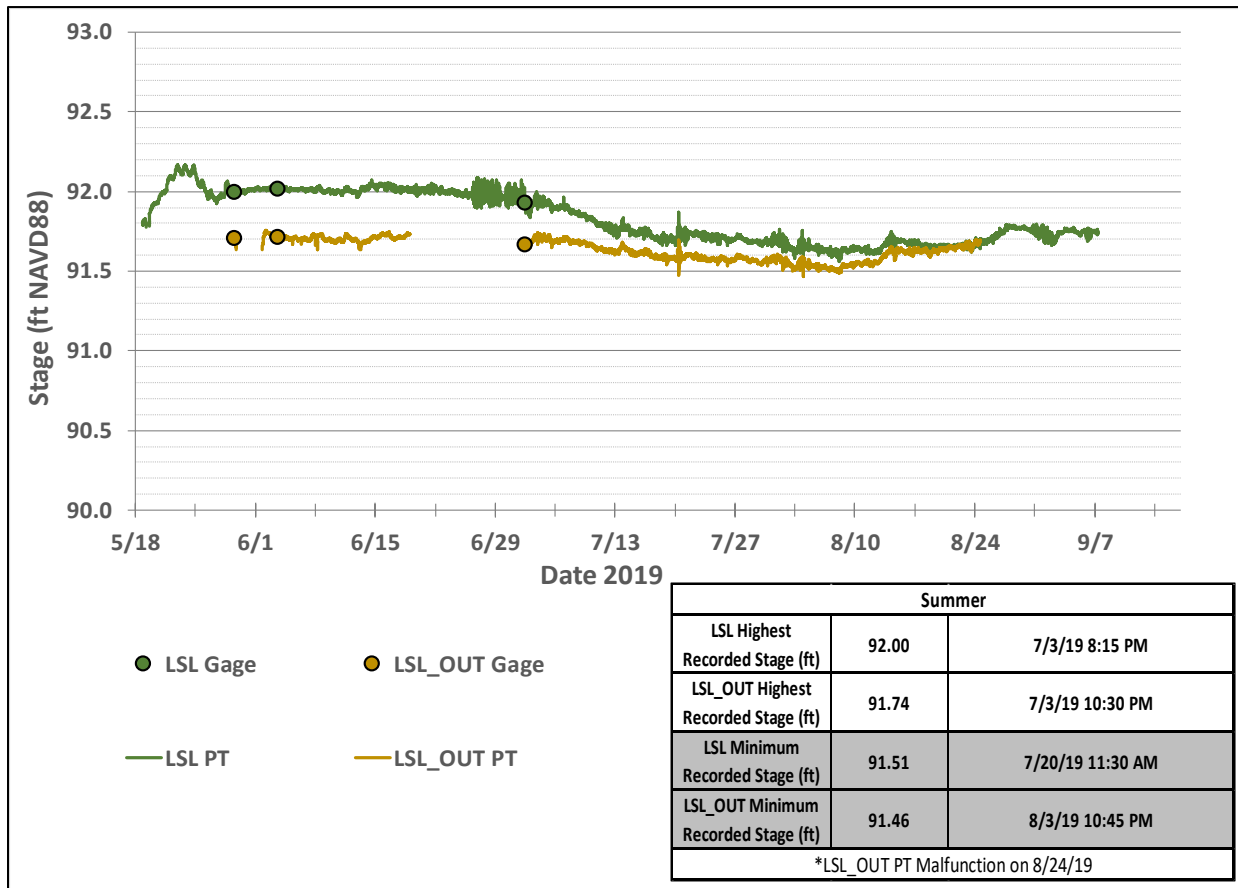
Graph 4.43: Lower Snowman at LSL & LSL\_OUT Summer Stage

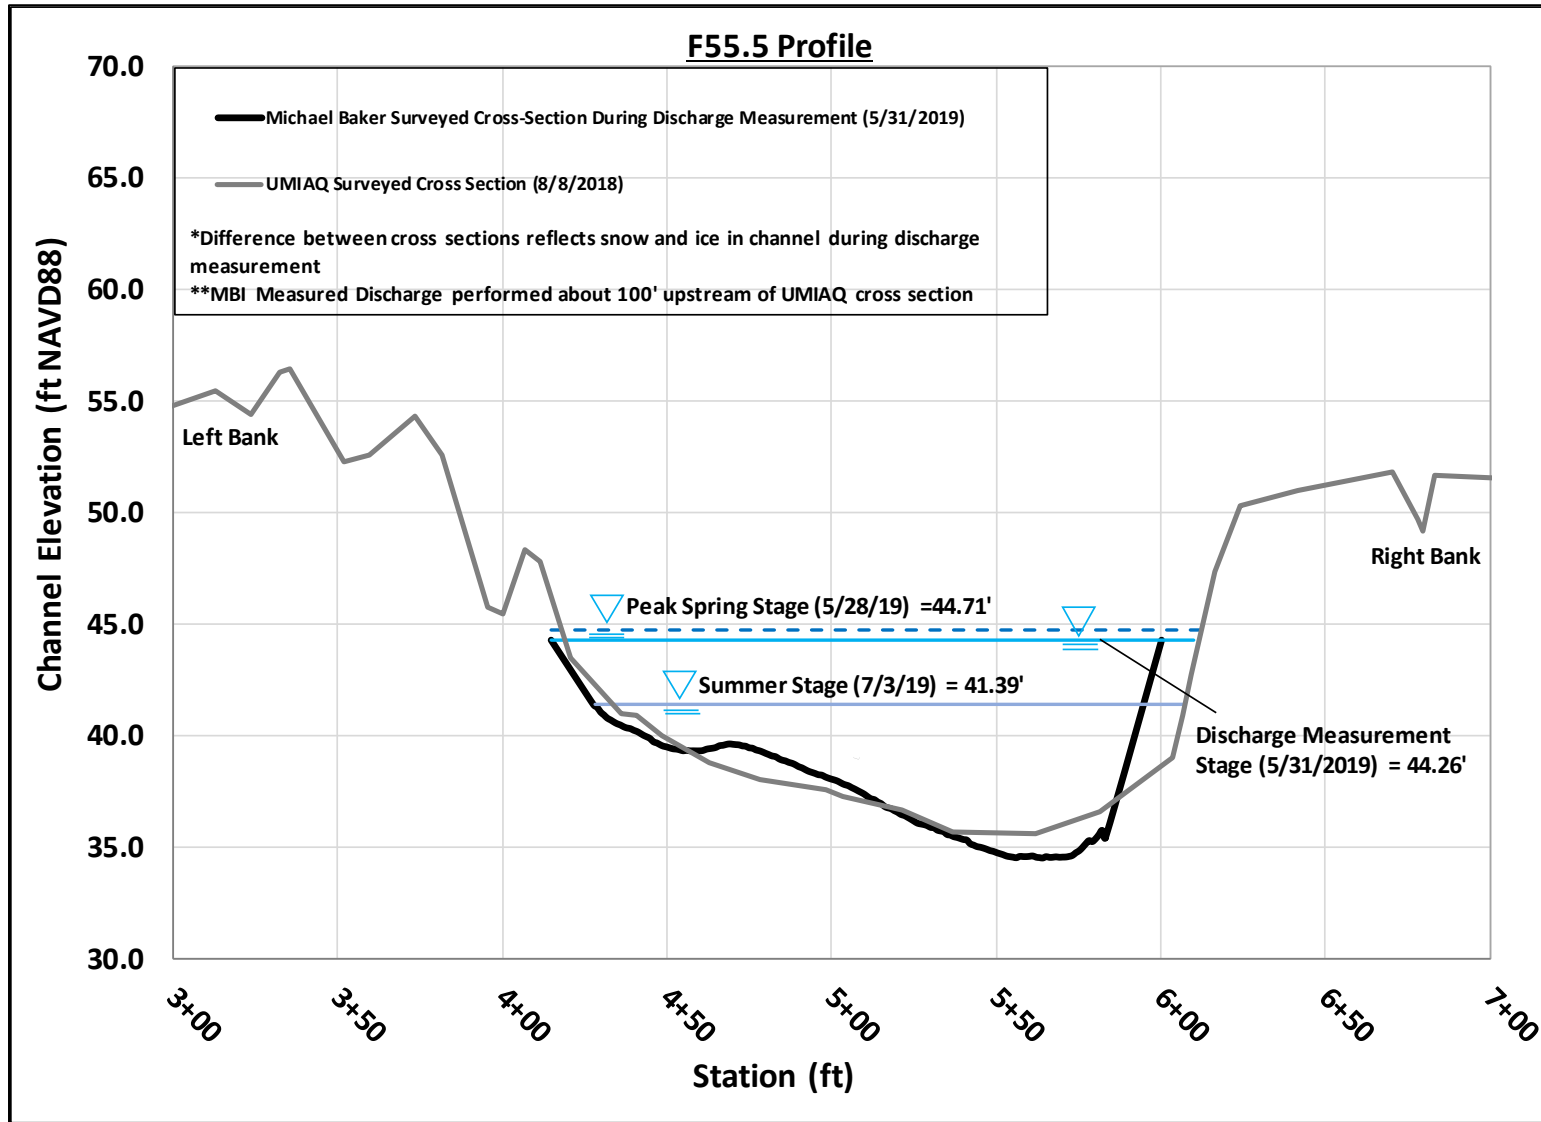
FIGURE C.1

Discharge was calculated indirectly using the Normal Depth method. The cross-section was developed from the average of four cross-sections extracted from the F55.5 May 31, 2019 ADCP direct discharge measurement. The energy grade line was approximated by the average water surface slope between F55.5U and F55.5D. Manning's n values were selected from reference documents (URS 2001) and calibrated to the measured discharge values in 2017. The 2019 calculated discharge values were compared to the direct discharge for 2019 to verify Manning's n values from 2017 are still valid. The calibrated Manning's n values used in the calculations were 0.023 for the left overbank, 0.020 for the main channel, and 0.023 for the right overbank.

Spring Breakup Cross-Section Profile
