# 2019 Willow Spring Breakup & Summer Monitoring & Hydrological Assessment

Prepared for:

**ConocoPhillips**  
Alaska

MSA Contract No. 296937

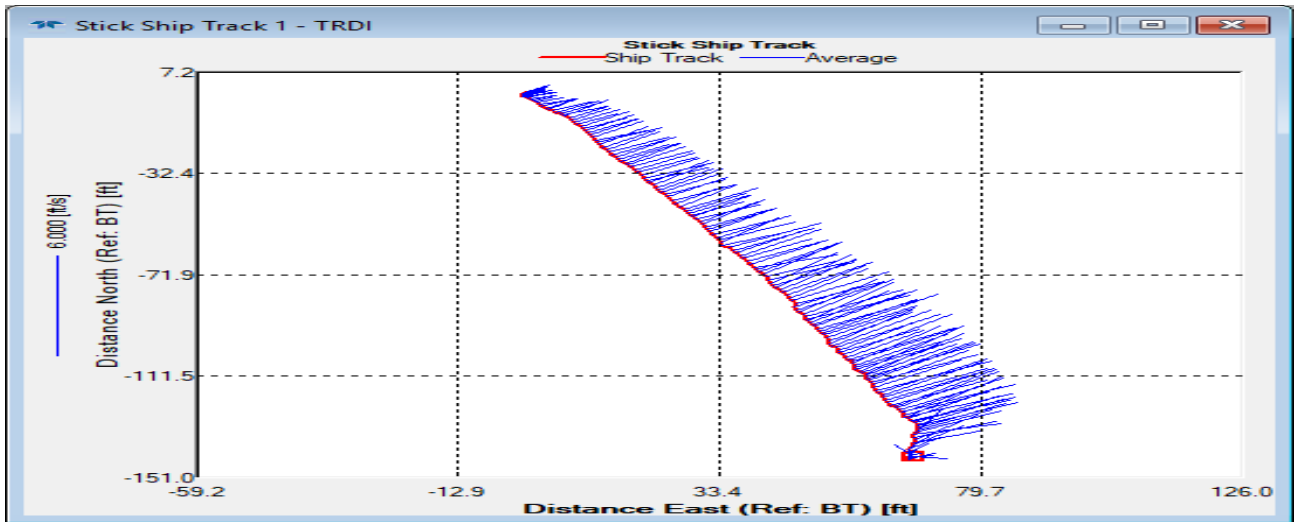
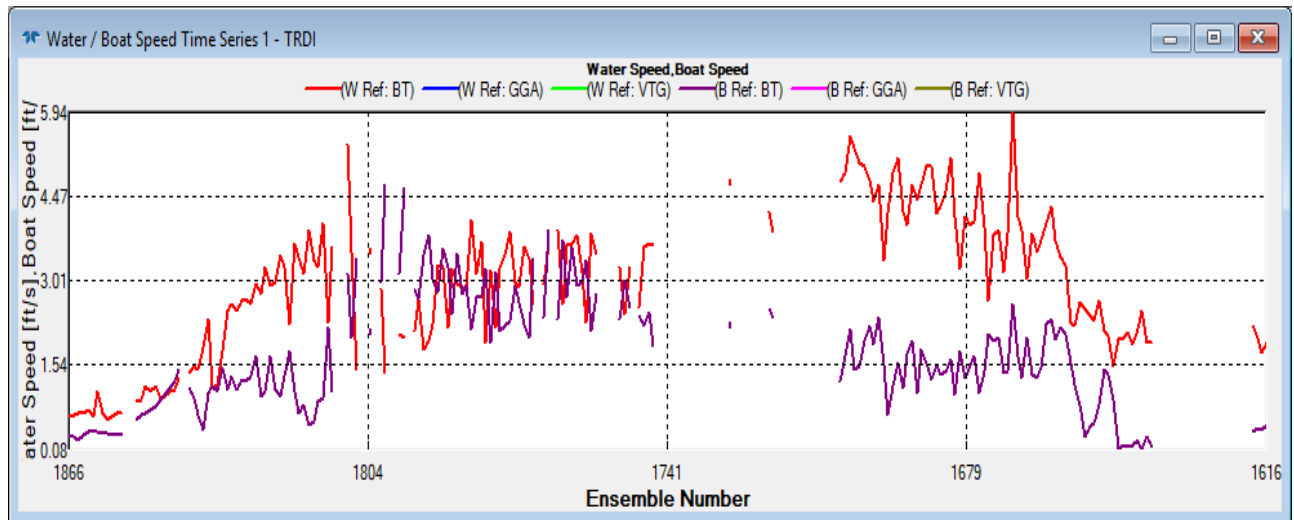
A. Transect J13.8-001 Raw Data Output

**Measurement Notes:** Moving bed conditions were identified, but discharge was not corrected for the moving bed using data acquired from the loop test because the percent bad bottom track (25%) exceeded the recommended threshold (5%).

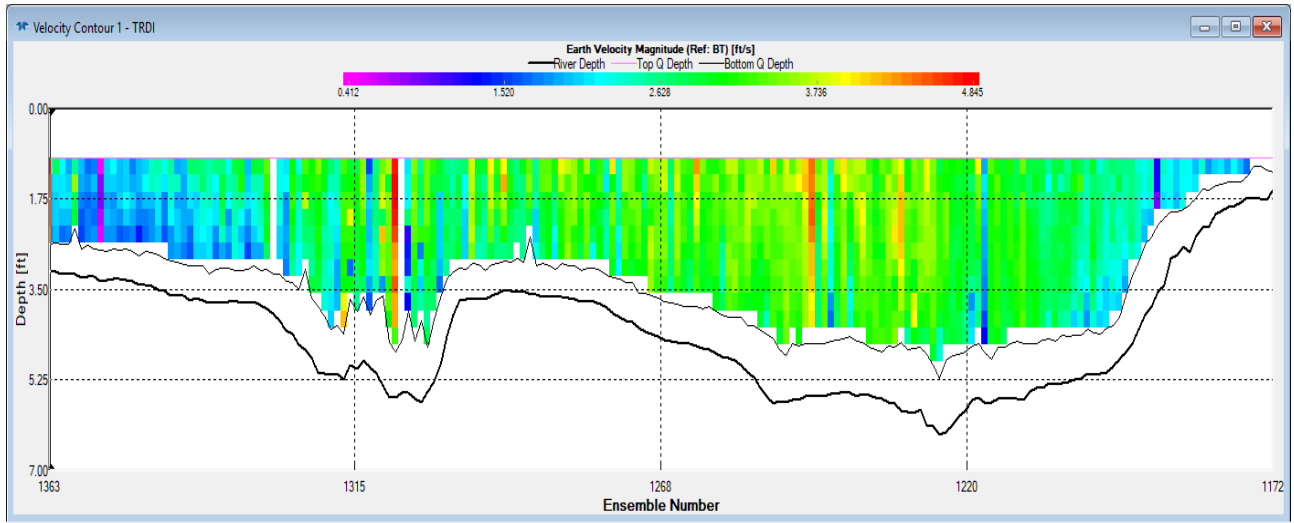
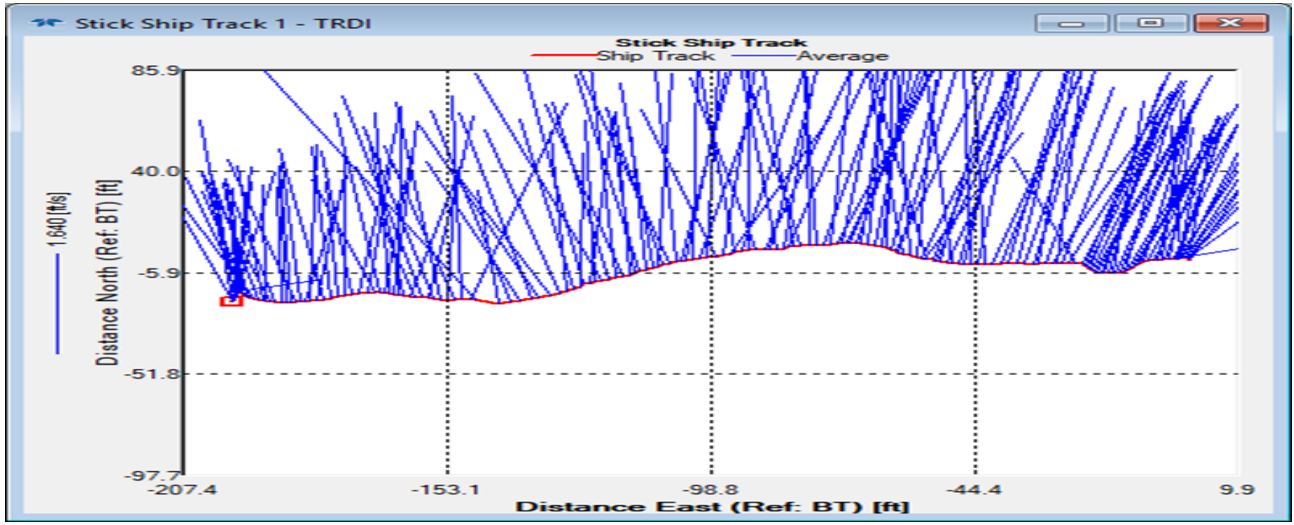
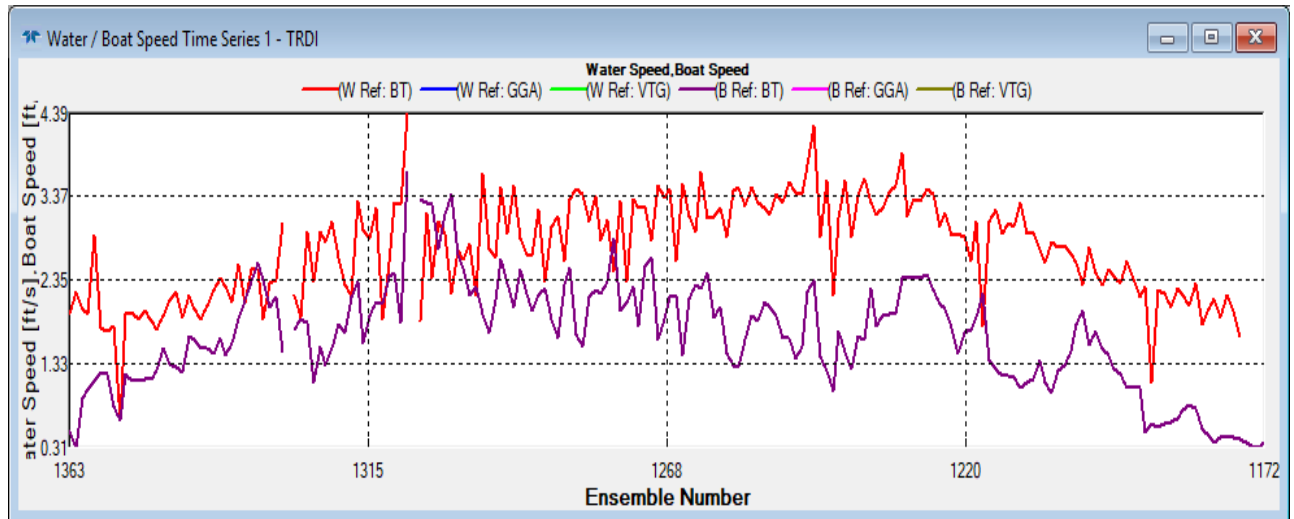
A. Transect J13.8-001 Raw Data Output

<b>Location:</b>	J13.8
<b>Date &amp; Time:</b>	June 1, 2019 12:15 PM
<b>Equipment:</b>	RiverRay ADCP mounted in a trimaran tethered to a tag line and pulled across the channel.
<b>Final Discharge (cfs):</b>	2,900
<b>Average Velocity (fps):</b>	3.1
<b>Measurement Rating:</b>	Fair

**Measurement Notes:** Moving bed conditions were identified and the discharge was corrected for moving bed using data acquired from the moving bed loop test performed before the six measured transects. Moving bed velocity estimated using the stationary moving bed test was 0.37 fps. The percentage of bad bottom track values (1.08%) was within the recommended maximum of 5%.

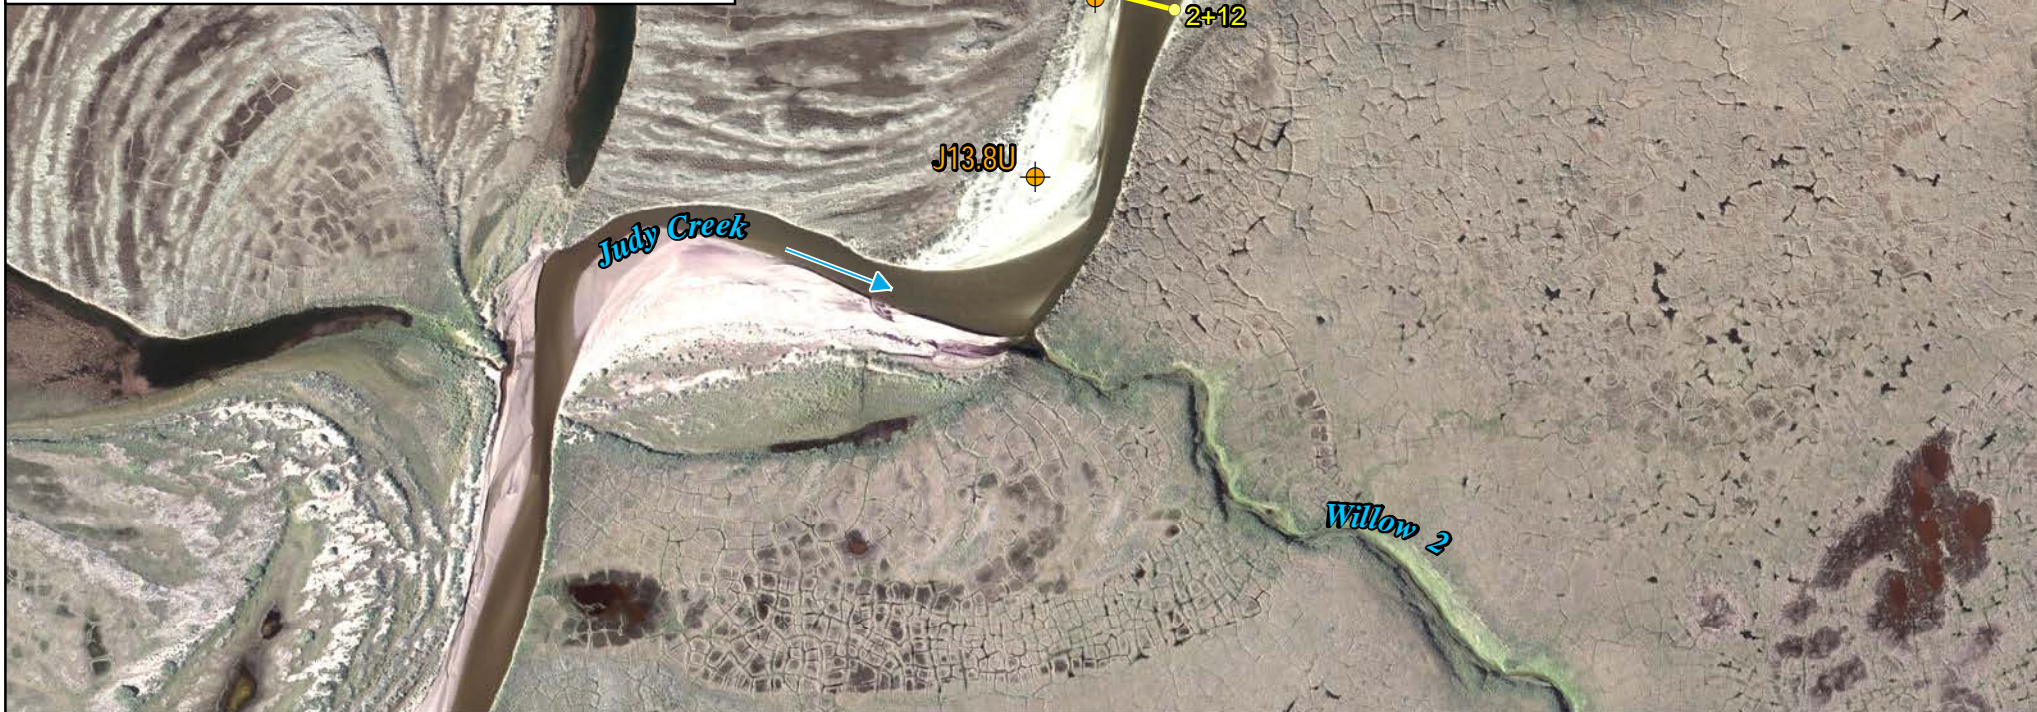
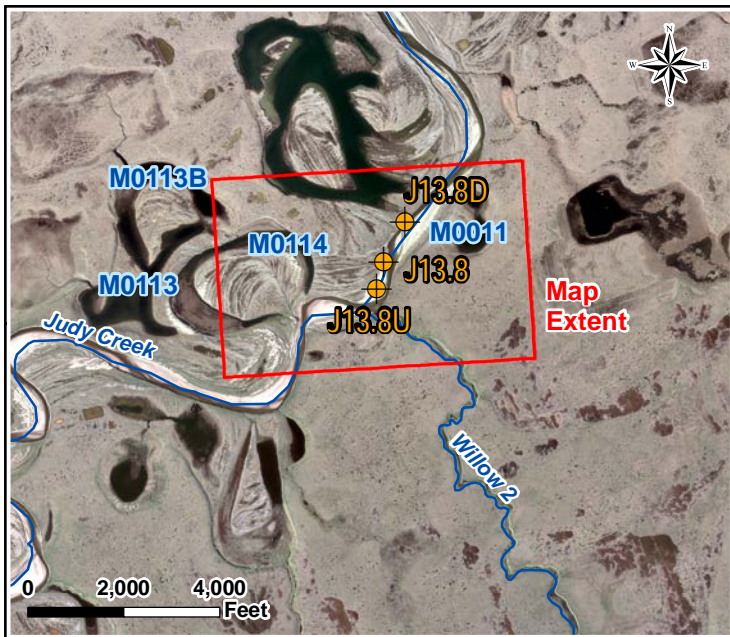
- Station
- Gage Location
- Flow Direction
- Discharge Measurement Cross Section

Discharge was calculated indirectly using the Normal Depth method. The cross-section was developed from the average of six cross-sections extracted from the J13.8 June 1, 2019 ADCP direct discharge measurement. The energy grade line was approximated by the average water surface slope between J13.8D and J13.8C. Stage at J13.8 was collected using PTs at the three gage locations (upstream, center, and down). Manning's n values were selected from reference documents (URS 2001) and calibrated to the measured discharge values. The calibrated Manning's n values used in the calculations were 0.035 for the left overbank, 0.022 for the main channel, and 0.035 for the right overbank.

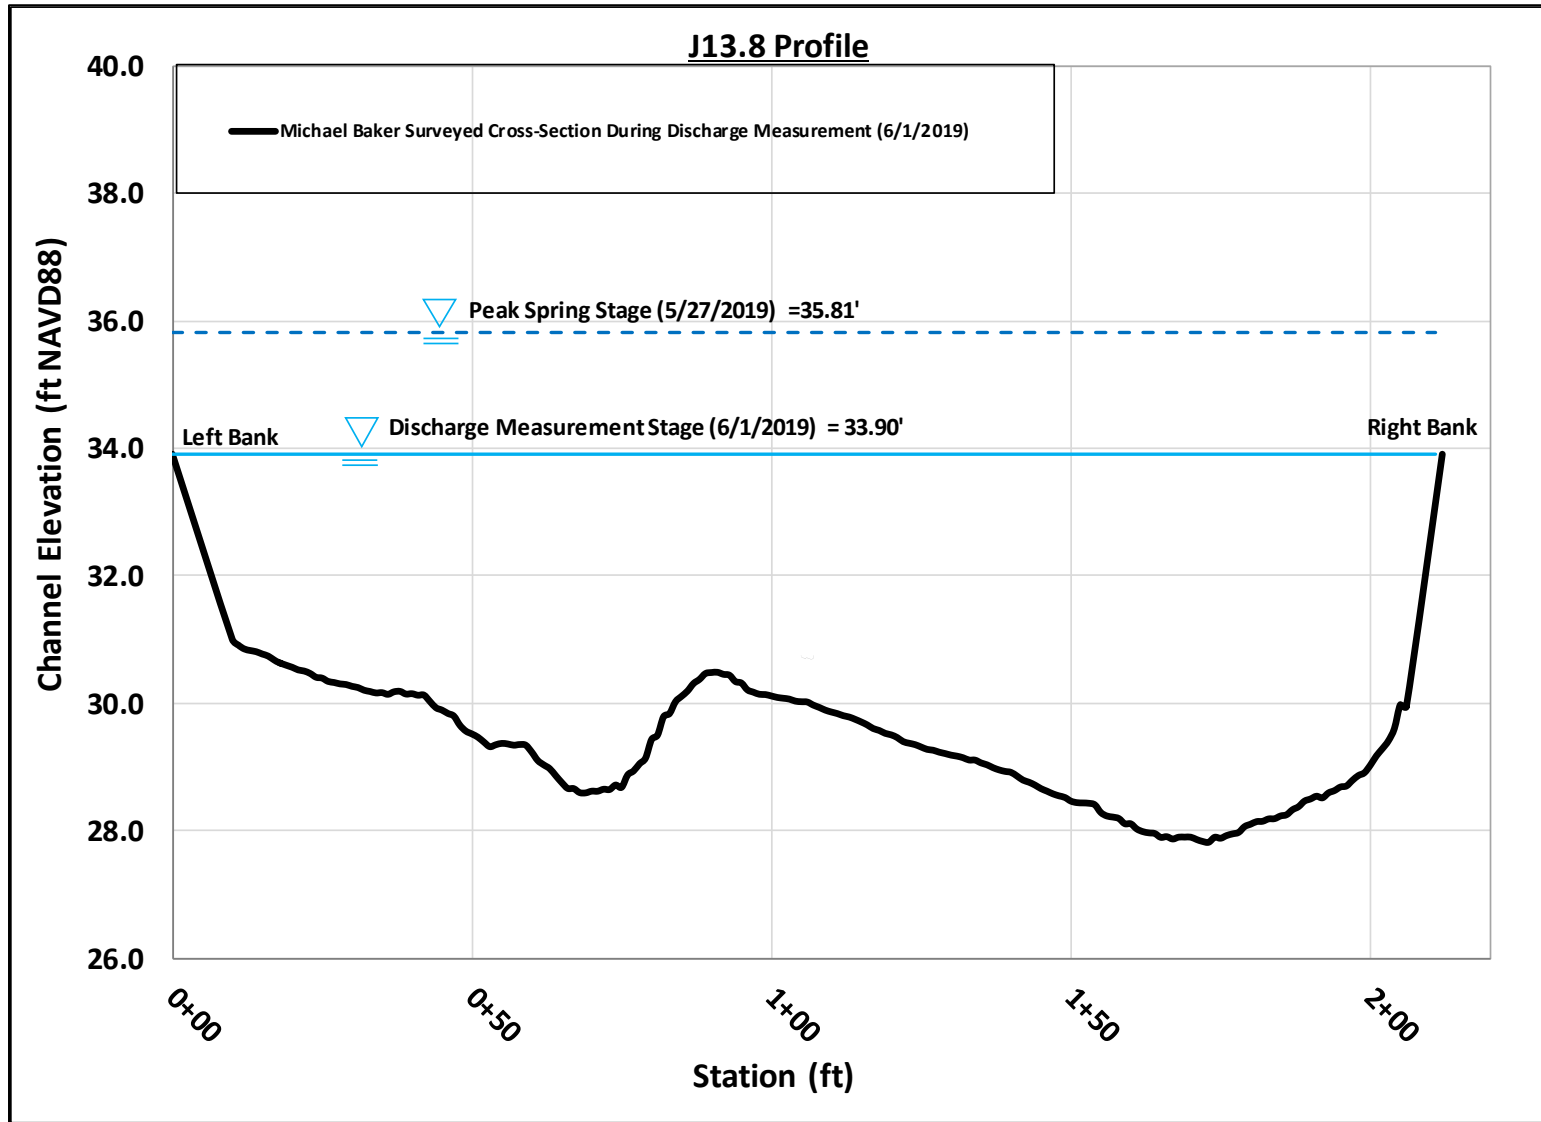
FIGURE C.2

Spring Breakup Cross-Section Profile

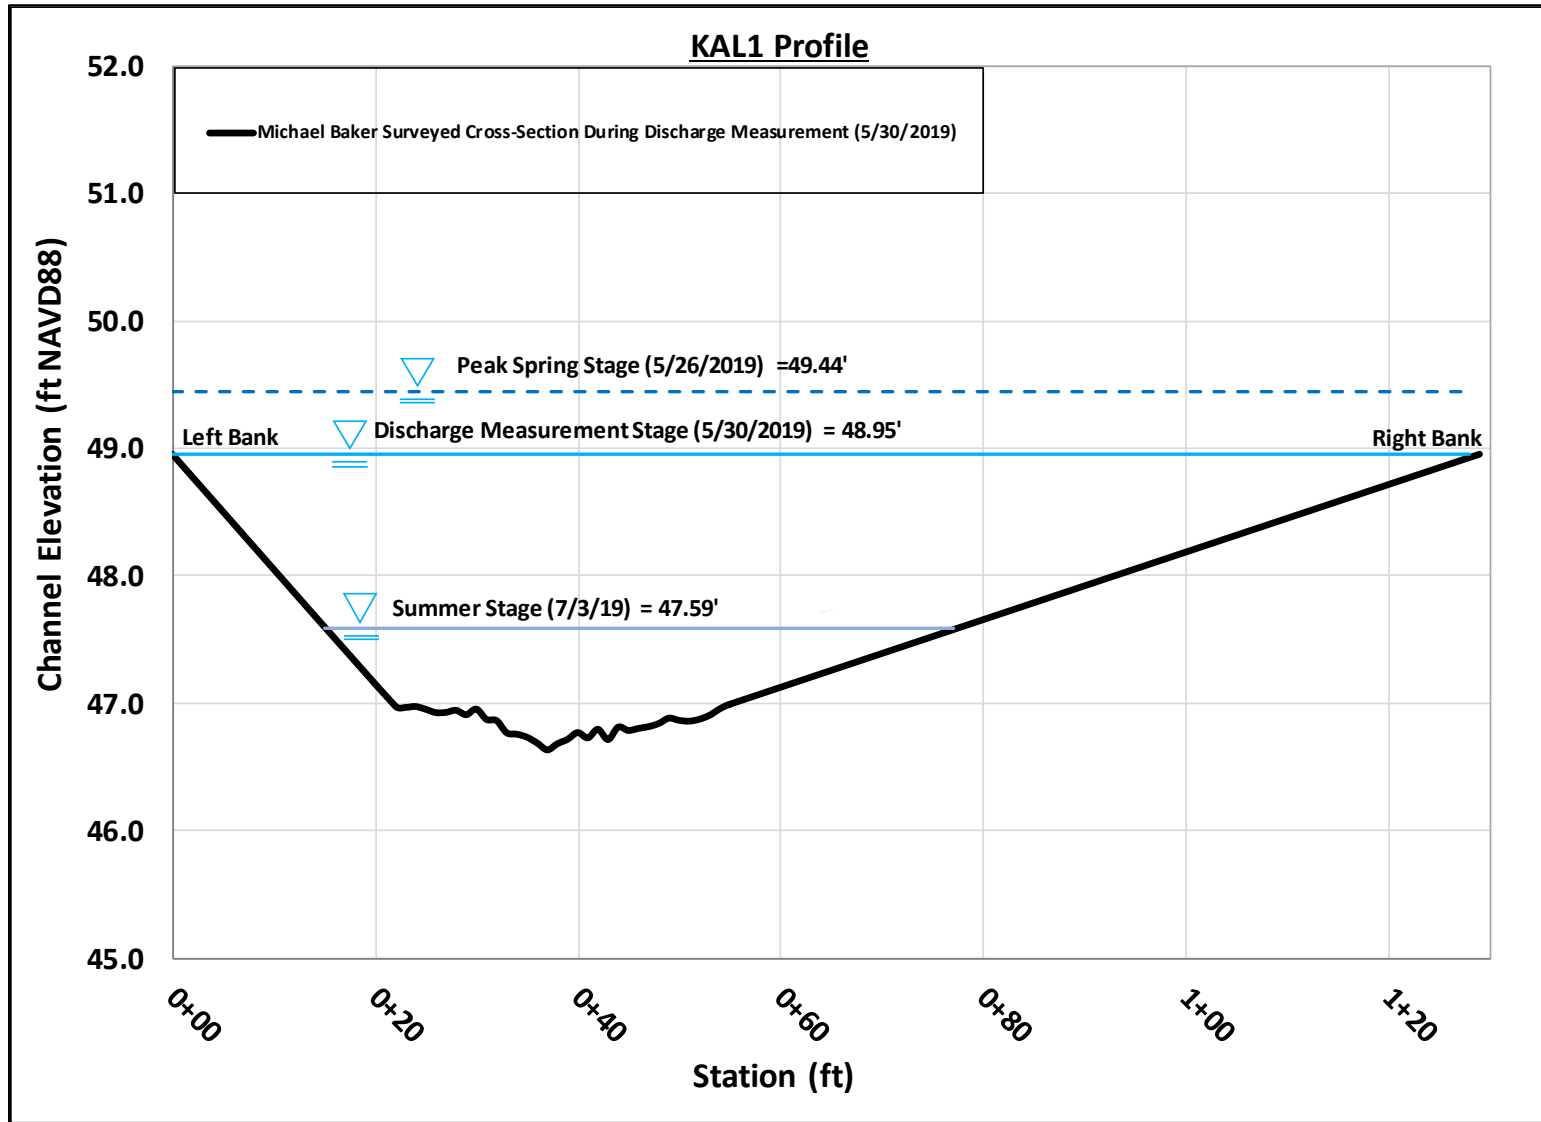
FIGURE C.3

Spring Breakup Cross-Section Profile

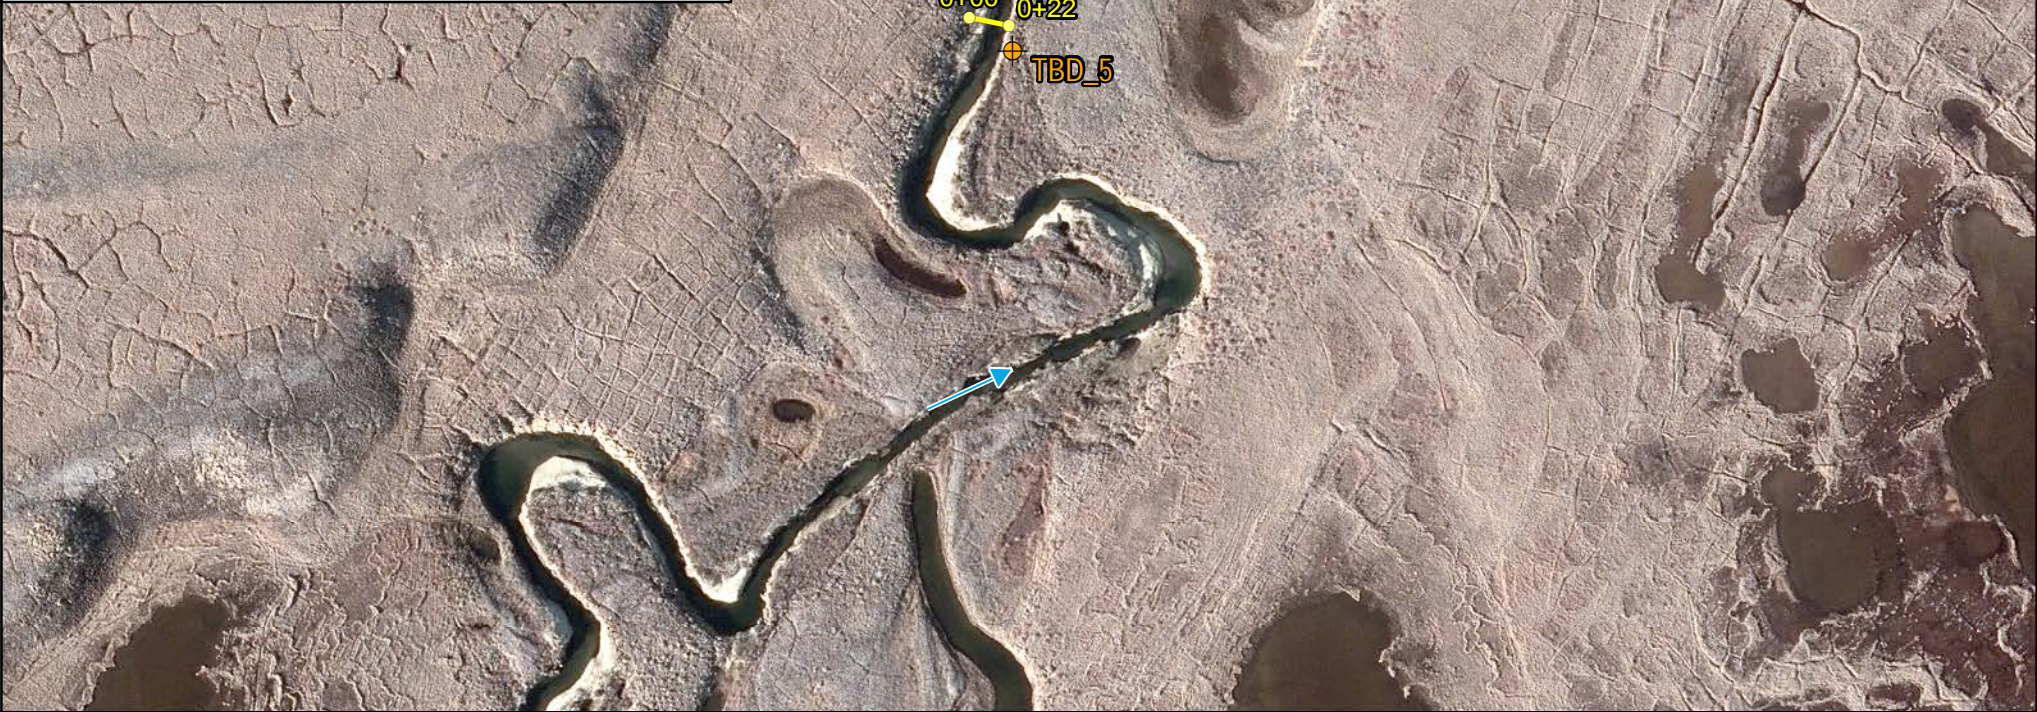
FIGURE C.4

- Station
- Gage Location
- Discharge Measurement Cross Section
- Flow Direction

Spring Breakup Cross-Section Profile

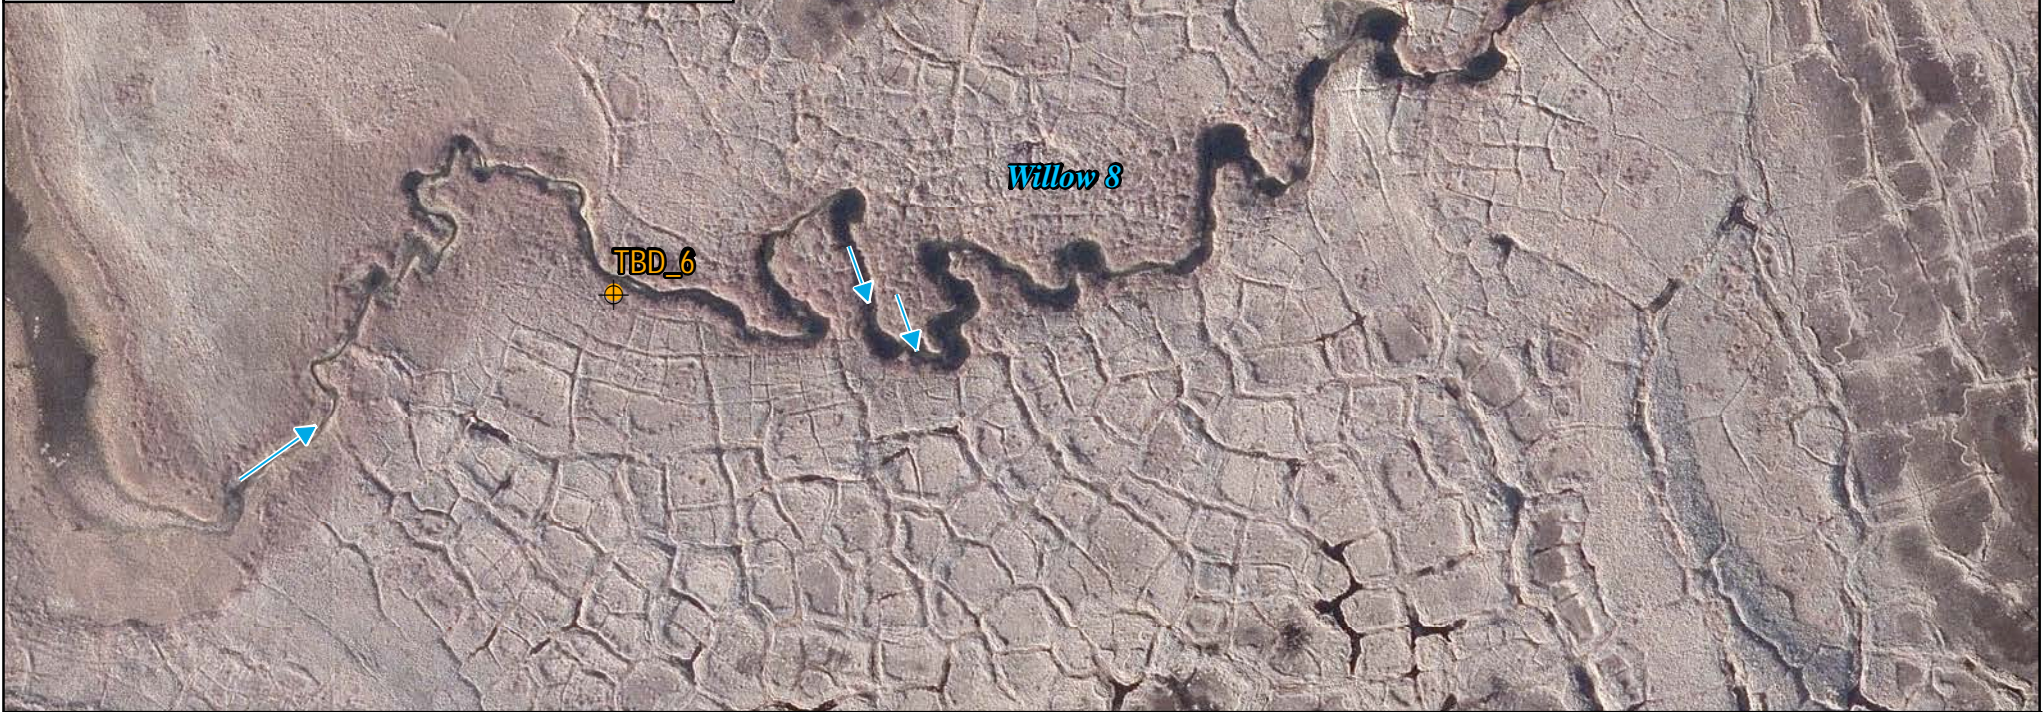
FIGURE C.5

- Station
- Gage Location
- Flow Direction
- Discharge Measurement Cross Section

Spring Breakup Cross-Section Profile

At the time of the measurement, the river was clear of snow and ice. Prior to deployment, diagnostic tests were performed, and the internal compass calibrated. The overall discharge measurement is considered fair based on the conditions at the time of the discharge measurement.

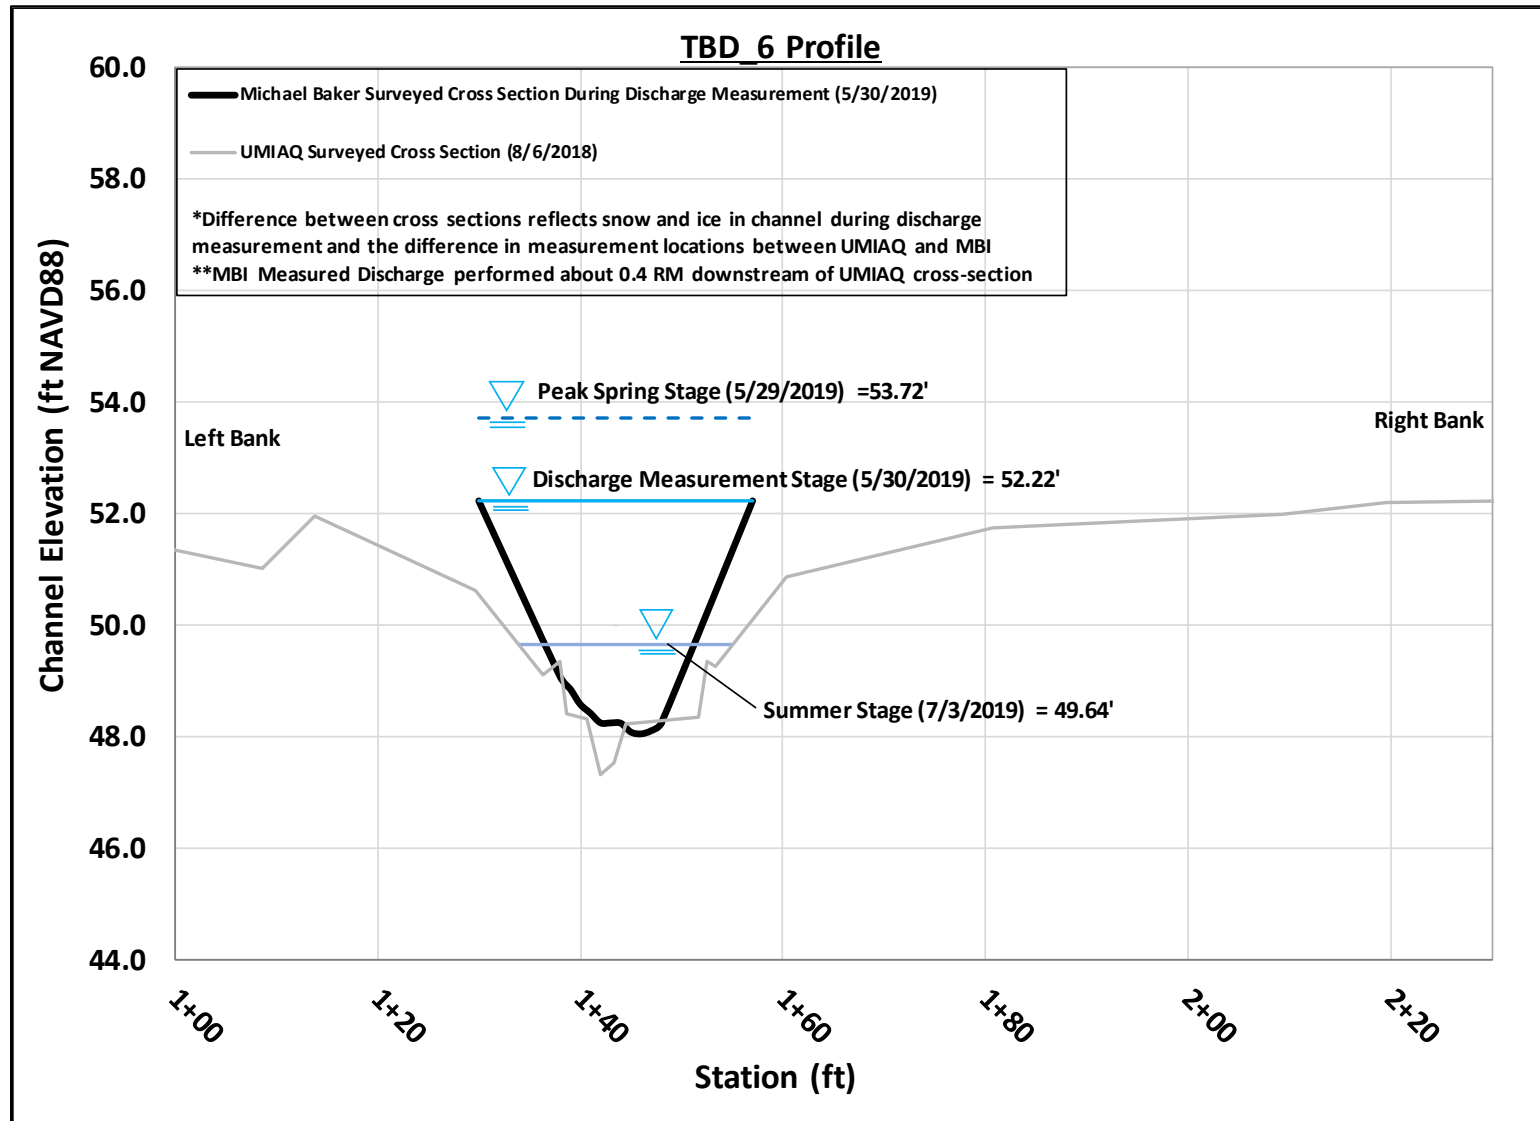
## C.5 TBD\_6

<b>Location:</b>	TBD_6
<b>Date &amp; Time:</b>	May 30, 4:00 PM
<b>Equipment:</b>	RiverRay ADCP mounted in a trimaran tethered to a tag line and pulled across the channel.
<b>Final Discharge (cfs):</b>	90
<b>Average Velocity (fps):</b>	1.2
<b>Measurement Rating:</b>	Fair
<b>Measurement Notes:</b>	Moving bed conditions were measured as minimal and not applied to the total discharge. The percentage of bad bottom track values (0.00%) was within the recommended maximum of 5%.

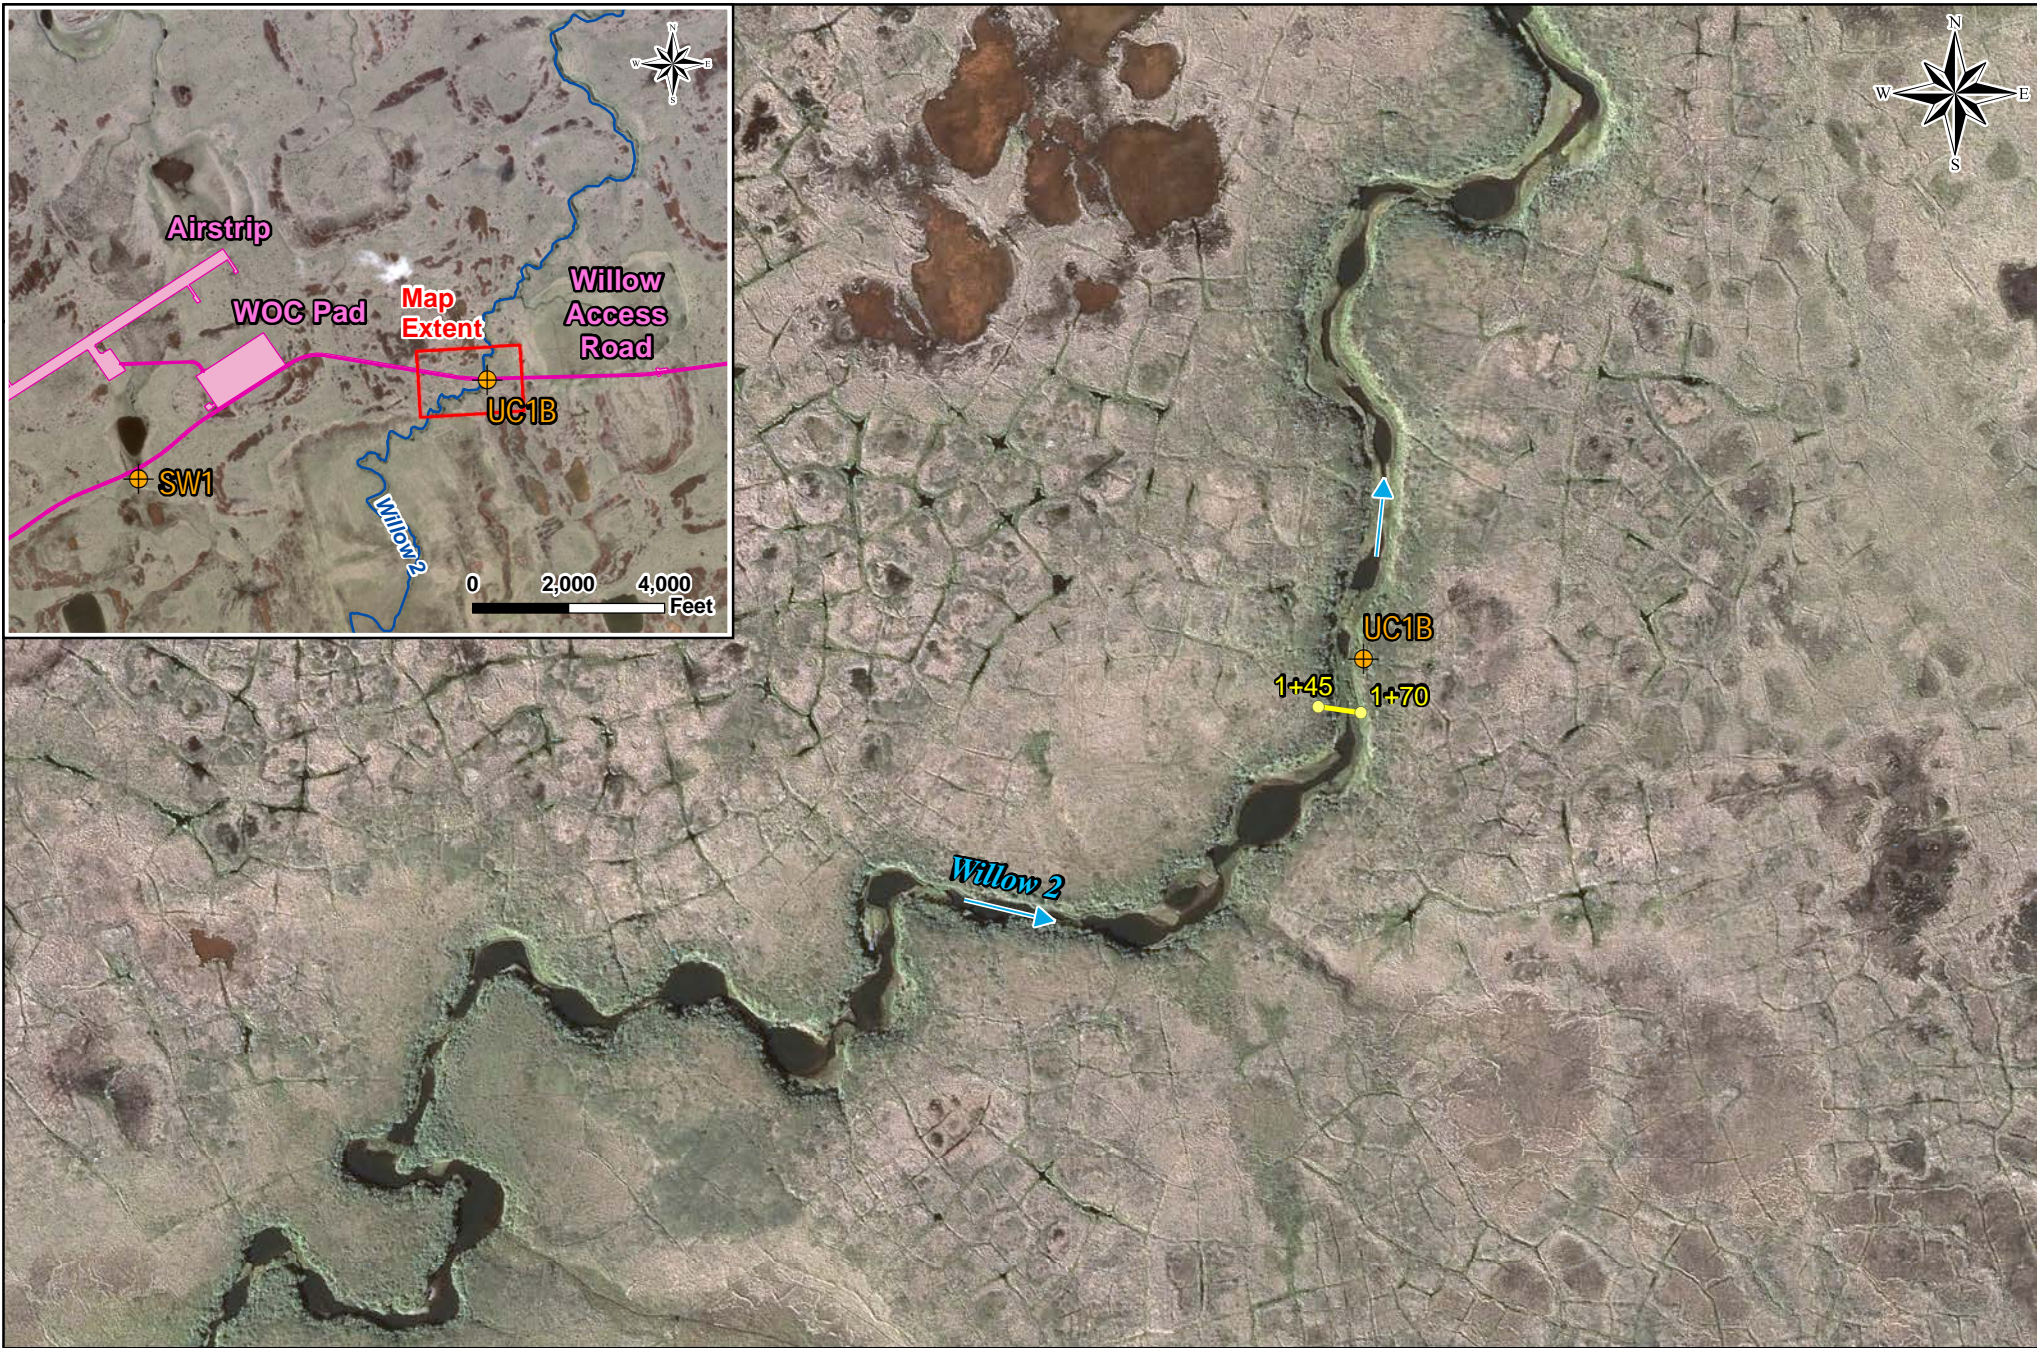
FIGURE C.6

- Station
- Flow Direction
- Gage Location
- Discharge Measurement Cross Section

Spring Breakup Cross-Section Profile

At the time of the discharge measurement, saturated snow remained along the banks. Prior to deployment, diagnostic tests were performed, and the internal compass calibrated. The overall discharge measurement is considered fair based on conditions at the time of measurement.

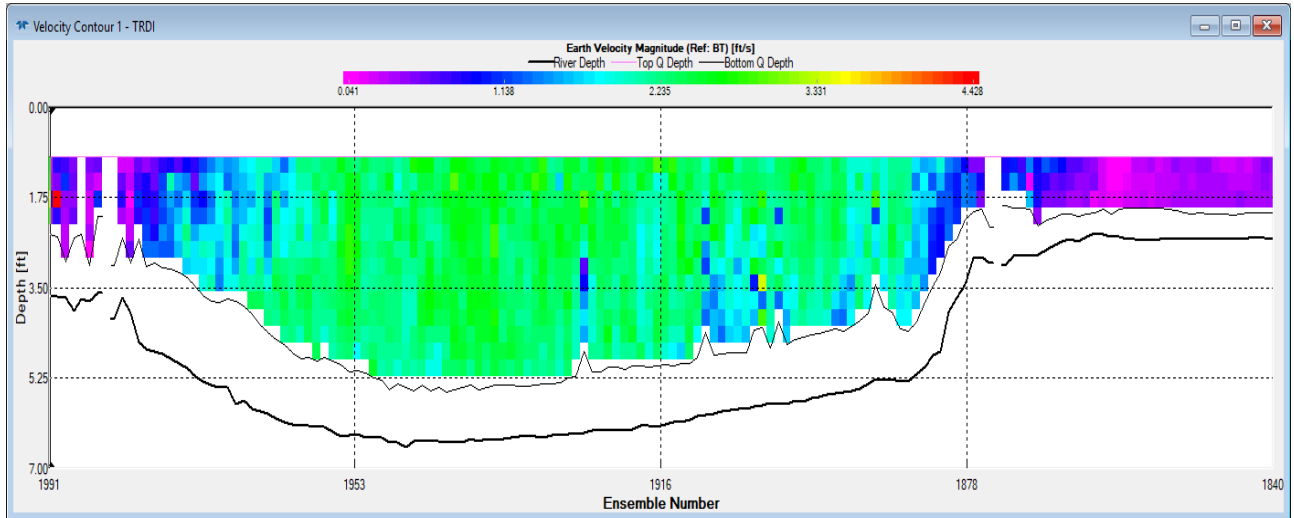
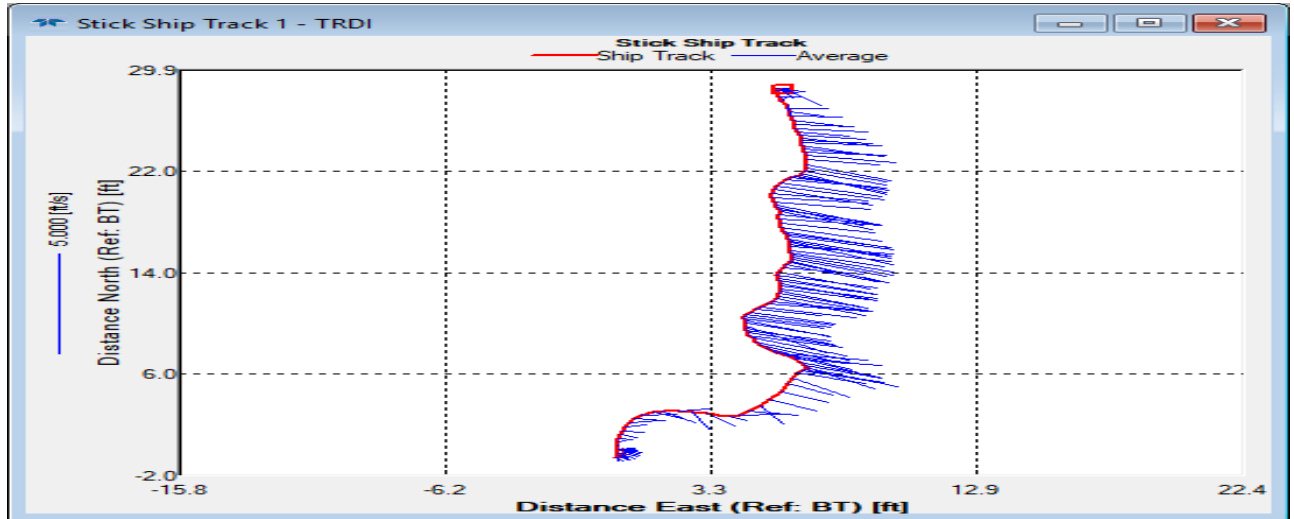
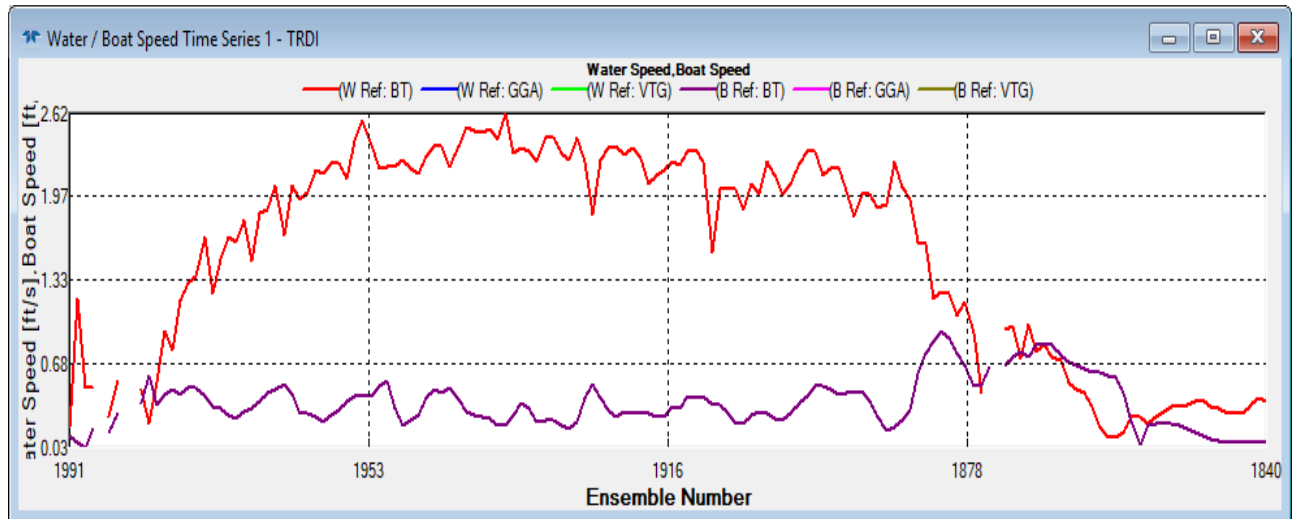
A. Transect UC2C-004 Raw Data Output

<b>Location:</b>	UC2C
<b>Date &amp; Time:</b>	May 30, 2019 2:30 PM
<b>Equipment:</b>	RiverRay ADCP mounted in a trimaran tethered to a tag line and pulled across the channel.
<b>Final Discharge (cfs):</b>	270
<b>Average Velocity (fps):</b>	1.5
<b>Measurement Rating:</b>	Good
<b>Measurement Notes:</b>	Moving bed conditions were measured as minimal and not applied to the total discharge. The percentage of bad bottom track values (1.27%) was within the recommended maximum of 5%.

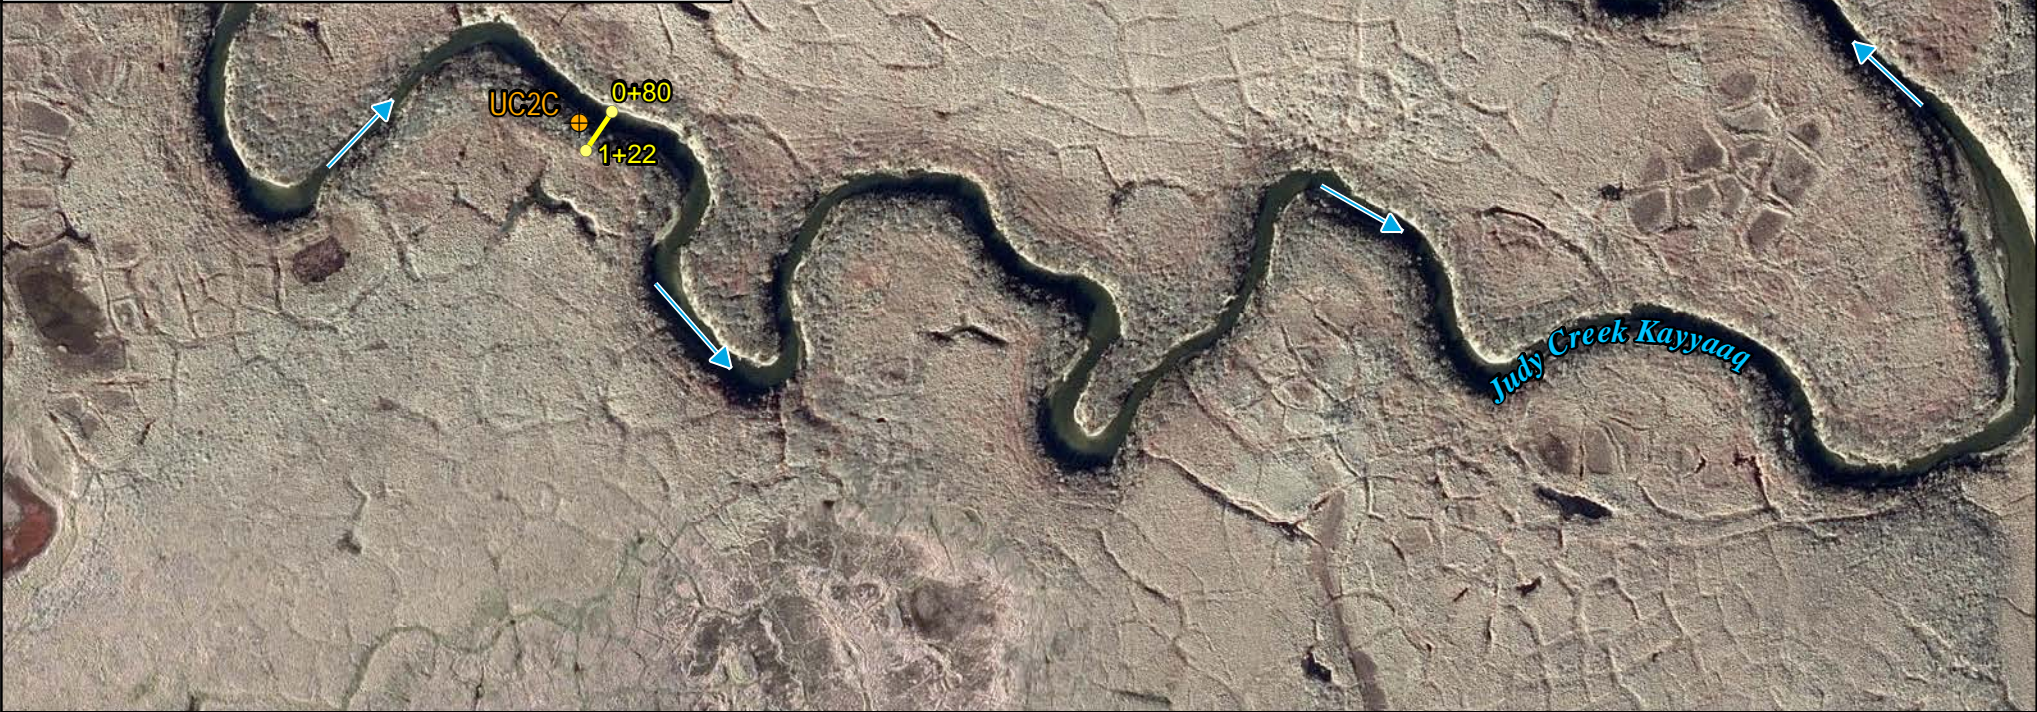
Date: 10/18/2019	Scale: 1 Inch = 200 Feet
Drawn: JEG	Project: 172339
Checked: GCY	File: PlanView_UC2C.mxd

Station		Flow Direction
	Gage Location		
	Discharge Measurement Cross Section

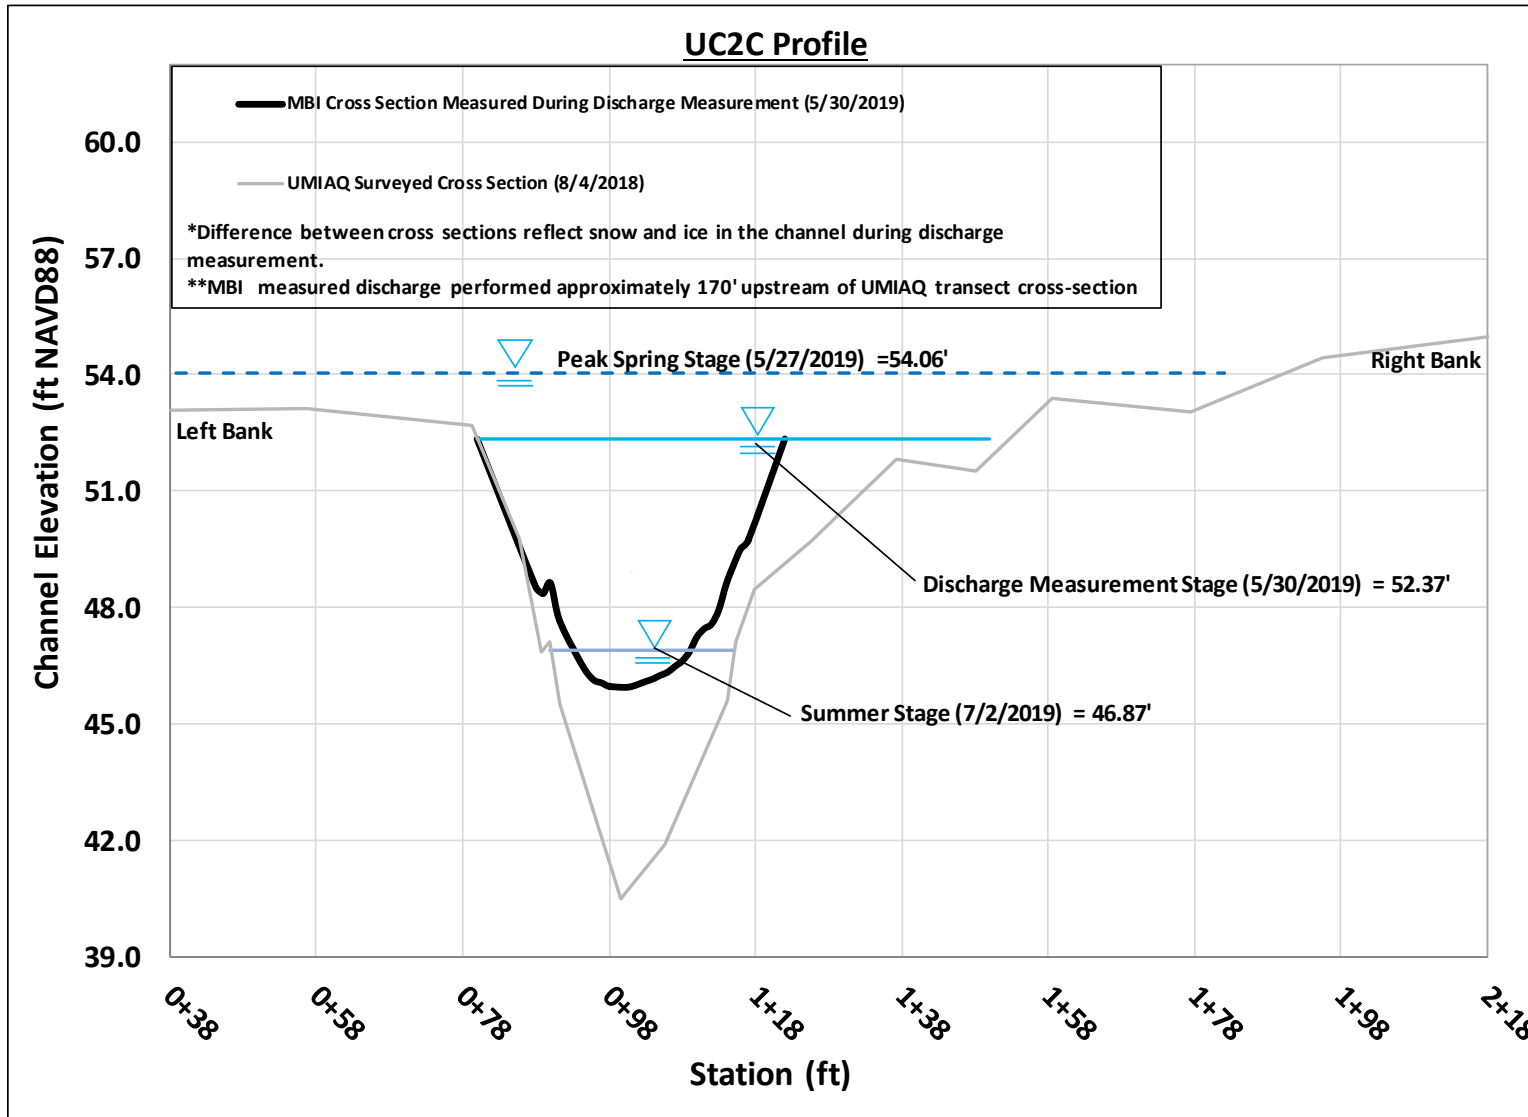
FIGURE C.7

Spring Breakup Cross-Section Profile
