# 2019 Willow Spring Breakup & Summer Monitoring & Hydrological Assessment

Prepared for:

**ConocoPhillips**  
Alaska

MSA Contract No. 296937

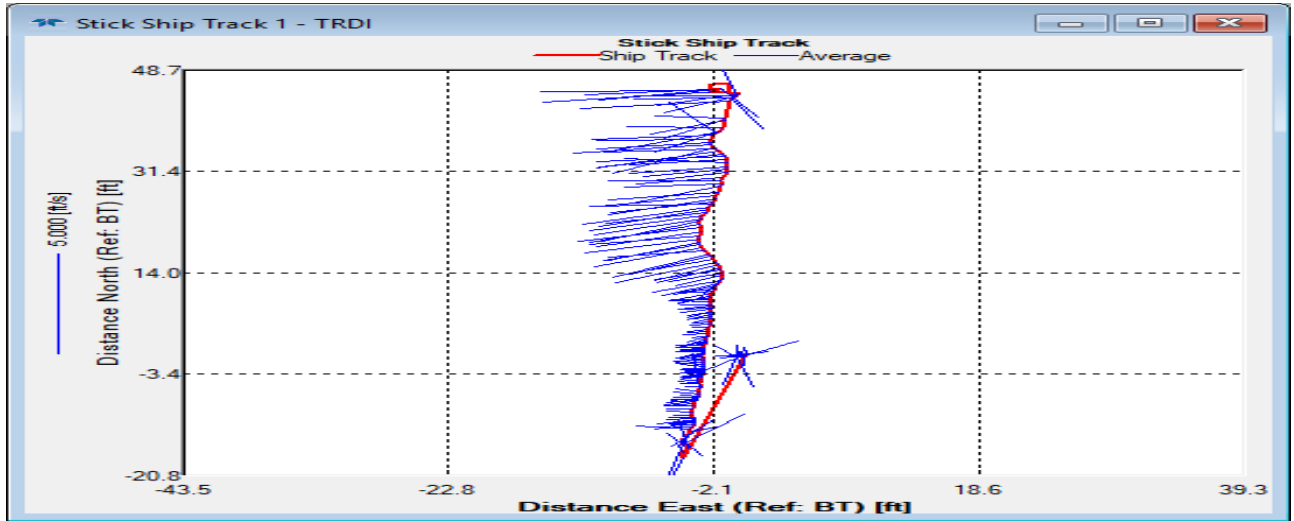
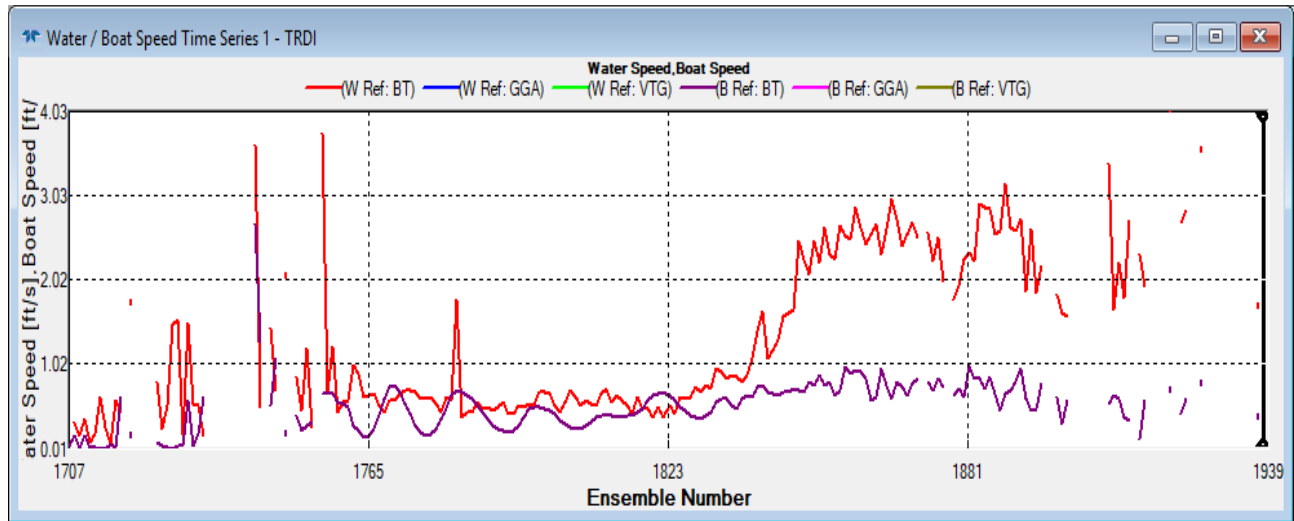
A. Transect W BS1-000 Raw Data Output

<b>Location:</b>	W_BS1
<b>Date &amp; Time:</b>	May 28, 3:30 PM
<b>Equipment:</b>	RiverRay ADCP mounted in a trimaran tethered to a tag line and pulled across the channel.
<b>Final Discharge (cfs):</b>	350
<b>Average Velocity (fps):</b>	1.4
<b>Measurement Rating:</b>	Fair
<b>Measurement Notes:</b>	Moving bed conditions were measured as minimal and not applied to the total discharge. The percentage of bad bottom track values (20%) exceeded the recommended maximum of 5%.

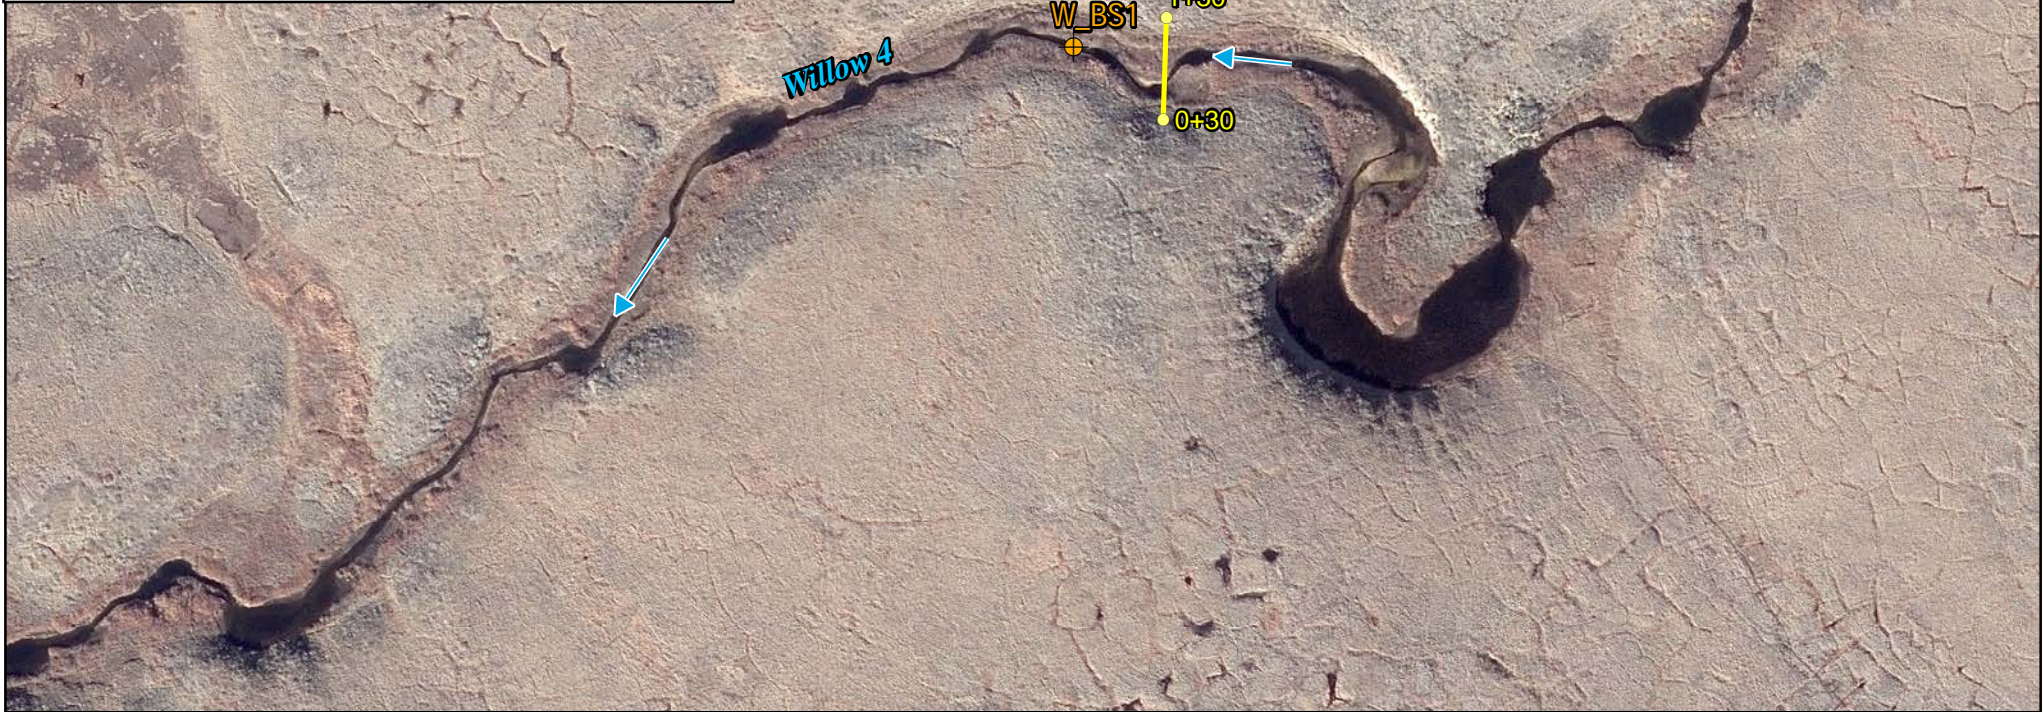
Date: 10/18/2019	Scale: 1 Inch = 200 Feet
Drawn: JEG	Project: 172339
Checked: GCY	File: PlanView_W_BS1.mxd

Gage Location		Flow Direction
	Station		
	Discharge Measurement Cross Section

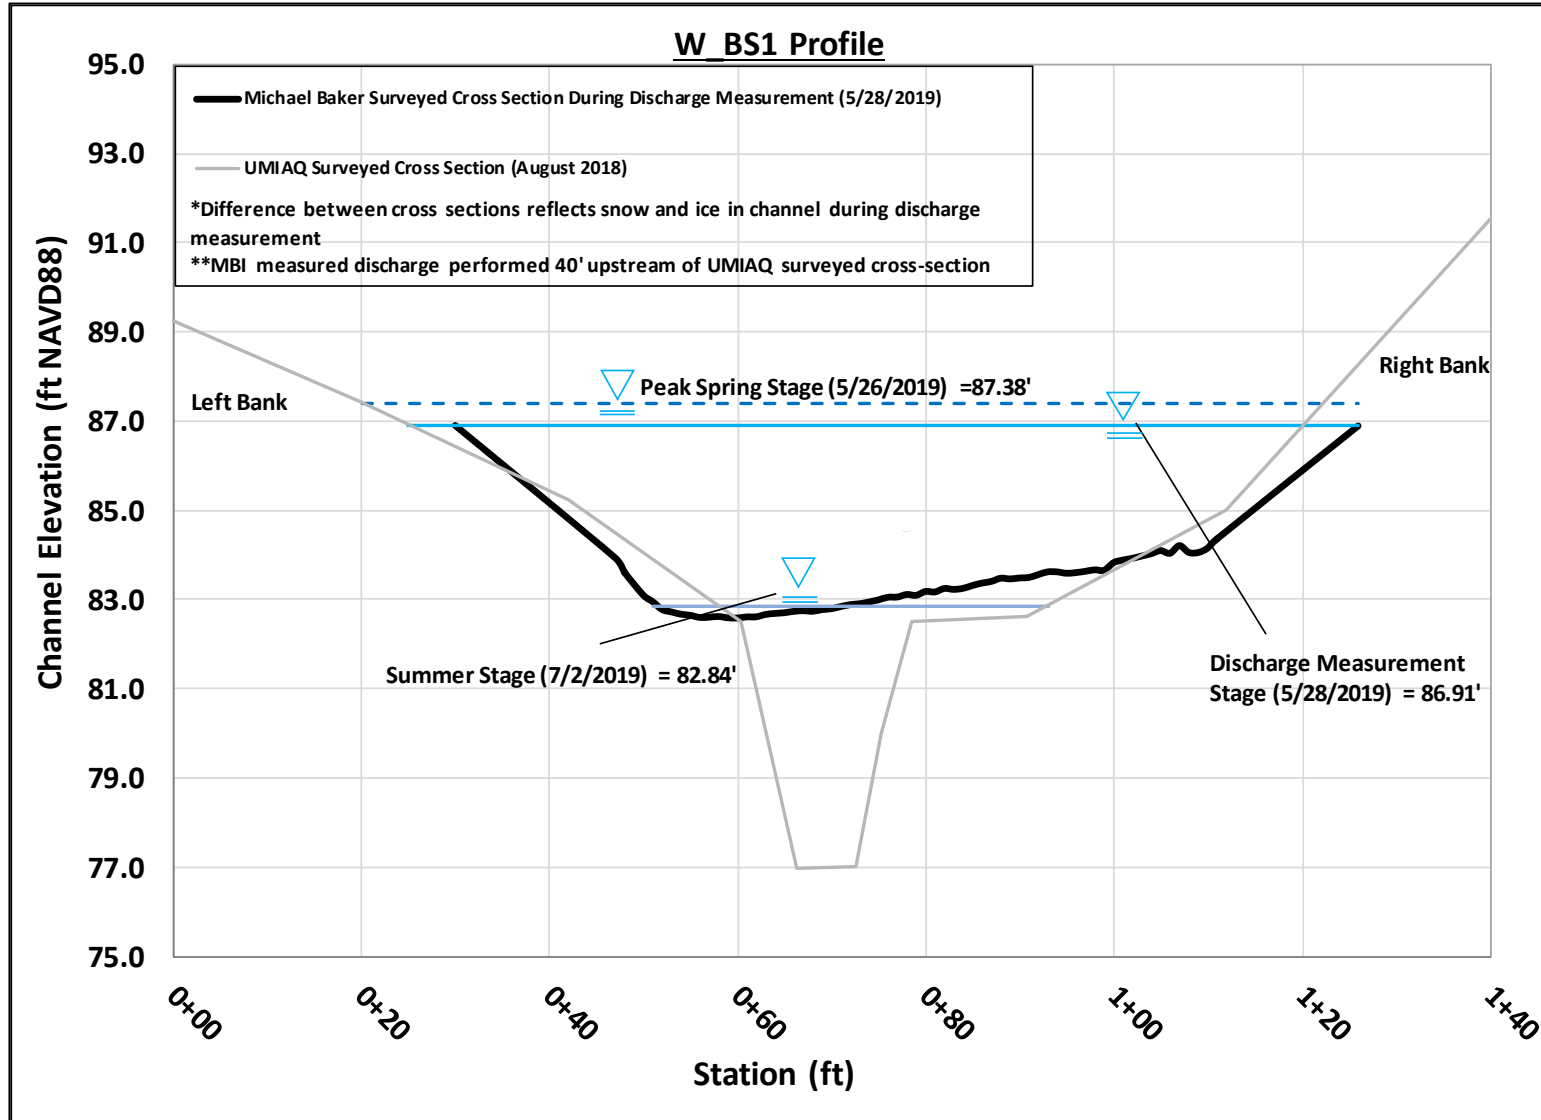
FIGURE C.8

Spring Breakup Cross-Section Profile

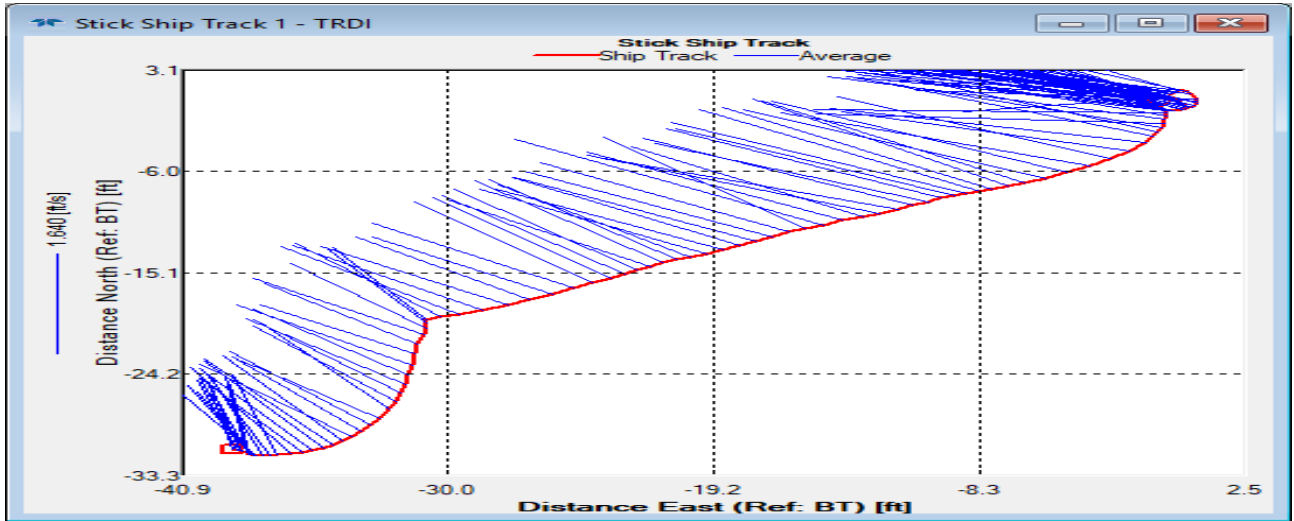
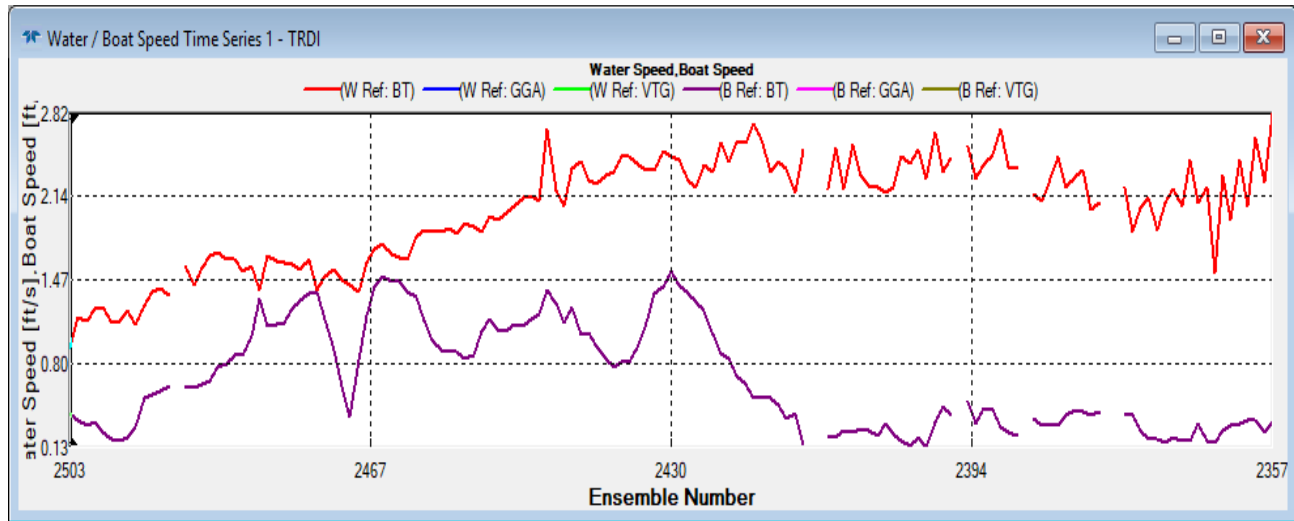
A. Transect W4-001 Raw Data Output

<b>Location:</b>	W4
<b>Date &amp; Time:</b>	June 2, 2:45 PM
<b>Equipment:</b>	RiverRay ADCP mounted in a trimaran tethered to a tag line and pulled across the channel.
<b>Final Discharge (cfs):</b>	450
<b>Average Velocity (fps):</b>	1.6
<b>Measurement Rating:</b>	Fair
<b>Measurement Notes:</b>	Moving bed conditions were measured as minimal and not applied to the total discharge. The percentage of bad bottom track values (10%) exceeded the recommended maximum of 5%.

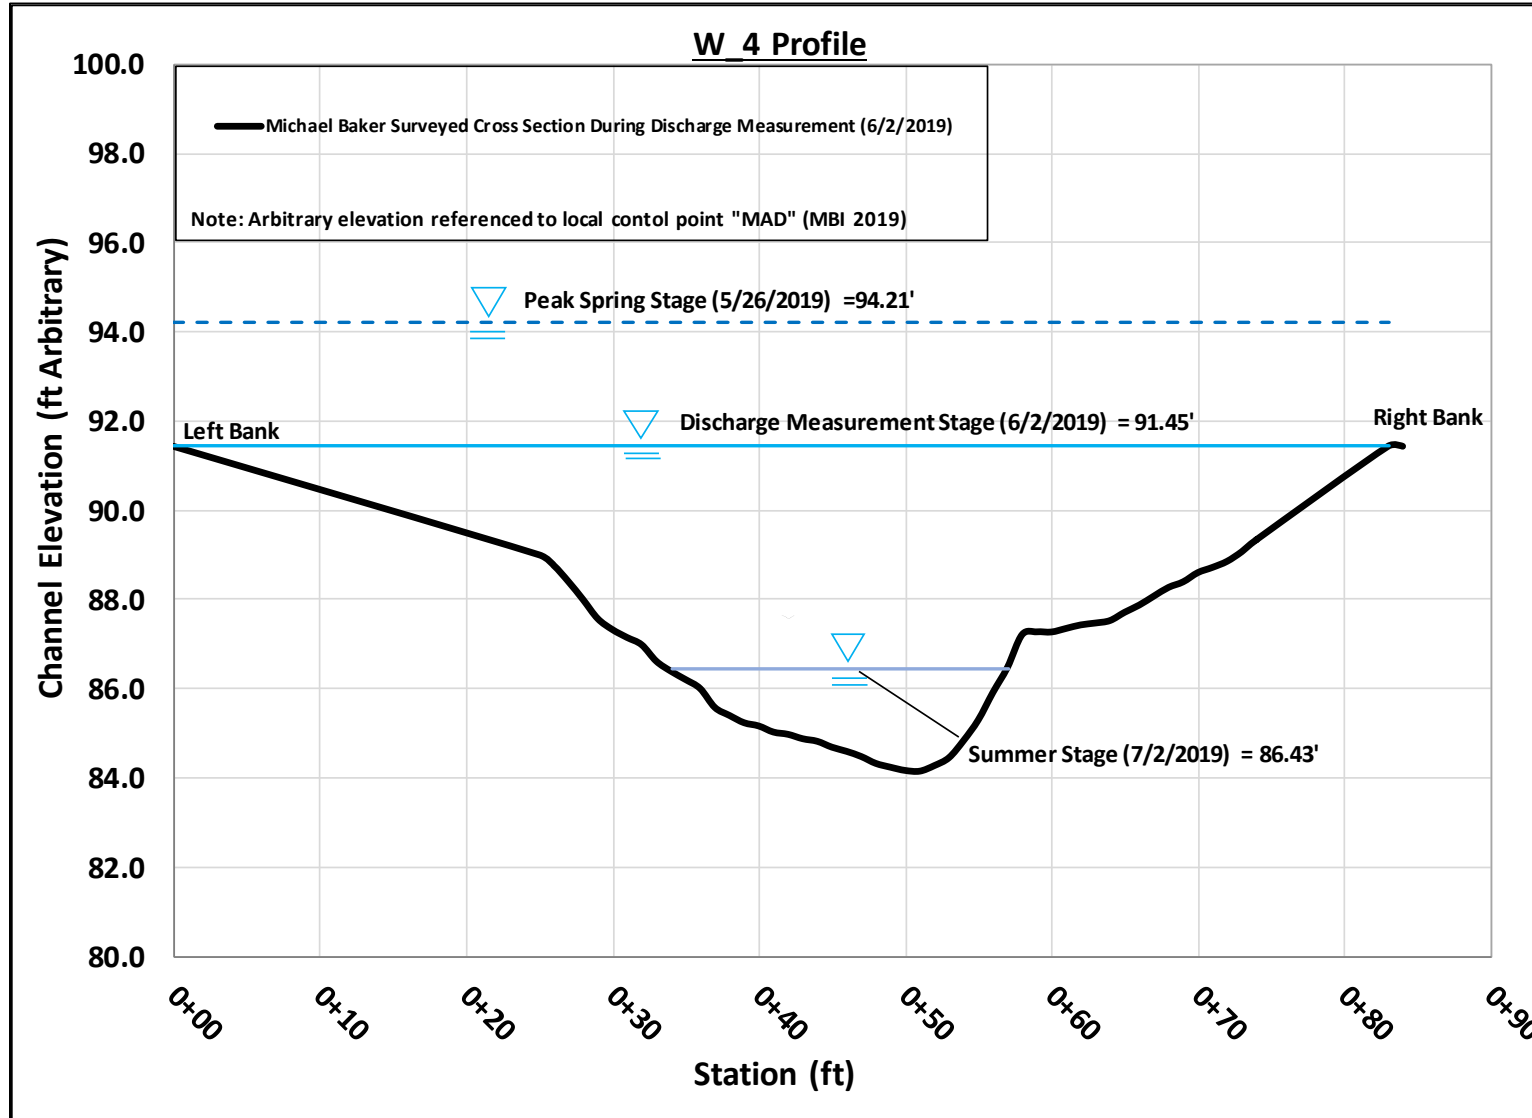
FIGURE C.9

Spring Breakup Cross-Section Profile

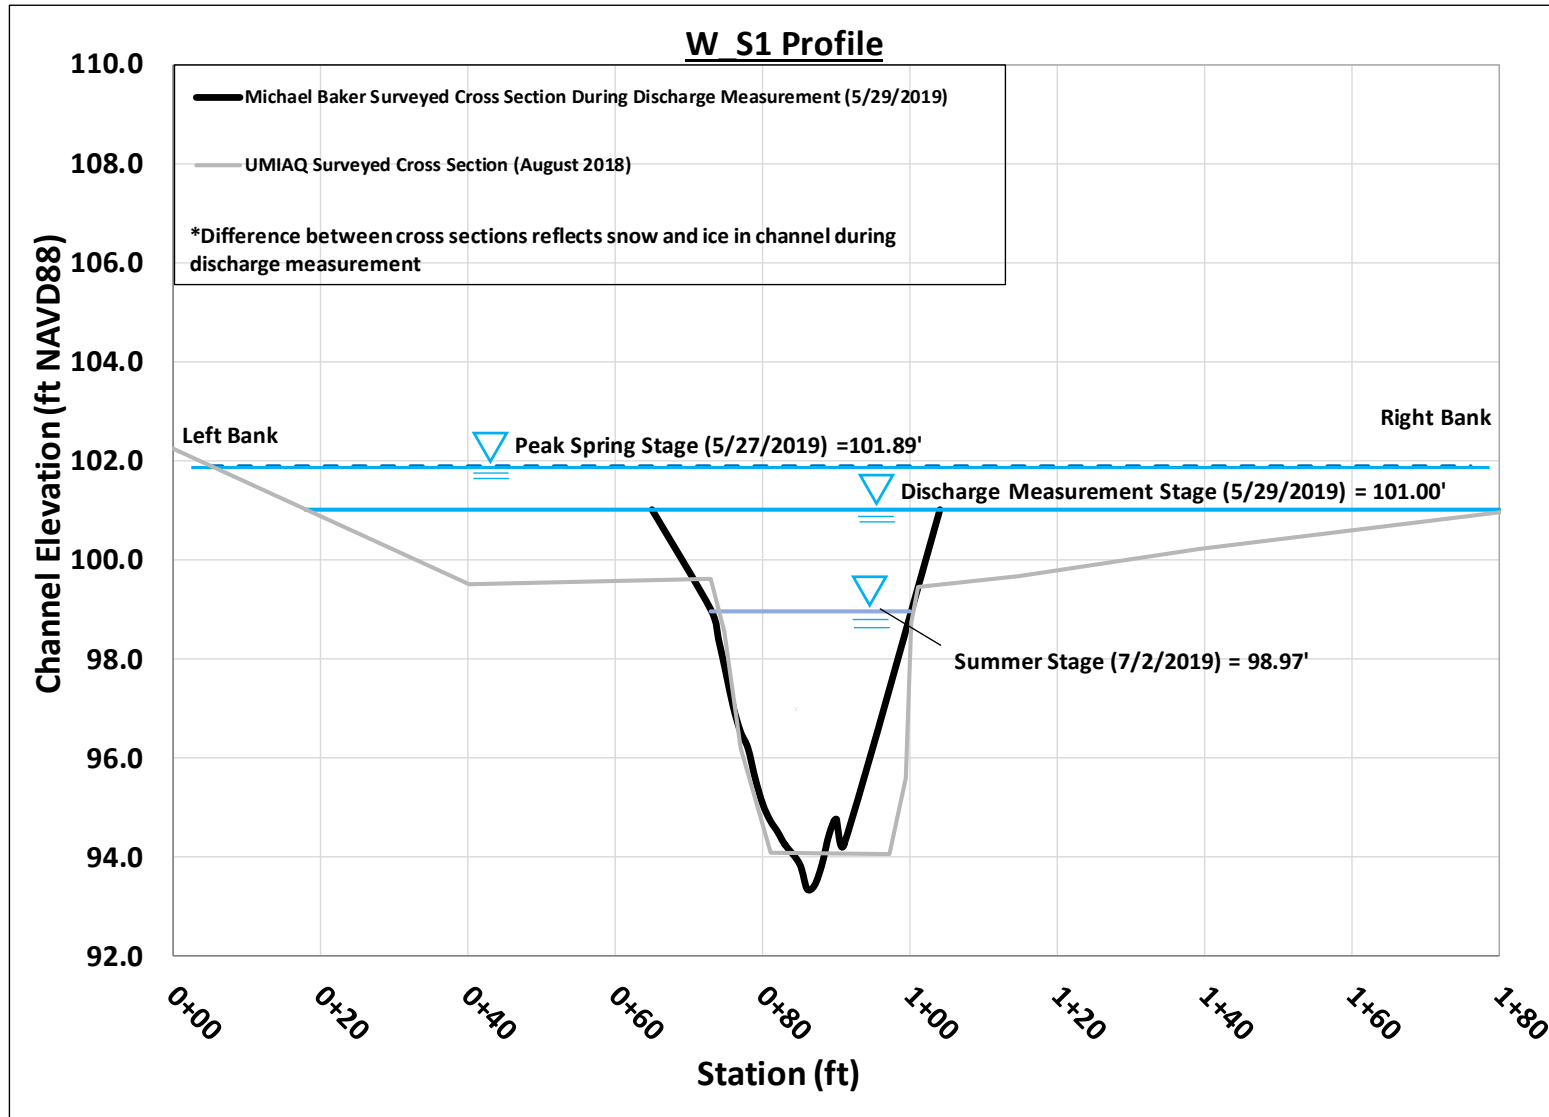
FIGURE C.10

Spring Breakup Cross-Section Profile

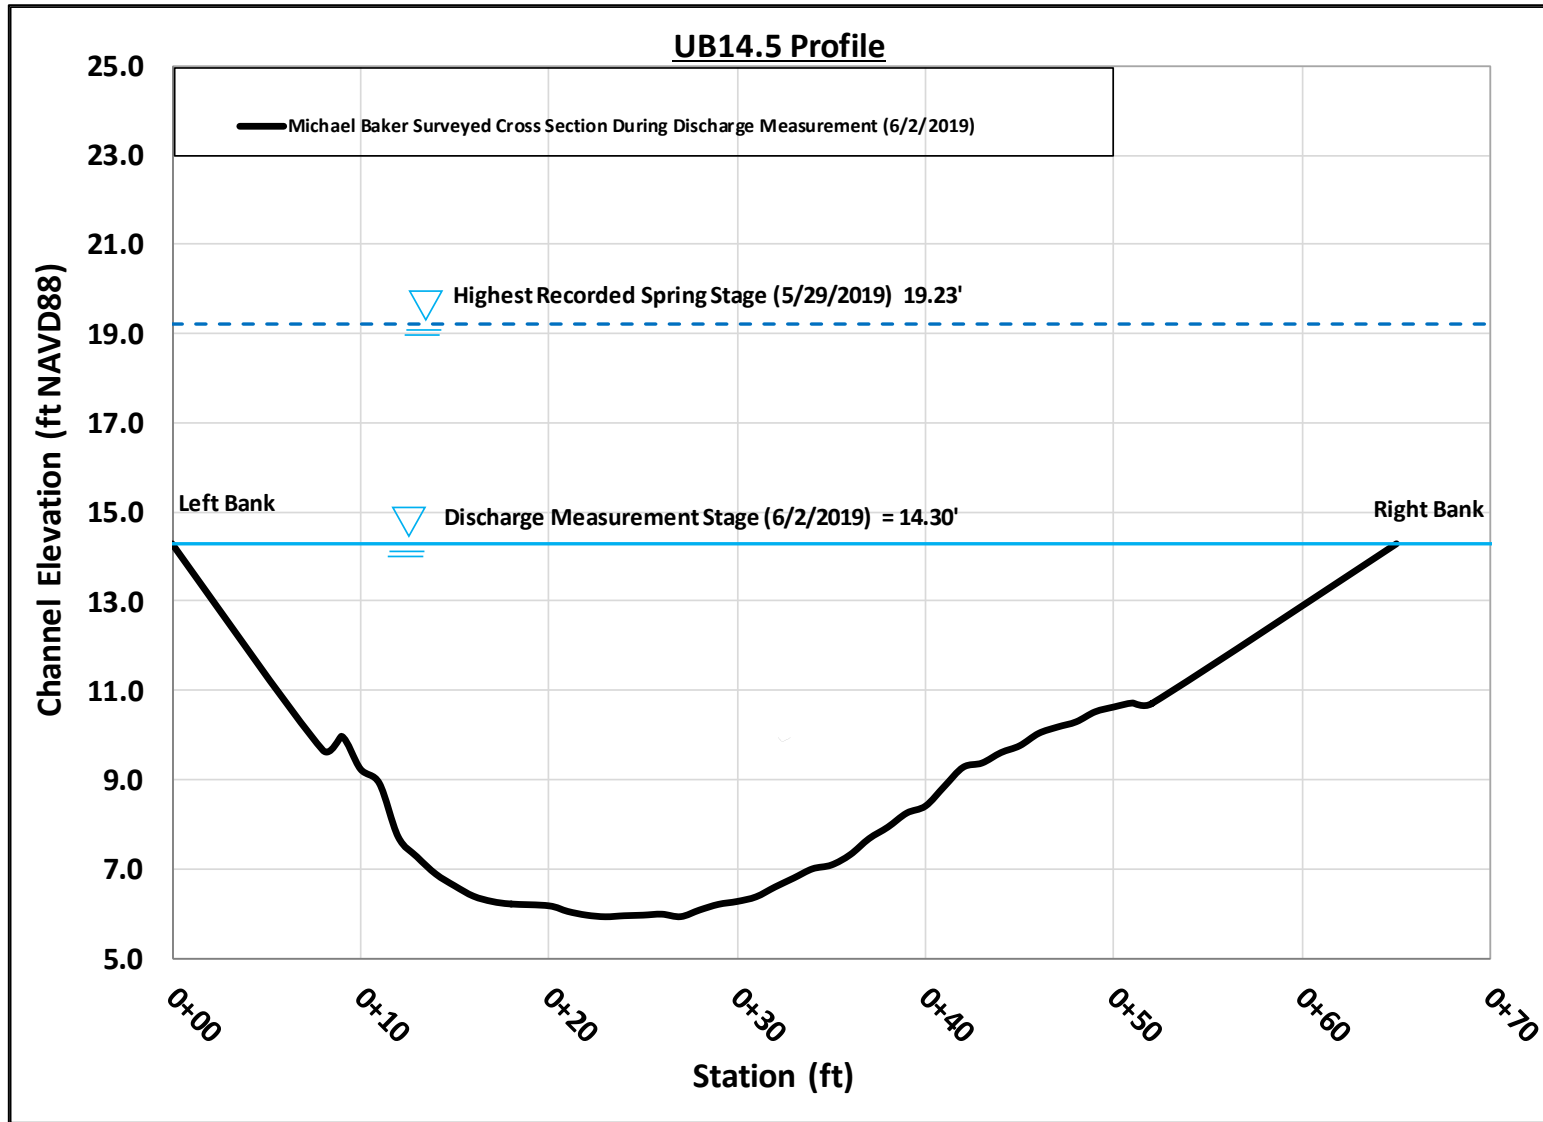
FIGURE C.11

Spring Breakup Cross-Section Profile

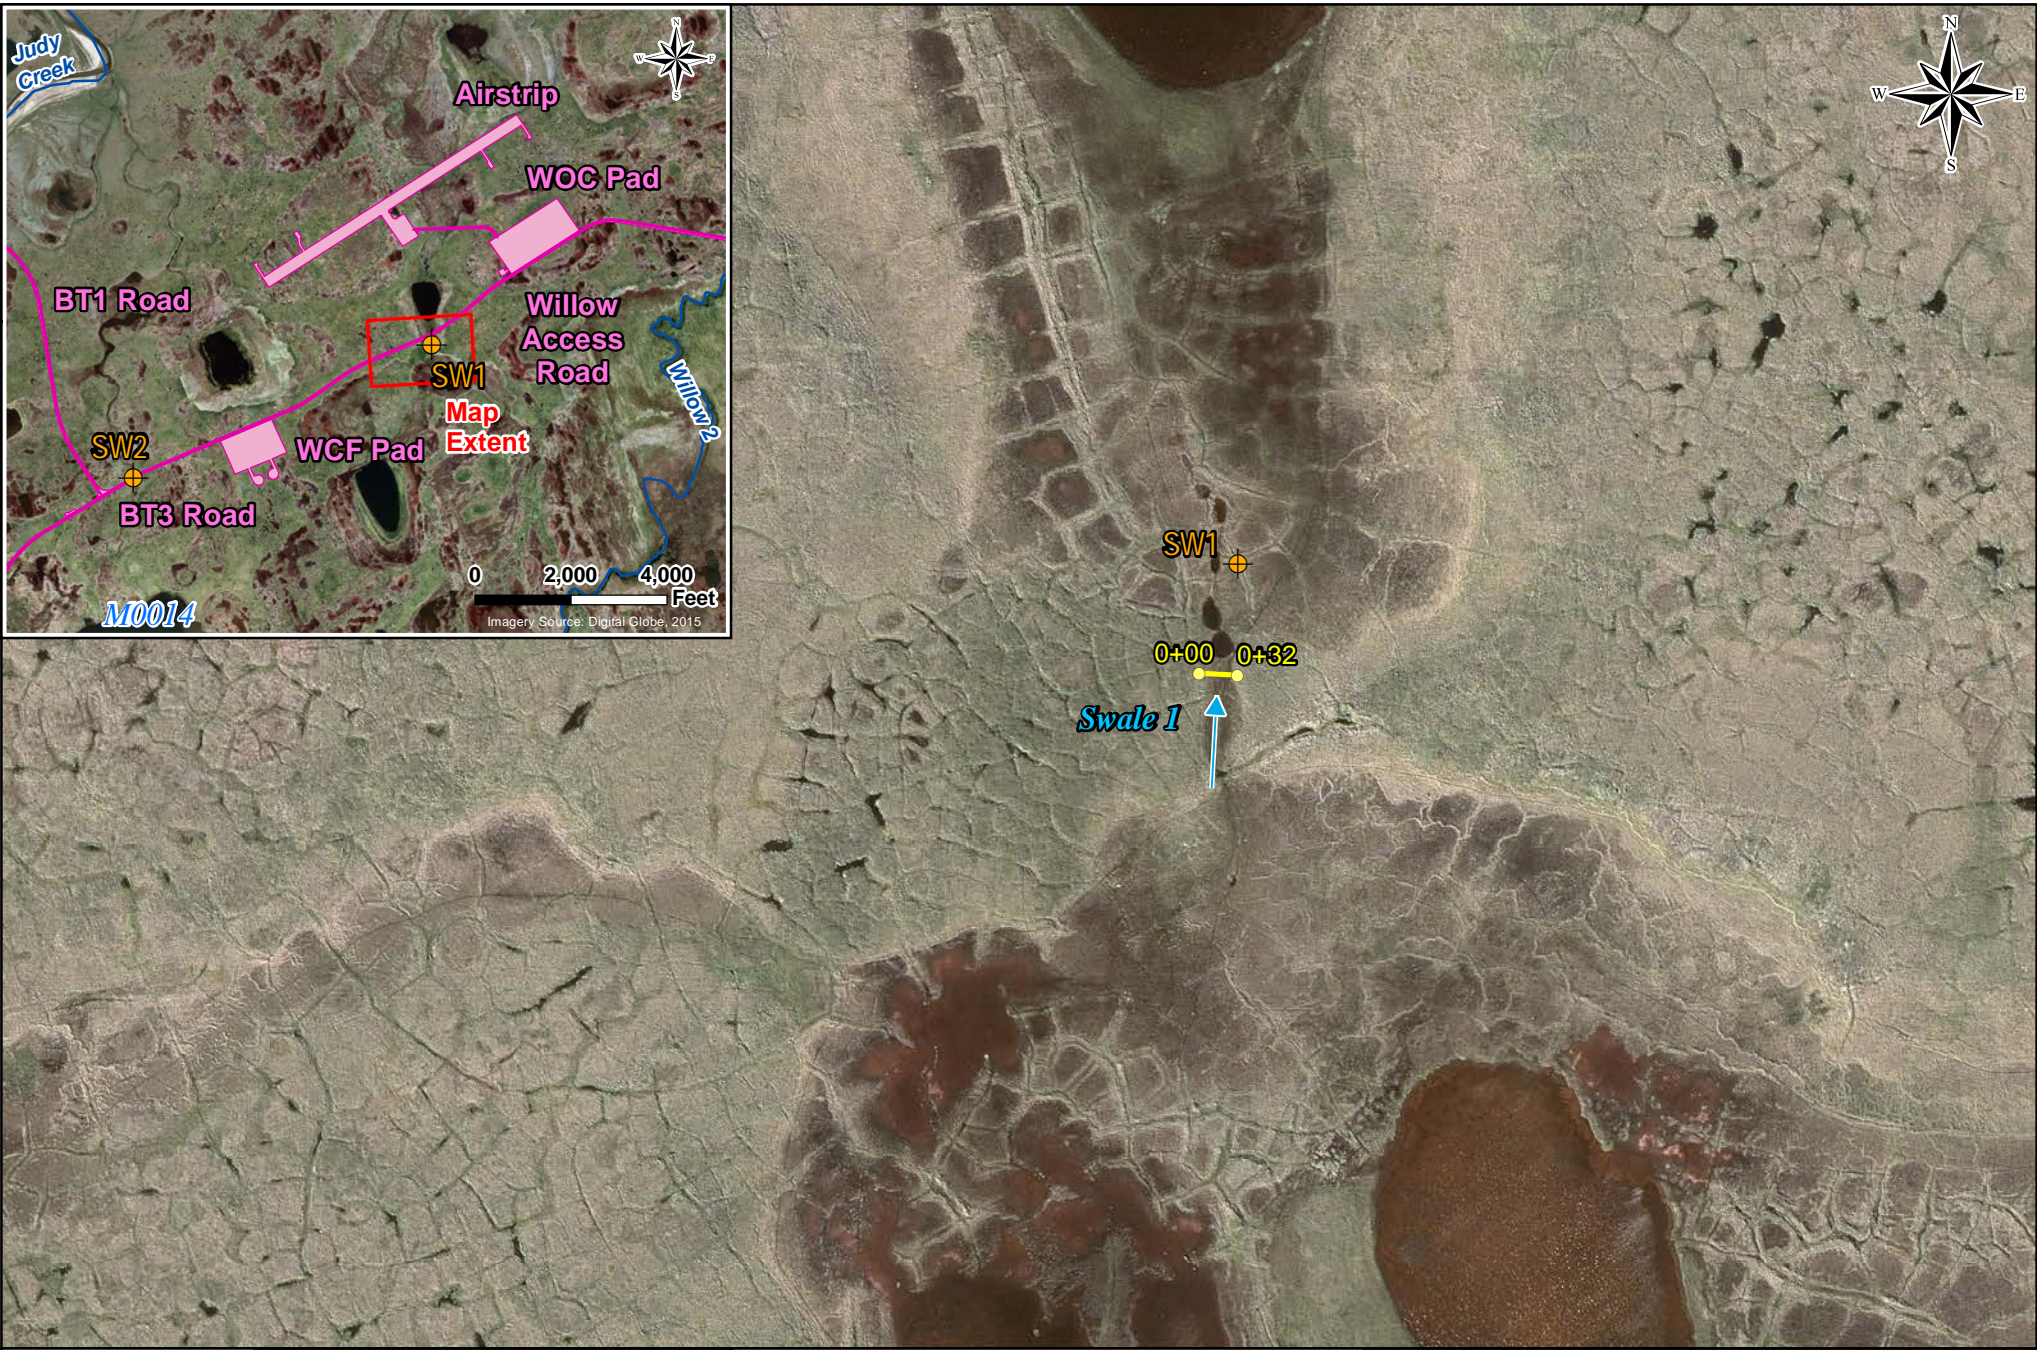
FIGURE C.12

Date: 1/24/2020	Scale: 1 Inch = 200 Feet	
Drawn: JEG	Project: 172339	
Checked: GCY	File: PlanView_UB14.5.mxd

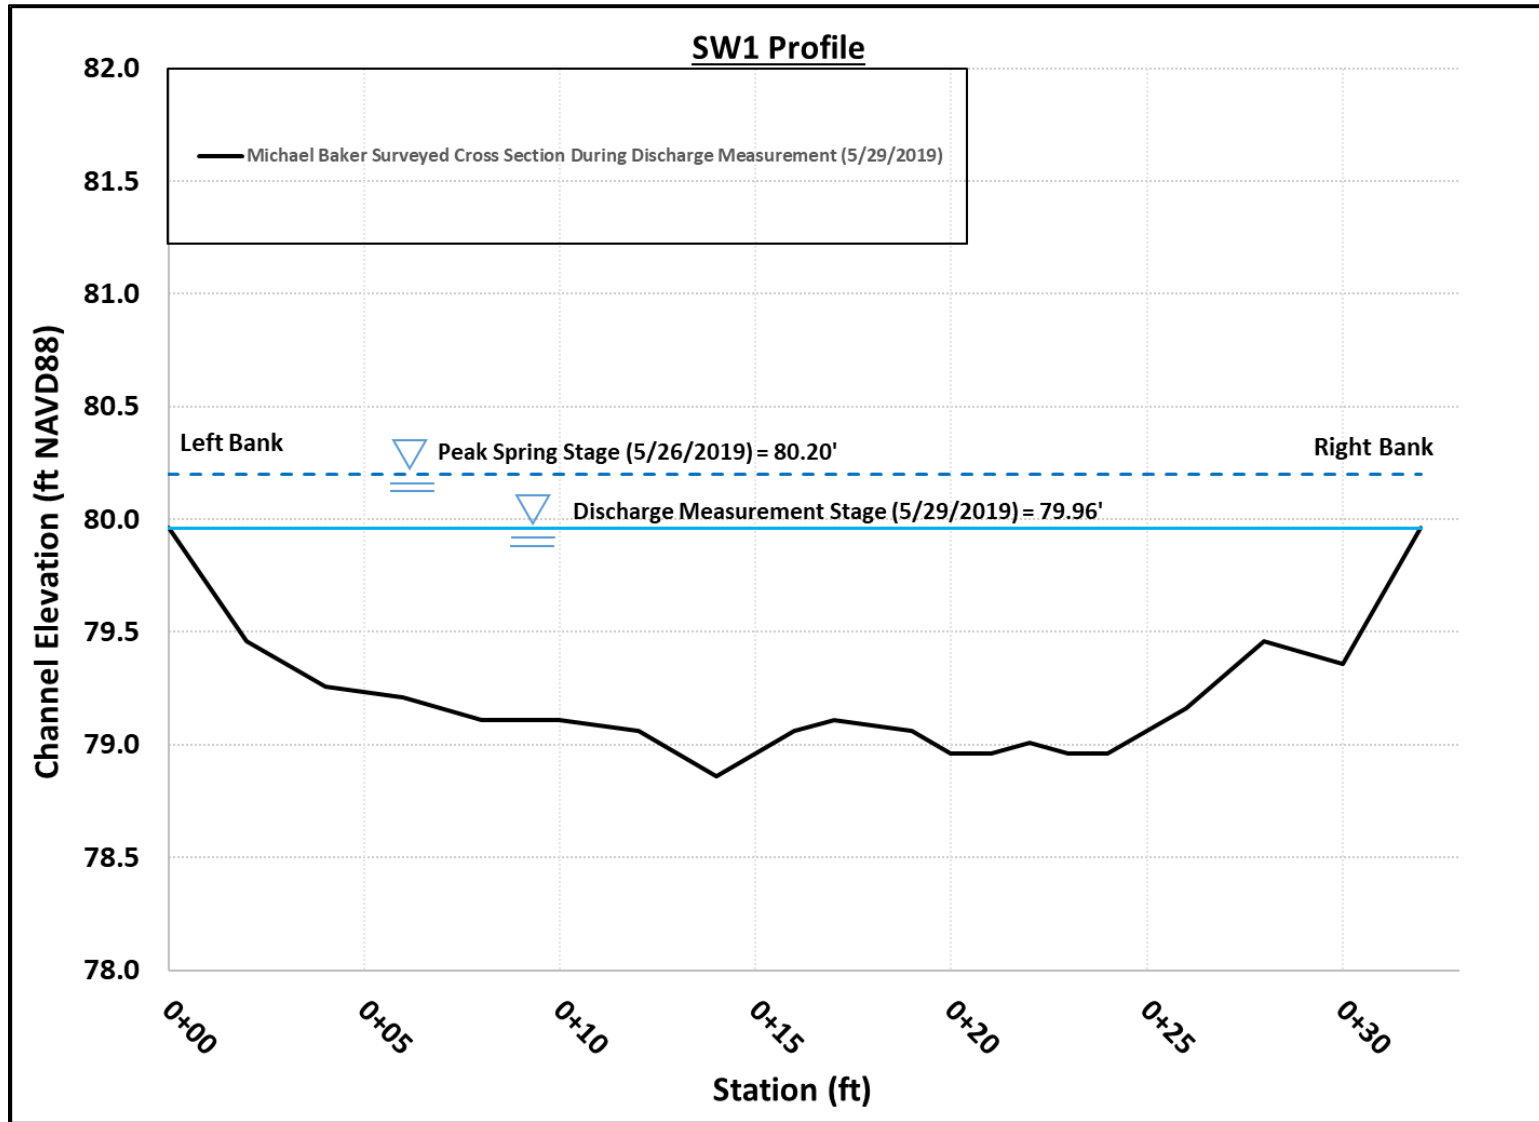
Spring Breakup Cross-Section Profile

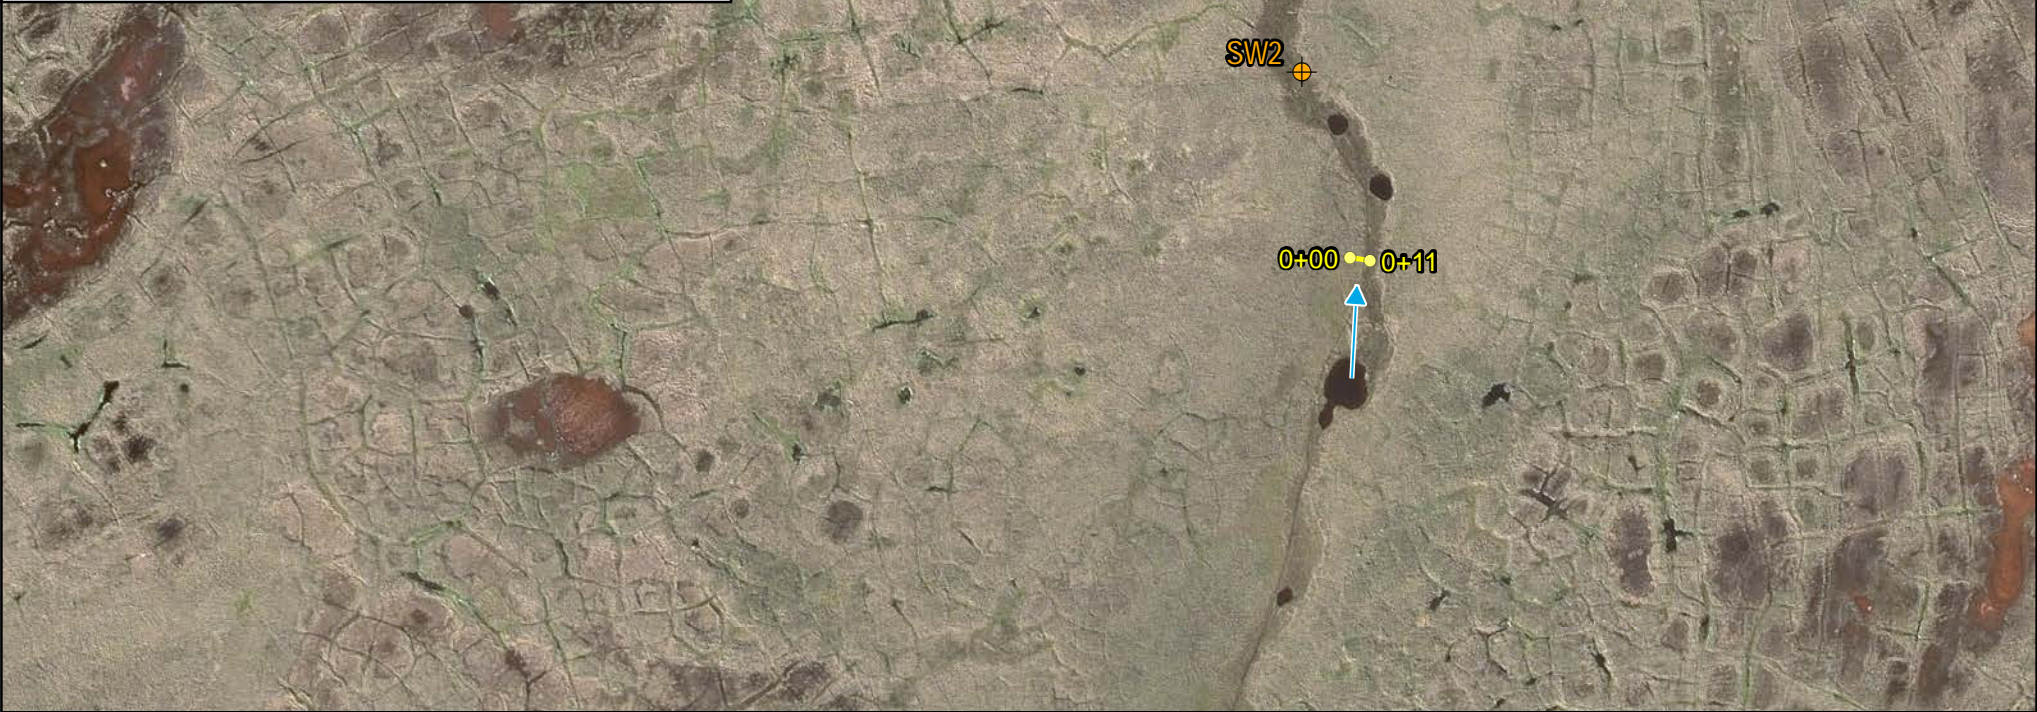
FIGURE C.13

Date: 10/18/2019	Scale: 1 Inch = 200 Feet
Drawn: JEG	Project: 172339
Checked: GCY	File: PlanView_SW2.mxd

Gage Location		Flow Direction
	Station		
	Discharge Measurement Cross Section

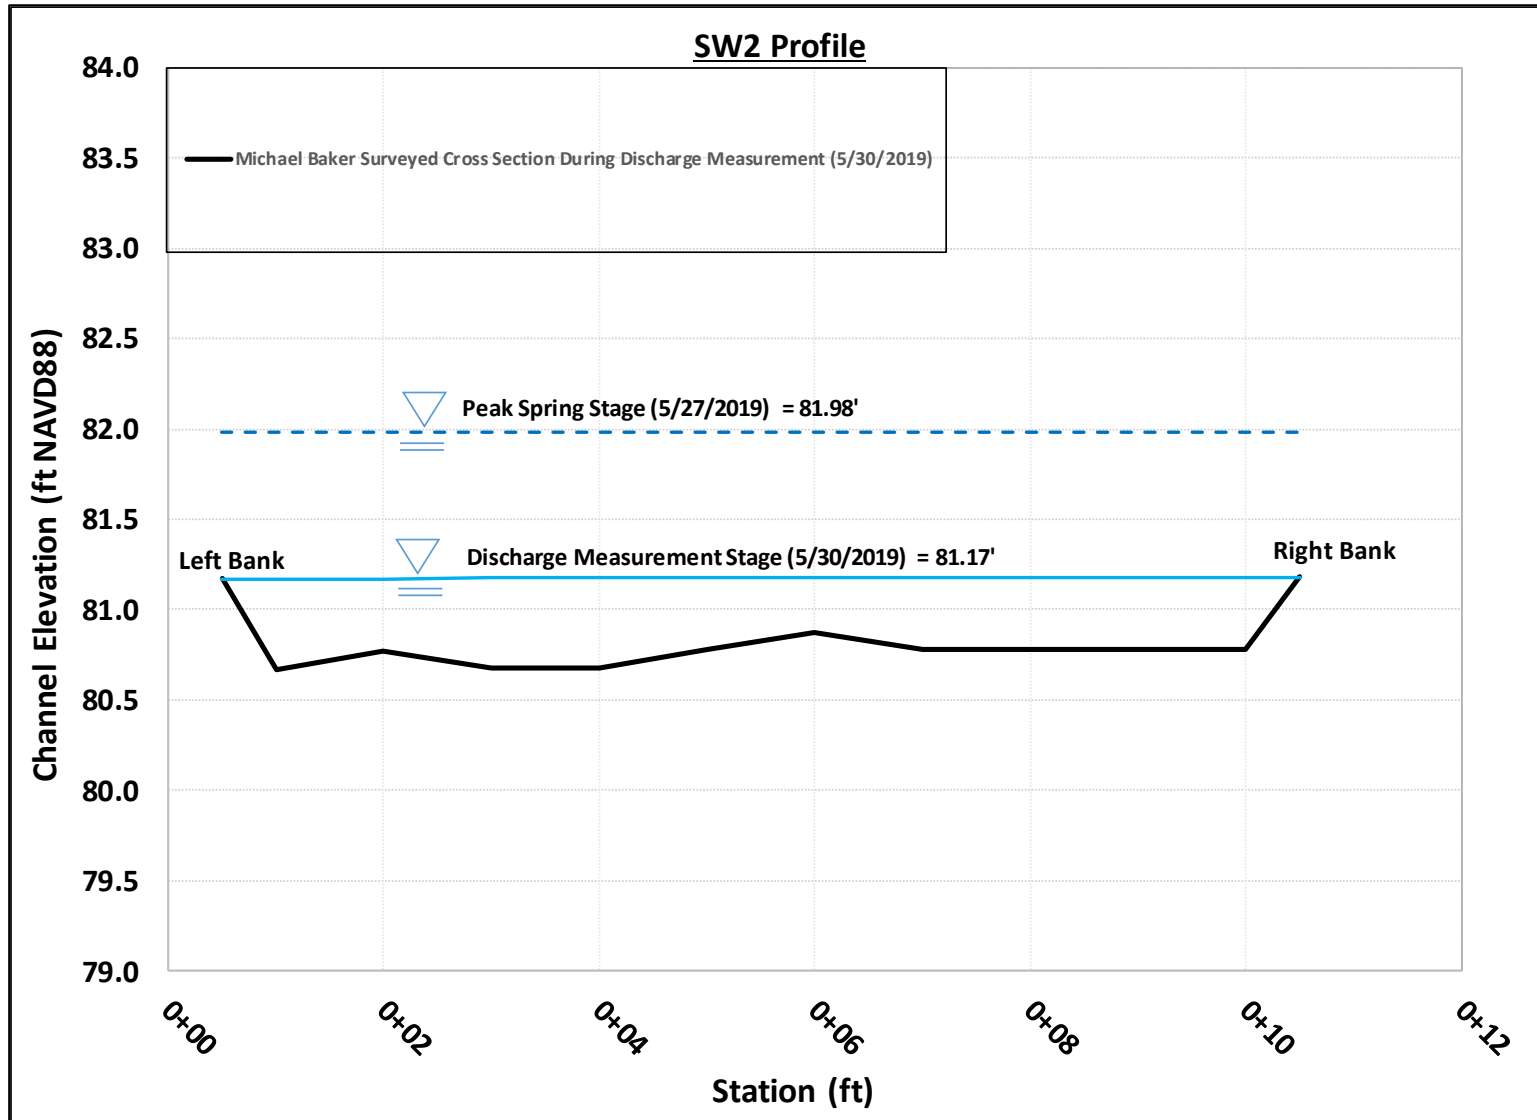
Date: 5/29/2019		Time: 3:15 PM		Method: USGS Mid-Section Technique			
Location: SW2		Crew: KDB, DTR, CMB, ACG		Depth: 0.6 of Measured Depth			
Lat: N 70.1289°		Long: W 152.0630°		Equipment: Hach Flow Meter			
Station (ft)	Channel Elevation (ft NAVD88)	Measured Depth (ft)	Velocity (ft/s)	Section Width (ft)	Area (ft <sup>2</sup> )	Discharge (ft <sup>3</sup> /s)	Note
0+00.5	81.17	0	-	-	-	-	RIGHT BANK
0+01.0	80.67	0.5	0.87	0.75	0.38	0.33	Grass
0+02.0	80.77	0.4	0.25	1.0	0.40	0.10	Grass
0+03.0	80.67	0.5	0.19	1.0	0.50	0.10	Grass
0+04.0	80.67	0.5	0.35	1.0	0.50	0.17	Grass
0+05.0	80.77	0.4	0.43	1.0	0.40	0.17	Grass
0+06.0	80.88	0.3	0.43	1.0	0.30	0.13	Grass
0+07.0	80.78	0.4	0.67	1.0	0.40	0.27	Grass
0+08.0	80.78	0.4	0.12	1.0	0.40	0.05	Grass
0+09.0	80.78	0.4	0.28	1.0	0.40	0.11	Grass
0+10.0	80.78	0.4	0.20	0.75	0.30	0.06	Grass
0+10.5	81.18	0	-	-	-	-	LEFT BANK
Total Width (ft)	Average Channel Elevation (ft NAVD88)	Average Depth (ft)	Average Velocity (ft/s)	-	Total Area (ft <sup>2</sup> )	Total Discharge (ft <sup>3</sup> /s)

Spring Breakup Cross-Section Profile

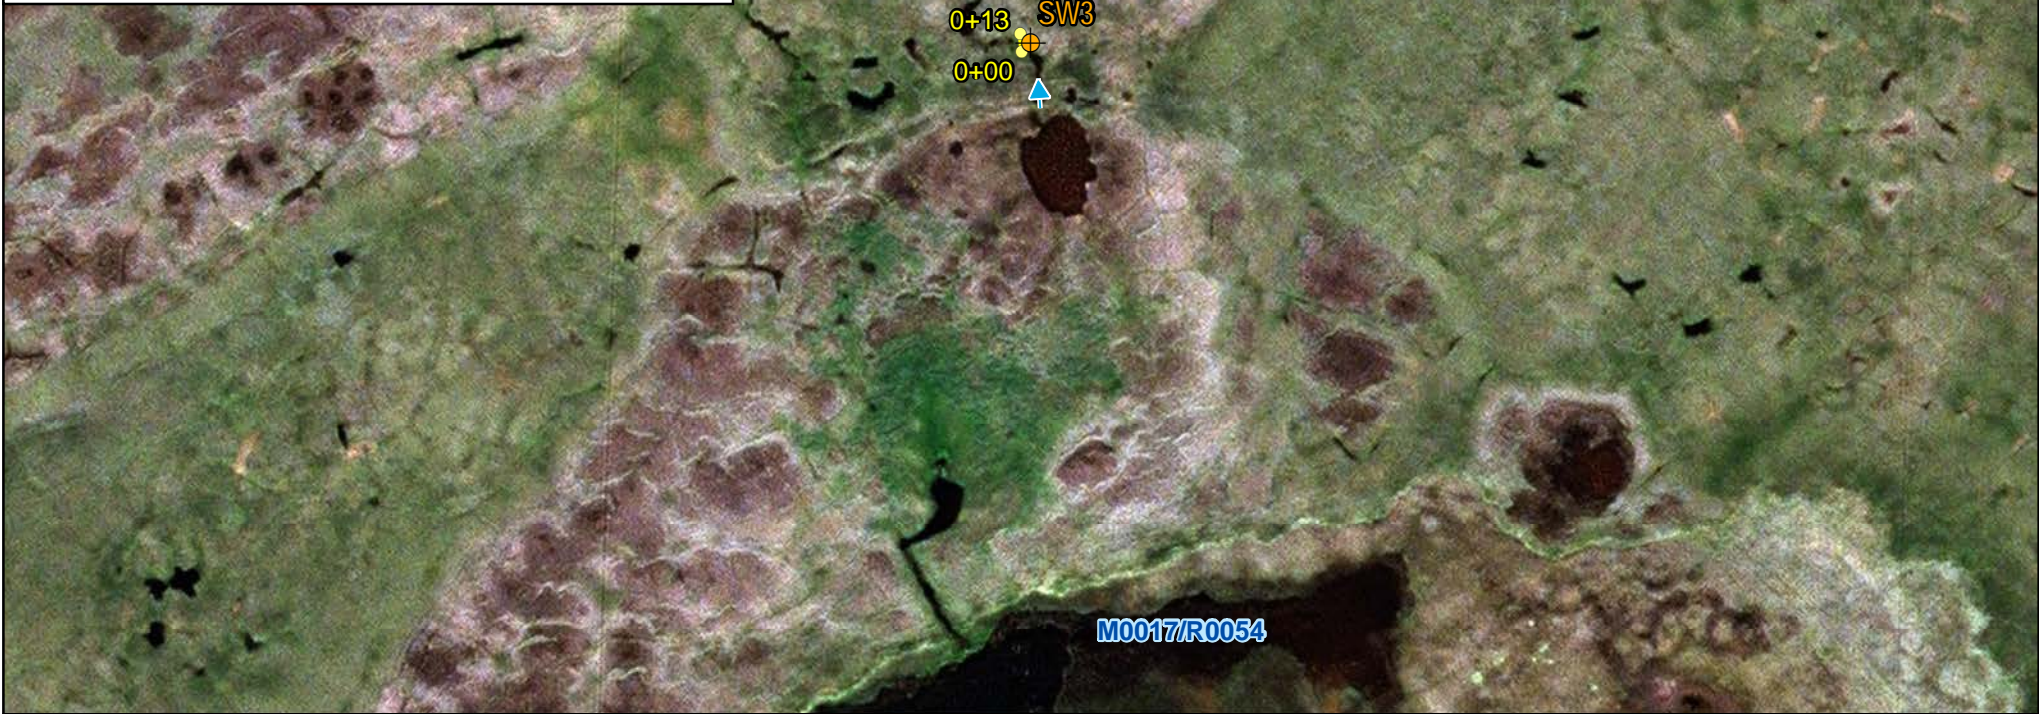
Date: 10/18/2019	Scale: 1 Inch = 200 Feet
Drawn: JEG	Project: 172339
Checked: GCY	File: PlanView_SW3.mxd

Gage Location		Flow Direction
	Station		
	Discharge Measurement Cross Section

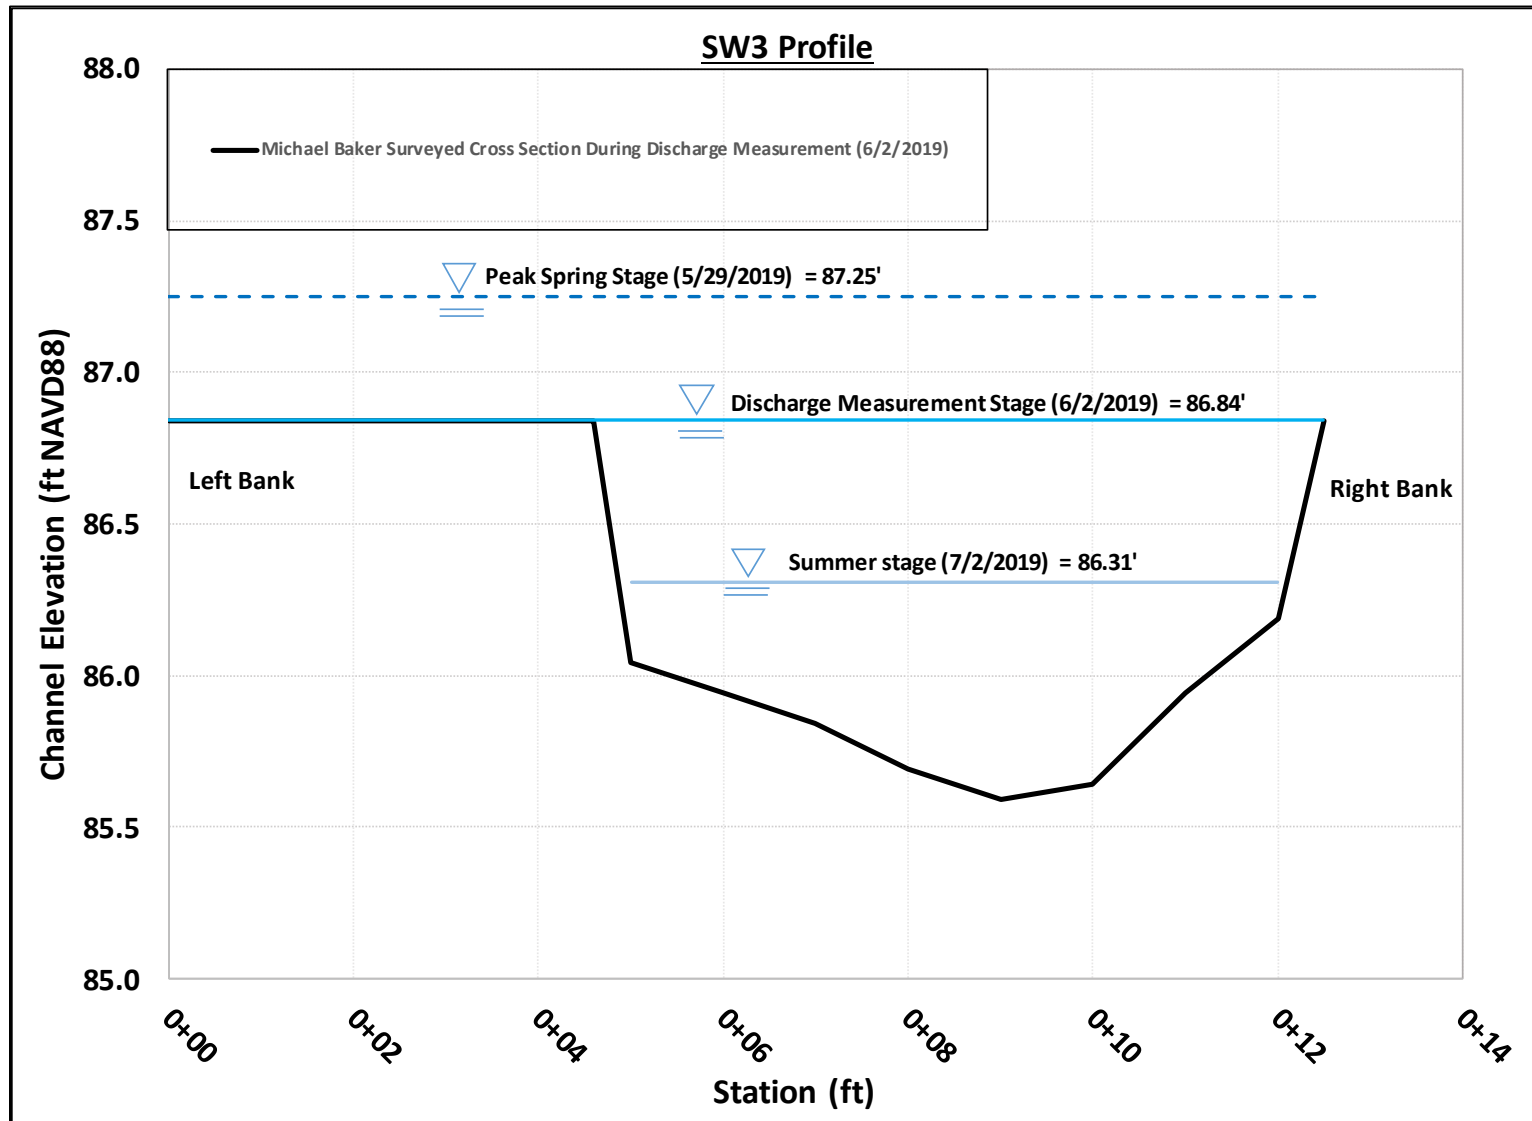
Date: 6/2/2019		Time: 2:30 PM		Method: USGS Mid-Section Technique			
Location: SW3		Crew: CMB, MDM		Depth: 0.6 of measured depth			
Lat: N 70.1058°		Long: W 152.1341°		Equipment: Hach Flow Meter			
Station (ft)	Channel Elevation (ft NAVD88)	Measured Depth (ft)	Velocity (ft/s)	Section Width (ft)	Area (ft <sup>2</sup> )	Discharge (ft <sup>3</sup> /s)	Note
0+01.5	86.84	0	-	-	-	-	RIGHT BANK
0+04.6	86.84	0	0.00	1.75	0.00	0.00	Grass
0+05.0	86.84	0.8	0.39	0.70	0.56	0.22	Grass
0+06.0	86.04	0.9	0.68	1.0	0.90	0.62	Grass
0+07.0	85.94	1.0	0.60	1.0	1.00	0.60	Grass
0+08.0	85.84	1.15	0.54	1.0	1.15	0.62	
0+09.0	85.69	1.25	0.58	1.0	1.25	0.72	Grass
0+10.0	85.59	1.2	0.41	1.0	1.20	0.49	Grass
0+11.0	85.64	0.9	0.20	1.0	0.90	0.18	Grass
0+12.0	85.94	0.65	0.00	0.75	0.49	0.00	Grass
0+12.5	86.19	0	-	-	-	-	LEFT BANK
Total Width (ft)	Average Channel Elevation (ft NAVD88)	Average Depth (ft)	Average Velocity (ft/s)	-	Total Area (ft <sup>2</sup> )	Total Discharge (ft <sup>3</sup> /s)

Spring Breakup Cross-Section Profile
