# 2019 Willow Spring Breakup & Summer Monitoring & Hydrological Assessment

Prepared for:

**ConocoPhillips**  
Alaska

MSA Contract No. 296937

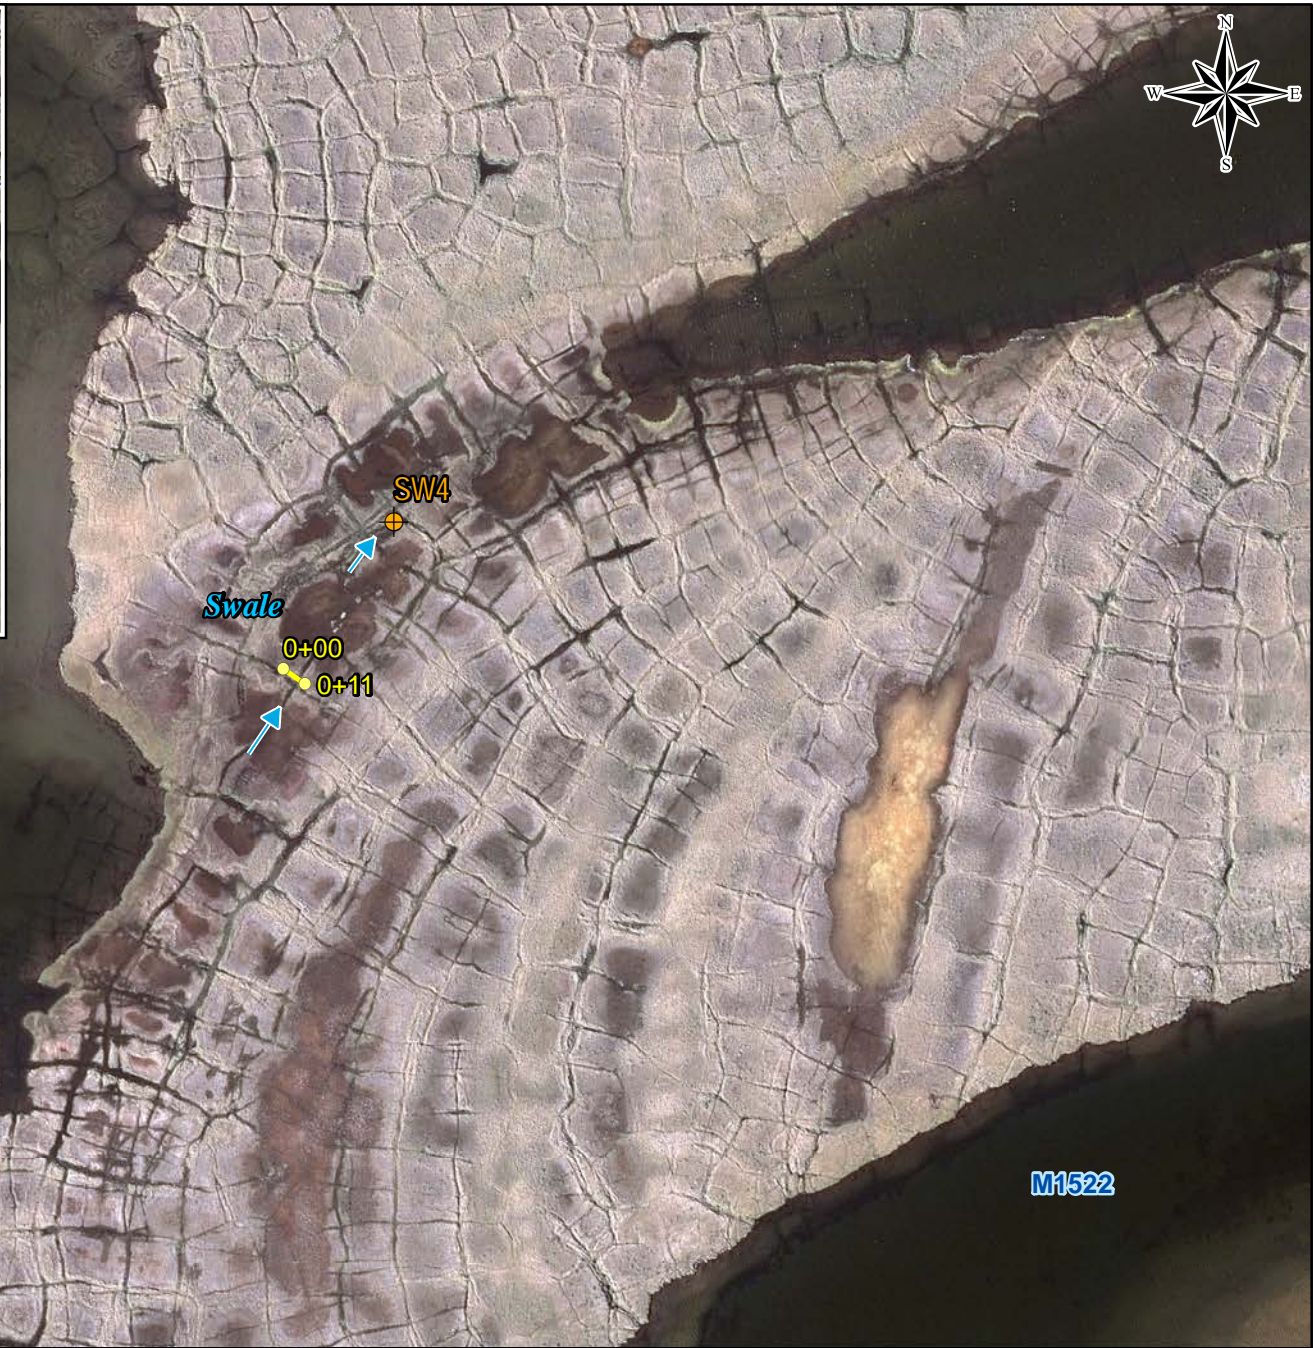
**2019 Spring Breakup**  
**Unnamed Swale**  
**SW4 Plan**  
 FIGURE C.15

Date: 10/18/2019	Scale: 1 Inch = 200 Feet
Drawn: JEG	Project: 172339
Checked: GCY	File: PlanView_SW4.mxd

Gage Location      Flow Direction  
 Station  
 Discharge Measurement  
 Cross Section

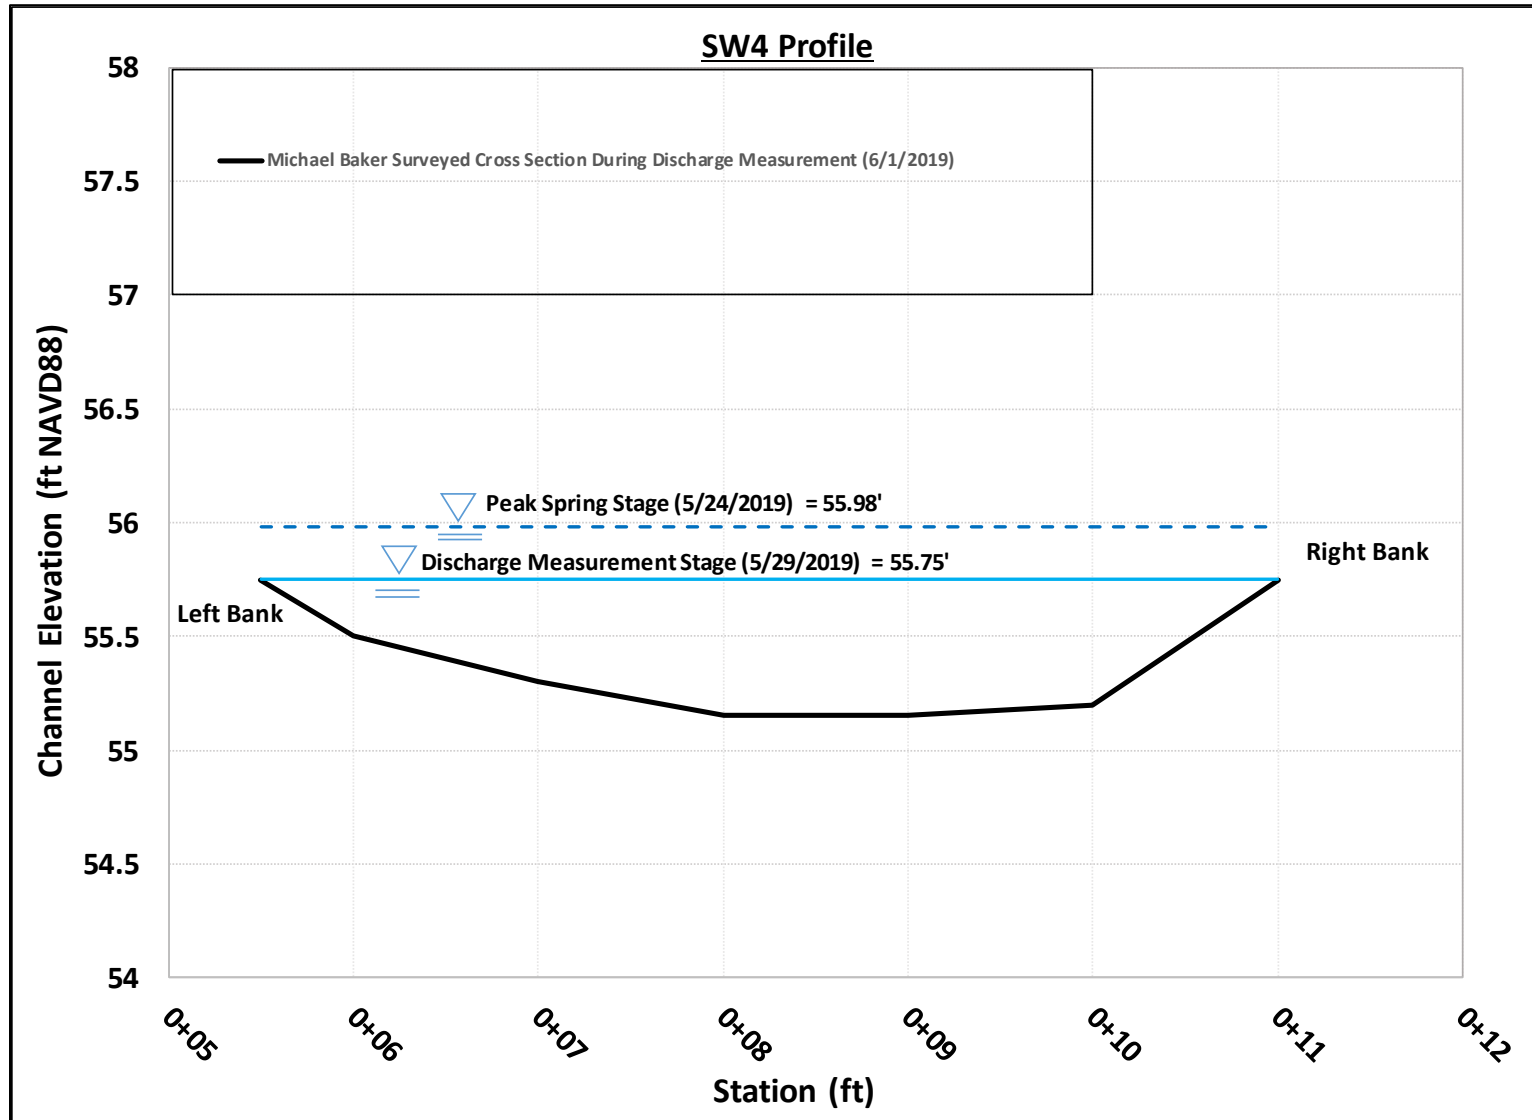
Date: 6/1/2019		Time: 3:00 PM		Method: USGS Mid-Section Technique			
Location: SW4		Crew: CMB, MDM		Depth: 0.6 of measured depth			
Lat: N 70.1560°		Long: W 152.0944°		Equipment: Hach Flow Meter			
Station (ft)	Channel Elevation (ft NAVD88)	Measured Depth (ft)	Velocity (ft/s)	Section Width (ft)	Area (ft <sup>2</sup> )	Discharge (ft <sup>3</sup> /s)	Note
0+05.5	55.75	0	-	-	-	-	LEFT BANK
0+06.0	55.50	0.25	0.10	0.75	0.19	0.02	Grass
0+07.0	55.30	0.45	0.07	1.0	0.45	0.03	Grass
0+08.0	55.15	0.60	0.62	1.0	0.60	0.37	Grass
0+09.0	55.15	0.60	0.78	1.0	0.60	0.47	Grass
0+10.0	55.20	0.55	0.47	1.0	0.55	0.26	Grass
0+11.0	55.75	0	-	-	-	-	RIGHT BANK
Total Width (ft)	Average Channel Elevation (ft NAVD88)	Average Depth (ft)	Average Velocity (ft/s)	-	Total Area (ft <sup>2</sup> )	Total Discharge (ft <sup>3</sup> /s)	
5.5	55.30	0.4	0.41		2.4	1.1

Spring Breakup Cross-Section Profile

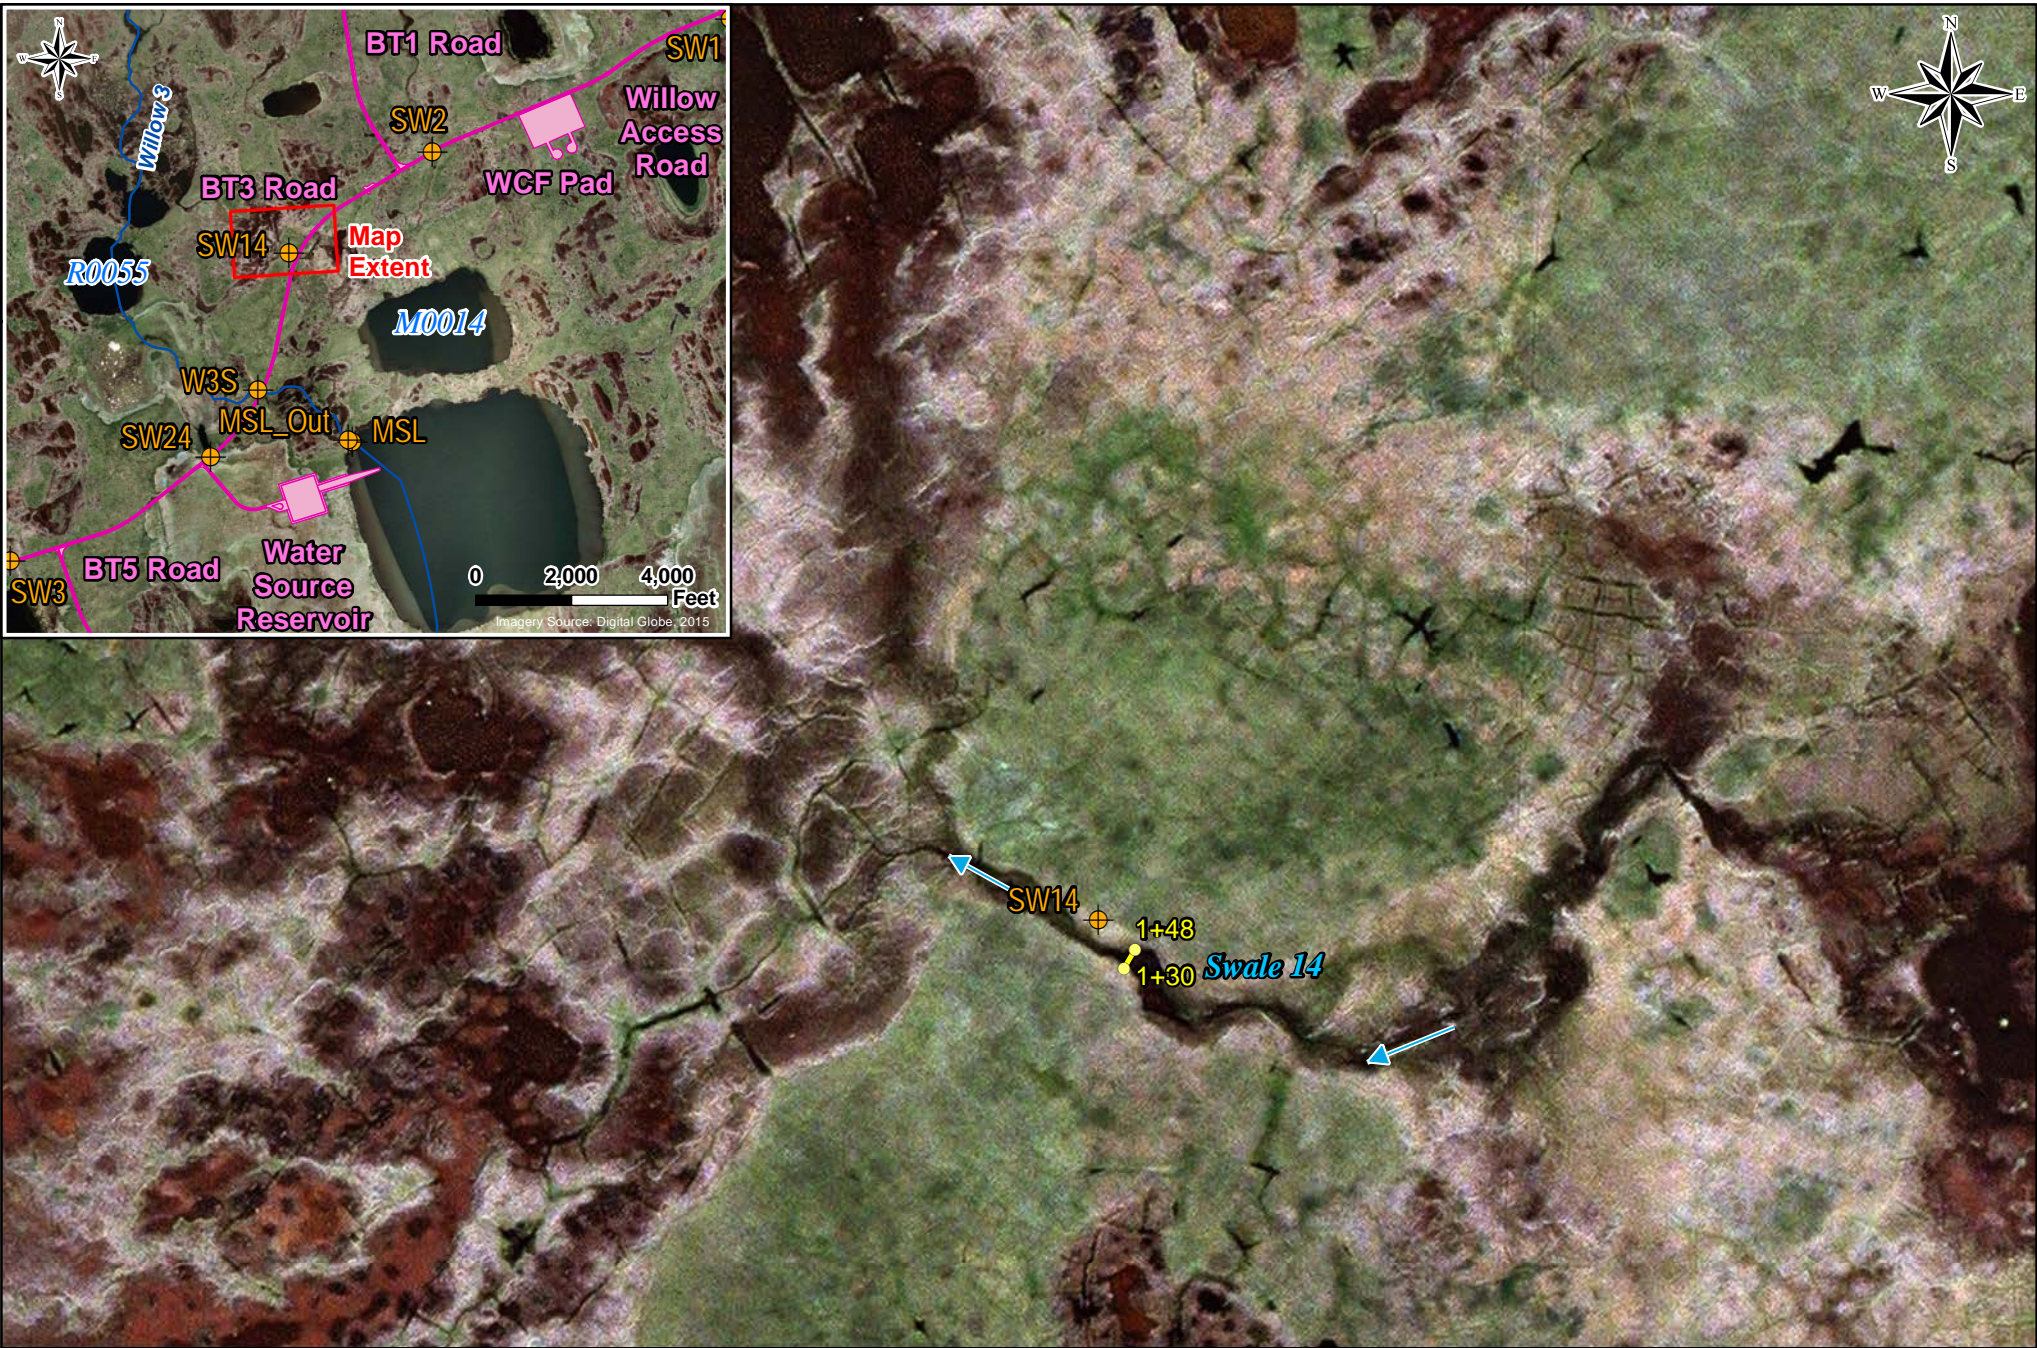
FIGURE C.16

Date: 10/18/2019	Scale: 1 Inch = 200 Feet
Drawn: JEG	Project: 172339
Checked: GCY	File: PlanView_SW14.mxd

Gage Location		Flow Direction
	Station		
	Discharge Measurement Cross Section

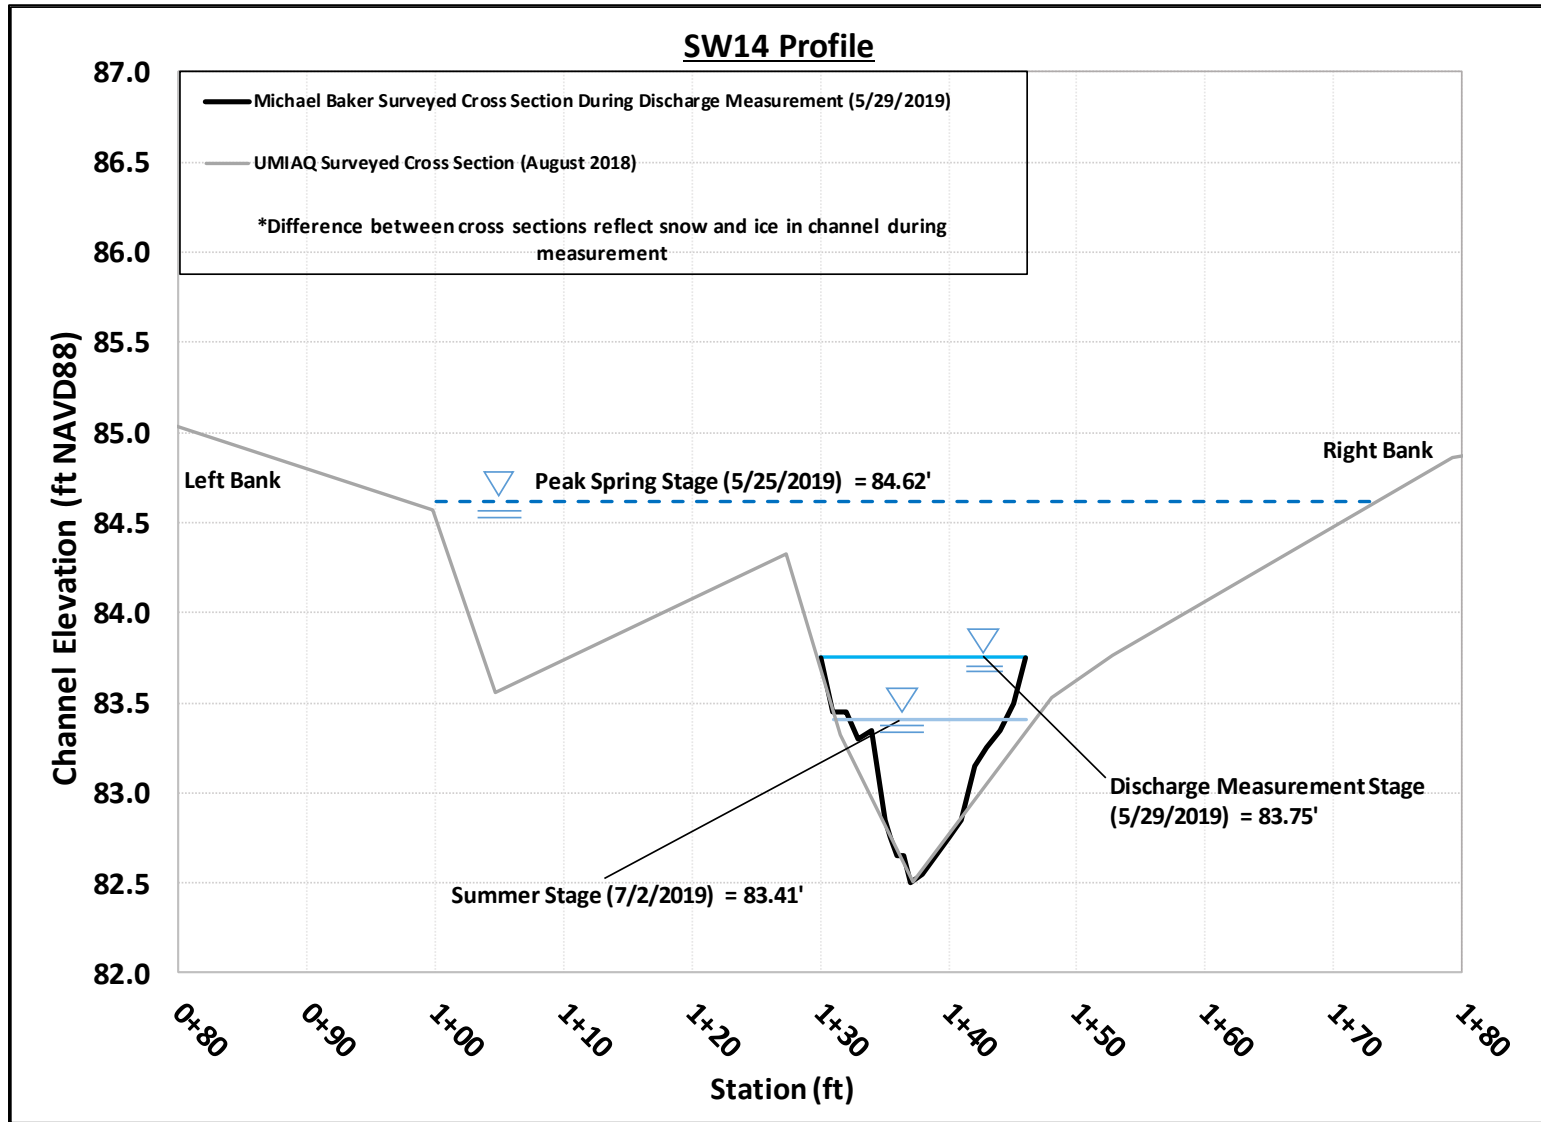
Spring Breakup Cross-Section Profile

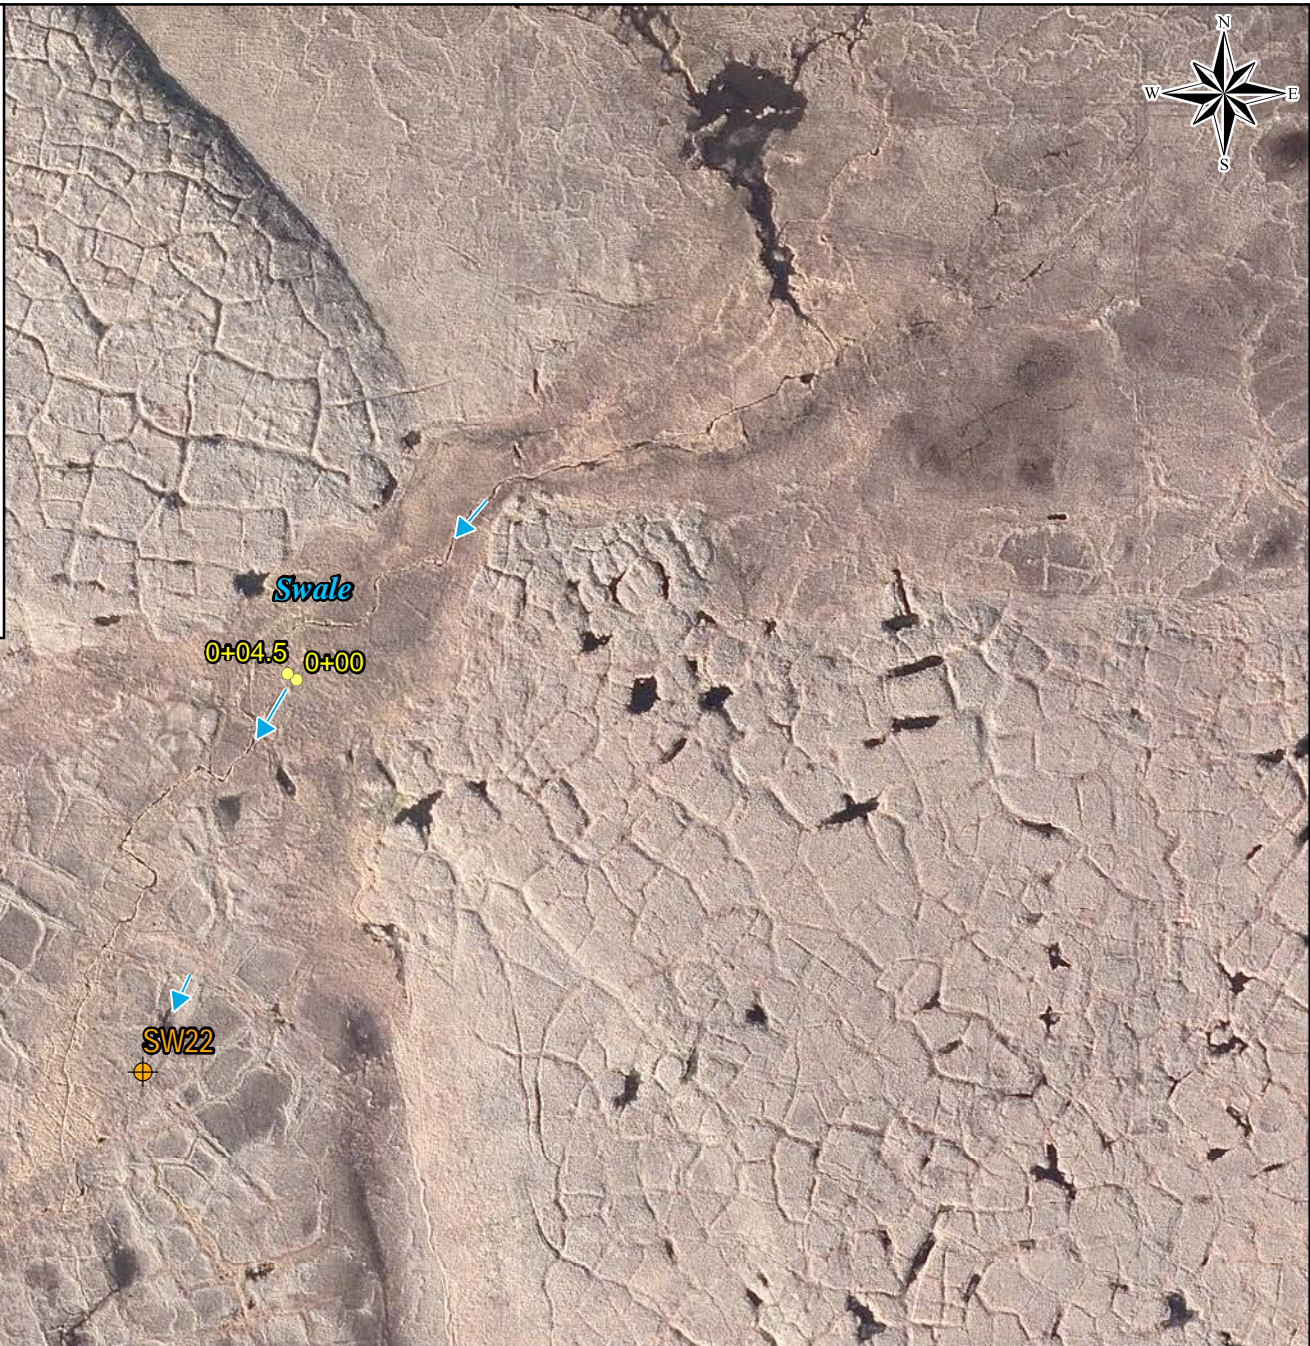
FIGURE C.17

Date: 10/18/2019	Scale: 1 Inch = 200 Feet
Drawn: JEG	Project: 172339
Checked: GCY	File: PlanView_SW22.mxd

Gage Location		Flow Direction
	Station		
	Discharge Measurement		
	Cross Section

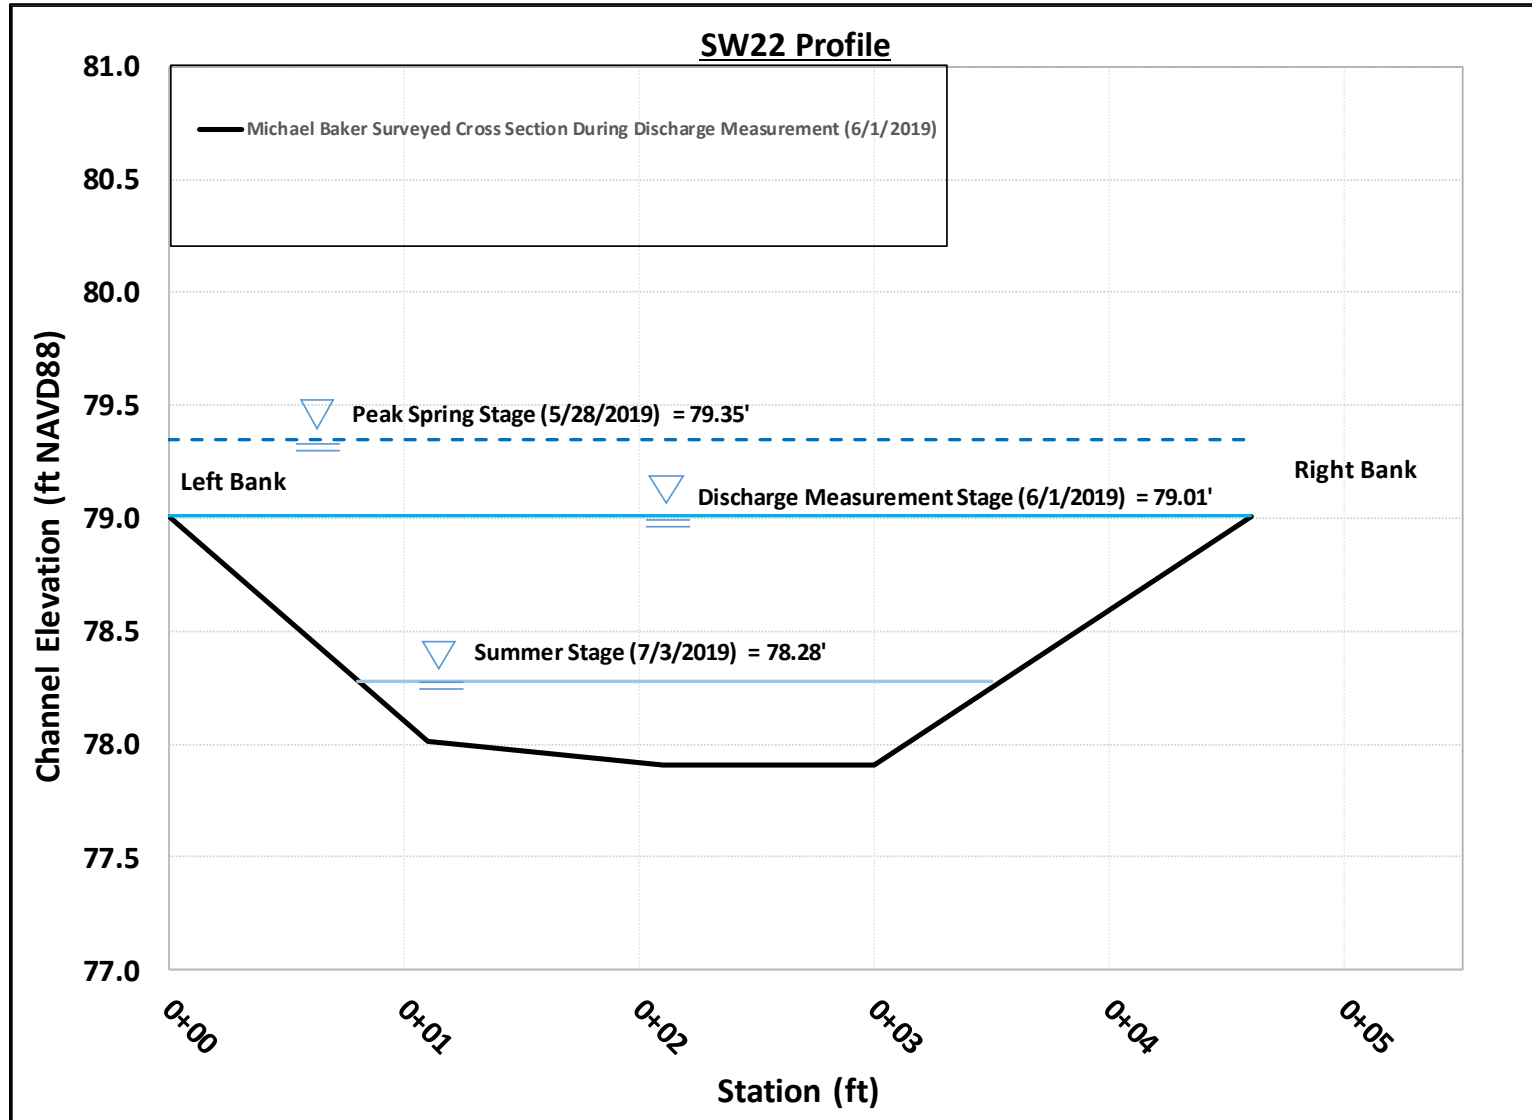
Date: 6/1/2019		Time: 1:30 PM		Method: USGS Mid-Section Technique			
Location: SW22		Crew: CMB, MDM		Depth: 0.6 of Measured Depth			
Lat: N 70.2762°		Long: W 152.1928°		Equipment: Hach Flow Meter			
Station (ft)	Channel Elevation (ft NAVD88)	Measured Depth (ft)	Velocity (ft/s)	Section Width (ft)	Area (ft <sup>2</sup> )	Discharge (ft <sup>3</sup> /s)	Note
0+00.0	79.01	0	-	-	-	-	LEFT BANK
0+01.1	78.01	1.0	0.76	1.05	1.05	0.80	Ice
0+02.1	77.91	1.1	0.83	0.95	1.05	0.87	Grass/Ice
0+03.0	77.91	1.1	1.47	1.25	1.38	2.02	Grass/Ice
0+04.6	79.01	0	-	-	-	-	RIGHT BANK
Total Width (ft)	Average Channel Elevation (ft NAVD88)	Average Depth (ft)	Average Velocity (ft/s)	-	Total Area (ft <sup>2</sup> )	Total Discharge (ft <sup>3</sup> /s)	
4.6	78.20	0.8	1.02	-	3.5	3.7

Spring Breakup Cross-Section Profile

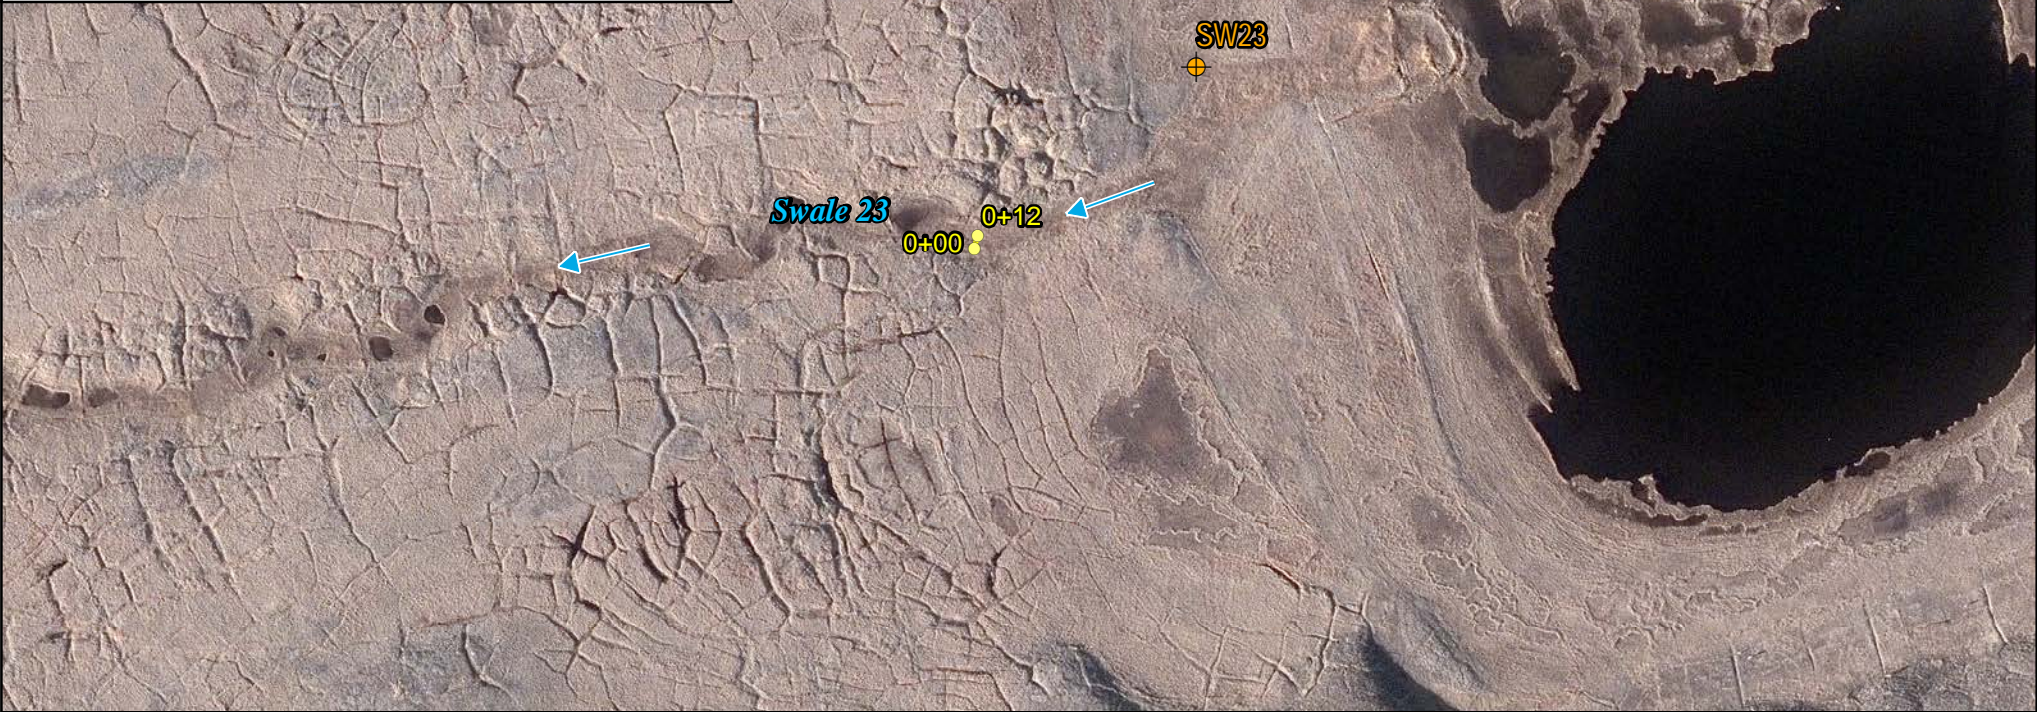
FIGURE C.18

Date: 10/18/2019	Scale: 1 Inch = 200 Feet
Drawn: JEG	Project: 172339
Checked: GCY	File: PlanView_SW23.mxd

Gage Location      Flow Direction  
 Station  
 Discharge Measurement Cross Section

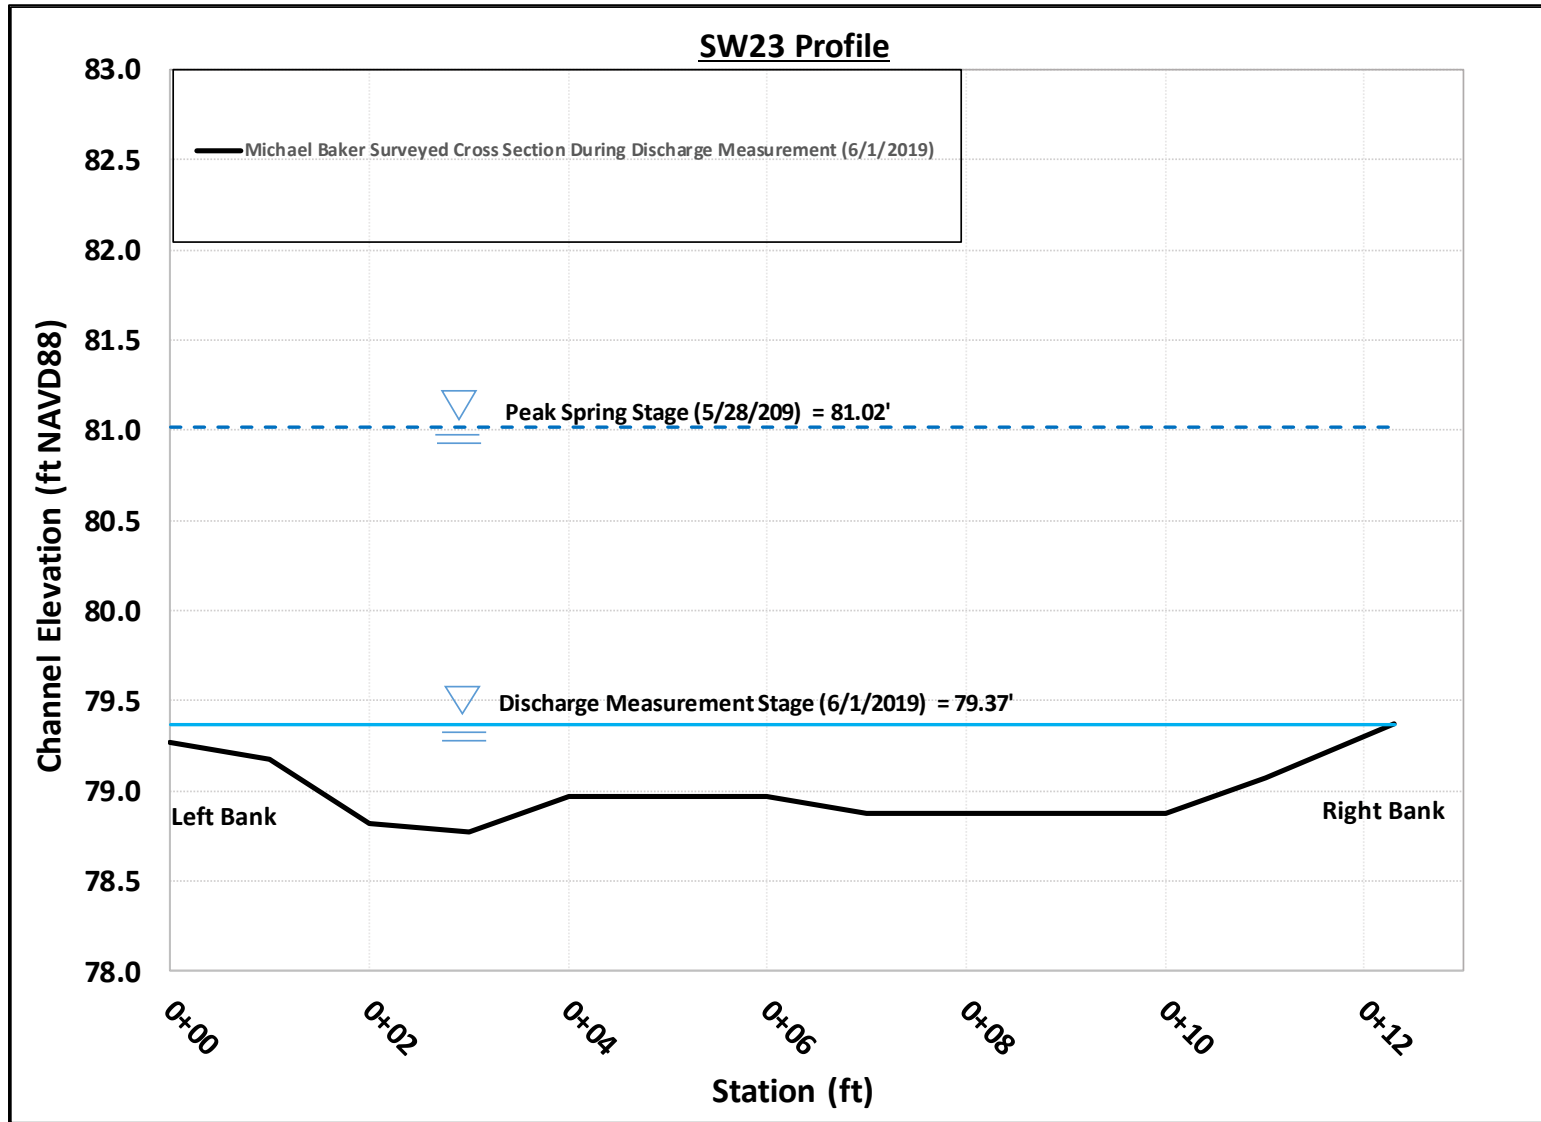
Date: 6/1/2019		Time: 12:30 PM		Method: USGS Mid-Section Technique			
Location: SW23		Crew: CMB, MDM		Depth: 0.6 of Measured Depth			
Lat: N 70.3150°		Long: W 152.1990°		Equipment: Hach Flow Meter			
Station (ft)	Channel Elevation (ft NAVD88)	Measured Depth (ft)	Velocity (ft/s)	Section Width (ft)	Area (ft <sup>2</sup> )	Discharge (ft <sup>3</sup> /s)	Note
0+00	79.27	0.1	-	-	-	-	RIGHT BANK
0+01	79.17	0.2	0.05	1.0	0.20	0.01	Grass
0+02	78.82	0.55	0.17	1.0	0.55	0.09	Grass
0+03	78.77	0.6	0.33	1.0	0.60	0.20	Grass
0+04	78.97	0.4	0.19	1.0	0.40	0.07	Grass
0+05	78.97	0.4	0.27	1.0	0.40	0.11	Grass
0+06	78.97	0.4	0.30	1.0	0.40	0.12	Grass
0+07	78.87	0.5	0.15	1.0	0.50	0.07	Grass
0+08	78.87	0.5	0.13	1.0	0.50	0.07	Grass
0+09	78.87	0.5	0.18	1.0	0.50	0.09	Grass
0+10	78.87	0.5	0.20	1.0	0.50	0.10	Grass
0+11	79.07	0.3	0.07	1.15	0.35	0.02	Grass
0+12.3	79.37	0	-	-	-	-	LEFT BAANK
Total Width (ft)	Average Channel Elevation (ft NAVD88)	Average Depth (ft)	Average Velocity (ft/s)	-	Total Area (ft <sup>2</sup> )	Total Discharge (ft <sup>3</sup> /s)

Spring Breakup Cross-Section Profile

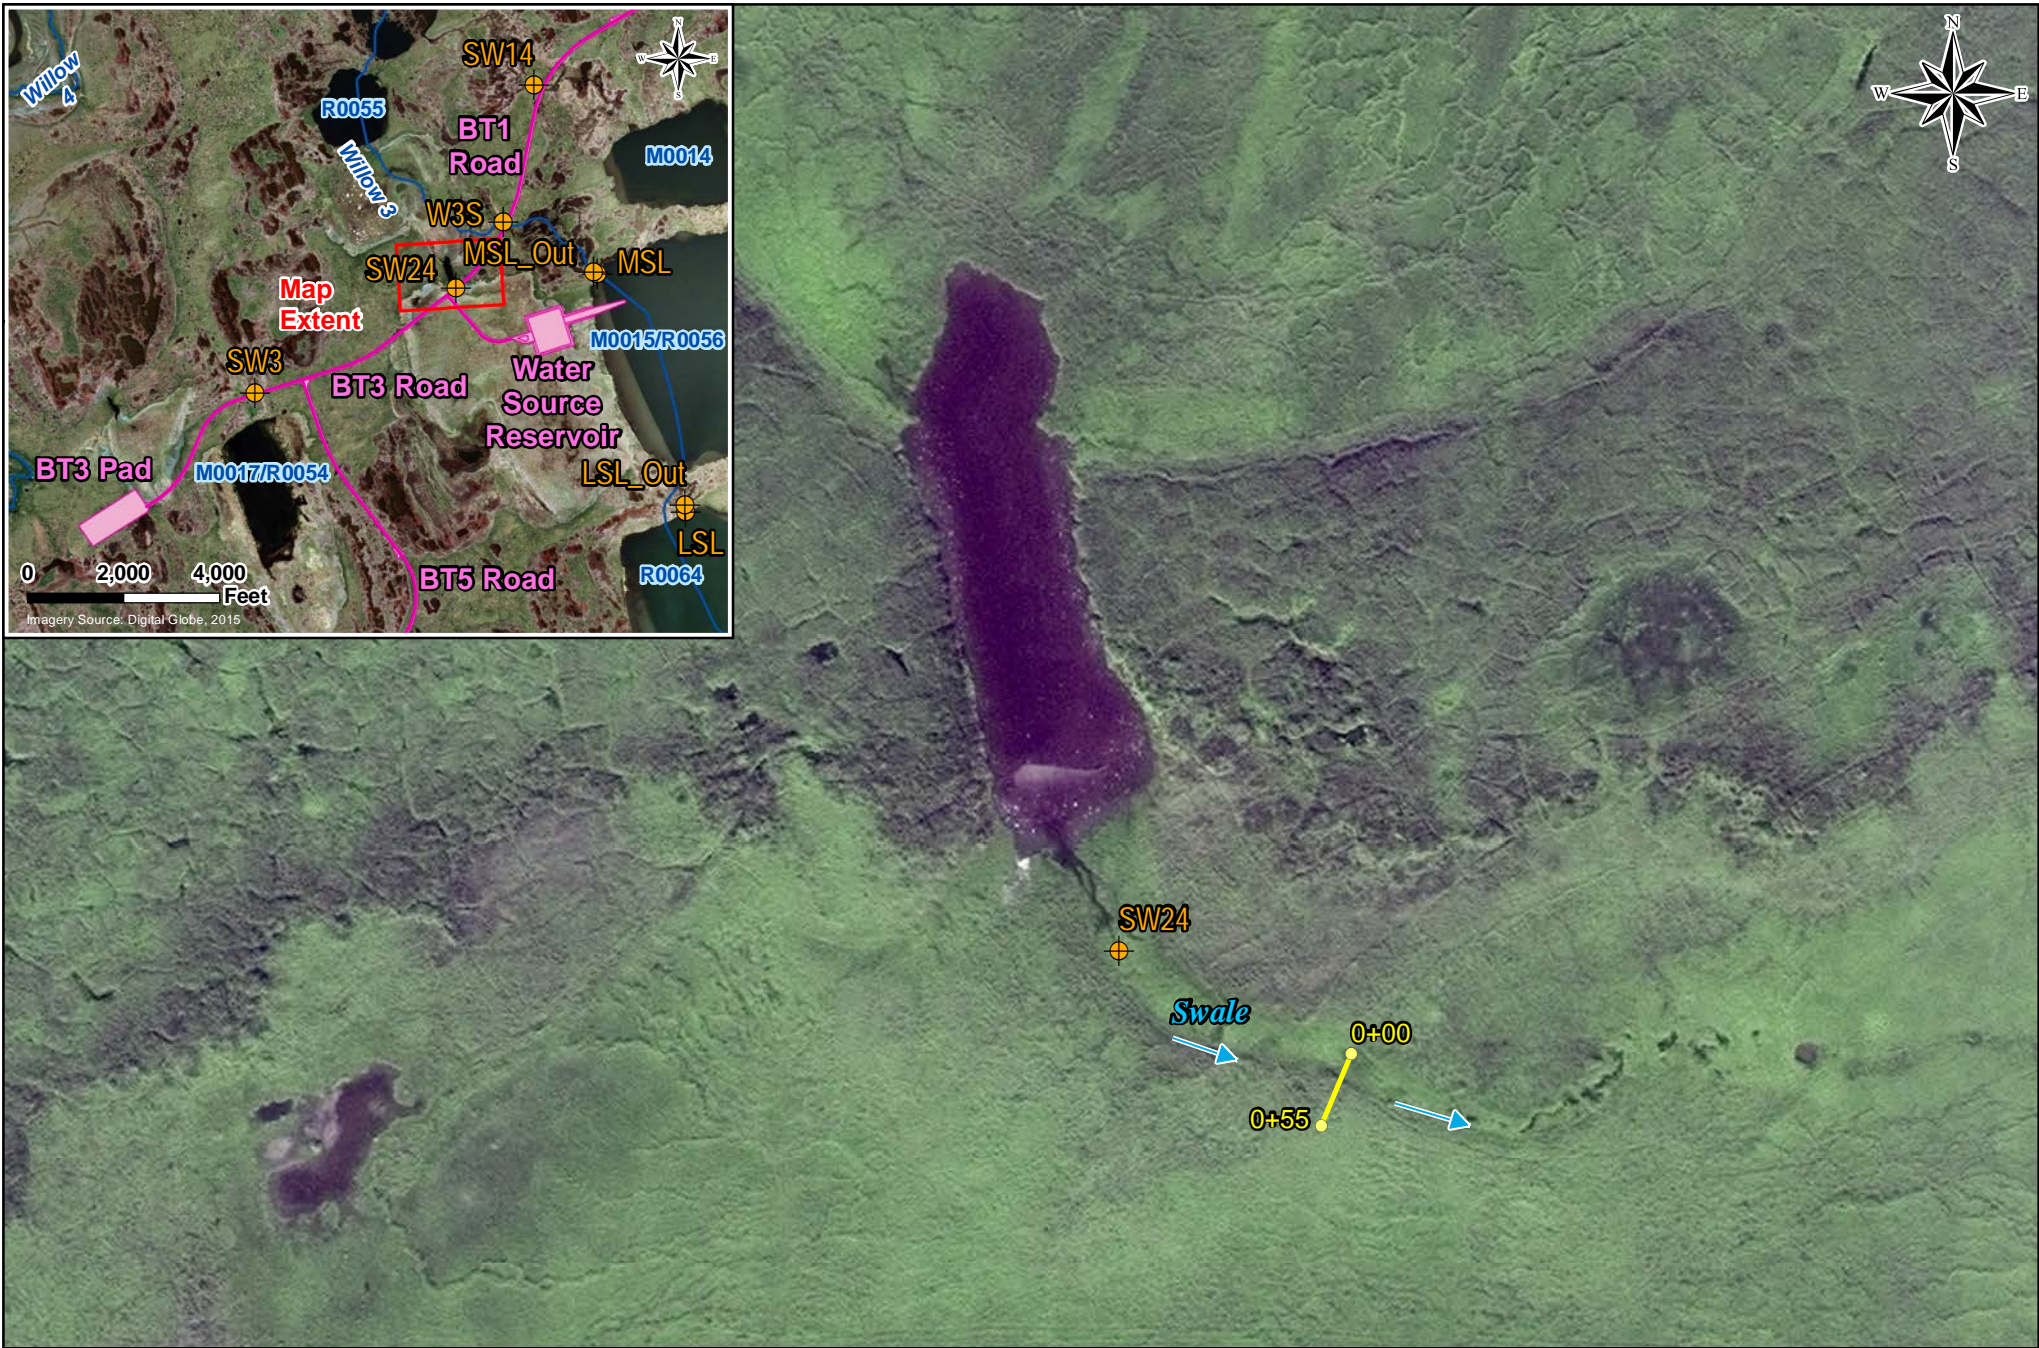
FIGURE C.19

Date:	10/18/2019	Scale: 1 Inch = 200 Feet
Drawn:	JEG	Project: 172339
Checked:	GCY	File: PlanView_SW24.mxd

Gage Location      Flow Direction  
 Station  
 Discharge Measurement Cross Section

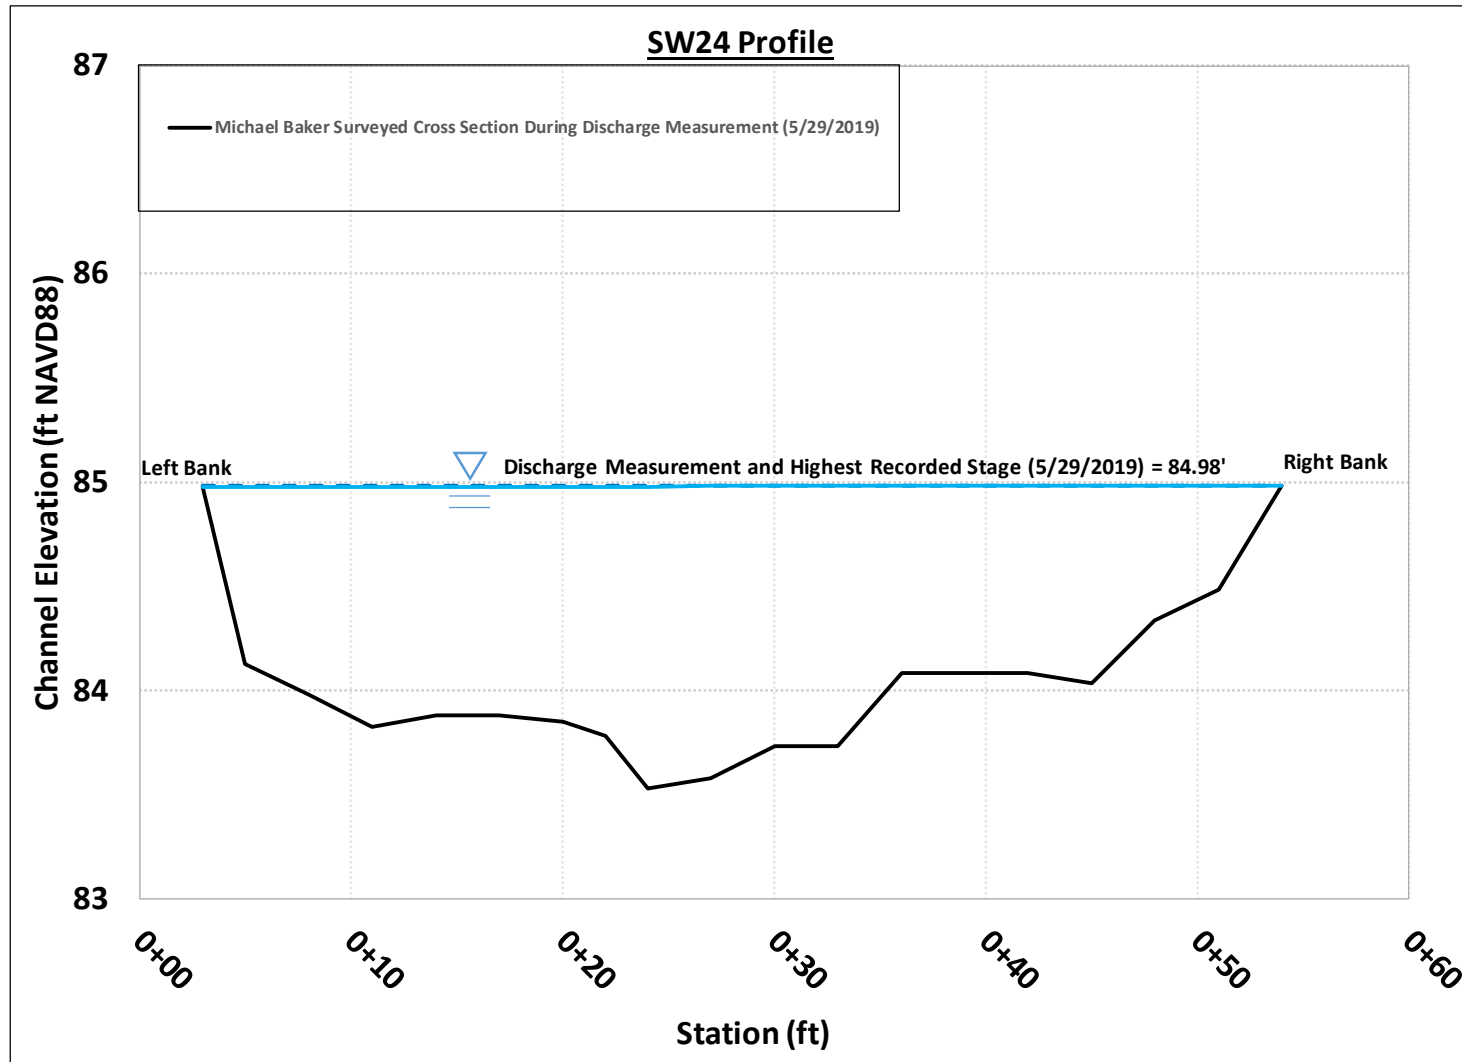
Spring Breakup Cross-Section Profile

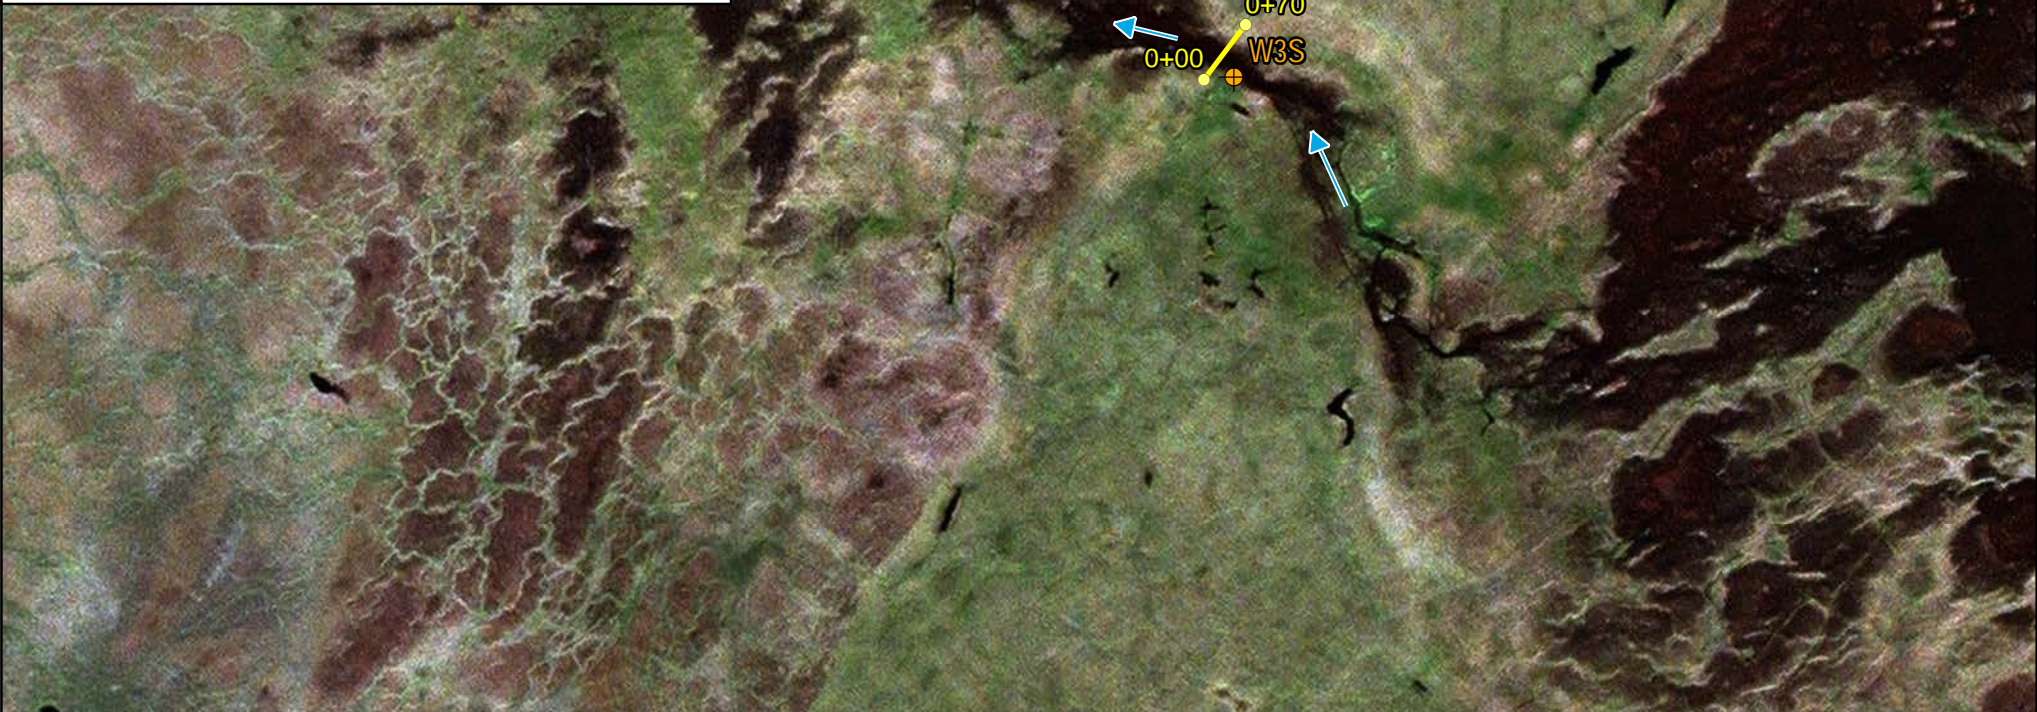
Date: 10/18/2019	Scale: 1 Inch = 200 Feet
Drawn: JEG	Project: 172339
Checked: GCY	File: PlanView_W3S.mxd

Gage Location		Flow Direction
	Station		
	Discharge Measurement		
	Cross Section
