# 2019 Willow Spring Breakup & Summer Monitoring & Hydrological Assessment

Prepared for:

**ConocoPhillips**  
Alaska

MSA Contract No. 296937

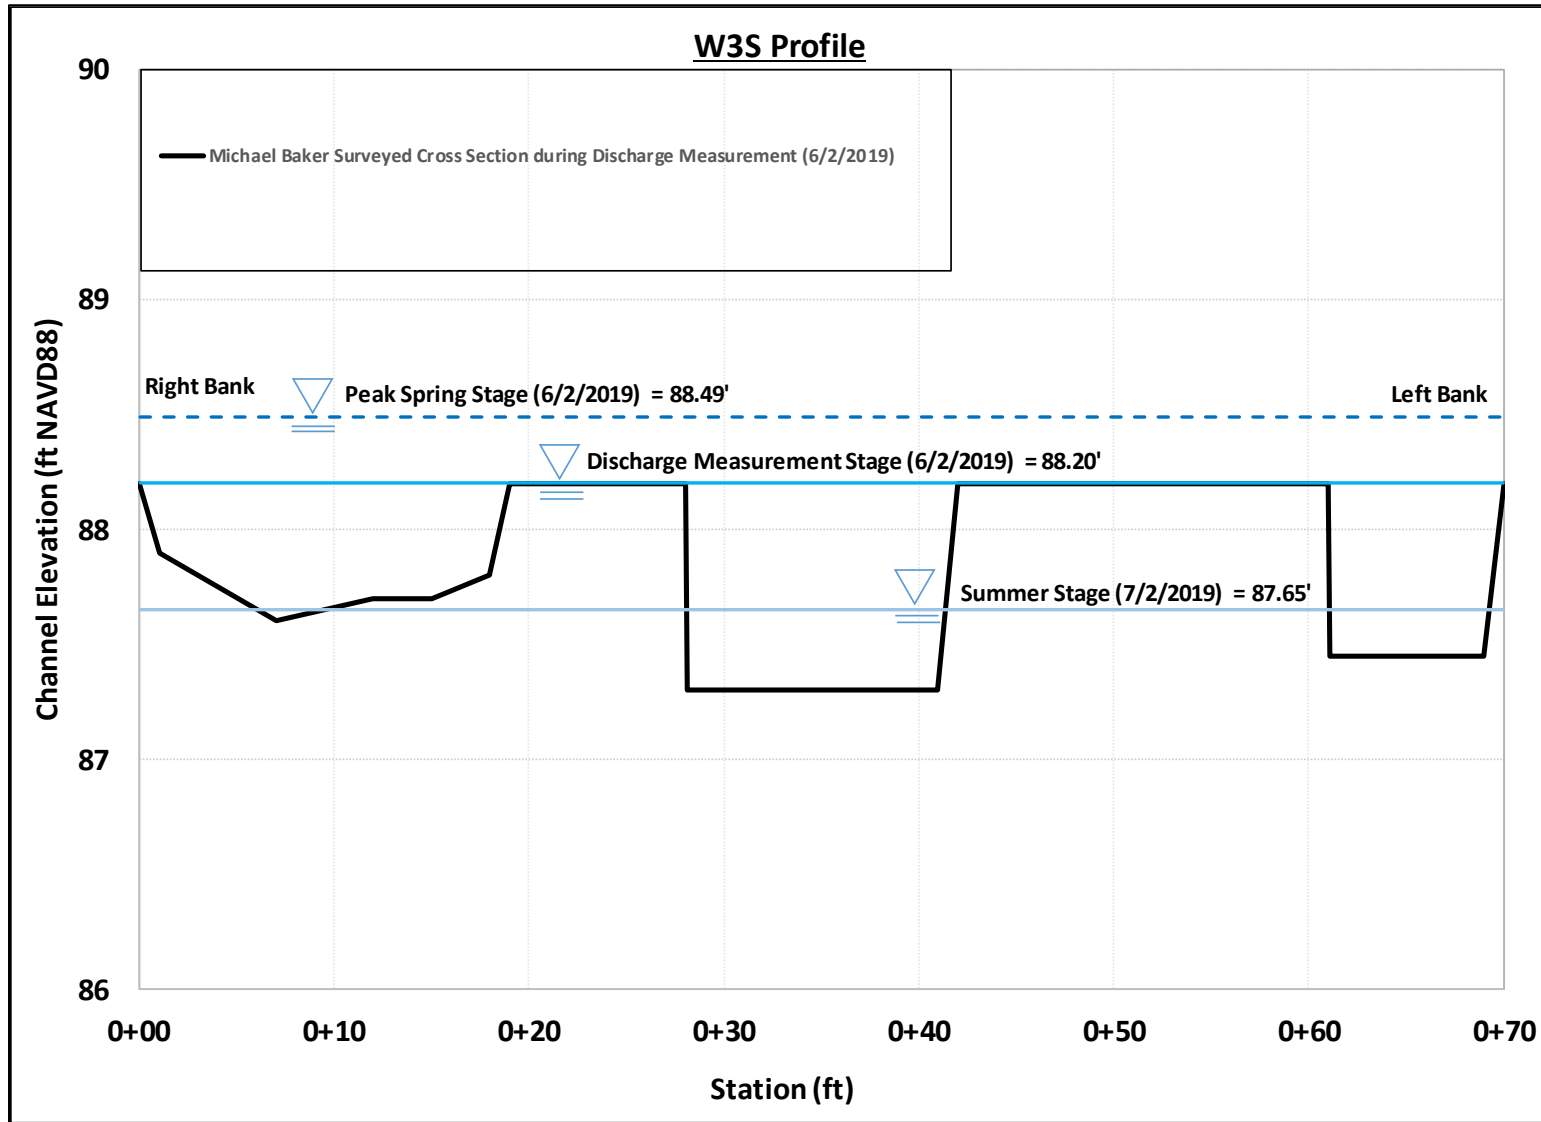
Station (ft)	Channel Elevation (ft NAVD88)	Measured Depth (ft)	Velocity (ft/s)	Section Width (ft)	Area (ft <sup>2</sup> )	Discharge (ft <sup>3</sup> /s)	Note
0+00.0	88.20	0	-	-	-	-	LEFT BANK
0+01.0	87.90	0.3	0.50	1.0	0.30	0.15	Grass, ice
0+07.0	87.60	0.6	0.10	6.0	3.60	0.36	Grass, ice
0+12.0	87.70	0.5	0.20	5.0	2.50	0.50	Grass, ice
0+15.0	87.70	0.5	0.15	3.0	1.50	0.23	Grass, ice
0+18.0	87.80	0.4	0.20	3.0	1.20	0.24	Grass, ice
0+19.0	88.20	0	-	-	-	-	Snow pack – no flow
0+28.0	88.20	0	-	10.0	0.00	-	Snow pack – no flow
0+28.1	87.30	0.9	-	-	-	-	
0+41.0	87.30	0.9	0.90	13.0	11.70	10.53	Center channel
0+42.0	88.20	0	-	-	-	-	Snow pack – no flow
0+61.0	88.20	0	-	20.0	0.00	-	Left channel
0+61.1	87.45	0.75	-	-	-	-	
0+69.0	87.45	0.75	0.70	8.0	6.00	4.20	Grass
0+70.0	88.20	0	-	-	-	-	RIGHT BANK
<b>Total Width (ft)</b>	<b>Average Channel Elevation (ft NAVD88)</b>	<b>Average Depth (ft)</b>	<b>Average Velocity (ft/s)</b>	-	<b>Total Area (ft<sup>2</sup>)</b>	<b>Total Discharge (ft<sup>3</sup>/s)</b>

Spring Breakup Cross-Section Profile
