2016

ALPINE PIPELINE HYDROLOGY MONITORING

► **MICHAEL BAKER INTERNATIONAL**

ConocoPhillips
Alaska

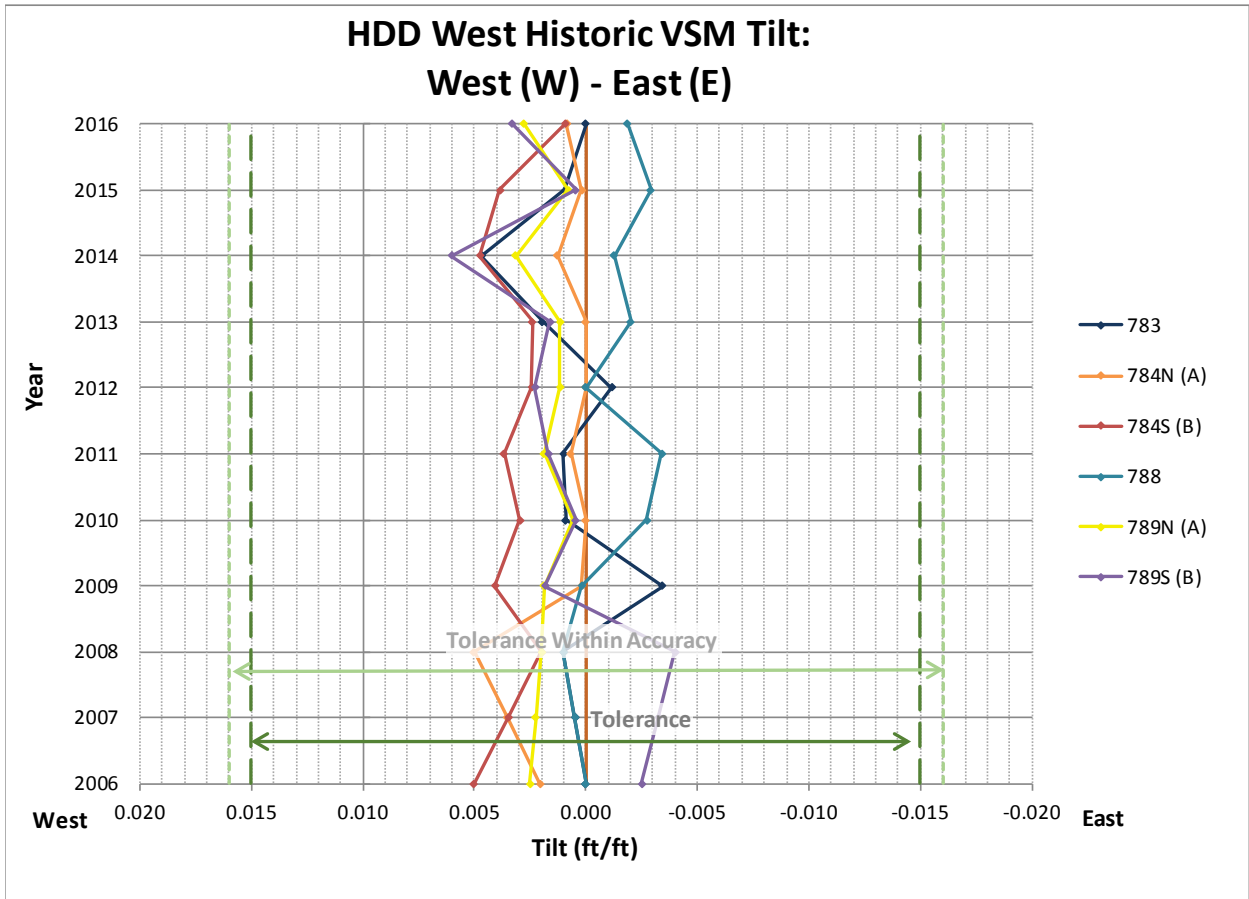
Graph 2: HDD West VSM Historical Change in Tilt, West/East

- Notes:**
1. Positive tilt indicates west (W), negative tilt indicates east (E).
 2. Project tilt tolerance for VSM is +/- 0.015 ft/ft.
 3. Survey accuracy of this project is +/-0.001 ft/ft.

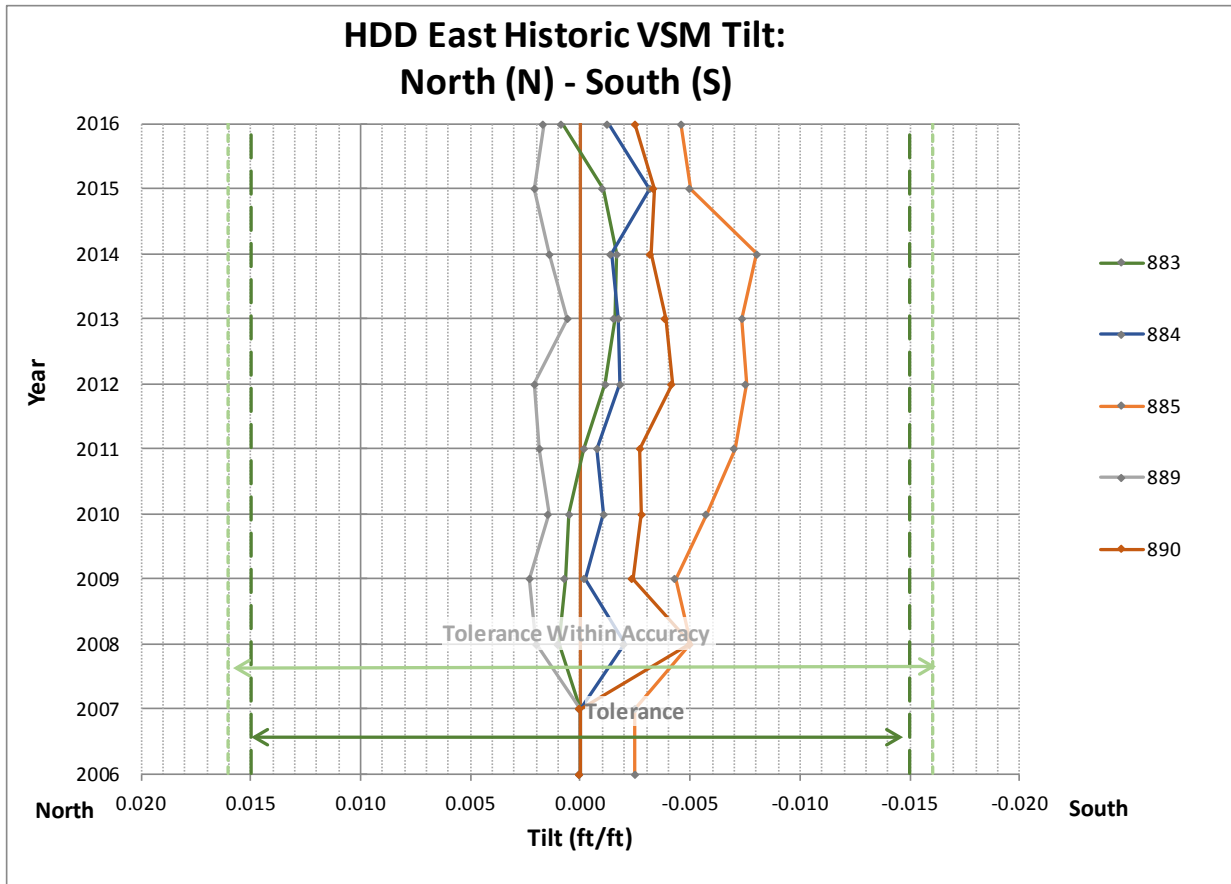
Graph 3: HDD East VSM Historical Change in Tilt, North/South

Graph 3 and Graph 4 present the historical VSM change in tilt by orientation between 2006 and 2016 (Michael Baker 2006, 2007, 2008, 2009, 2010, 2011, 2012, 2013, 2014 and 2015).

- Notes:**
1. Positive tilt indicates north (N), negative tilt indicates south (S).
 2. Project tilt tolerance for VSM is +/- 0.015 ft/ft.
 3. Survey accuracy of this project is +/-0.001 ft/ft.

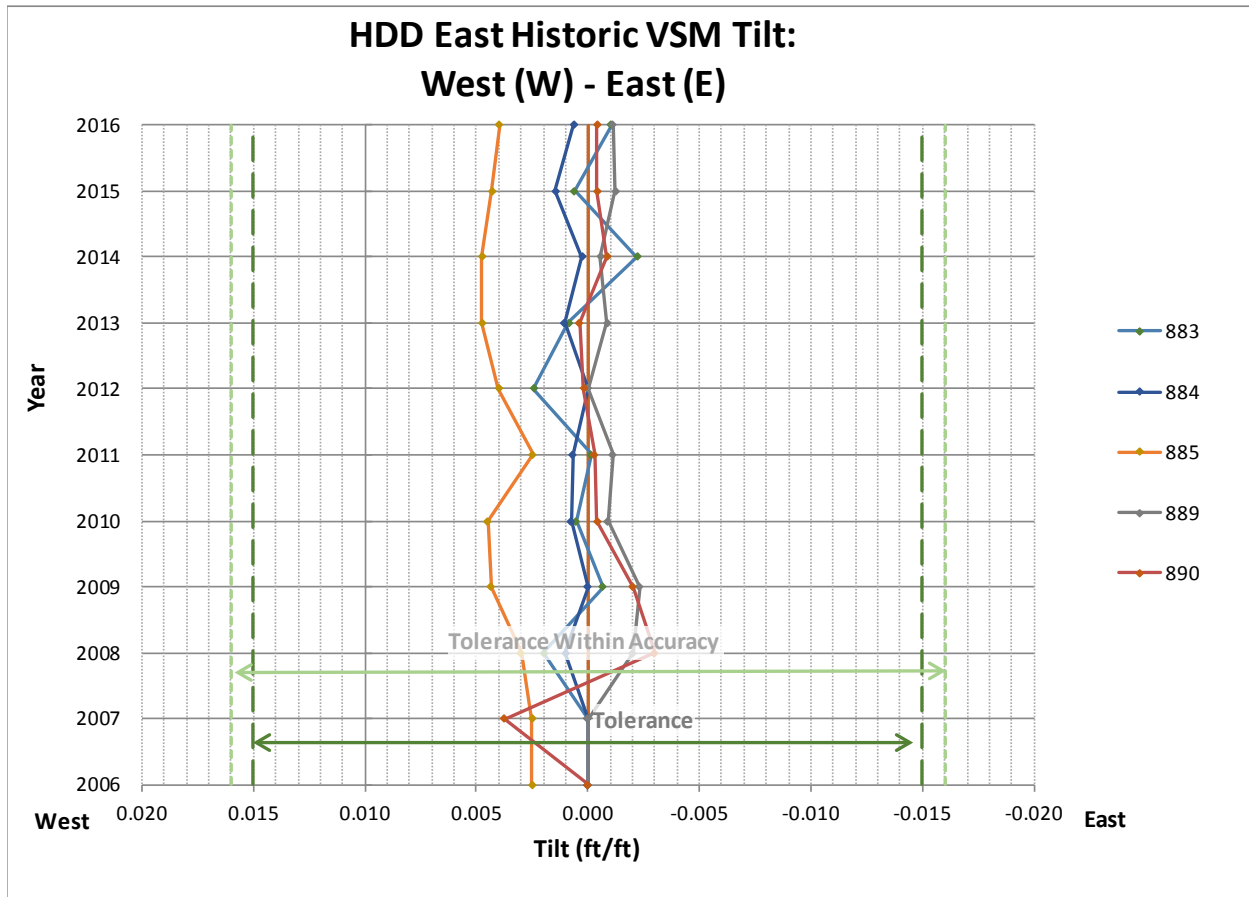
Graph 4: HDD East VSM Historical Change in Tilt, West/East

- Notes:**
1. Positive tilt indicates west (W), negative tilt indicates east (E).
 2. Project tilt tolerance for VSM is +/- 0.015 ft/ft.
 3. Survey accuracy of this project is +/-0.001 ft/ft.

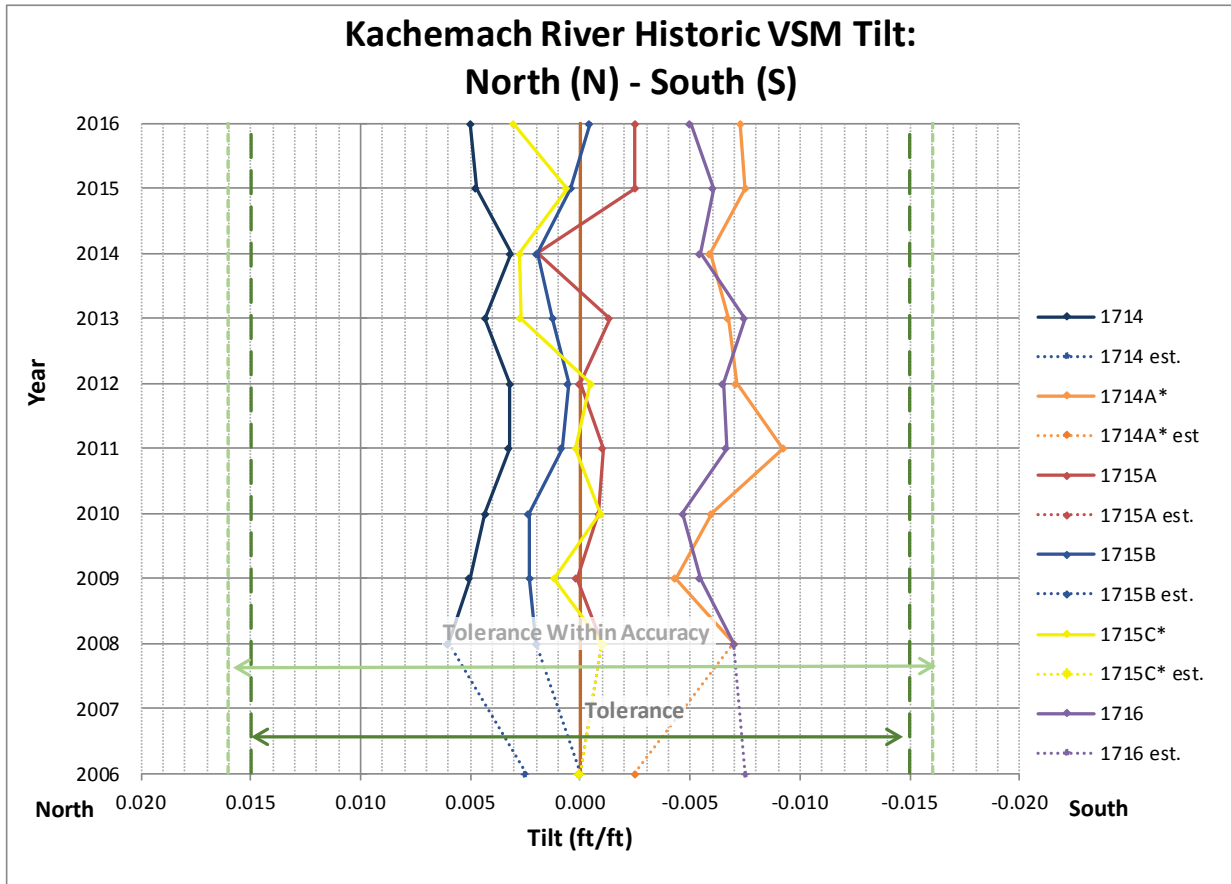
Graph 5: Kachemach River VSM Historical Change in Tilt, North/South

Graph 5 and Graph 6 present the historical VSM change in tilt by orientation between 2006 and 2016 (Michael Baker 2006, 2007, 2008, 2009, 2010, 2011, 2012, 2013, 2014, and 2015).

- Notes:**
1. Positive tilt indicates north (N), negative tilt indicates south (S).
 2. Project tilt tolerance for VSM is +/- 0.015 ft/ft.
 3. Survey accuracy of this project is +/-0.001 ft/ft.
 4. Tilt measurements were not taken at this location in 2007; tilt is estimated between 2006 and 2008.
 5. VSMs 1714A and 171C are abandoned.

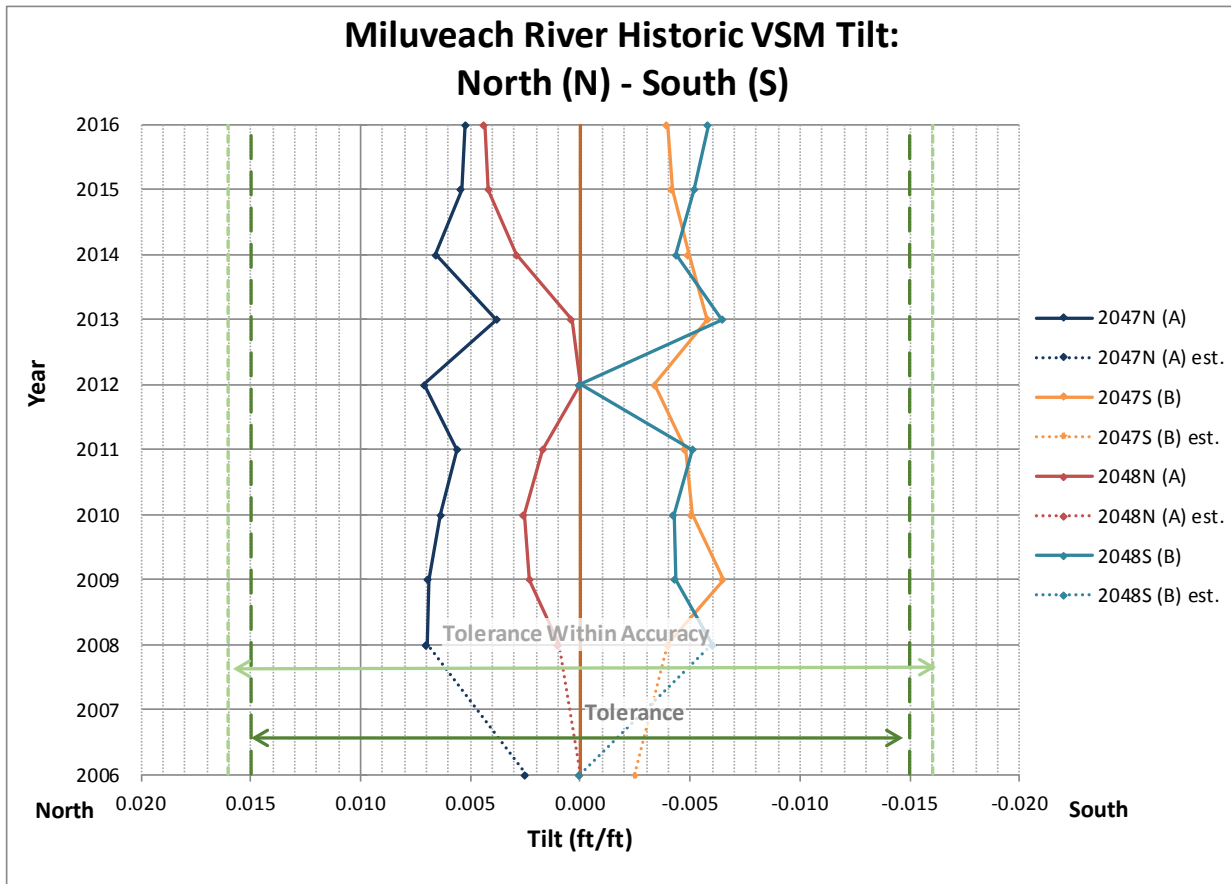
Graph 7: Miluveach River VSM Historical Change in Tilt, North/South

Graph 7 and Graph 8 present the historical VSM change in tilt by orientation between 2006 and 2016 (Michael Baker 2006, 2007, 2008, 2009, 2010, 2011, 2012, 2013, 2014, and 2015).

- Notes:**
1. Positive tilt indicates north (N), negative tilt indicates south (S).
 2. Project tilt tolerance for VSM is +/- 0.015 ft/ft.
 3. Survey accuracy of this project is +/-0.001 ft/ft.
 4. Tilt measurements were not taken at this location in 2007; tilt is estimated between 2006 and 2008.

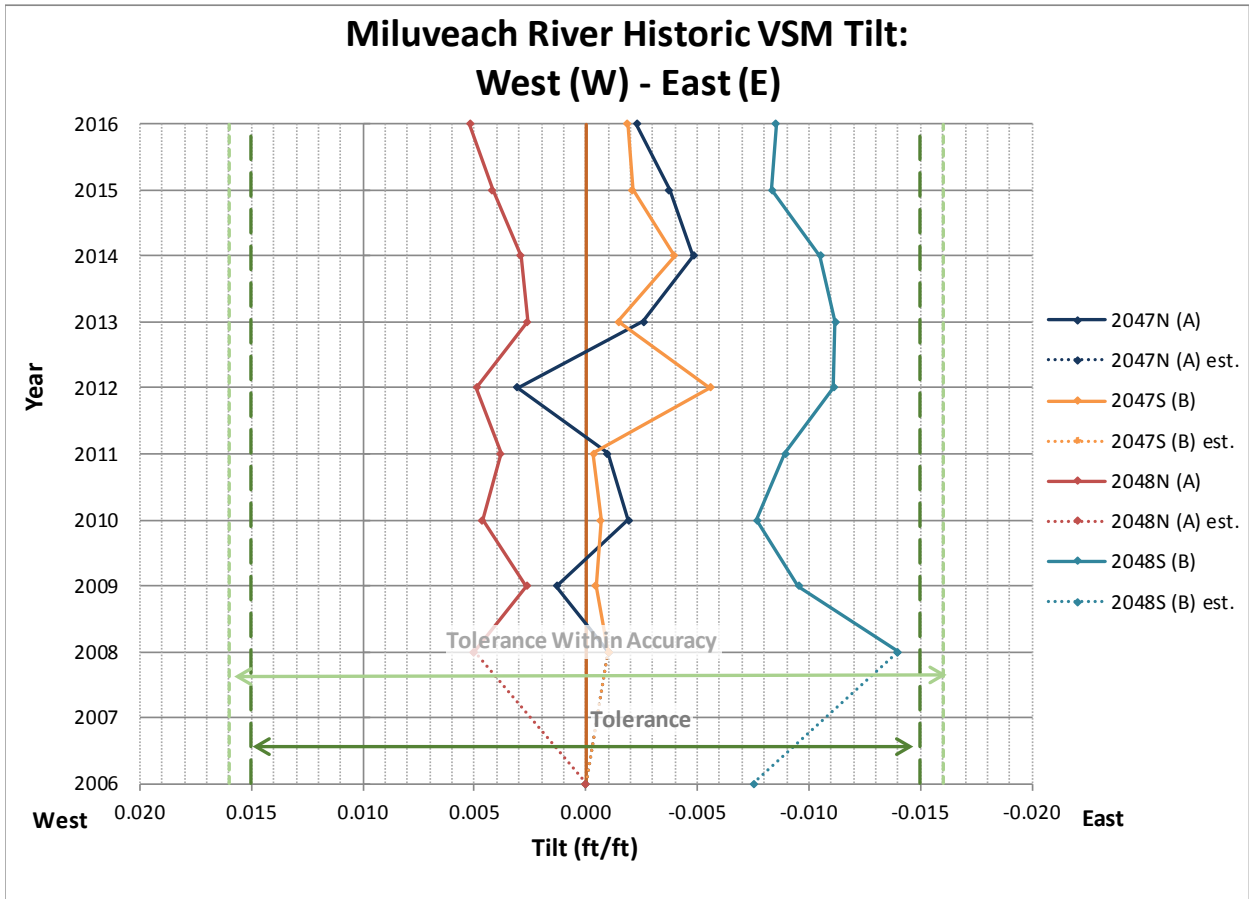
Graph 8: Miluveach River VSM Historical Change in Tilt, West/East

- Notes:**
1. Positive tilt indicates west (W), negative tilt indicates east (E).
 2. Project tilt tolerance for VSM is +/- 0.015 ft/ft.
 3. Survey accuracy of this project is +/-0.001 ft/ft.
 4. Tilt measurements were not taken at this location in 2007; tilt is estimated between 2006 and 2008.

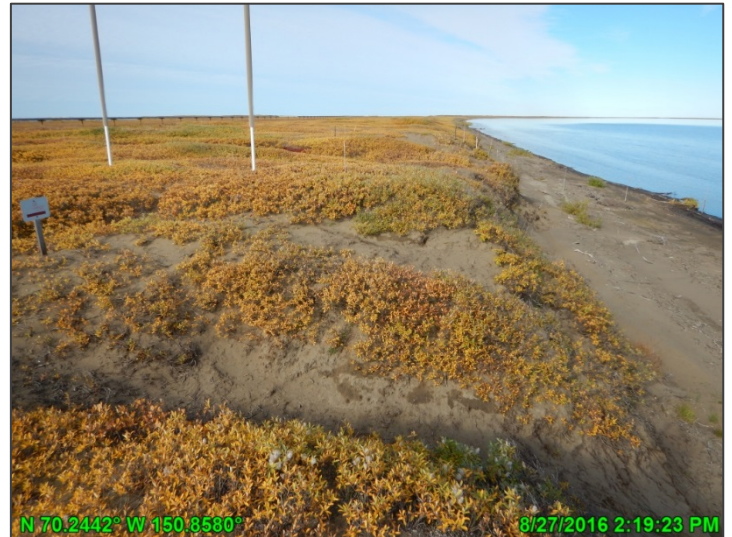
Photo A-12: HDD West bank post breakup, looking north; August 27, 2016

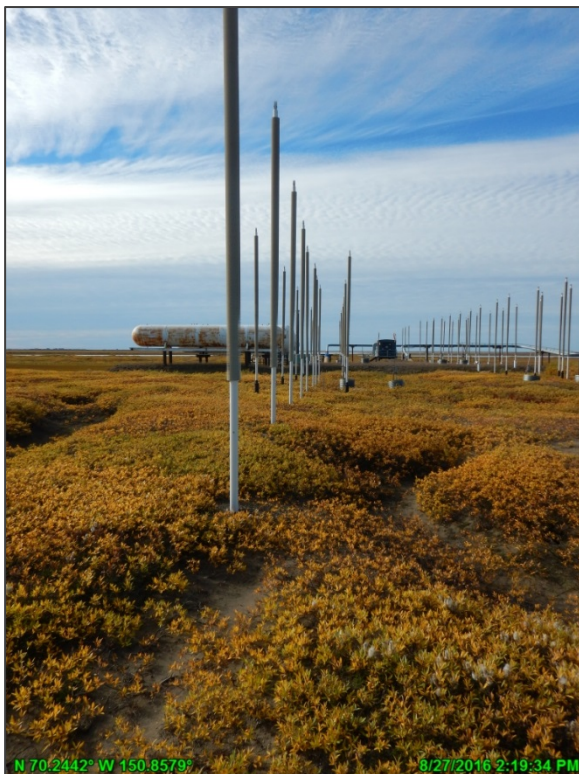
Photo A-13: HDD West south side thermosyphons, looking west; August 27, 2016

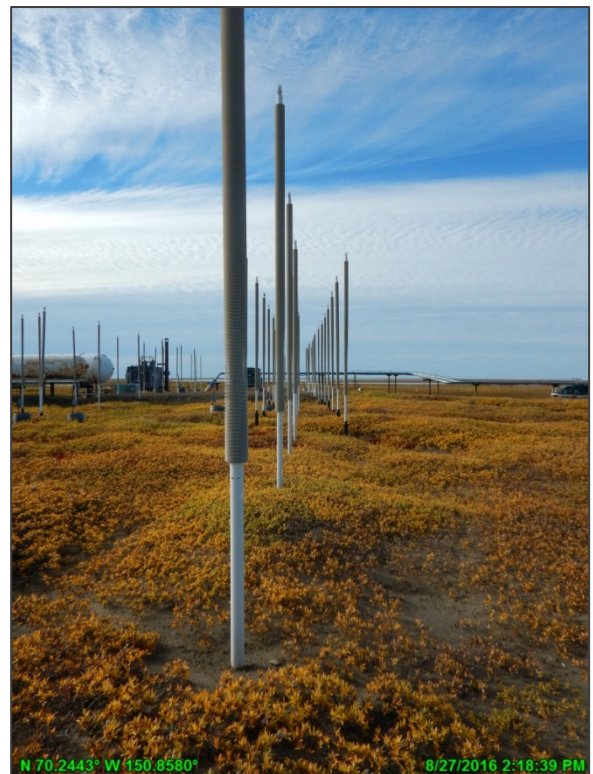
Photo A-14: HDD West north side thermosyphons, looking west; August 27, 2016

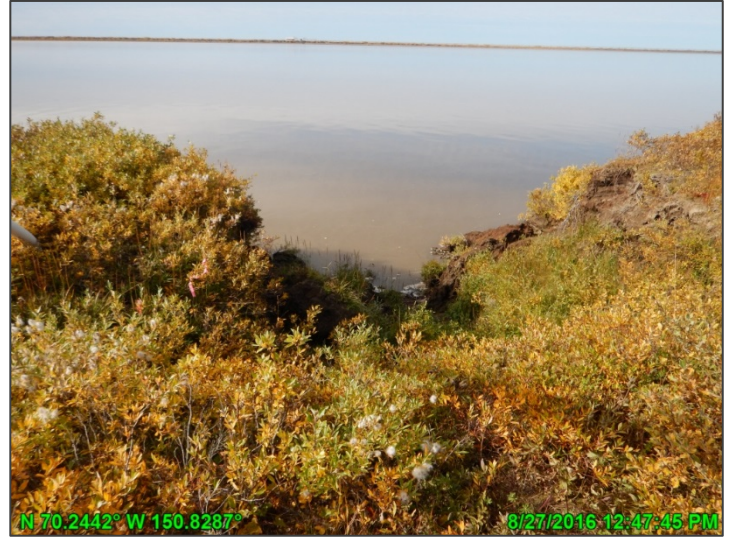
Active erosion and sloughing continue along the east bank north of the NPS 14 oil pipeline. In 2001, sandbags and Styrofoam were installed in the bank to reduce melting ice lenses and combat further erosion. Exposed sandbags and Styrofoam were evident at the toe of the polygon trough, similar to site conditions encountered during the 2015 field visit.

Photo A-20: HDD East bank post breakup, looking west; August 27, 2016

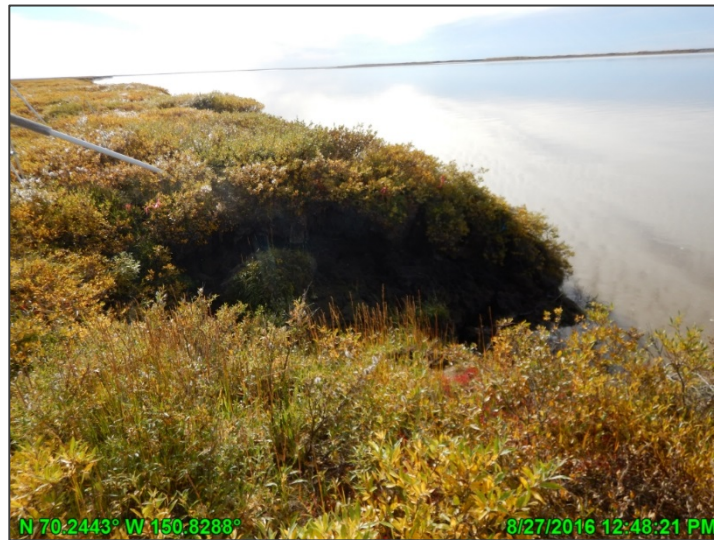
Photo A-21: HDD East bank post breakup, looking south; August 27, 2016

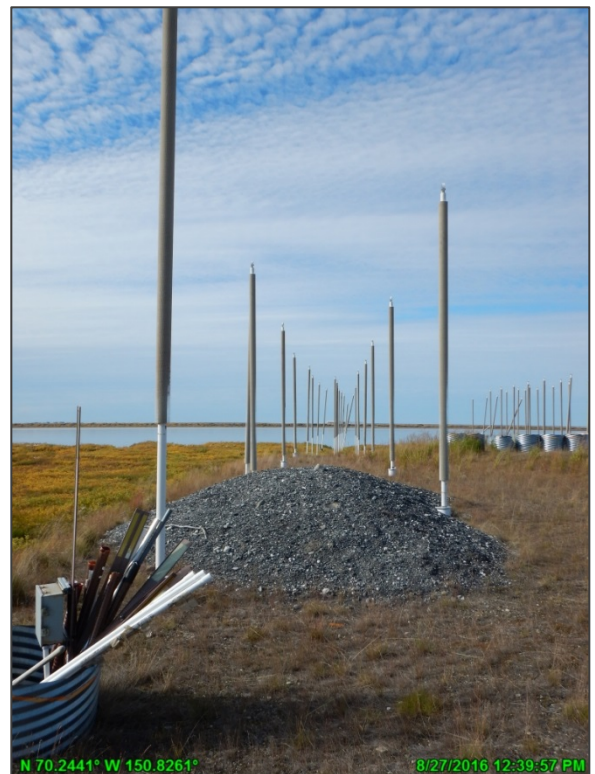
Photo A-25: HDD East t south side thermosyphons, looking west; August 27, 2016

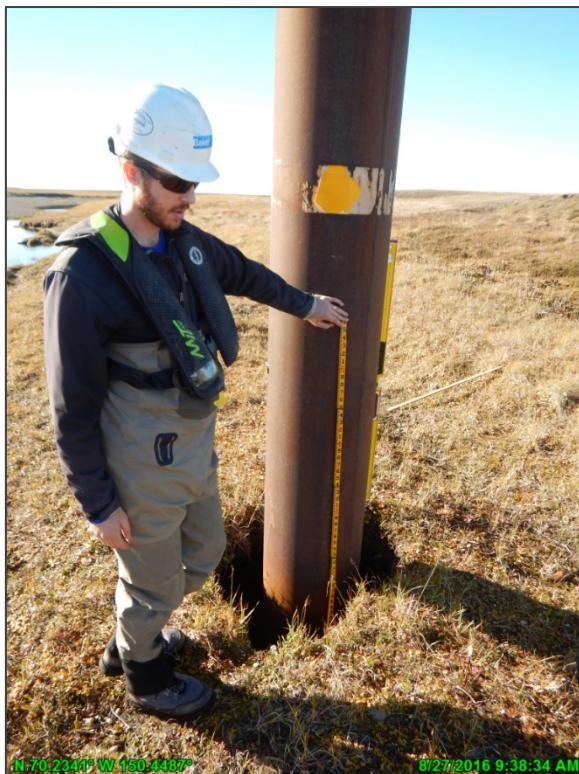
Table 9 contains observed scour conditions during the 2016 field visit. Ground depressions observed at the base of VSM 1714, 1715C and 1716 are likely the result of consolidated backfill material and are not attributed to hydraulic events.

Photo A-36: Kachemach River post breakup scour measurement, looking north; August 27, 2016

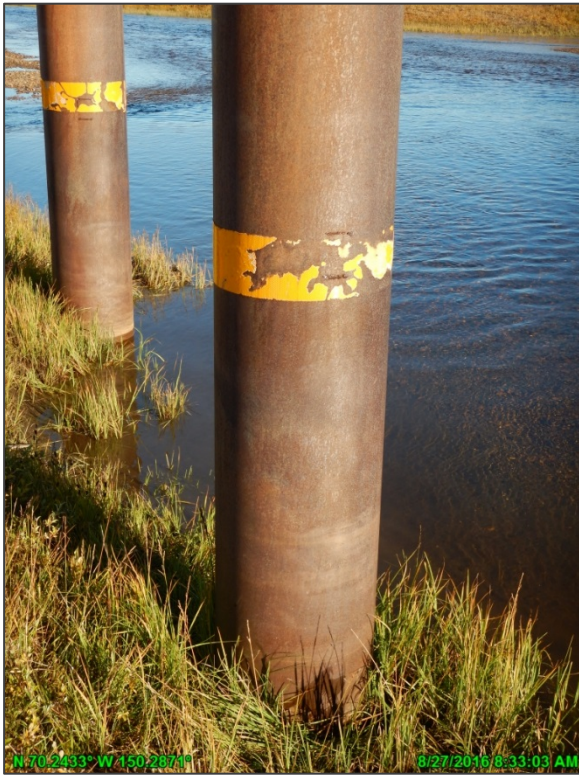
Photo A-48: Miluveach River VSMs; August 27, 2016

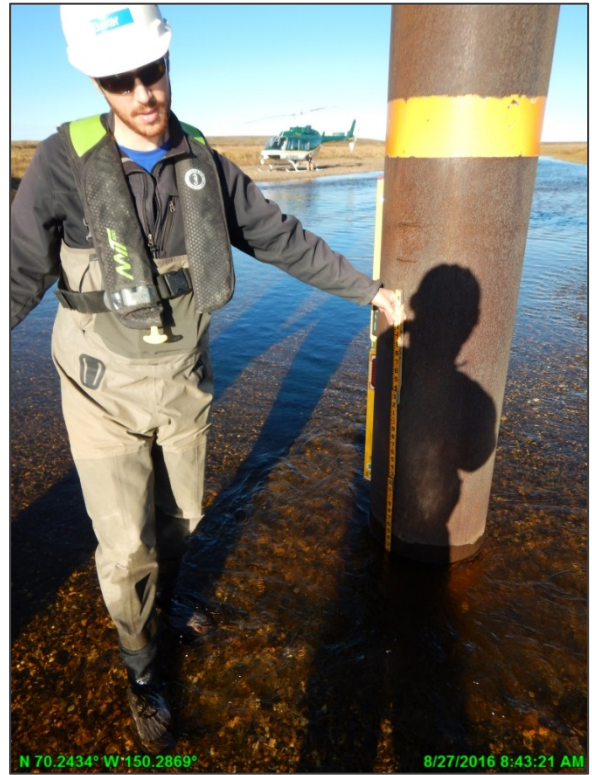
Visual observations and measurements were collected to evaluate scour for the VSMs located within the active Miluveach River channel. No excessive scour was observed at the base of any VSMs located within the channel or nearby floodplain. The design scour limit for the main channel of the Miluveach River is 35.1 feet BPMSL (Michael Baker 2003c). No quantitative survey was conducted during this monitoring cycle. The last topographic scour survey was conducted by LCMF in 2004 (Michael Baker 2004). Table 12 presents observed scour conditions during the 2016 field visit.

Photo A-49: Miluveach River post breakup scour measurement, looking northwest; August 27, 2016
