# 2007 Colville River Delta Lakes Recharge Monitoring and Analysis

**Michael Baker Jr., Inc.**  
1400 W. Benson Blvd., Suite 200  
Anchorage, Alaska 99503

**110919-MBJ-RPT-001**

**October 26, 2007**

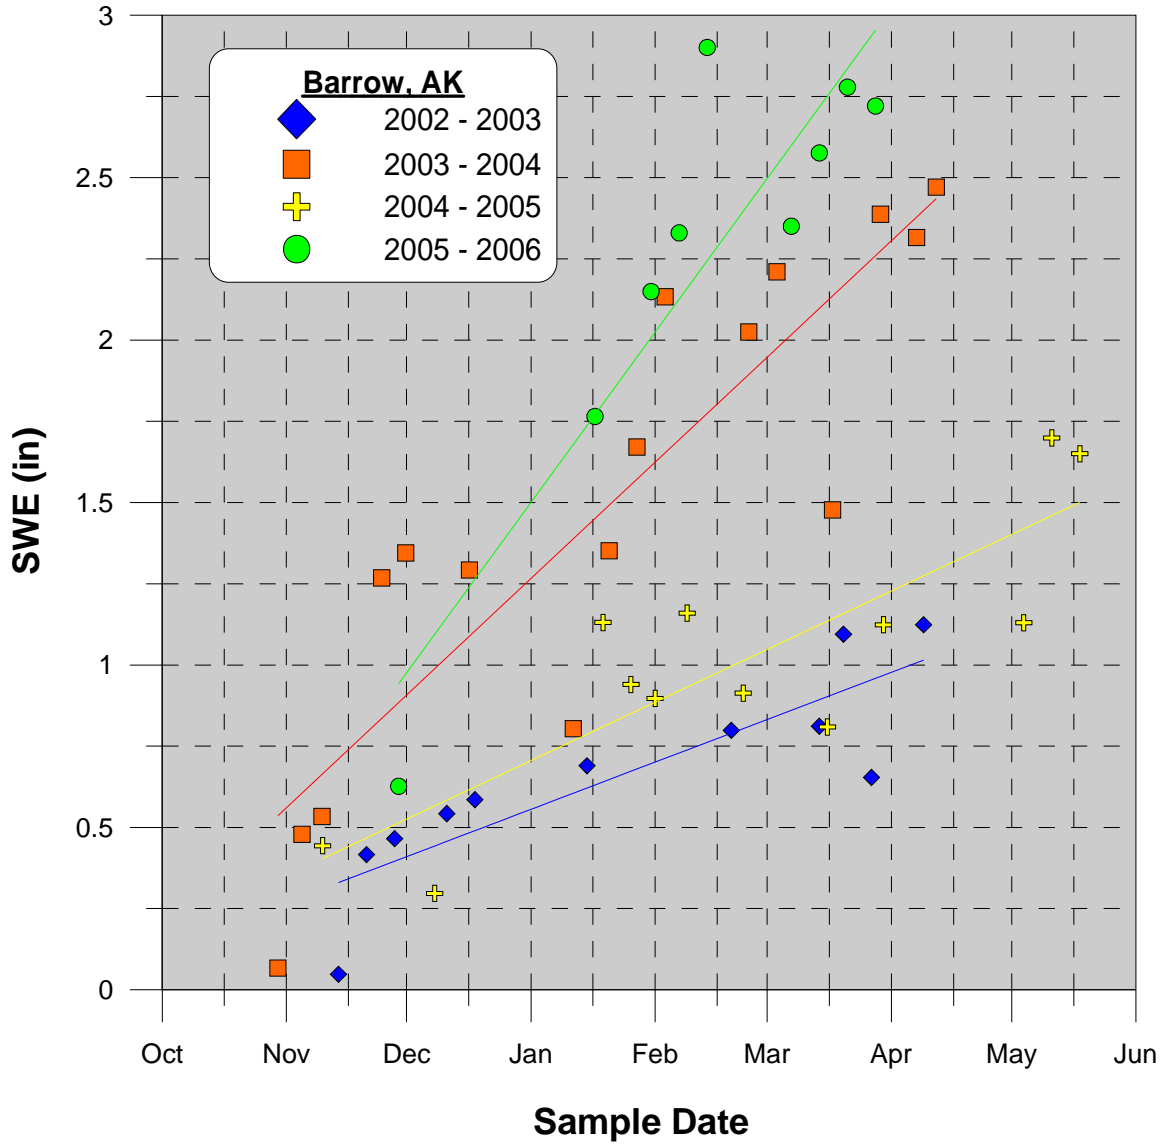
Graph 1-1 Historic Snow Water Equivalent Data (2002-2006) Barrow, AK

In addition to the spatial fluctuations in SWE, annual and seasonal variations also occur. An example of the annual variations in SWE is evident from data collected at Imikpuk Lake in Barrow. Dr. Martin Keffries has overseen the collection of SWE data as part of the Alaska Lake Ice and Snow Observatory Network (ALISON) since 2002. Graph 1-1 presents the results. The data demonstrate seasonal and annual variability of local SWE values. The maximum SWE was generally measured in May prior to breakup (Keffries 2007).

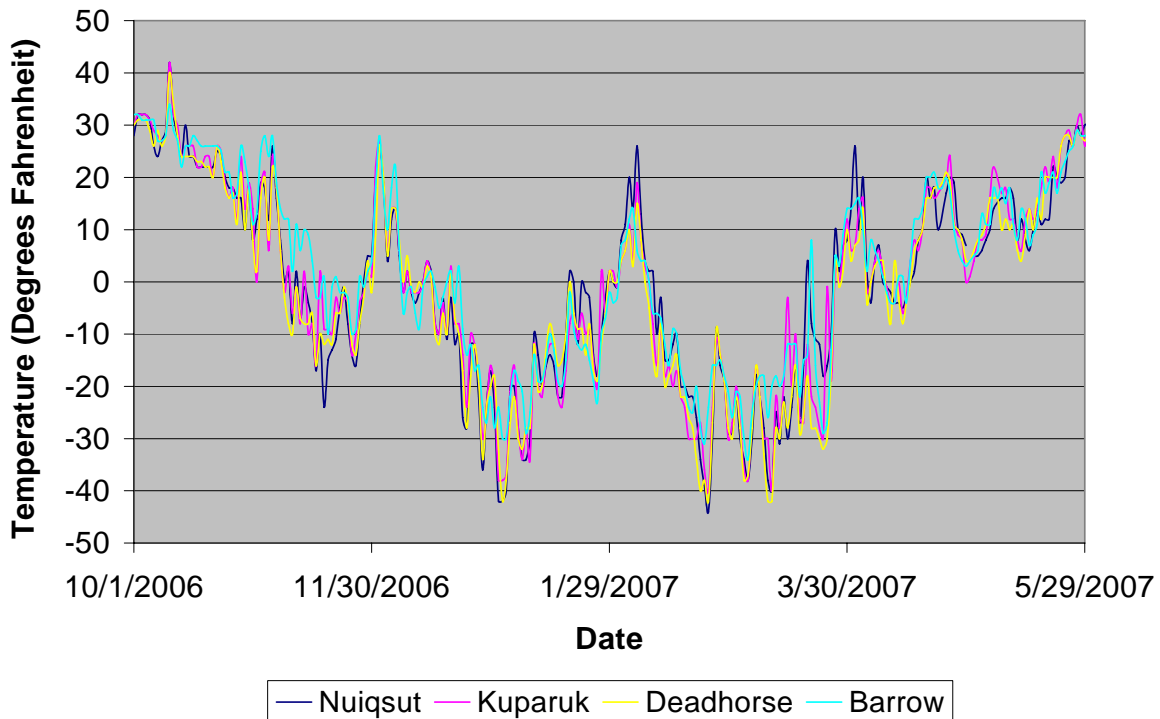
**Graph 2-1 Daily Mean Air Temperatures at Nuiqsut, Kuparuk, Deadhorse, and Barrow**

Tabulated weather data revealed a strong correlation between the four coastal stations. Similar daily mean temperatures were observed across the region with analogous warming and cooling trends (Graph 2-1).

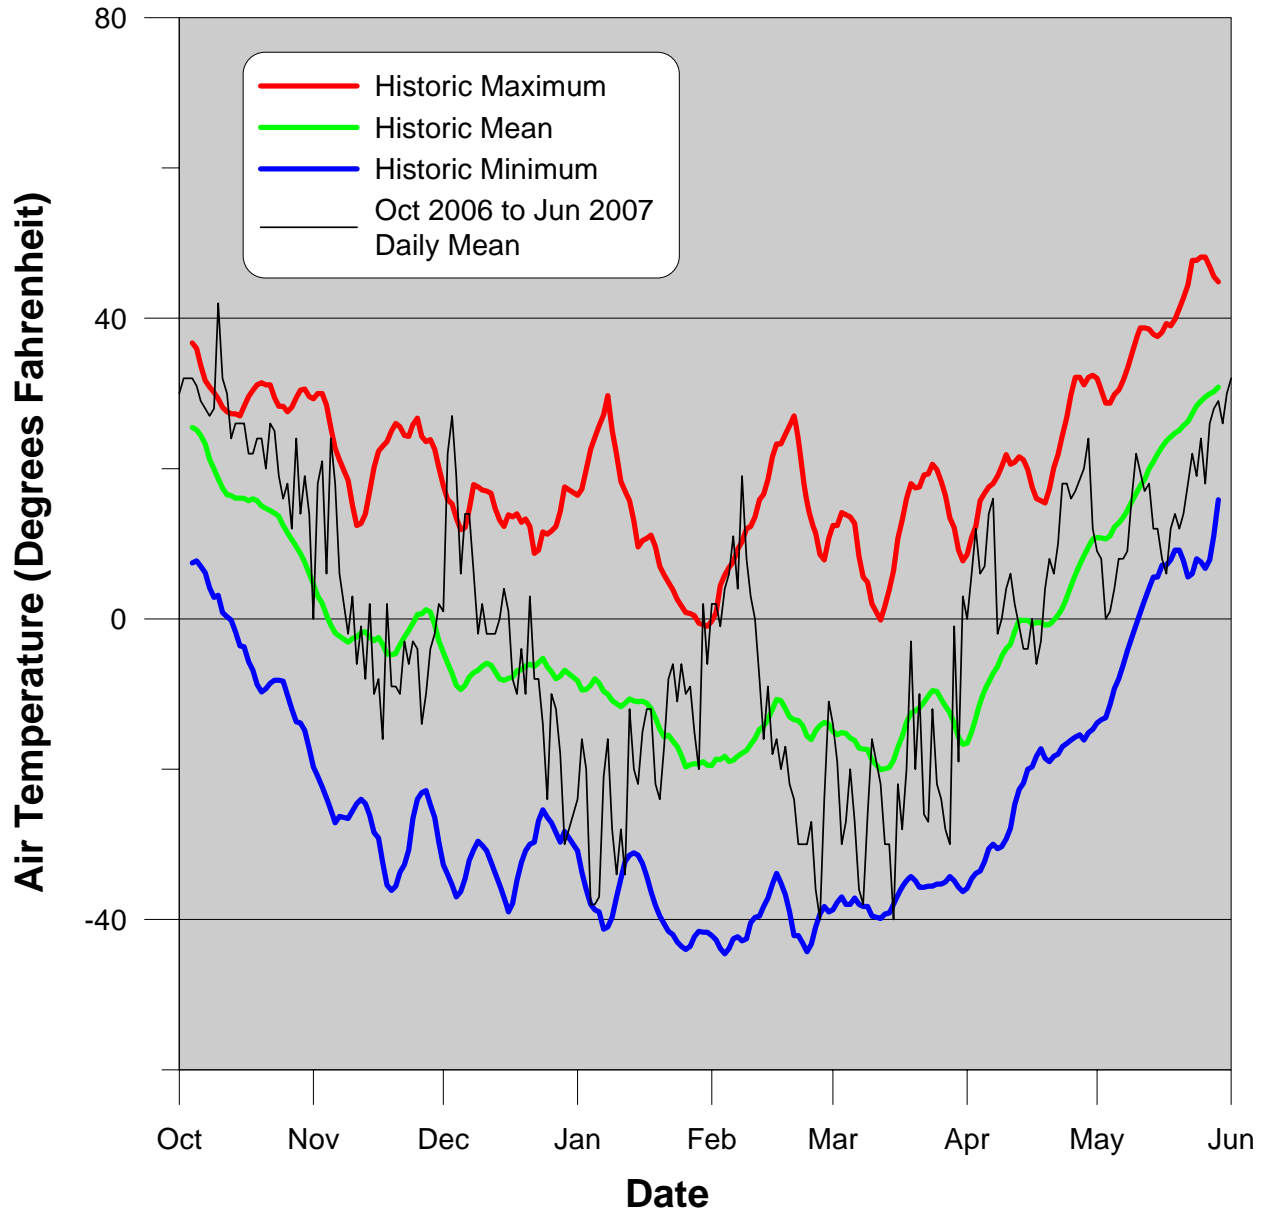
Graph 2-2 Kuparuk Historic Air Temperature, 2000 - 2006 (October to June)

Past meteorological data from Nuiqsut was not available. To evaluate the severity of the 2006/2007 winter conditions in the CRD, Kuparuk data was compared to a six-year historic record. Overall, temperatures observed at Kuparuk were within the range of normal highs and lows as presented in Graph 1-1. Abnormally warm weeks were observed in December and February with temperatures dropping below normal during the months of January and March. Record highs were observed in October, late November, and early February. Observed trends in temperature relative to historic values are assumed to translate well to the CRD given the strong correlation of observed mean daily values between Nuiqsut and Kuparuk in 2006/2007.

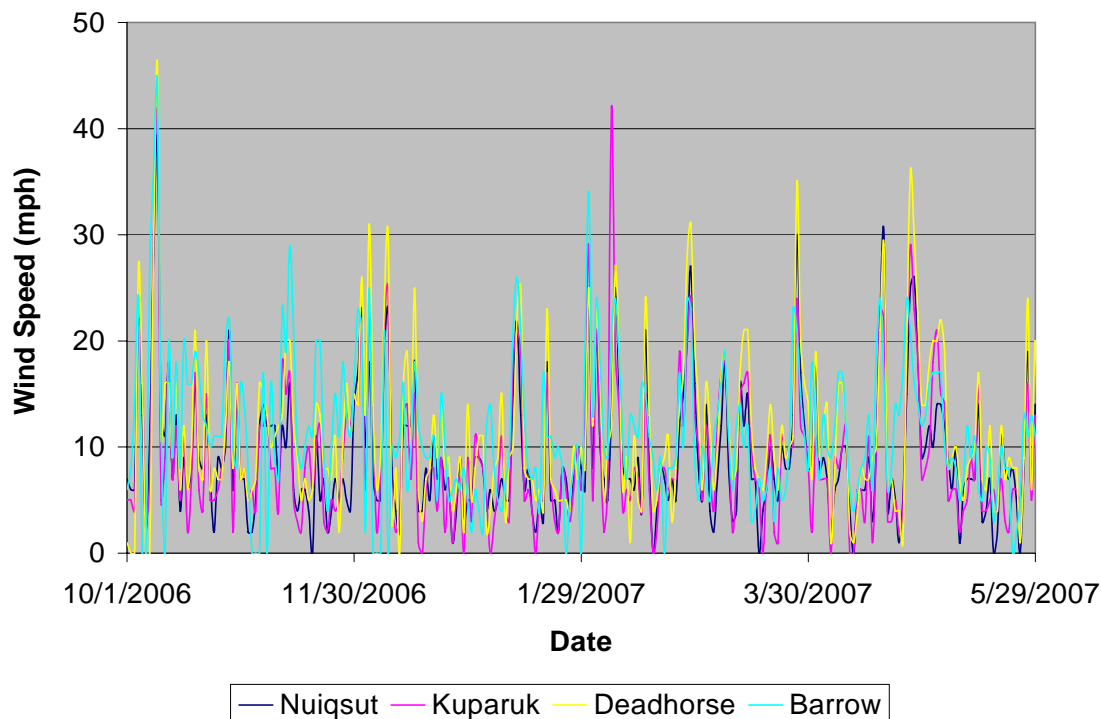
**Graph 2-3 Daily Mean Wind Speed at Nuiqsut, Kuparuk, Deadhorse, and Barrow**

Observed winter 2006/2007 wind velocities suggest that conditions in the CRD were typical of the region (Graph 2-3). A point of significant interest is the daily variability of high winds, with numerous daily mean velocities well above 20 miles per hour (mph). Though wind bearing shifted throughout the winter season, it predominantly followed an east-west line dominated by easterly winds (Graph 2-4).

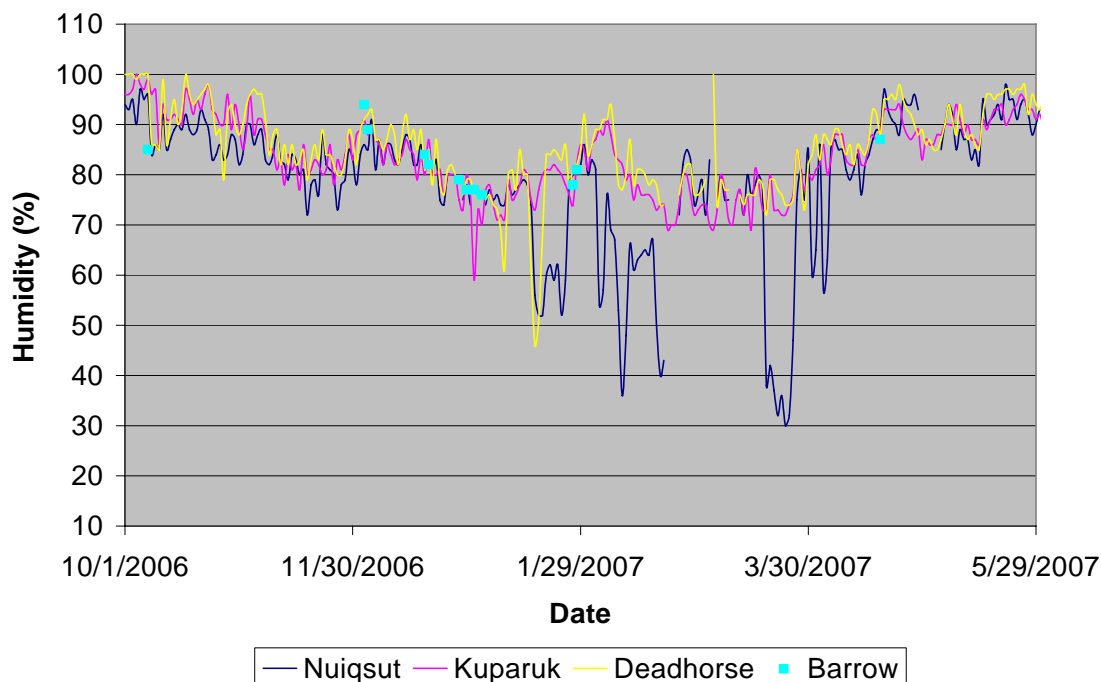
**Graph 2-5 Daily Mean Humidity at Nuiqsut, Kuparuk, Deadhorse, and Barrow**

Humidity trends were relatively uniform between the four coastal stations (Graph 2-5). Data values collected at Nuiqsut were consistently lower than the other stations. Periods of significantly low relative humidity were reported at Nuiqsut during January, early February, and March. Between October 1, 2006 and June 1, 2007, 163 daily precipitation events associated with snow were documented at Nuiqsut. This value was the lowest of the four identified locations: Kuparuk (180 days), Deadhorse (178 days), and Barrow (191 days).

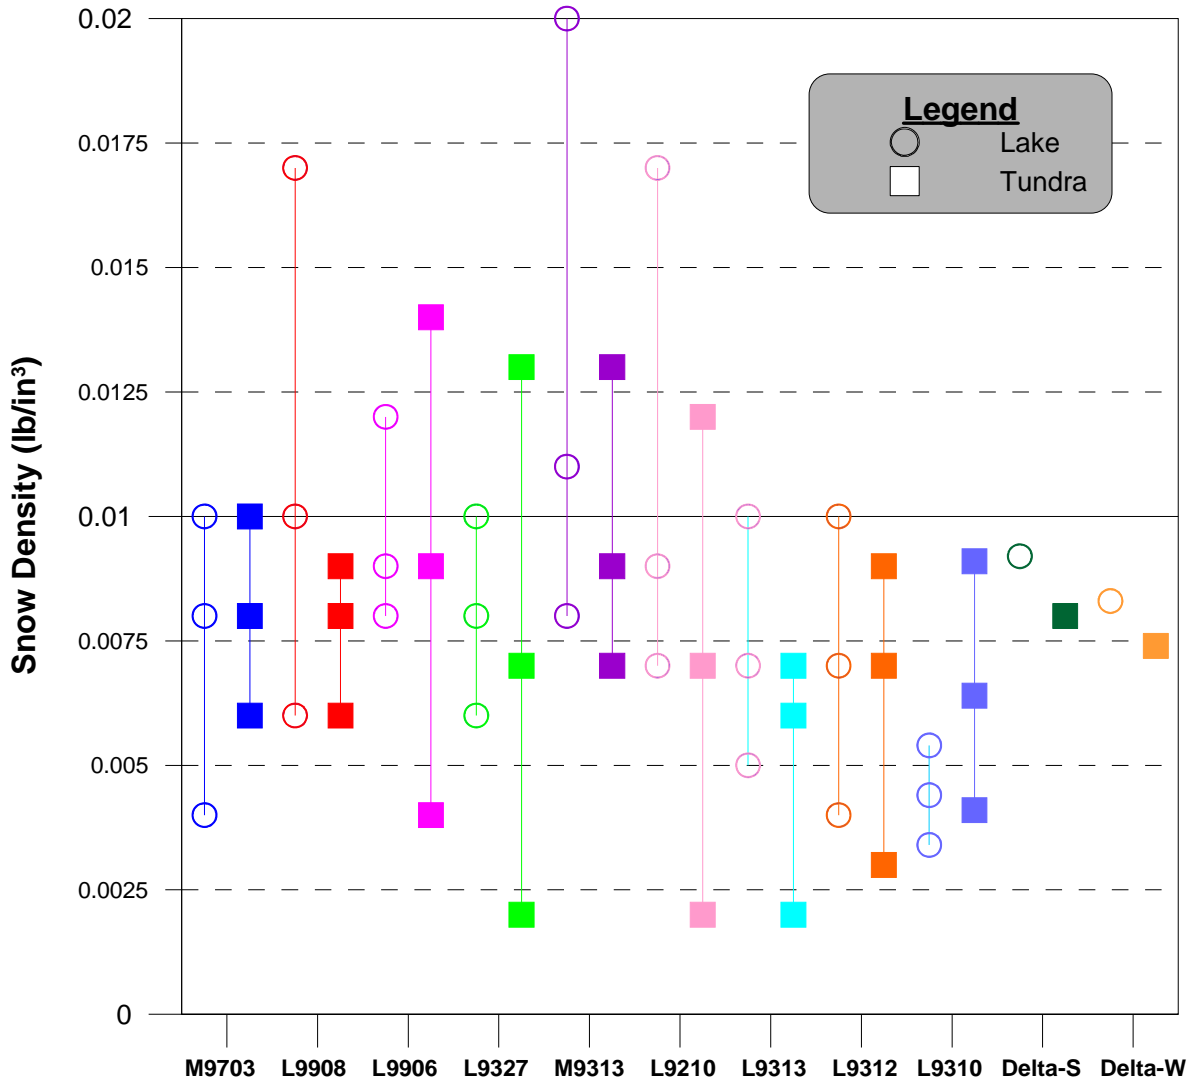
Graph 5-2 Minimum, Average, and Maximum Snow Density of Snow Sampled Lakes

Trends in snow depth variability were also observed in snow density (Graph 5-2) and snow water equivalent ( Graph 5-3).

Snow densities varied by as much as 0.011 pounds per cubic inch (lb/in<sup>3</sup>) within individual catchments. Maximum and minimum values of measured snow density were 0.02 and 0.002 lb/in<sup>3</sup>. Average snow densities within six of the nine catchments were higher on lakes than on tundra. In the few remaining cases, lake specific density was equivalent or below tundra specific snow density. Though snow density was greater on lakes, observed snow depths were considerably lower overall on lakes than on tundra. As a result, snow water equivalent was consistently lower on lakes than on tundra. Of the nine lakes studied, M9313 was anomalous with respect to density and snow water equivalent. This is likely a direct result of snow deposition within the catchment being augmented by the presence of, and snow removal from, the

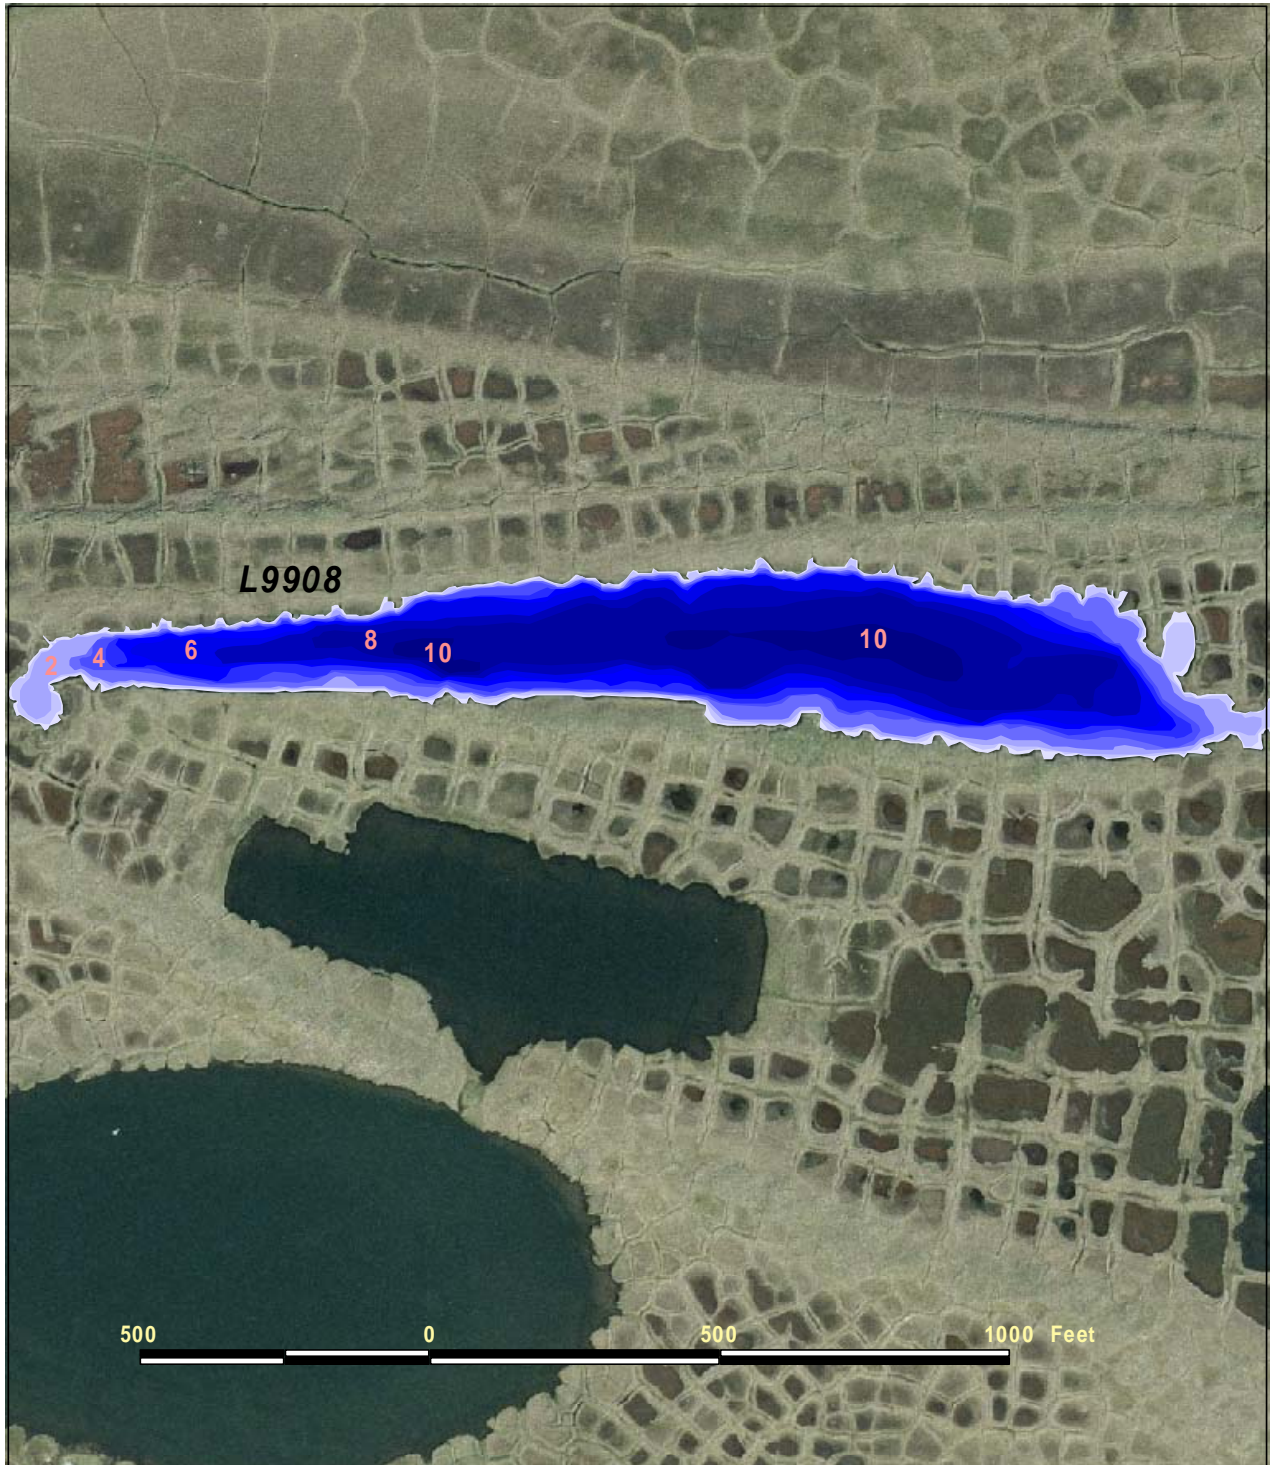
Depth contours of lake L9908 based on transects surveyed on July 29, 2006.  
(depths in 1 foot intervals)

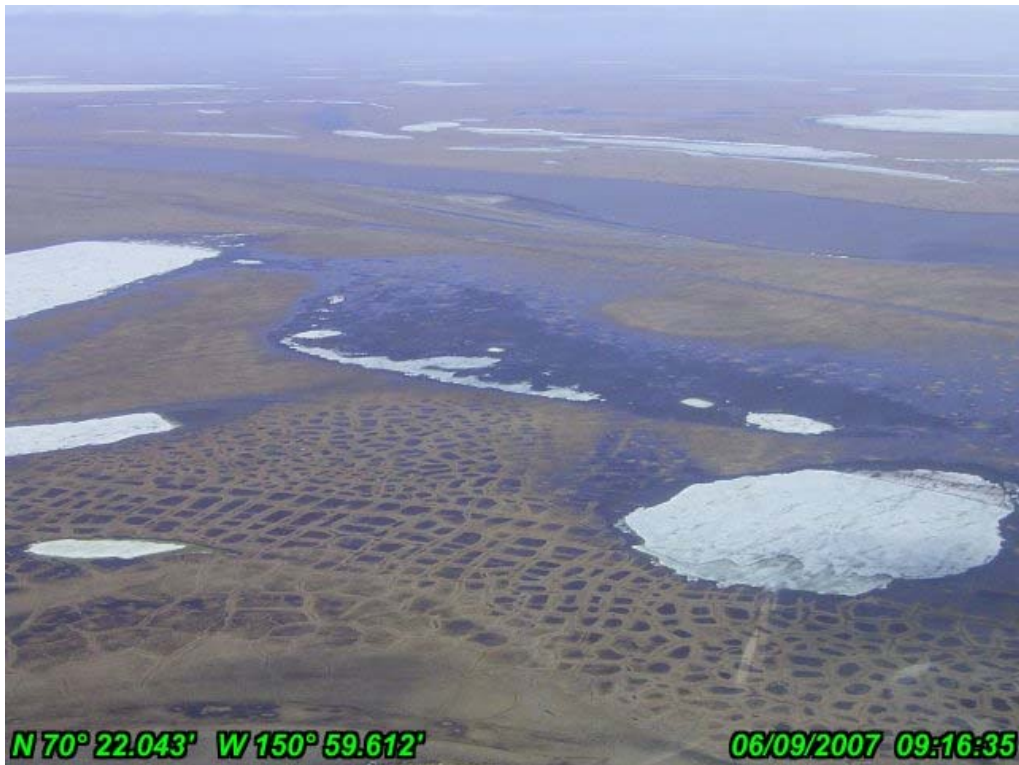
Photo 2 B8533 hydraulically connected to northern wetland

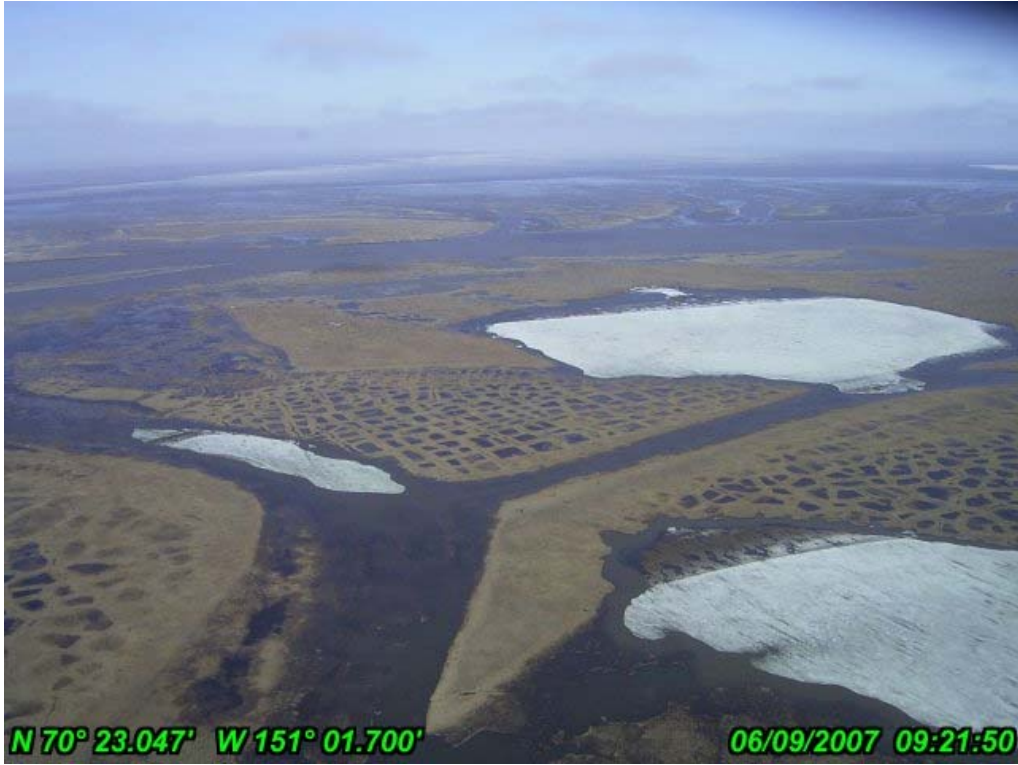
Photo 11 L9401 (top right) hydraulically connected to M0675 (bottom right)

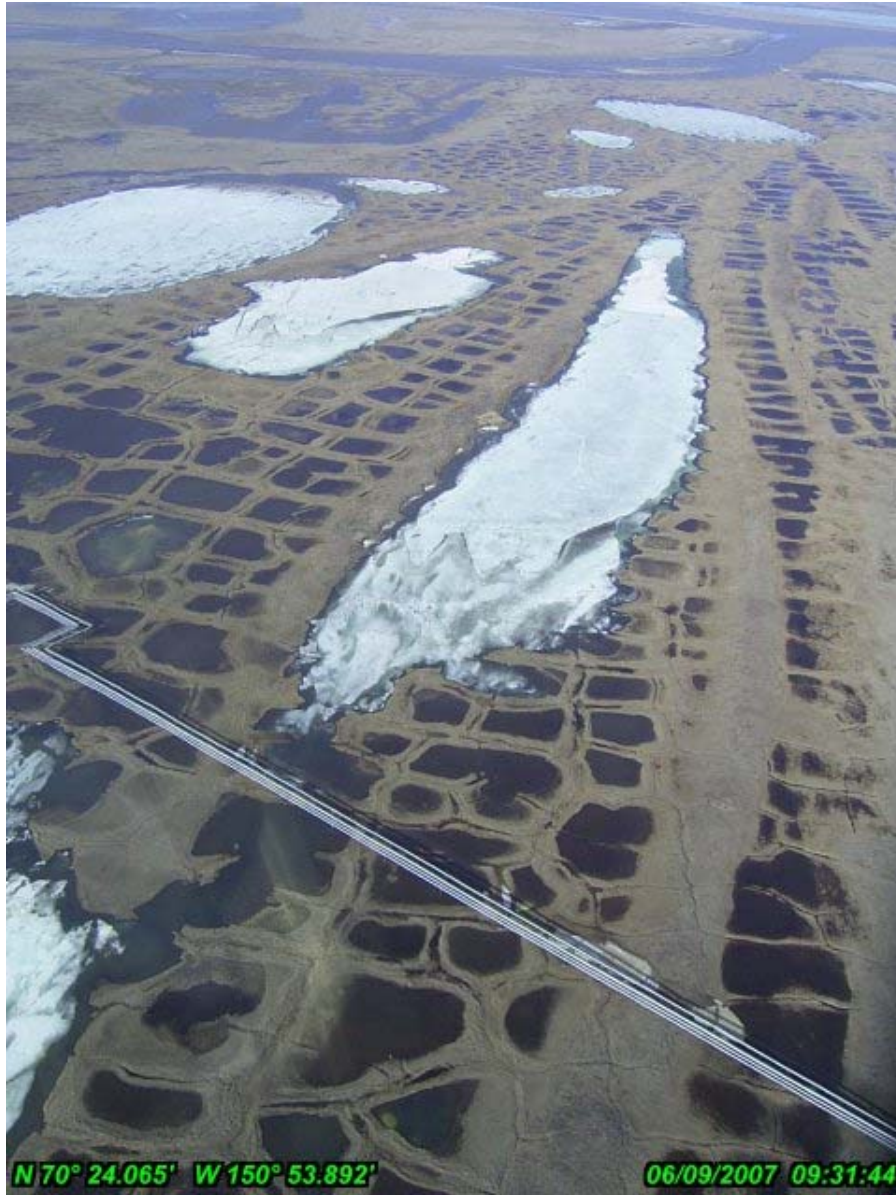
Photo 21 L9908 (center) hydraulically connected to L9907 (bottom left)

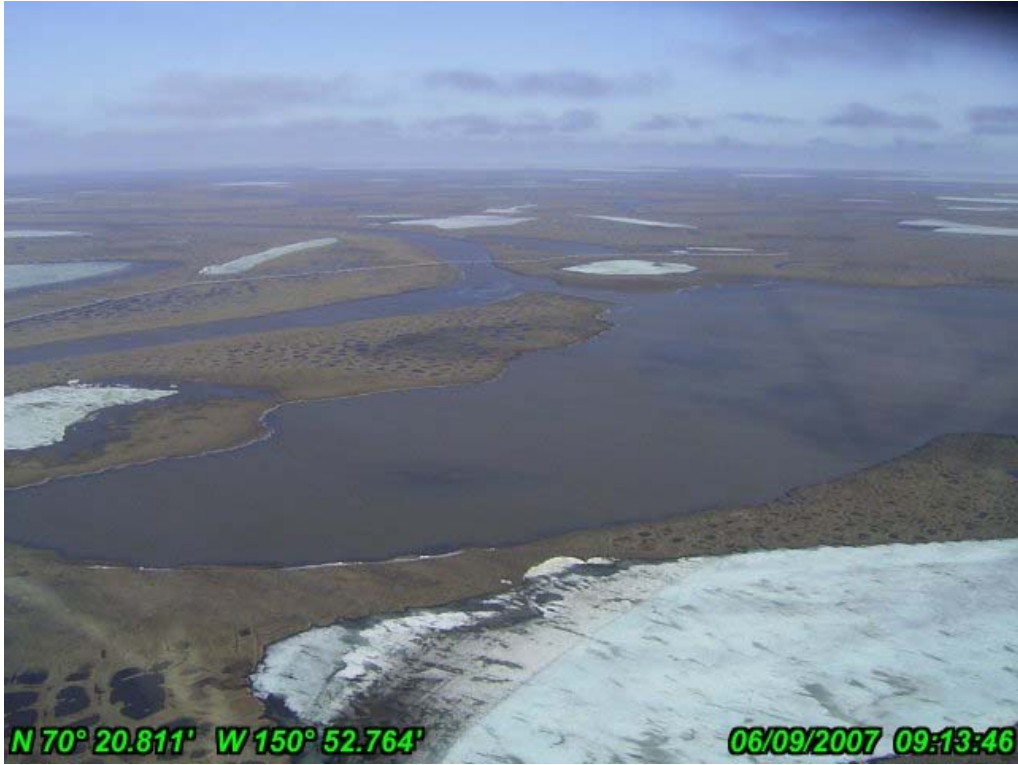
Photo 30 South end of M9521 recharging from Sak Channel

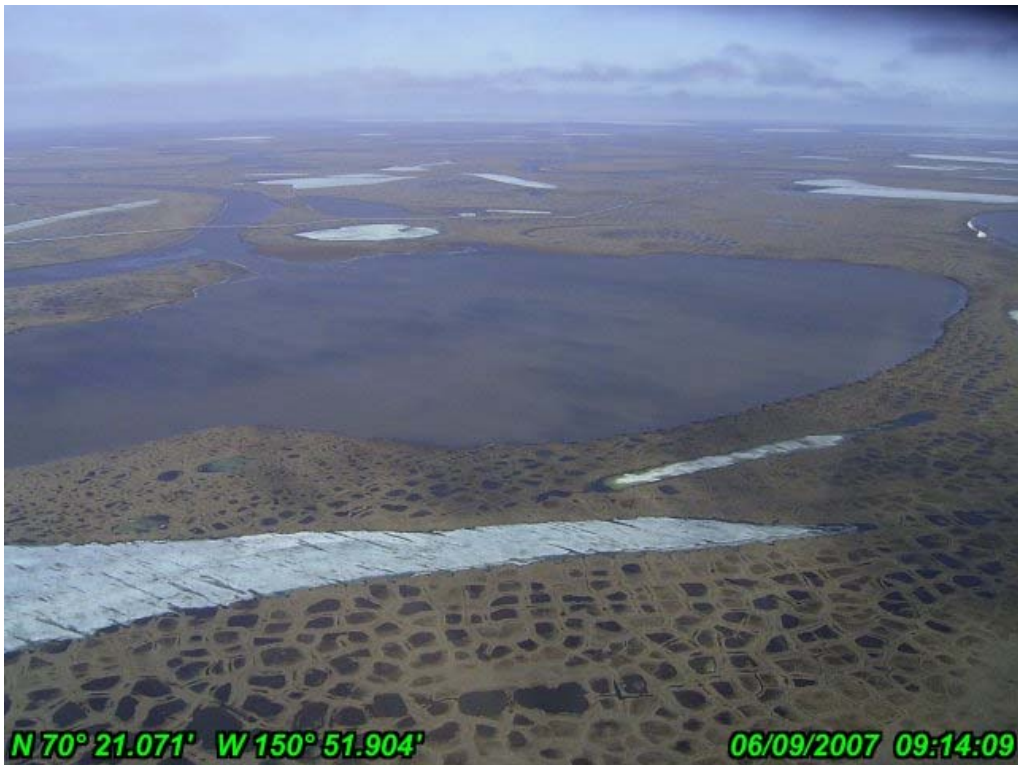
Photo 31 North end of M9521 recharging from Sak Channel

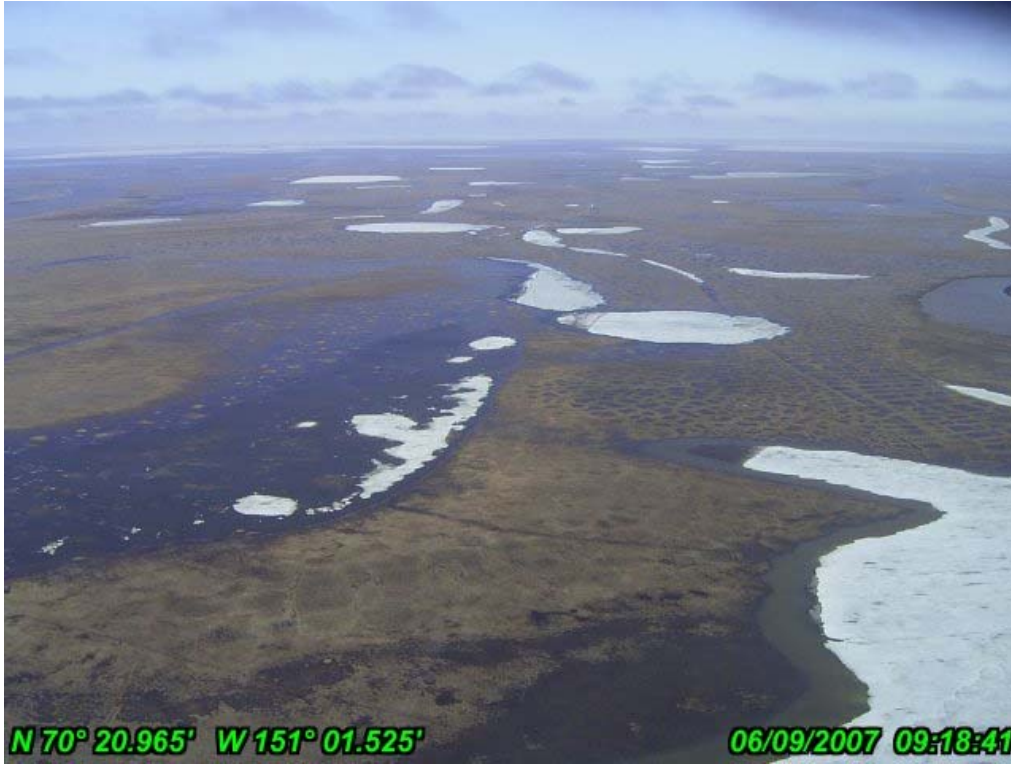
Photo 42 M9701 (center bottom) and M9702 (center top) connected to wetland

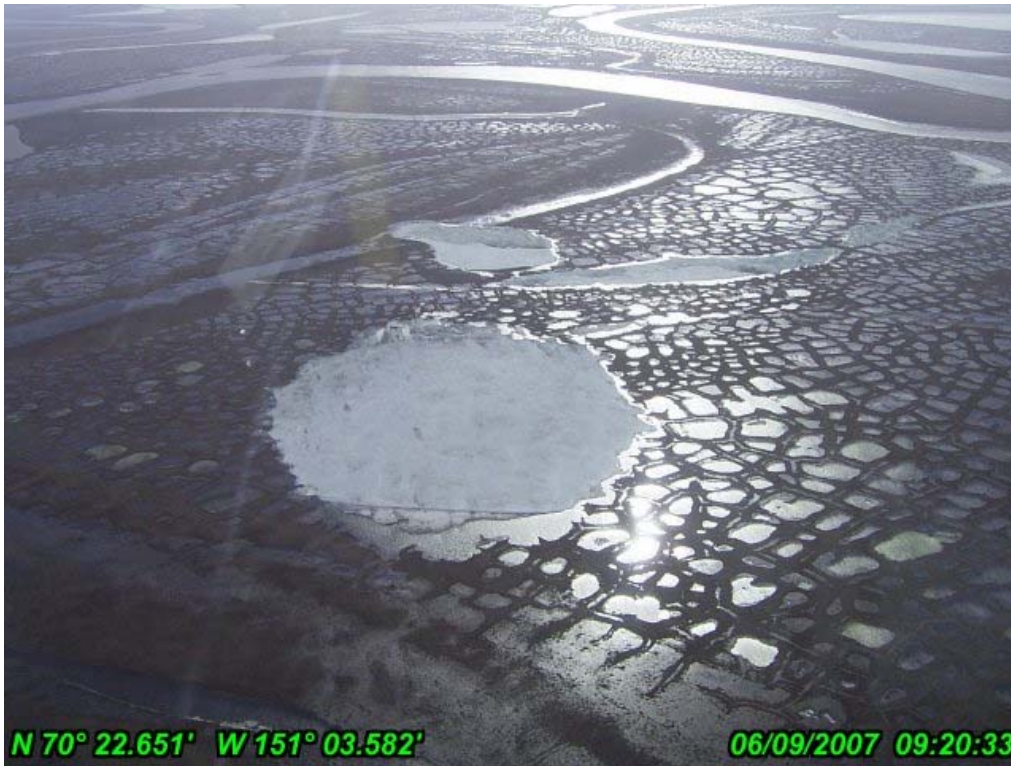
Photo 46 M9703 (center) and recharge swale (bottom)

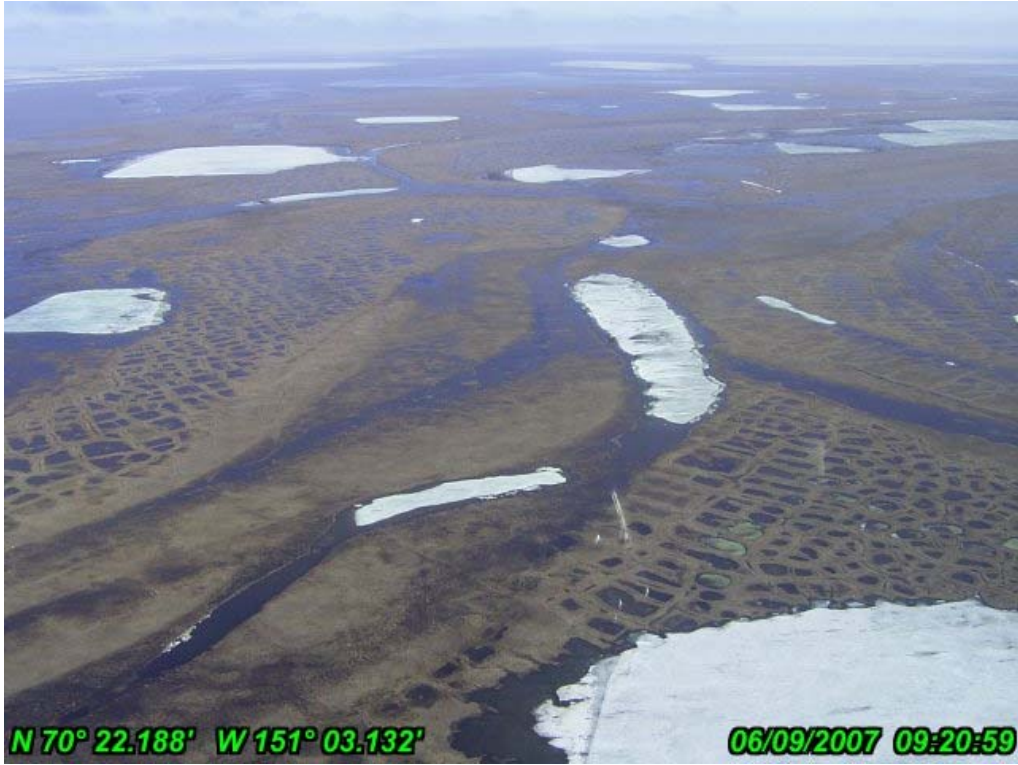
Photo 48 M9704 (center) and recharge channel east of Nigliq Channel
