COLVILLE RIVER DELTA SPRING BREAKUP 2009 HYDROLOGIC ASSESSMENT

ConocoPhillips Alaska, Inc.

December 2009
117011-MBJ-RPT-001

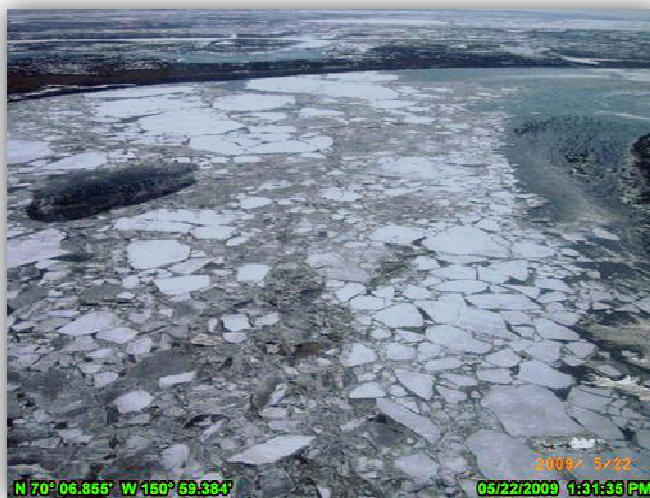
Ribbon ice was still present in the vicinity of MON1 on May 22, as shown in Photo 4.5. Significant ice jamming was also observed on May 22 in the area of the meander bends upstream of the Itkillik River confluence, located approximately 2.5 RM upstream of MON1 (see Photo 4.6). On May 22, ice jamming was also noted at the Anaktuvuk confluence. Breakup ice jams can be unstable events. Upon formation, water begins to back up behind the upstream edge of the ice jam. Upon release, often sudden and unpredictable, the stored water inundates downstream areas.

PHOTO 4.6: ICE JAM IN COLVILLE UPSTREAM OF ITKILLIK CONFLUENCE. MAY 22, 2009.

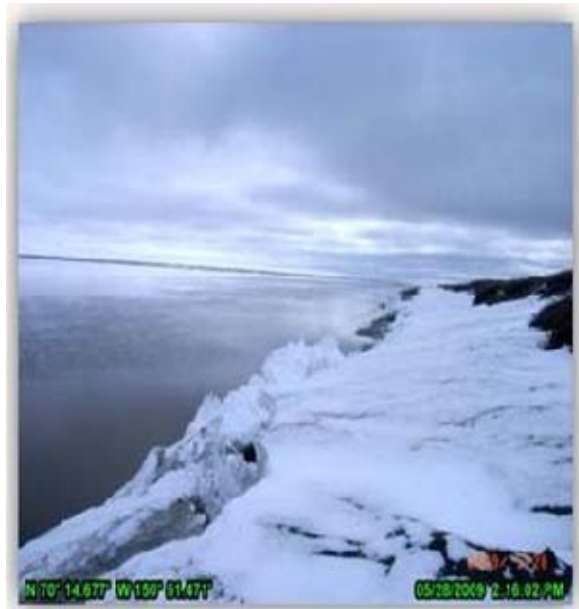
PHOTO 4.9: OPEN CHANNEL, MON9. MAY 28, 2009.

The following day, a discharge measurement was taken at MON1. By this point the channel was sufficiently free of ice and debris to allow a safe discharge measurement by boat. The MON9 area was relatively ice-free by May 28, as seen in Photo 4.9. On May 27, channel ice began to break up and move out of the vicinity of Monument 35

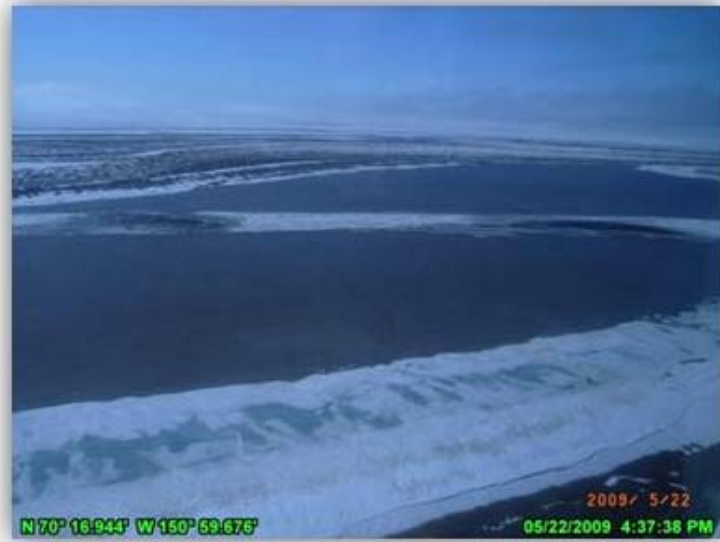
PHOTO 4.10: RIBBON ICE IN VICINITY OF MON20. MAY 22, 2009.

Erratic stage fluctuation was most likely due to small, local ice jams in the Nigliq Channel. Ribbon ice was present throughout the entire Nigliq Channel on May 22, as shown in Photo 4.10, taken in the vicinity of MON20. As discussed in previous sections in this chapter, significant ice jamming occurred upstream in the Colville River at this time.

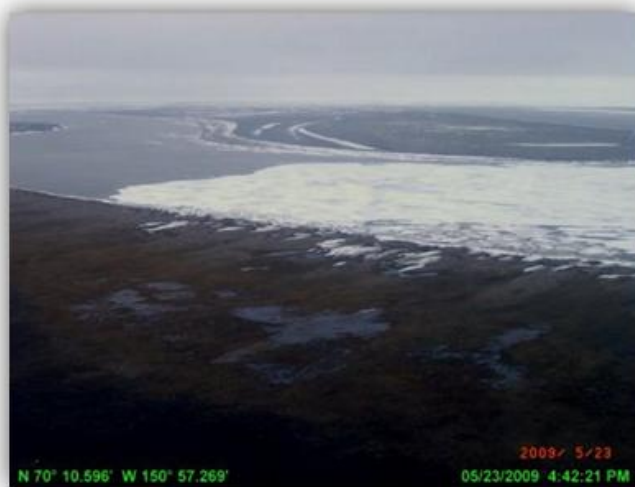
PHOTO 4.11: ICE JAM IN COLVILLE RIVER DIVERTING INTO NIGLIQ. MAY 23, 2009.

On May 23, part of the Colville River ice jam diverted into the Nigliq Channel, as seen in Photo 4.11. By May 24, the bulk of the ice jam had moved down the Nigliq, settling temporarily in the channel adjacent to Nuiqsut, coming into contact with ribbon ice still present throughout the channel.

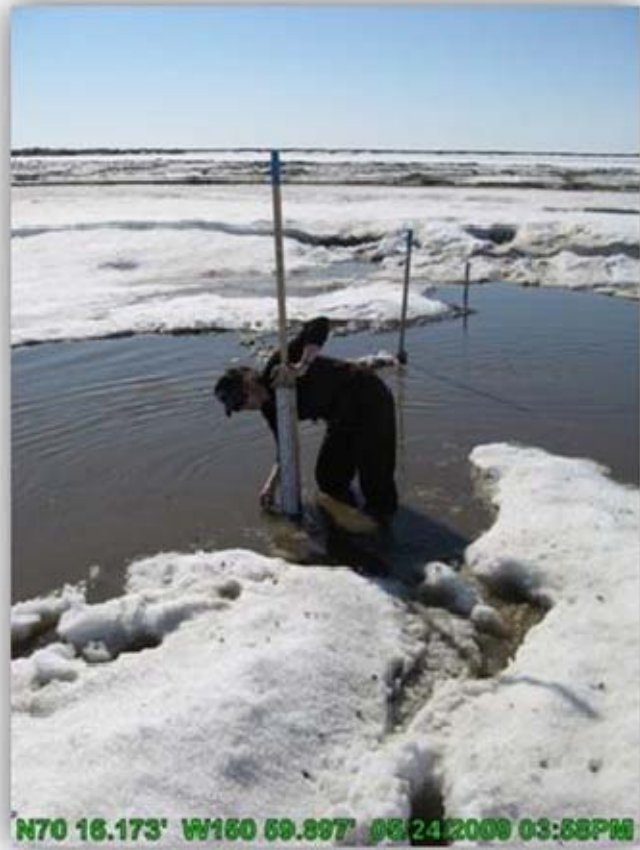
Photo 4.12 was taken at MON20, downstream from Nuiqsut, approximately 12 hours before peak stage. Significant channel ice is visible in the background. The Nigliq Channel in the vicinity of the Alpine facilities was mostly ice-free by May 28, as shown in Photo 4.13 (visible ice in channel is accumulation from a recent snowfall). Channel ice was still present in the vicinity of MON28 gages on May 28 (see Photo 4.14).

PHOTO 4.12: MON20 GAGE READING. MAY 24, 2009.

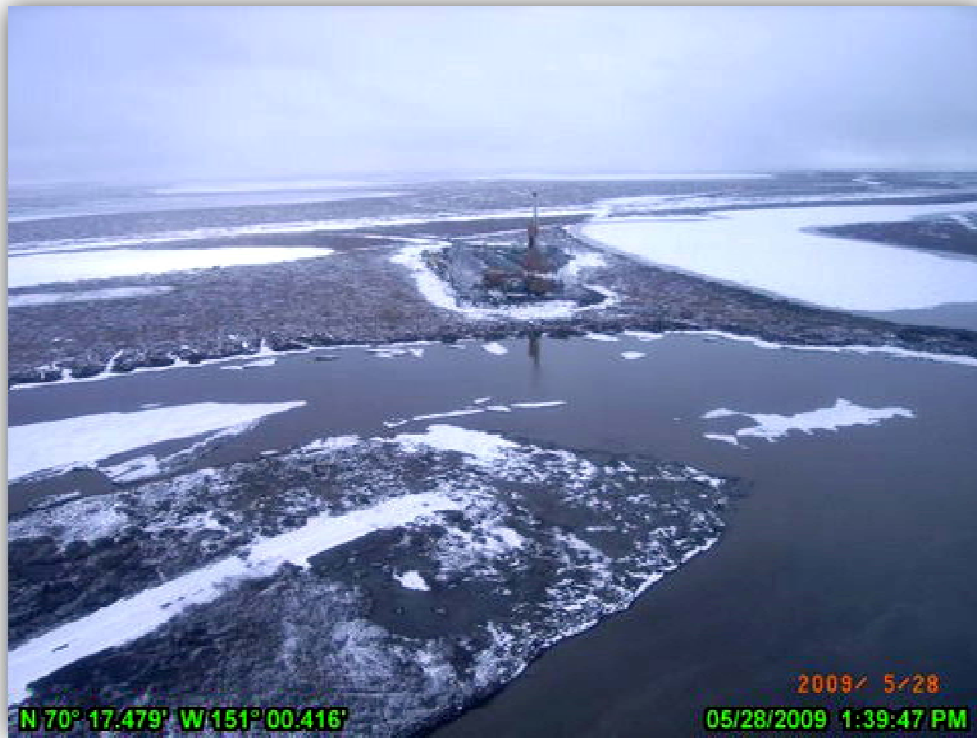
PHOTO 4.13: NIGLIQ CHANNEL AND CD4. MAY 28, 2009.

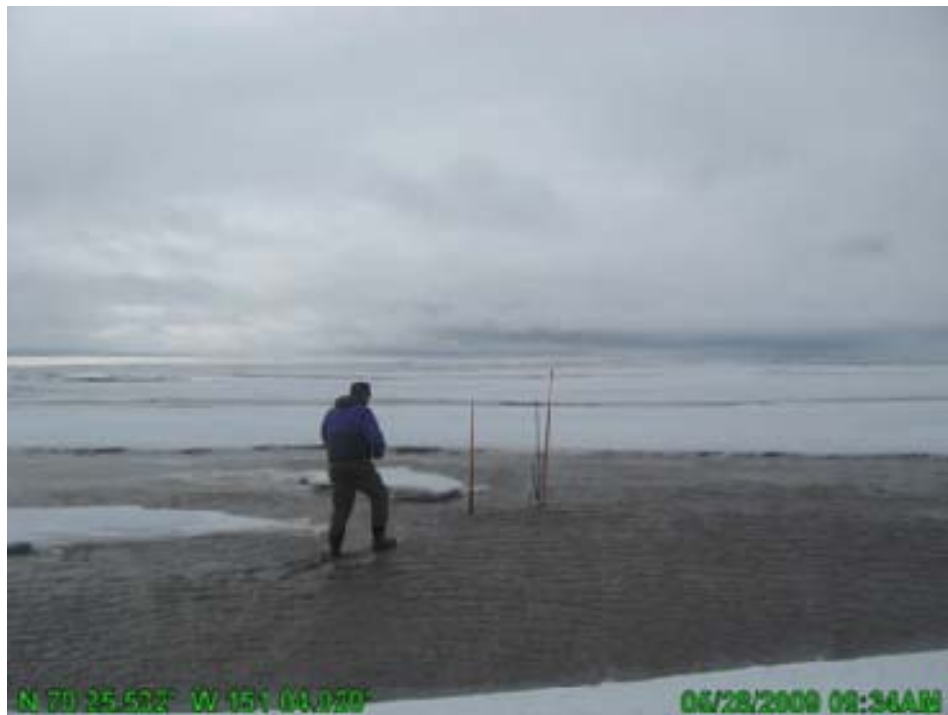
PHOTO 4.14: MON28 GAGE READING. MAY 28, 2009.

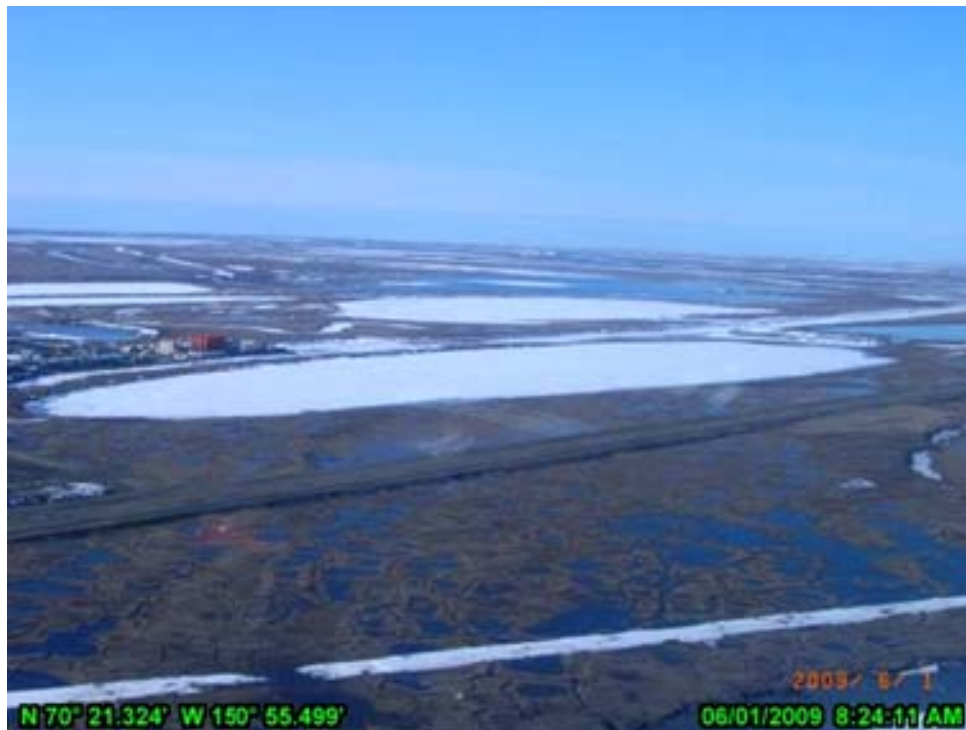
PHOTO 4.17: LAKES L9312 & L9313. JUNE 1, 2009.

WSE data and observations for the Alpine lakes are provided in Table 4.15. Photo 4.17 shows an aerial view of L9313 and L9312 on June 1, after breakup flooding receded, but before peak stage was recorded at L9312.

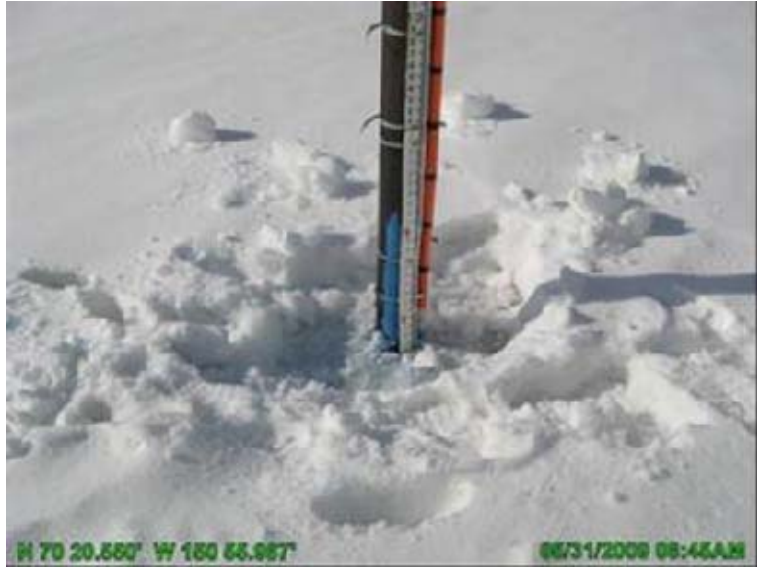
Gage G9 at Lake L9312 remained frozen until after May 31. Photo 4.18 shows G9 on May 31.

PHOTO 4.18: GAGE G9, LAKE L9312. GAGE REMAINED FROZEN THROUGHOUT MAY. MAY 31, 2009.

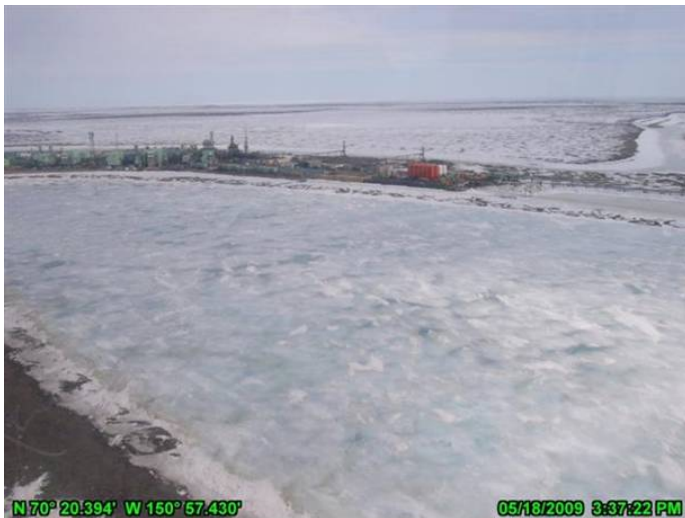
PHOTO 4.19: LAKE L9313. MAY 18, 2009.

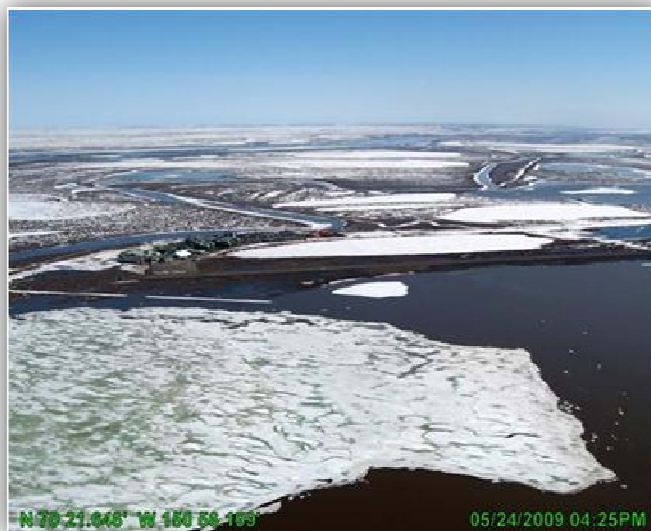
Observed WSE and field notes are provided in Table 4.15. Photo 4.19 shows L9313 prior to breakup. Photo 4.20 shows floodwaters from the Sakoonang approaching L9313 on May 24. Photo 4.21 shows L9313 on May 25 with floodwaters reaching the lake. High water was observed in L9313 on May 26. In the background of Photo 4.21, behind L9313, L9312 remained frozen and not connected to floodwater.

PHOTO 4.20: LAKE L9313 AND LAKE L9312 WITH SAKOONANG FLOODWATERS APPROACHING L9313. MAY 24, 2009.

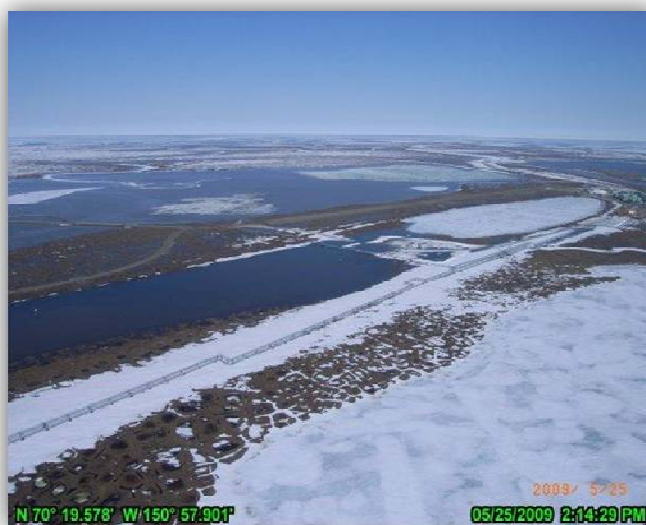
PHOTO 4.21: LAKE L9313. RECHARGE BY SAKOONANG FLOODWATERS. MAY 25, 2009.

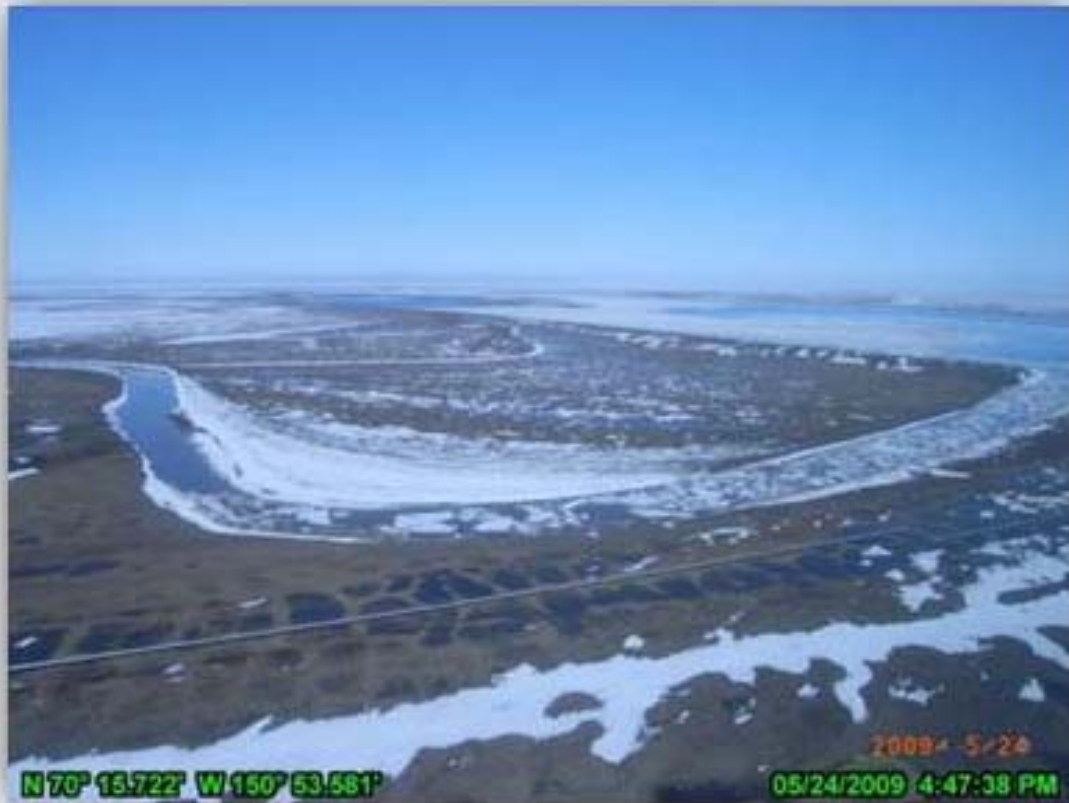
Stage at all gages, the SAK and TAM gages in particular, was most likely affected by ice jamming both in channel and from the Colville. Photo 4.36 shows ice from the released Colville ice jam diverting into the Sakoonang Channel. Photo 4.37 is an aerial view of the Ulamnigiaq pipe bridge during peak stage. Photo 4.38 shows gage TAM-B on May 28, 2009. Photo 4.39 shows an aerial view of the Tamayagiaq on June 2.

PHOTO 4.36: ICE DIVERTING INTO THE SAKOONANG CHANNEL. MAY 24, 2009.

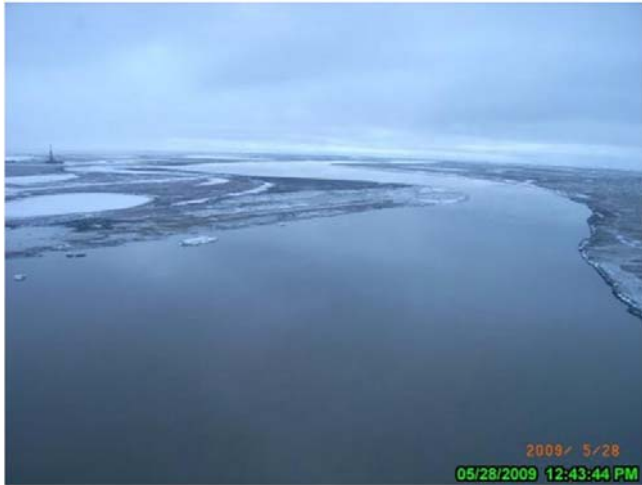
**PHOTO 4.40: PROPOSED NIGLIQ CD5 ROAD CROSSING.
MAY 28, 2009.**

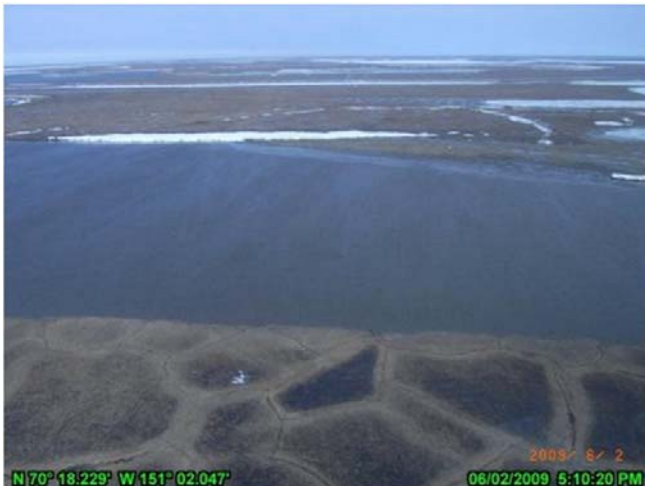
**PHOTO 4.41: WEST SIDE PROPOSED CD5 NIGLIQ
CROSSING. JUNE 2, 2009.**

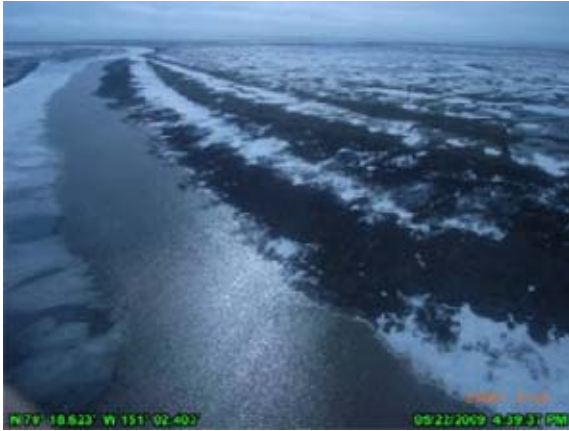
As shown in Photo 4.42, open water was observed in L9341 on May 22. However, measureable water did not reach gage G22 until several days later. A high water mark was observed on May 27. Peak WSE at G22 was 8.00 feet BPMSL based on an observed HWM. Photo 4.43 shows a survey to determine below-gage water surface elevation. Photo 4.44 shows an aerial view of the CD5 road proposed L9341 bridge crossing location after peak stage. WSE data and observations are provided in Table 4.18.

PHOTO 4.42: PROPOSED LAKE L9341 CD5 CROSSING. MAY 22, 2009.

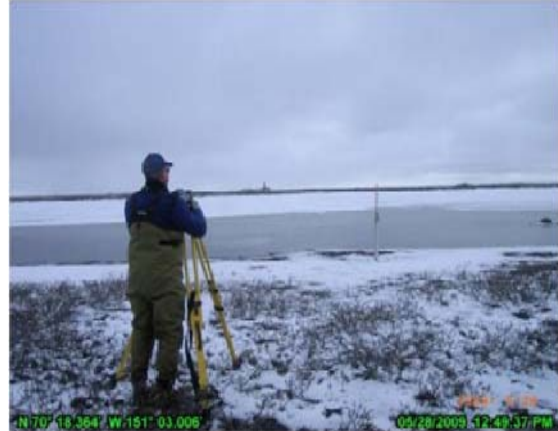
PHOTO 4.43: WSE SURVEY AT LAKE L9341. MAY 28, 2009.

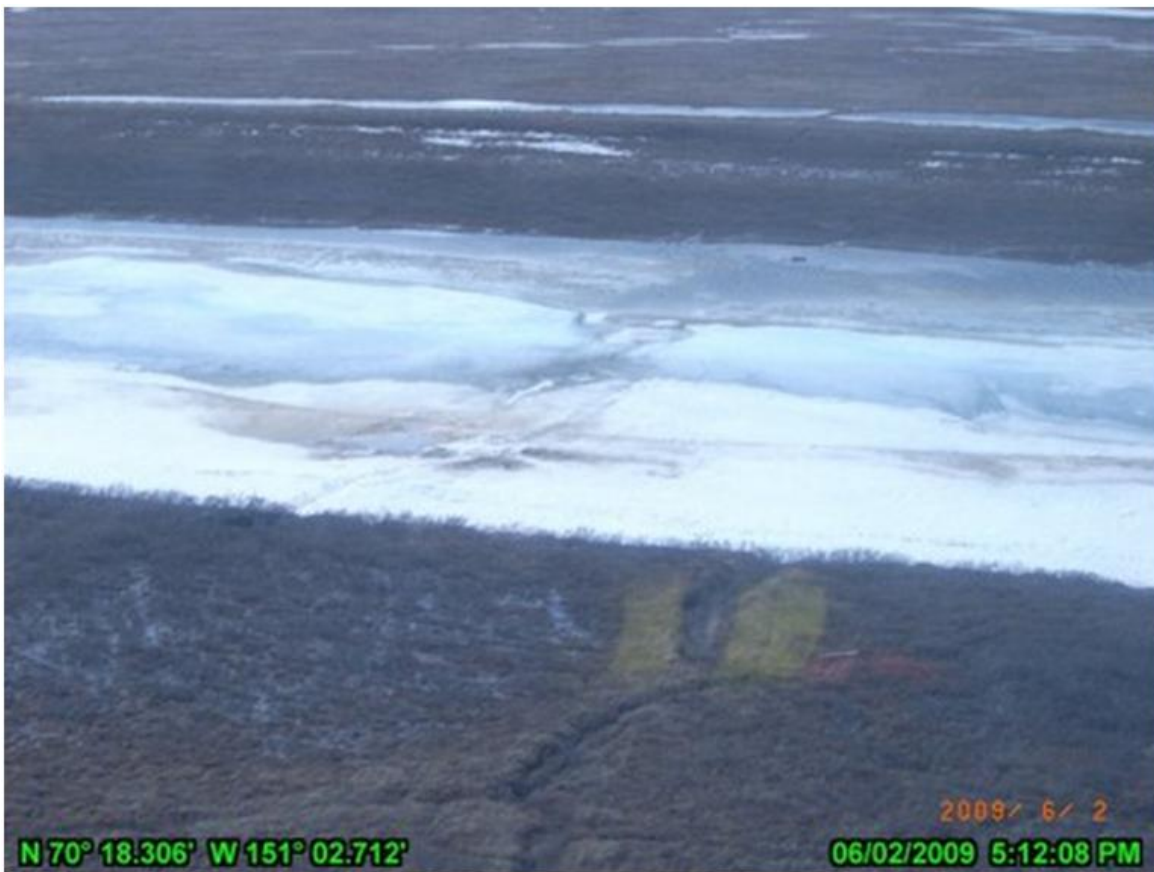
PHOTO 4.44: PROPOSED L9341 CD5 CROSSING. JUNE 2, 2009.

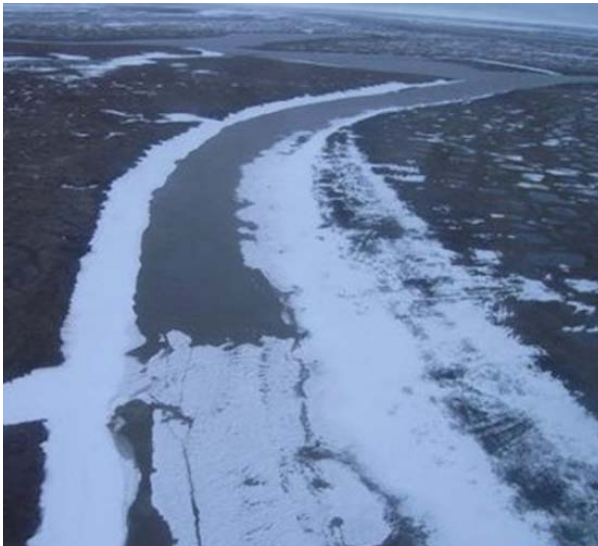
A considerable amount of snow remained in-channel and along the banks of the Nigliagvik throughout the duration of the breakup period. The majority of the snow was in place along the steeper west bank. The 2009 breakup flow was contained within the channel banks and did not extend into the floodplain to the east. Peak WSE at G23 was 7.71 feet BPMSL.

Photo 4.45 shows the CD5 road proposed Nigliagvik bridge crossing location on May 27. Photo 4.46 shows an aerial view of the same location, with an open channel after recession of breakup floodwaters. Table 4.19 presents the observations and WSE recorded for G23.

PHOTO 4.45: NIGLIAGVIK PROPOSED CD5 CROSSING. MAY 27, 2009.

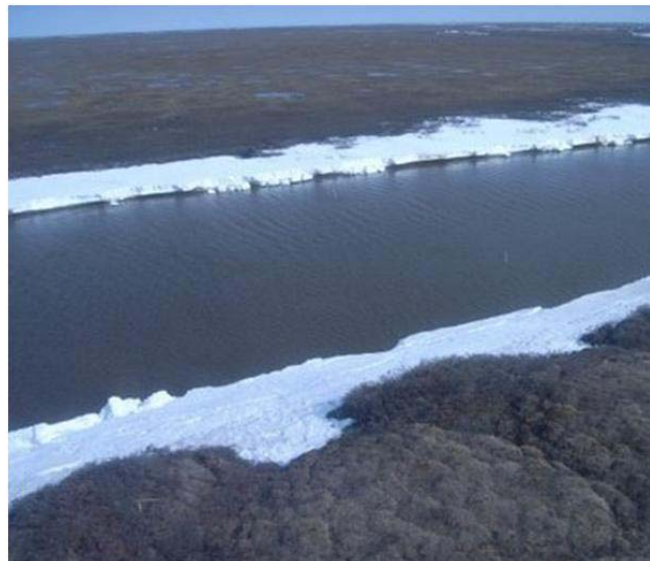
PHOTO 4.46: NIGLIAGVIK PROPOSED CD5 ROAD CROSSING. JUNE 2, 2009.

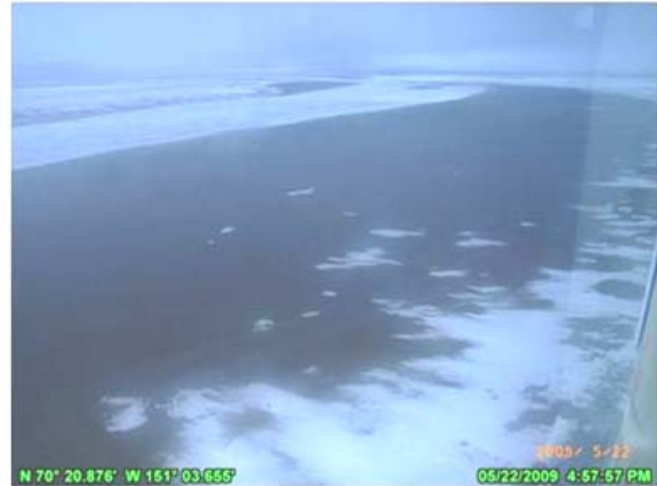
PHOTO 5.1: RIBBON ICE IN THE VICINITY OF MON23. MAY 22, 2009.
