2017

COLVILLE RIVER DELTA SPRING BREAKUP MONITORING & HYDROLOGICAL ASSESSMENT

Michael Baker

This report presents the observations and results from the 2017 Colville River Delta Spring Breakup Monitoring and Hydrological Assessment conducted by Michael Baker International for ConocoPhillips Alaska. In the Colville River Delta, the breakup and downstream movement of river ice typically occurs during a three-week period in May and June. The spring breakup event historically produces flooding, and rapid rise and fall of stage can occur as the result of ice jam formation and release. Annual study and reporting of spring breakup is required by U.S. Army Corps of Engineers Permits 2-960874 Special Condition #6, POA-2004-253 Special Condition #17, and POA-2005-1576 Special Conditions #1 and #17 and Alaska Department of Fish and Game Permits FH04-III-0238, FG97-III-0260, FG99-III-0051, and FG97-III-0190. The analyses provide data to support design, permitting, and operation of oilfield development.

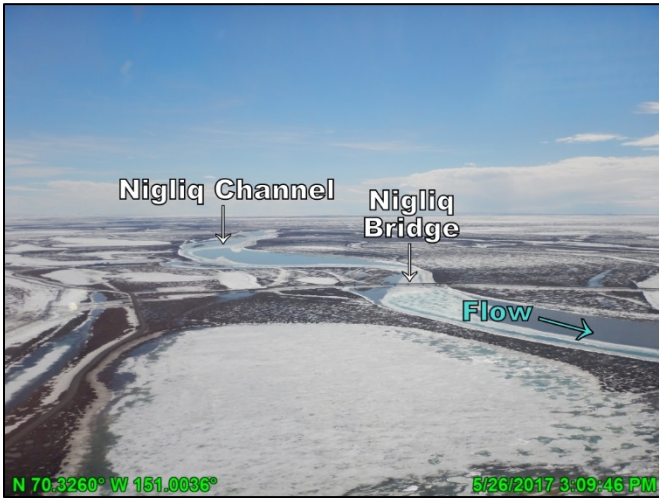
Photo 3.5: Degrading channel ice in the Nigliq Channel, looking southeast (upstream); May 26, 2017

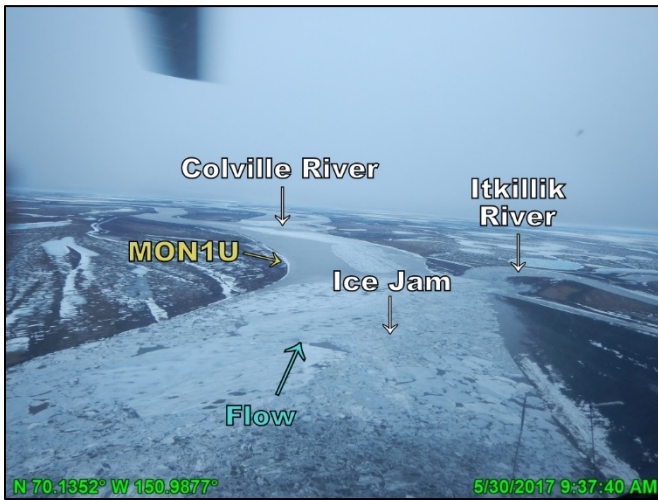
Peak stage and peak discharge at MON1 were the results of backwater from the ice jam within the MON1 reach (Photo 4.1 and Photo 4.2). The ice jam formed between MON1C and MON1D resulting in backwater at MONC and MON1U, just prior to release. Additionally, ice floes were moving through the reach when the ice jam released, impacting stage. The estimated peak discharge was assigned a fair quality rating (Table 2.1) because of these influences.

Photo 4.1: Conditions the day of peak stage and peak discharge at MON1, looking northeast (downstream); May 30, 2017

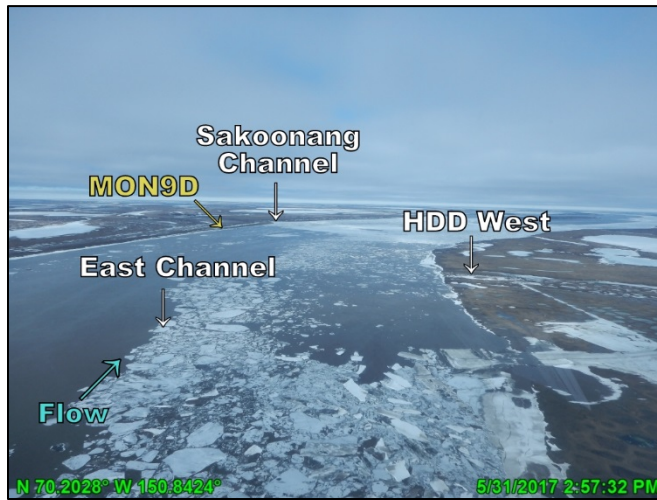
Photo 4.5: Conditions the day of peak stage and peak discharge at MON9, looking north (downstream); May 31, 2017

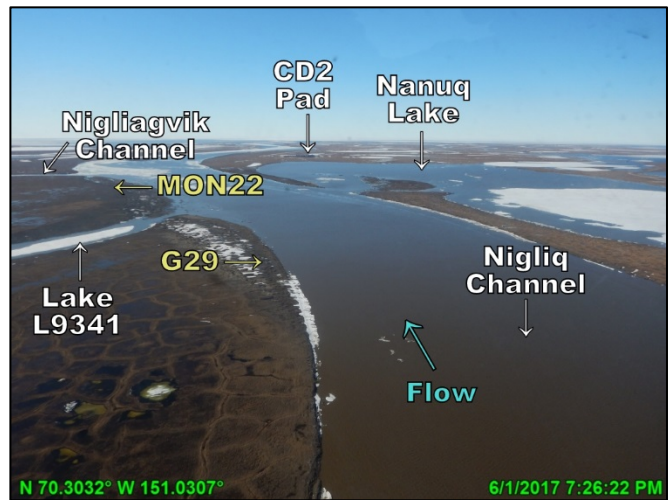
Peak stage in the Nigliq Channel occurred while channel ice was still present at all locations except at MON20. On May 31, stage increased in the MON20-MON23 reach after the ice jam at MON1 released the evening prior. Increasing stage at MON20 on June 1 was likely the result of floes jamming on intact channel ice upstream of the Nigliq Bridge (Photo 4.6). Backwater diminished by the evening though floes and channel ice remained in place. Channel ice remained intact at and downstream of MON22 that evening (Photo 4.7). Open channel conditions were observed throughout the MON20 to MON22 reach by June 2. Channel ice was still observed in the MON28 vicinity on June 5.

Photo 4.7: Channel ice at MON22 the day after peak stage, looking northwest (downstream); June 1, 2017

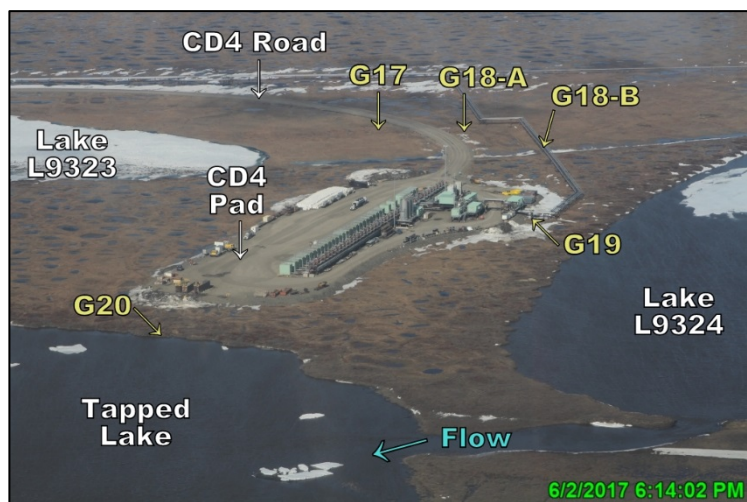
At the CD4 pad, gage G19 remained dry. Stage at G20 was affected by ice conditions in the Nigliq Channel and is estimated to have peaked at the same time as stage peaked at MON20 on June 1 (Photo 4.17).

Photo 4.17: CD4 pad and road one day after estimated peak at gage G20, looking northeast; June 2, 2017

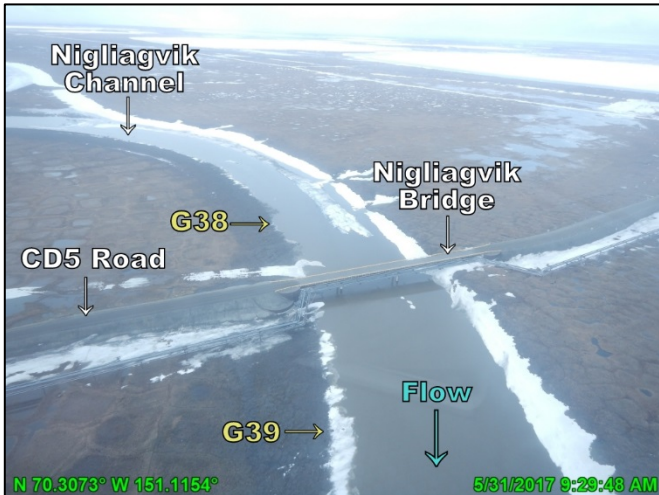
Peak stage at the Nigliagvik Bridge occurred approximately concurrent with peak stage in the Nigliq Channel. Peak discharge timing occurred on the rising limb of the stage hydrograph. Aerial observations suggest that the influences of ice and snow in the Nigliagvik channel during peak discharge were minimal (Photo 4.22) and as a result, peak discharge was assigned a good quality rating (Table 2.1).

Photo 4.22: Nigliagvik Bridge conditions the day of peak stage and peak discharge, looking southeast (upstream); May 31, 2017

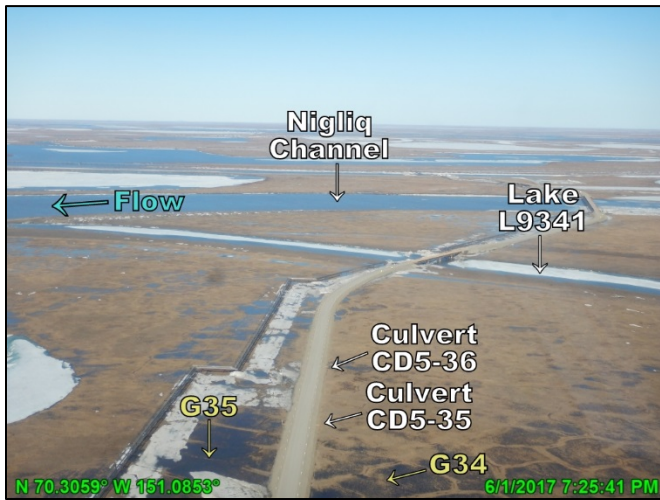
Gages G34/G35 (Photo 4.24) and gages G36/G37 were dry throughout monitoring. Peak stage at gages G30/G31 was recorded as a HWM. Low flow through the paleochannel at gages G30/G31, attributed to the equalization of local melt, (Photo 4.25) was measured at one associated culvert. Peak discharge through this culvert was not determined because the HWMs were of low confidence. Gages G30/G31 stage and discharge data is provided in Graph 4.17 and the direct discharge measurement is summarized in Table 4.5.

Photo 4.24: Local melt near culverts associated with gages G34/G35, looking west; June 1, 2017

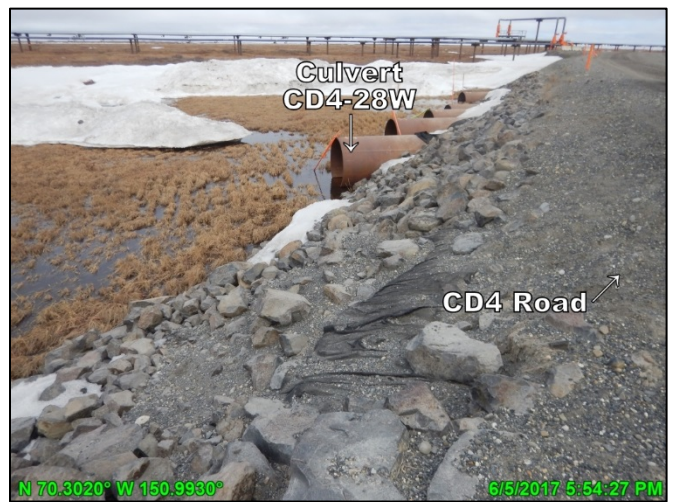
Alpine road and pads were inspected for erosion between June 5 and 7. Other than minor washlines, no discernable erosion was observed during aerial and ground reconnaissance of the CD2 (Photo 5.1), CD4 (Photo 5.2), and CD5 (Photo 5.3) roads. Floodwaters did not reach CD5 bridge abutments or the majority of the CD5 road within the CRD. A prominent washline from 2015 spring breakup was evident along portions of the CD2, CD4, and CD5 roads. There were no signs of sloughing or undermining at drainage structures. Additional photo documentation of erosion surveys and breakup conditions along the Alpine facilities roads and pads are shown in Appendix D.1.

Photo 5.2: East side of CD4 road near CD5 intersection, looking southeast; June 5, 2017

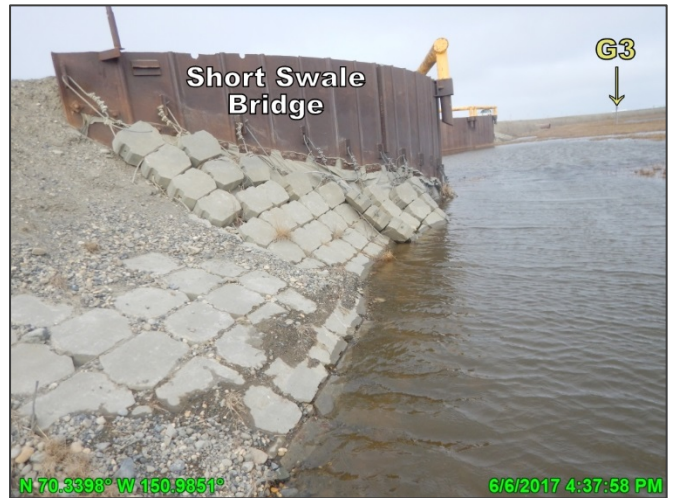
Photo D.4: South side of CD2 road west of the Short Swale Bridge, looking northeast; June 6, 2017

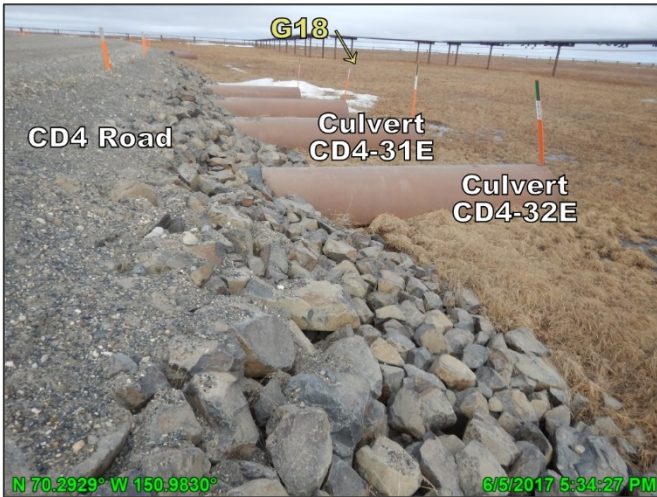
Photo D.9: South side of CD4 road east of CD4 pad, looking west; June 5, 2017
