2017

GMT1 Spring Breakup & Summer Monitoring & Hydrological Assessment

Michael Baker

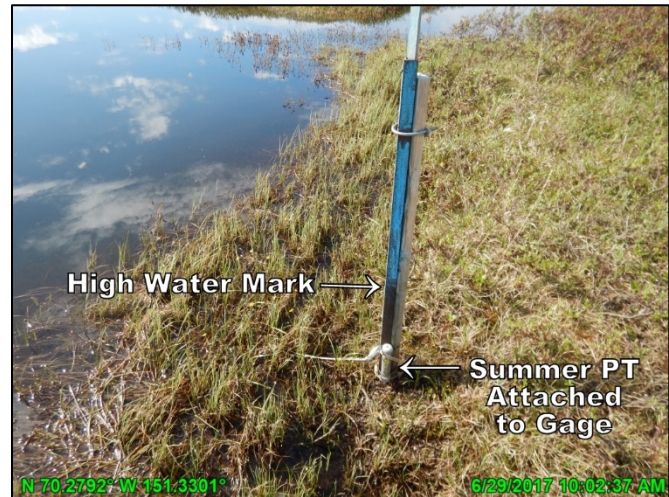
Each gage assembly includes a standard U.S. Geological Survey (USGS) metal faceplate mounted on a wooden two-by-four. The two-by-four is attached with U-bolts to a 1.5-inch-wide angle iron post driven into the ground. The faceplate is graduated and indicates water levels every 100th of a foot between 0.00 to 3.33 feet (Photo 2.1). High water marks (HWMs) were measured by applying chalk on the angle iron gage supports or VSMs and measuring the wash line (Photo 2.2).

Photo 2.2: Chalked gage S5-C with HWM and PT; June 29, 2017

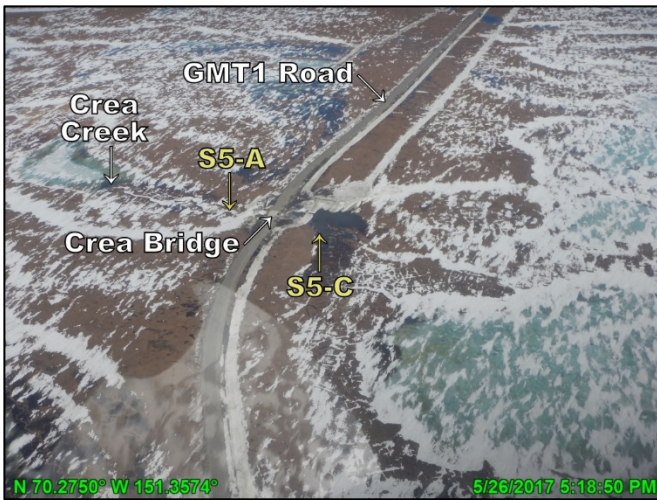
Photo 3.6: Ponded local melt in Crea Creek, looking east; May 26, 2017

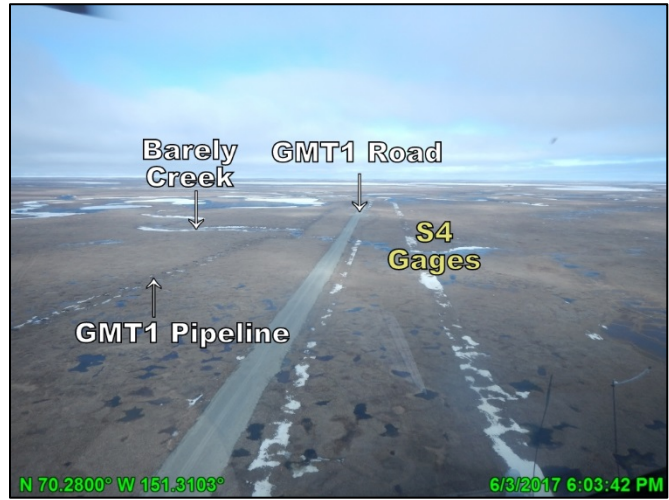
Photo 3.9: Remaining snow cover along GMT1 access road, looking east; June 3, 2017

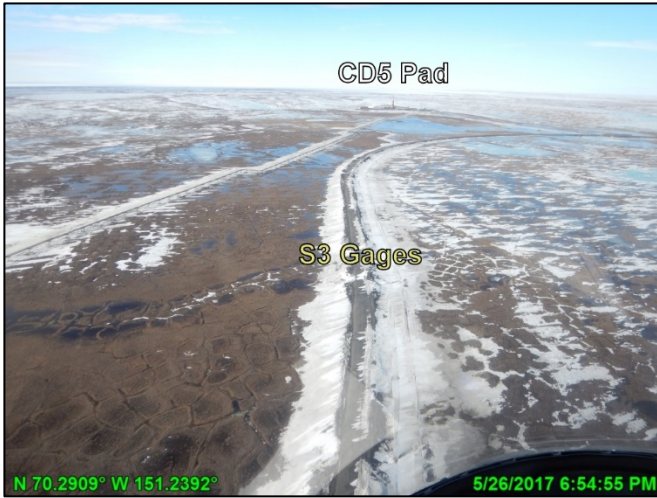
Photo 4.26: Local melt at S3 gages, looking northeast; May 26, 2017

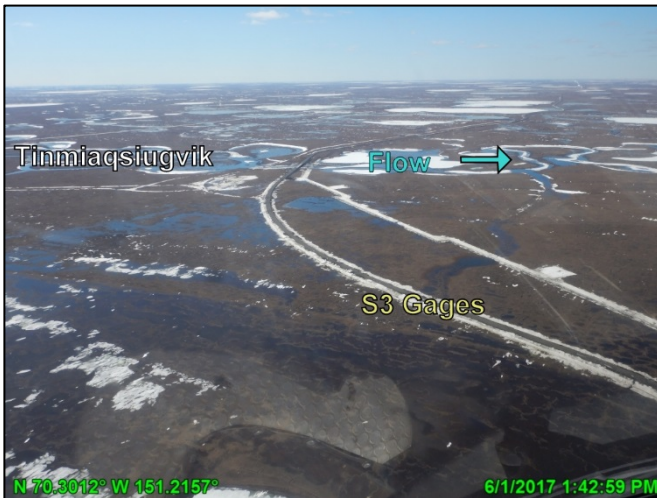
Photo 4.28: S3 gages the day of peak stage at gage S3-A, looking west (downstream); June 1, 2017

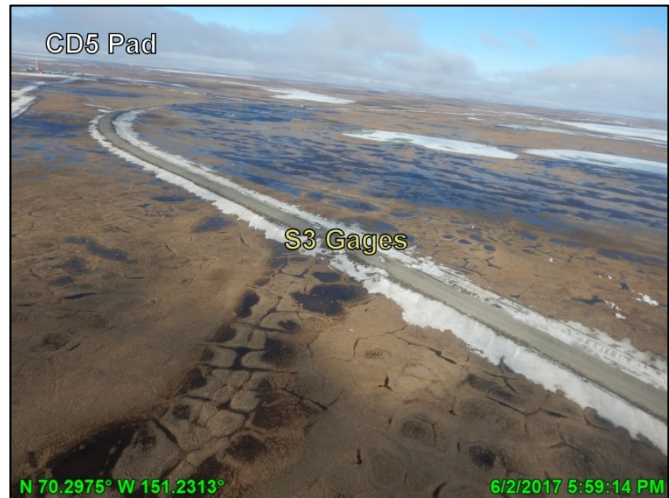
Similar to conditions observed at the S2 gage stations, the pipeline construction ice road north (downstream) of the GMT1 access road remained partially intact during breakup. Similarly, meltwater accumulated between the GMT1 access road and the pipeline construction ice road, influencing water levels at the S3 gage stations. The PT installed on the upstream gage, S3-B, remained dry throughout breakup and aerial observations indicate no meltwater was on the south side of the road embankment. As a result, no hydraulic connections were established through the culverts during breakup (Photo 4.26, Photo 4.27, and Photo 4.28). Observations on June 2 confirmed that there were no visible drainages melted through the snowpack in the vicinity of the culvert inlets and outlets (Photo 4.29).

Photo 4.29: S3 gages the day after spring peak stage, looking southeast (upstream); June 2, 2017

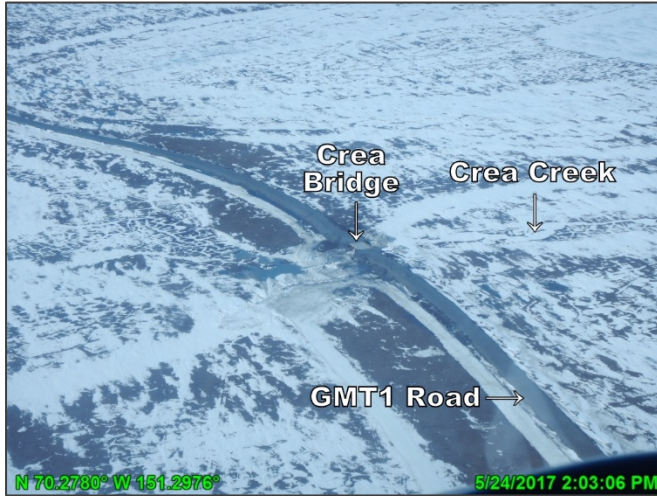
Photo D.37: Crea Creek pre-breakup, looking northwest; May 24, 2017

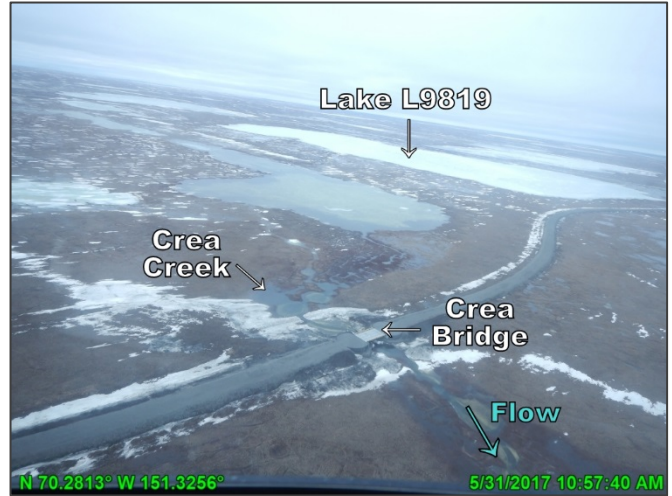
Photo D.38: Crea Creek during breakup, looking southwest; May 31, 2017

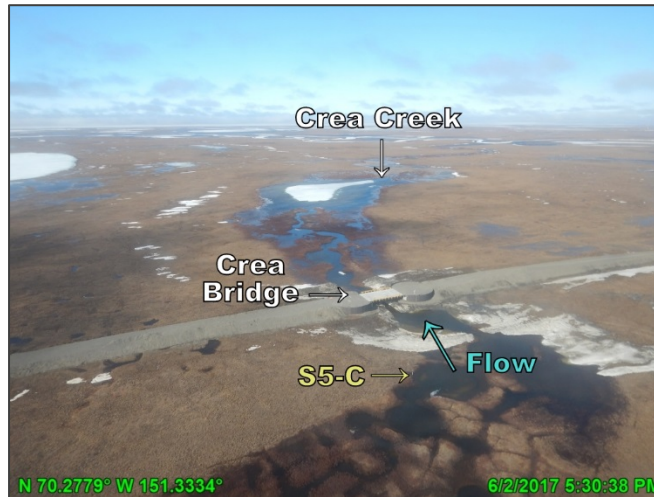
Photo D.39: Crea Creek post-breakup, looking north (downstream); June 2, 2017

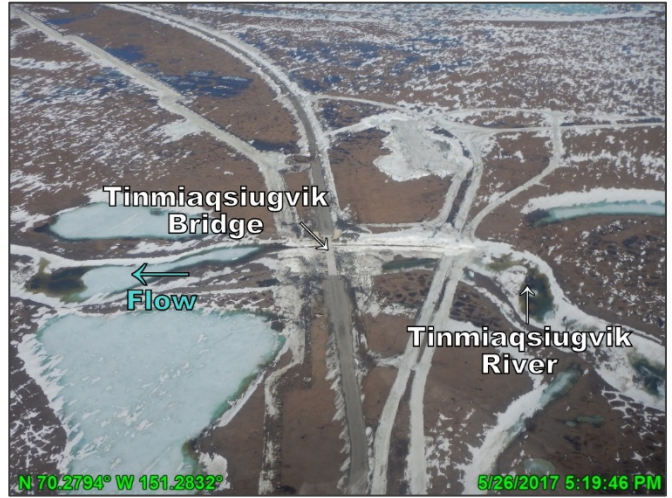
Photo D.41: Tinmiaqsiugvik River during breakup, looking northeast; May 26, 2017

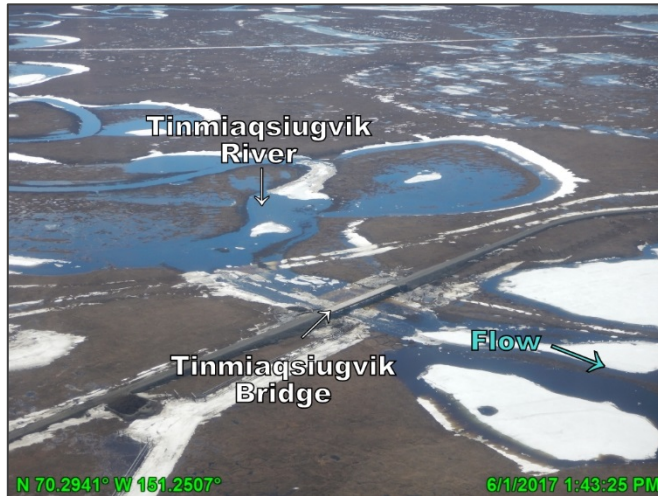
Photo D.42: Tinmiaqsiugvik River during breakup, looking south (upstream); June 1, 2017

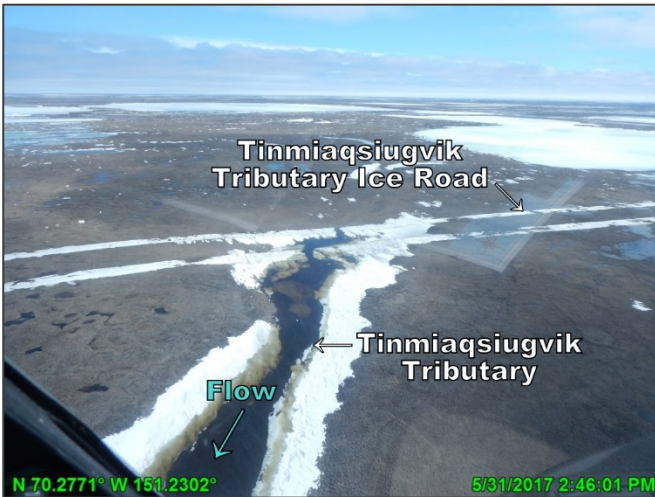
Photo D.43: Tinmiaqsiugvik Tributary during breakup, looking west; May 31, 2017

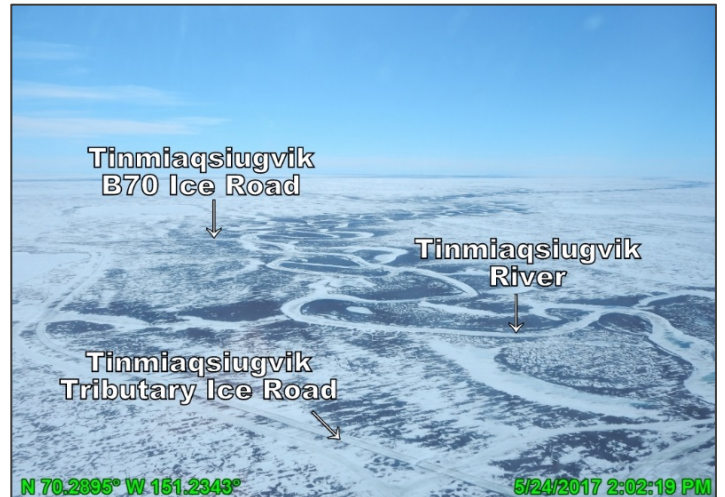
Photo D.44: Tinmiaqsiugvik Tributary and B70 pre-breakup, looking south; May 24, 2017

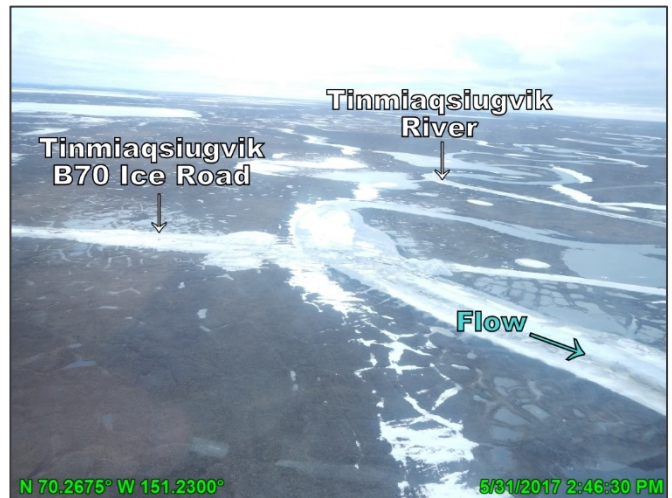
Photo D.46: Tinmiaqsiugvik B70 during breakup, looking south; May 31, 2017
