2018

COLVILLE RIVER DELTA SPRING BREAKUP MONITORING & HYDROLOGICAL ASSESMENT

Michael Baker
INTERNATIONAL

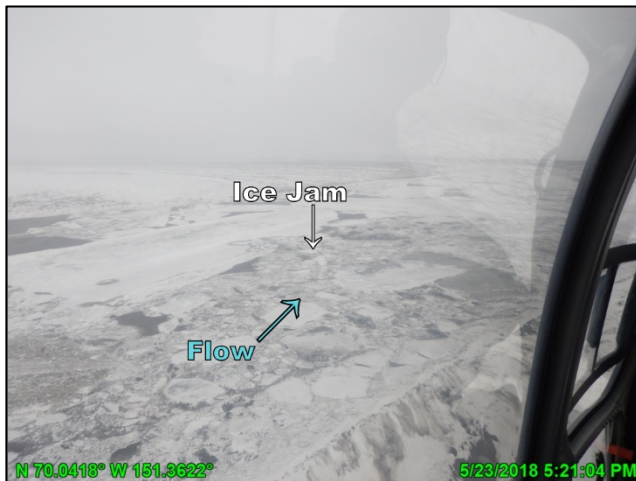
Photo 3.5: Ice jam on the Colville River approximately 14 RM upstream of MON1, looking east (downstream); May 23, 2018

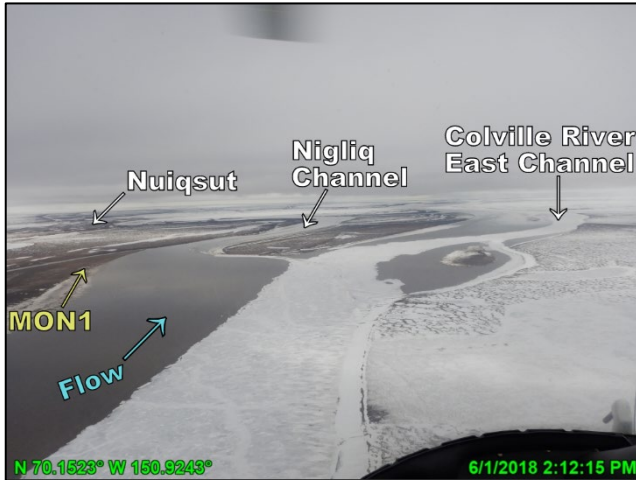
Photo 4.1: Intact channel ice downstream of the MON1 reach the day prior to peak stage, looking northeast (downstream); June 1, 2018

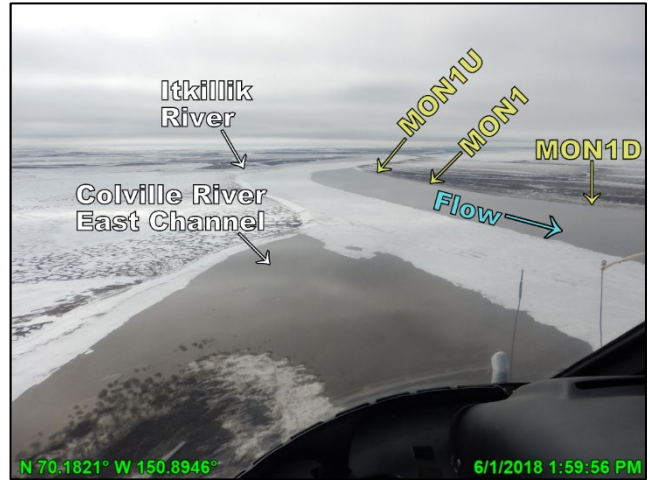
Photo 4.2: Intact channel ice through the MON1 reach the day prior to peak stage at MON1C, looking southwest (upstream); June 1, 2018

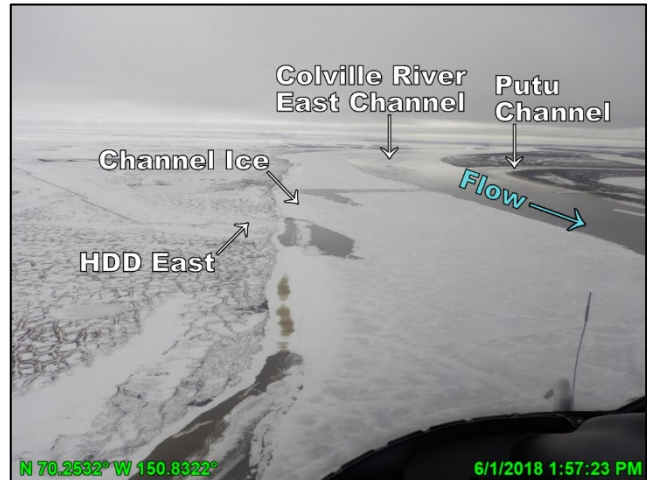
Photo 4.7: Conditions the day prior to peak stage and discharge at MON9, looking southwest (upstream); June 1, 2018

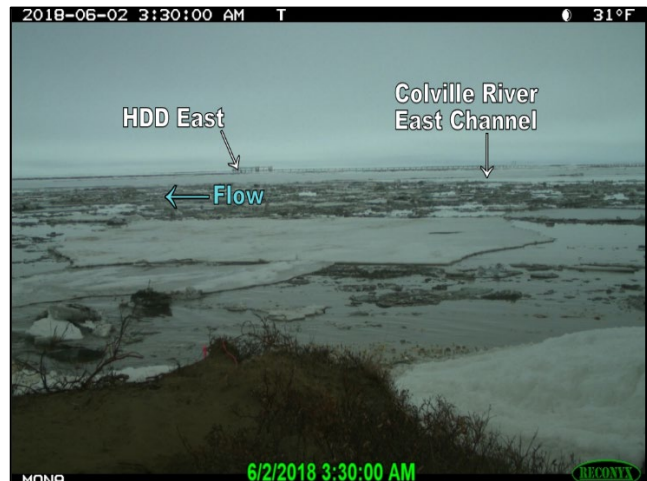
flowing through the reach via remote field camera images (Photo 4.9). The estimated discharge was assigned a fair quality rating (Table 2.1) due to these influences. Site specific discharge data and plan and profile drawings are provided in Appendix C.

Photo 4.9: Ice jam releasing through the MON9 reach, looking east (upstream); June 2, 2018

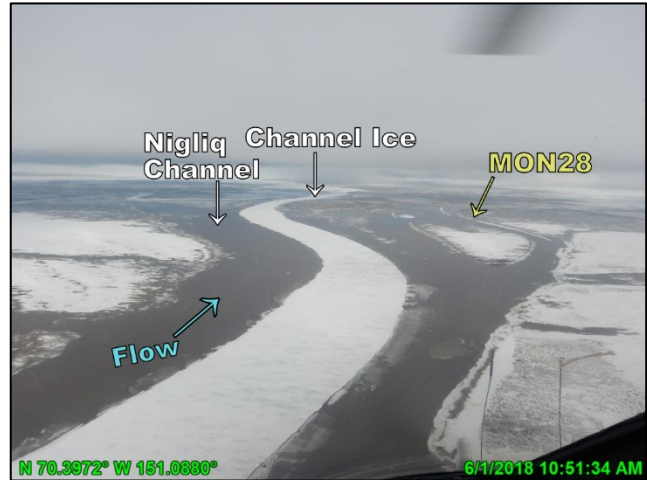
Intact channel ice was observed in the Nigliq channel on June 1 (Photo 4.11). Stage initially crested at MON20 and MON23 and peaked at MON22 on June 2 (Photo 4.12). A small ice jam with minimal backwater was observed upstream of MON20, behind channel ice that remained intact through the Nigliq Channel (Photo 4.13). The ice jam released on the morning of June 3, flushing the downstream channel ice through the CD5 bridge. The ice jam release and accompanying backwater produced peak stage at MON20, MON23, and MON28. Open channel conditions were observed throughout the MON20 to MON22 reach by June 4 (Photo 4.14). Channel ice was still observed between MON23 and MON28 on June 4 (Photo 4.15).

Photo 4.11: Channel ice in the Nigliq Channel between MON23 and MON28, looking north (downstream); June 1, 2018

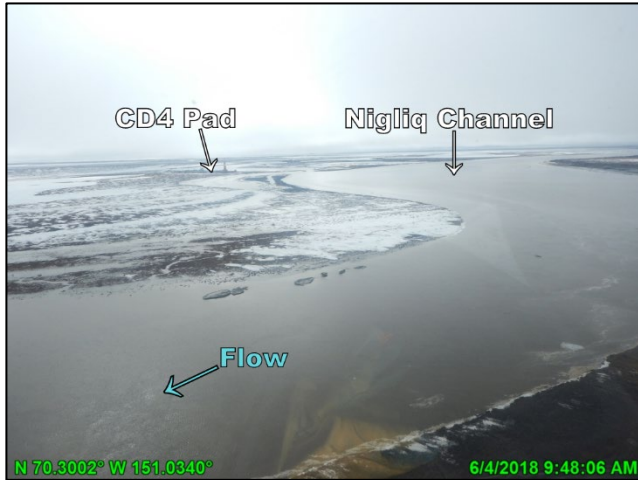
Photo 4.14: Open water conditions the day after to peak stage at MON20, looking southwest (upstream); June 4, 2018

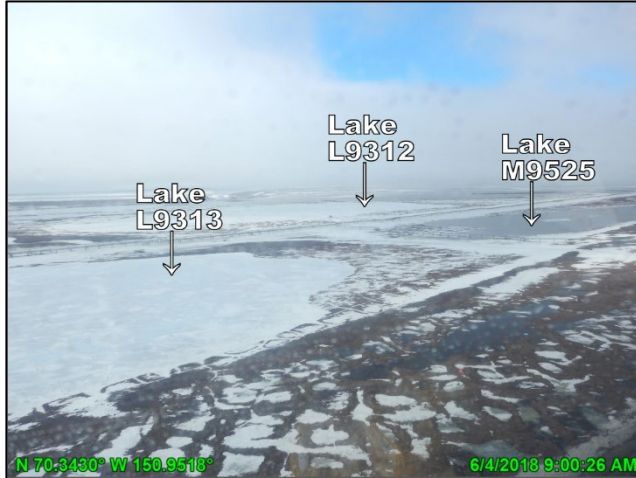
Spring breakup overbank flow did not reach Lake L9312 or Lake L9313 this year (Photo 4.16). Water levels remained below the gage G9 PT and gage G10 PT throughout the duration of breakup. Snowmelt recharge from within the L9312 lake basin reached bankfull elevation, observed on June 9. Snowmelt recharge from within the L9313 lake basin reached bankfull elevation, based on a hydraulic connection to Lake M9525 observed on July 10 and July 18 (Photo 4.17 through Photo 4.19). Stage at gage G9 (L9313) and gage G10 (L9313) is presented in Graph 4.7.

Photo 4.16: Lake L9312 and Lake L9313 hydraulically isolated the day after peak stage, looking south; June 4, 2018

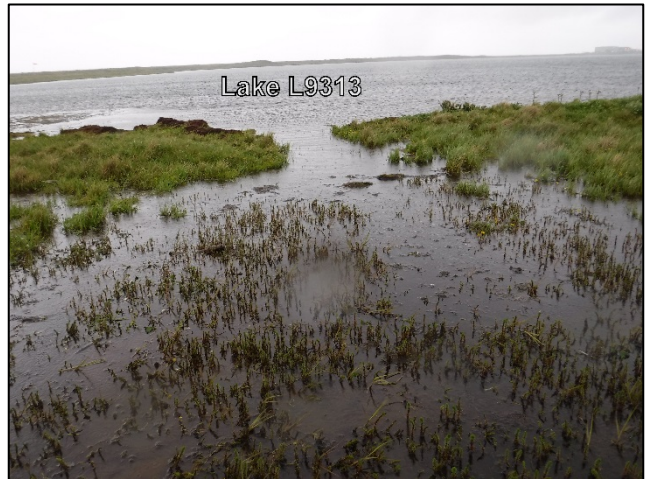
Photo 4.19: Outflow from Lake L9313 looking north; July 18, 2018

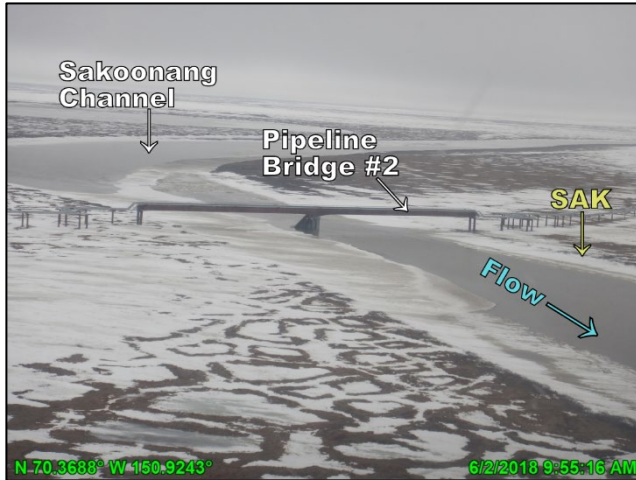
Photo 4.23: Sakoonang Channel the day prior to peak stage at SAK, looking south; June 2, 2018

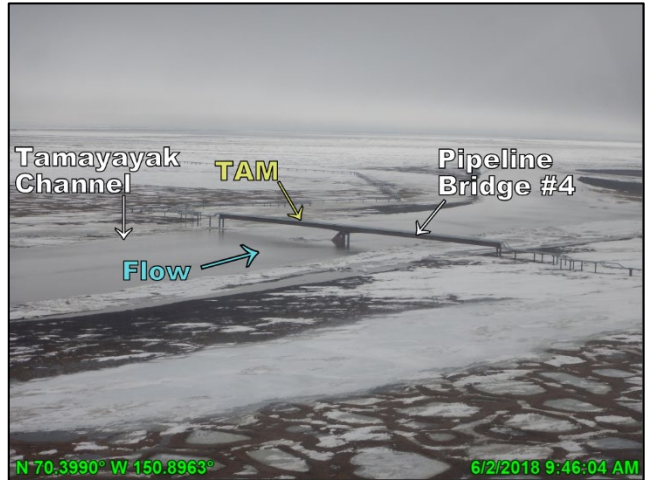
Photo 4.24: Tamayayak Channel the day of peak stage at TAM, looking southwest; June 2, 2018

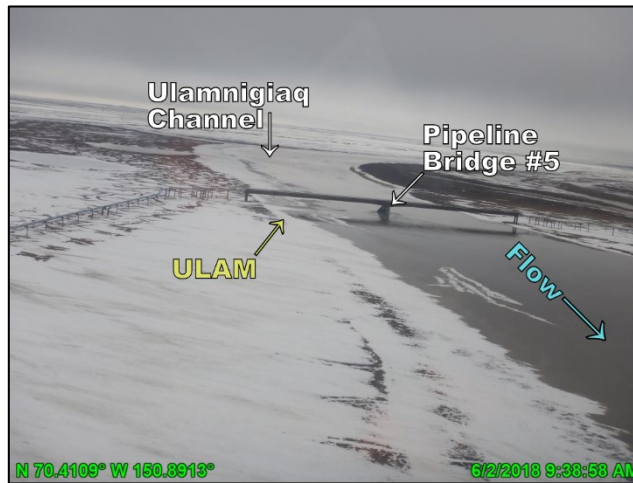
Photo 4.25: Ulamniglaq Channel the day of peak stage at ULAM, looking southeast; June 2, 2018

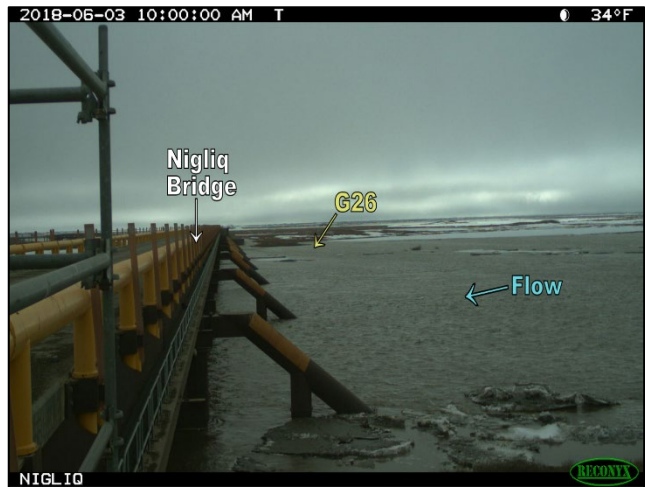
result of the ice jam and backwater release at MON20. Game camera images indicate channel ice was still present around the bridge during peak stage but was flushed a few hours afterwards (Photo 4.32).

Photo 4.32: Peak conditions at the Nigliq Bridge from remote camera, looking east; June 3, 2018

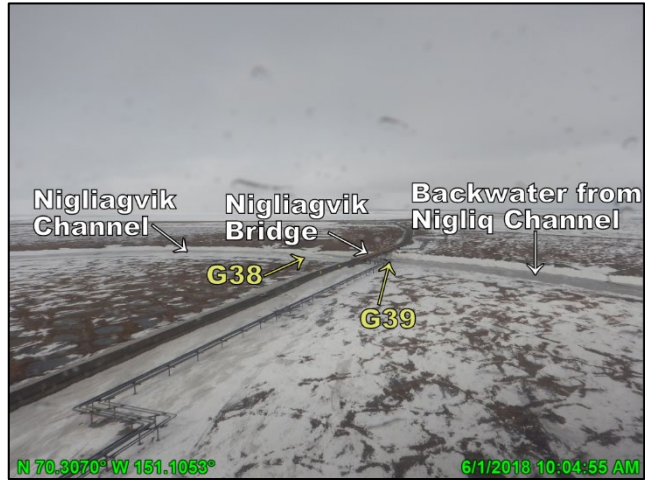
Photo 4.36: Nigliagvik Channel two days prior to peak stage, looking southwest (upstream); June 1, 2018

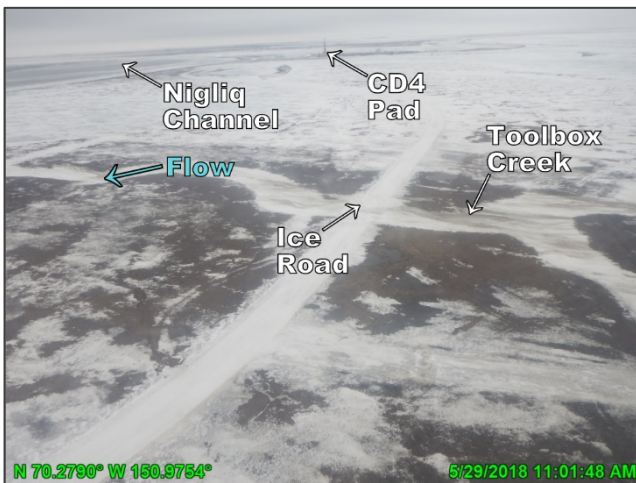
Photo D.12: Toolbox Creek ice road crossing pre-breakup, looking south; May 29, 2018

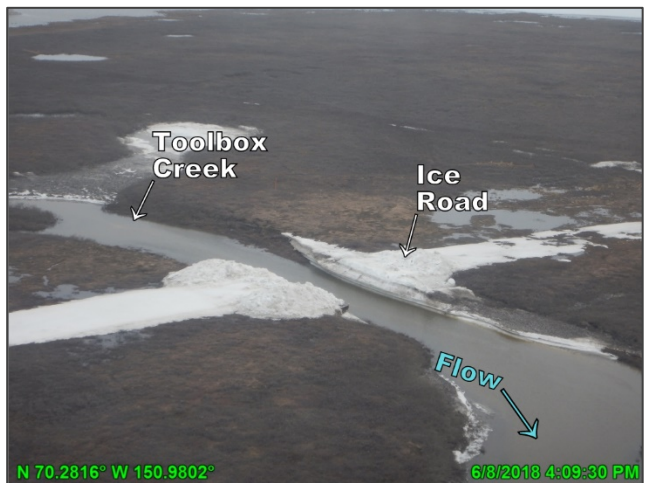
Photo D.13: Toolbox Creek post-breakup, looking east; June 8, 2018

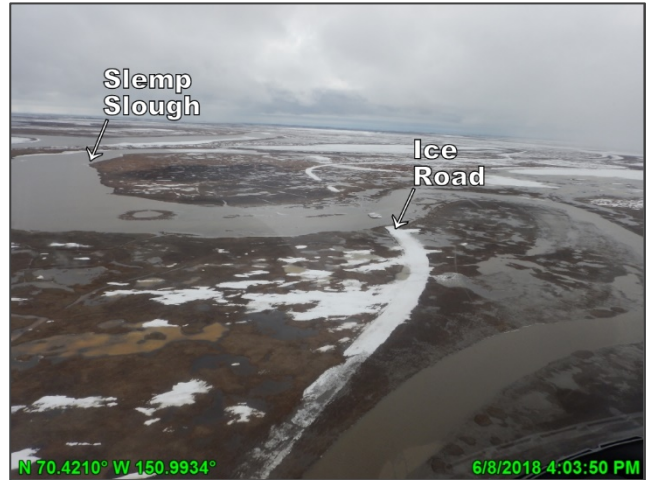
Photo D.15: Slemph Slough post-breakup, looking southwest; June 8, 2018

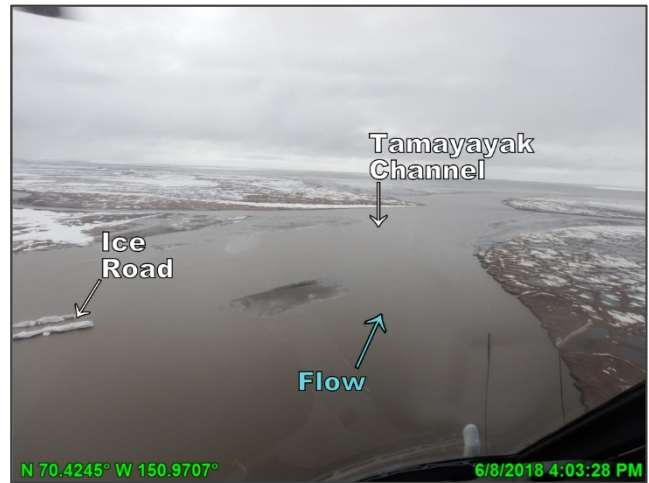
Photo D.17: Tamayayak Channel during breakup, looking northwest; June 8, 2018
