2018

GMT1 SPRING BREAKUP & SUMMER MONITORING & HYDROLOGICAL ASSESSMENT

Michael Baker

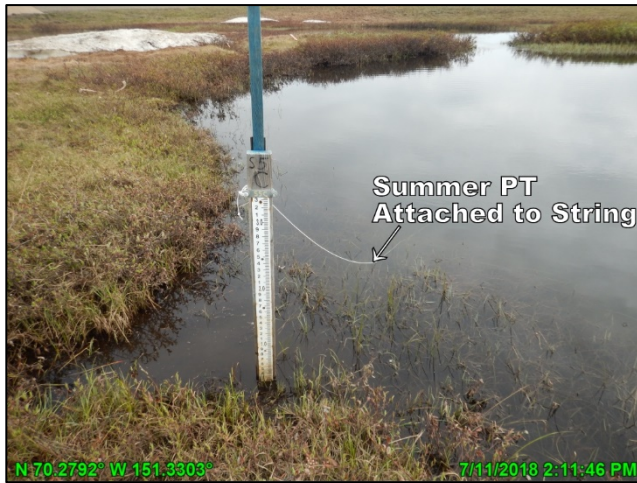
Photo 2.1: Gage S5-C; July 11, 2018

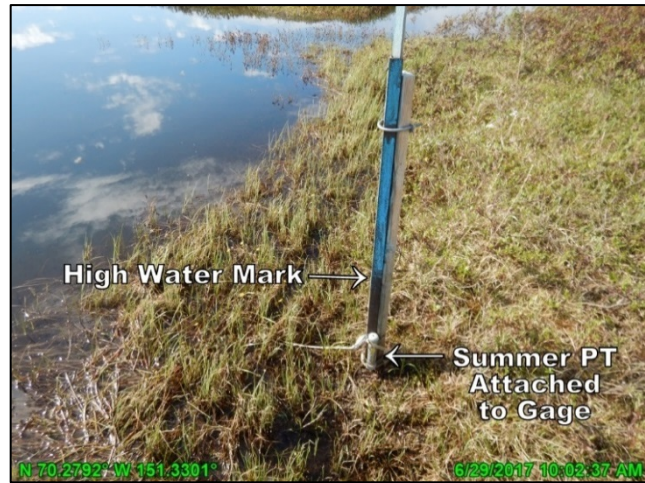
Each gage assembly includes a standard U.S. Geological Survey (USGS) metal faceplate mounted on a wooden two-by-four. The two-by-four is attached with U-bolts to a 1.5-inch-wide angle iron post driven into the ground. The faceplate is graduated and indicates water levels every 100th of a foot between 0.00 to 3.33 feet (Photo 2.1). High water marks (HWMs) were measured by applying chalk on the angle iron gage supports or VSMs and measuring the wash line (Photo 2.2).

Photo 2.2: Chalked gage S5-C with HWM and PT; June 29, 2017

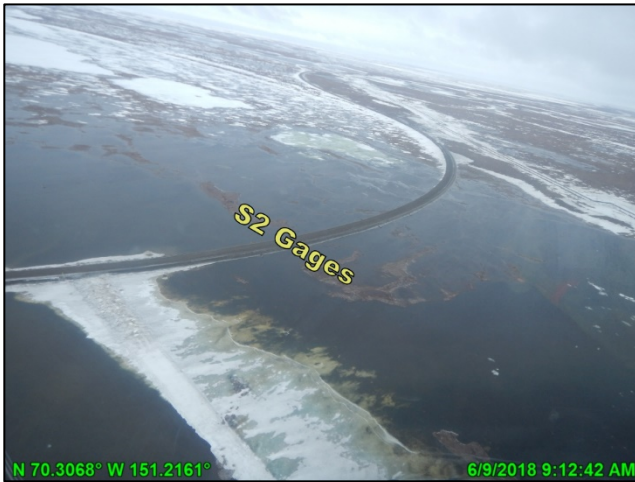
Photo 3.3: Meltwater at S2, looking west; June 9, 2018

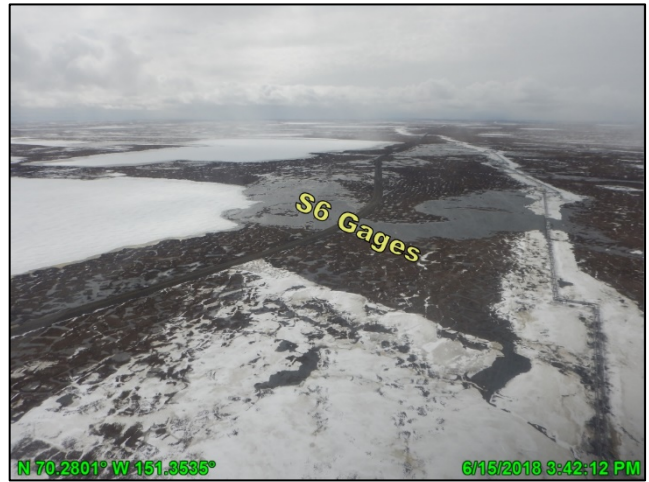
Photo 3.4: S6, looking west; June 15, 2018

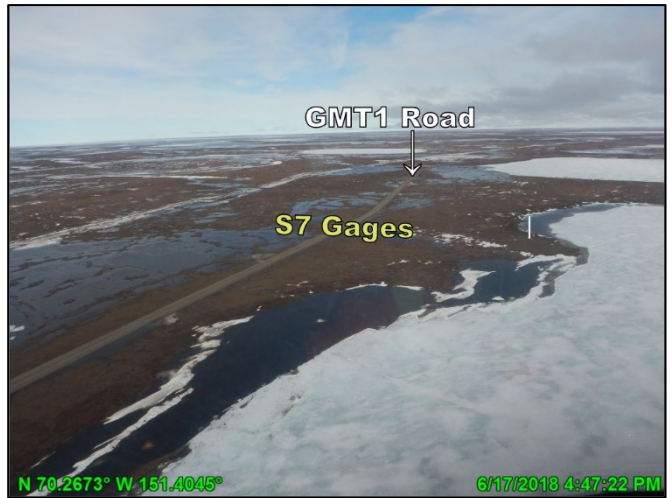
On May 26, local melt was observed at the downstream gage (S7-A) along with saturated snow between the gage and the road. Peak stage was recorded at the upstream gage (S7-B) on June 2 and was the result of local, disconnected meltwater (Photo 4.27). S7-B stage began steadily receding after June 2. Observations on June 8 show culverts GMT1-21 through GMT1-24 dry while culverts GMT1-25 through GMT1-29 had pooled, stagnant water on each side (Photo 4.28). The stagnant water was likely caused by iced-in culvert bladders. Hydraulic connection was likely established through culverts GMT1-25 and GMT1-26 around June 9, corresponding with a decrease in stage at the upstream gage and a rise in stage at the downstream gage. Peak stage at S7-A occurred on June 9 and was attributed to the hydraulic connection established through the GMT1-25 and GMT1-26 culverts (Photo 4.29). Discharge was not measured at any of the culverts related to the S7 drainage since no discernable flow was observed on June 8, the day culvert discharge measurements were taken. By June 17, minimal snow remained in the S7 drainage area. (Photo 4.30).

Photo 4.30: S7, looking northeast; June 17, 2018

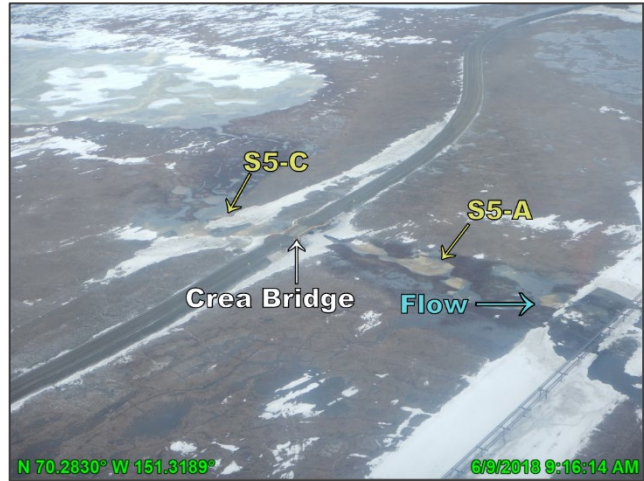
Photo D.24: Crea Creek during breakup, looking southwest; June 9, 2018

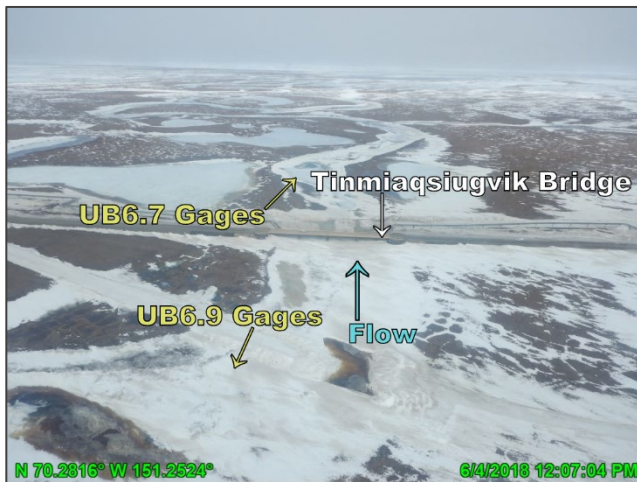
Photo D.26: Tinmiaqsiugvik River pre-breakup, looking north (downstream); June 14, 2018

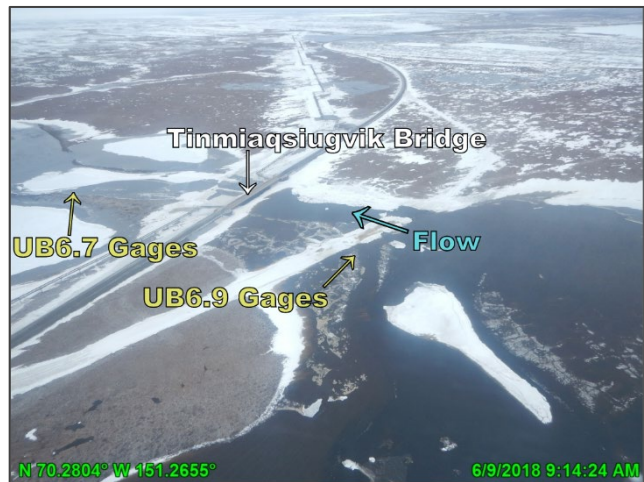
Photo D.27: Tinmiaqsiugvik River during breakup, looking northeast; June 9, 2018

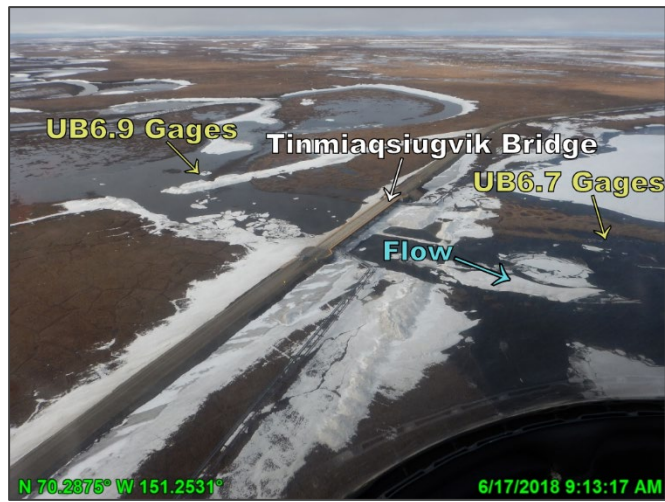
Photo D.28: Tinmiaqsiugvik River, looking southwest (upstream); June 17, 2018
