2020 Colville River Delta Spring Breakup Monitoring & Hydrological Assessment - Final

ConocoPhillips
Alaska

EXECUTIVE SUMMARY

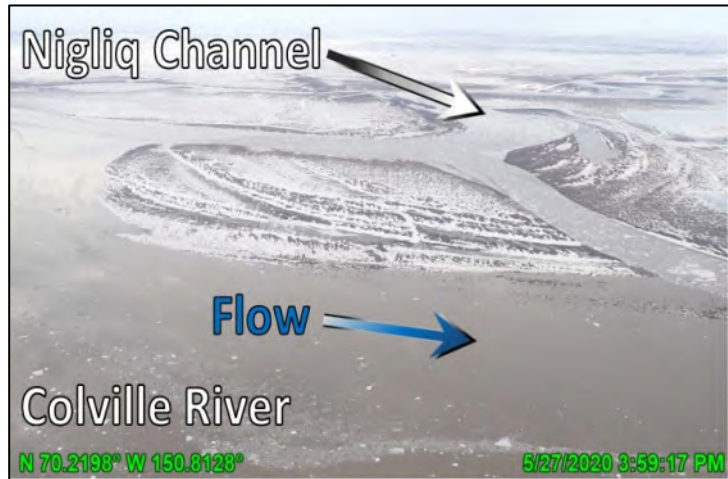
Photo 3-6: Ice jam in the Nigliq Channel and Putu Channel bifurcations, looking west (downstream - Nigliq); May 27, 2020

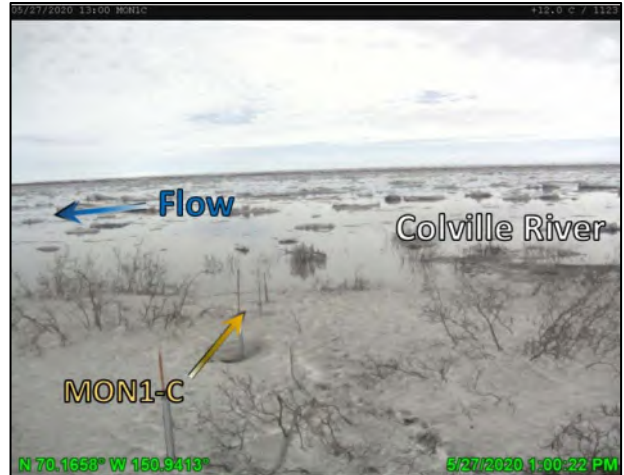
Photo 4-2: RTFM photo of MON1C near peak discharge, looking east; May 27, 2020

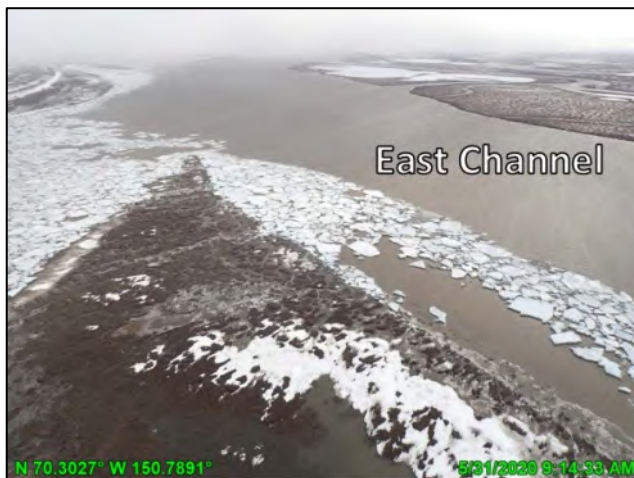
As backwater was relieved through the Nigliq Channel stage decreased steadily, until a sharp drop was recorded corresponding to the East Channel jam releasing at approximately 5:00 PM on May 29. Aerial observations from May 31 show stranded ice indicating receding stage (Photo 4-9).

Photo 4-9: Stranded ice near the Tamayayak Channel bifurcation, looking north (downstream); May 31, 2020

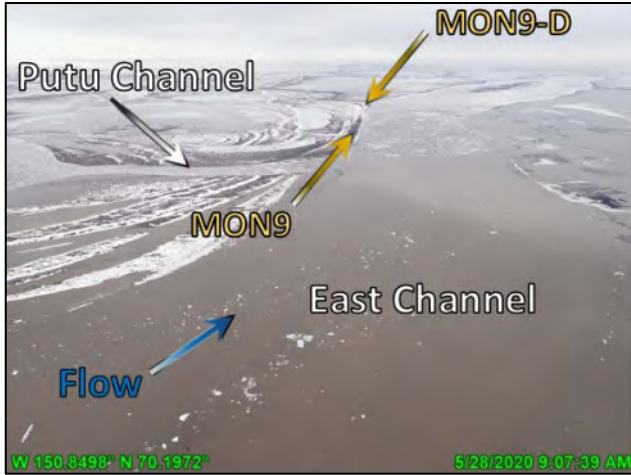
Peak stage at MON9 and MON9D occurred on May 28 and was the result of backwater accumulation from the ice jam at the Tamayayak Channel bifurcation in the East Channel (Photo 4-10, Photo 4-11 and Photo 4-12). Peak stage at MON35 occurred on May 30. Peak discharge at MON9 occurred on May 27 at approximately 12:15 PM, corresponding to the release of the Horseshoe Bend ice jam. Peak discharge at MON9 occurred at a stage lower than peak stage.

Photo 4-11: Stage near peak in the East Channel at MON9, looking north (downstream); May 28, 2020

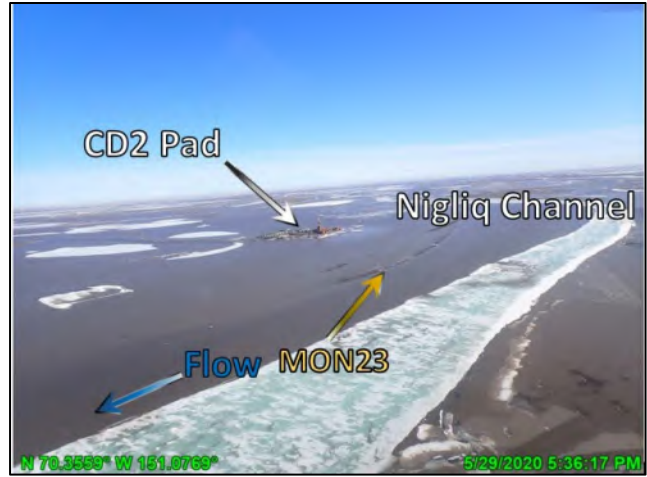
During peak stage, widespread overbank flooding was observed around the CD4 pad, along the CD5 road, and along the CD2 road and pad (Photo 4-16, Photo 4-17, and Photo 4-18). The ice jam near MON22 was observed to still be in place at approximately 5:30 PM on May 29. By May 31, aerial observations confirmed the ice jam near MON22 had cleared, and stage had receded below bankfull (Photo 4-19 and Photo 4-20). Widespread stranded ice was observed near CD2.

Photo 4-16: Widespread overbank flooding in the Nigliq Channel near CD2, looking south (upstream); May 29, 2020

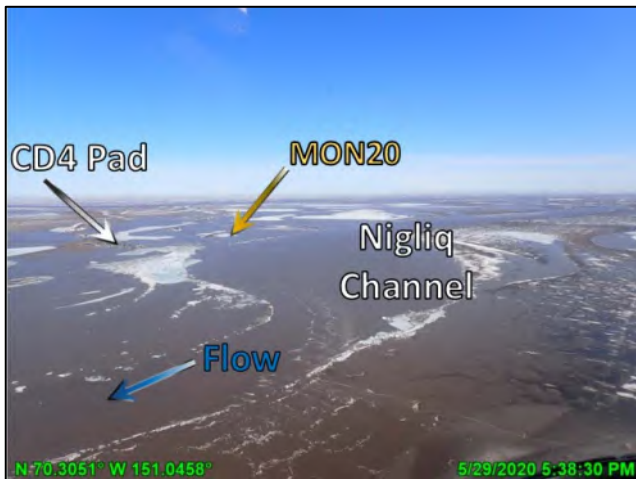
Photo 4-17 Widespread overbank flooding in the Nigliq Channel near CD4, looking southeast (upstream); May 29, 2020

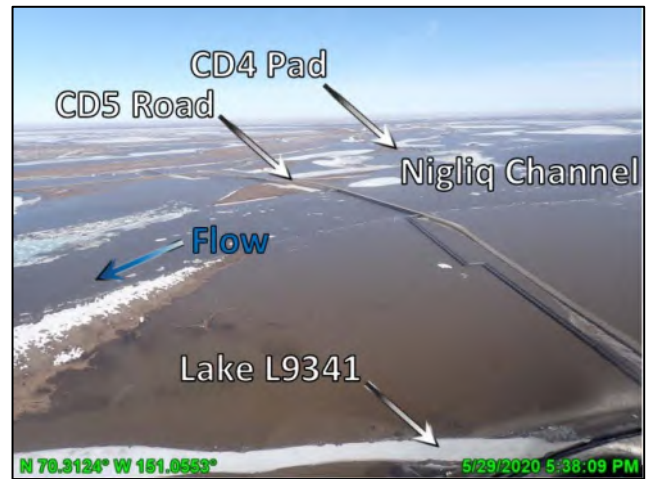
Photo 4-18: Peak Stage along the CD5 road, looking southeast (upstream); May 29, 2020

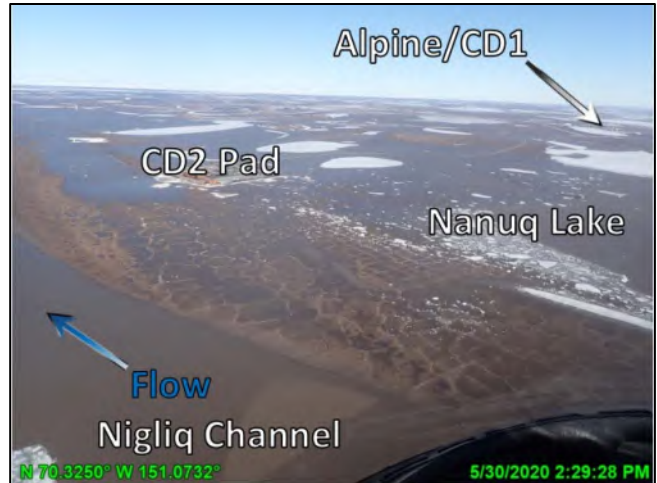
Photo 4-50: Stranded ice on the east bank of the Nigliq channel, looking northeast; May 30, 2020

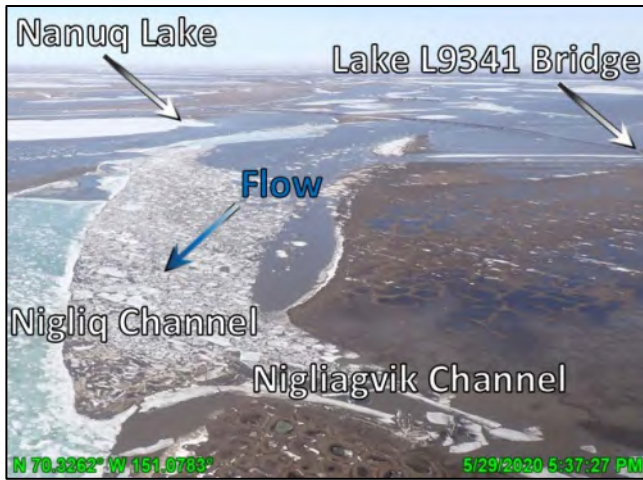
Photo 4-55: L9341 and vicinity near peak stage, looking southeast (upstream); May 29, 2020

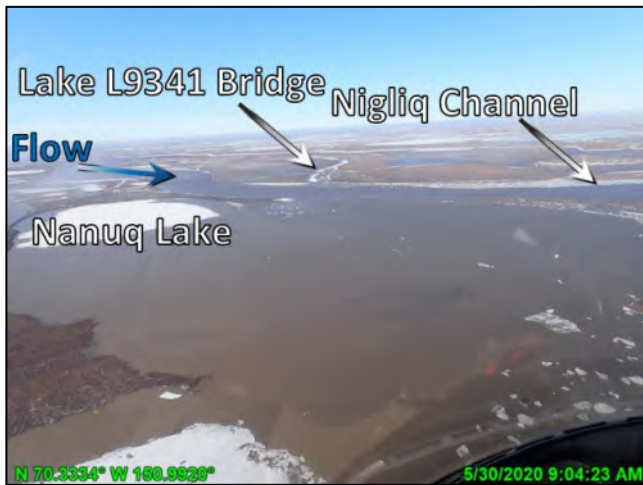
Photo 4-57: Lake L9341 hydraulically connected to Nigliq Channel on north end, looking north (upstream); May 30, 2020

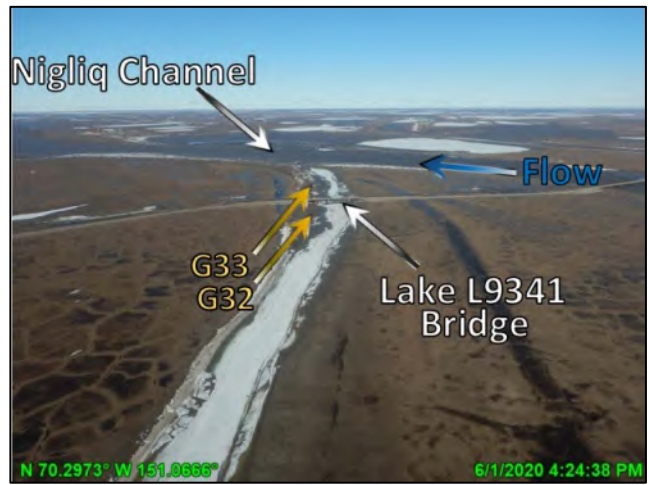
Aerial photographs confirm that intact ice persisted in Lake L9341 throughout breakup and after peak stage. An overflight on June 1 showed ice present in Lake L9341 from the northern confluence with the Nigliq extending south past the bridge crossing (Photo 4-58). The intact ice under the bridge prevented discharge from being measured. Discharge calculations were not performed due to the uncertainties in channel geometry associated with the intact ice.

Photo 4-58: Chanel ice persisting in Lake L9341 after peak, looking north; June 1, 2020

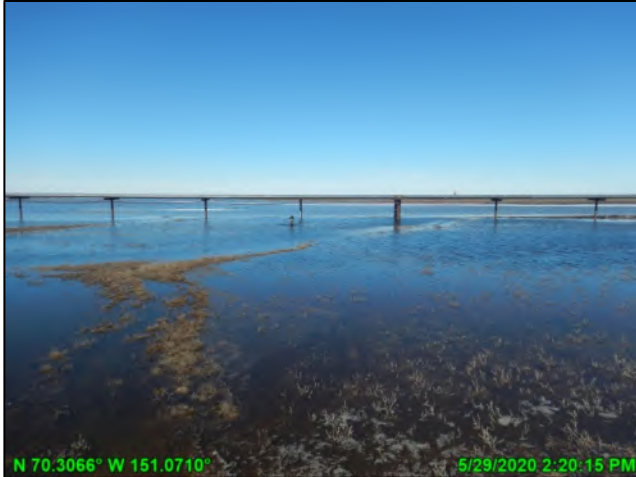
Photo 4-63: Widespread inundation west of the Nigliq channel due to overbank flooding, looking north; May 29, 2020

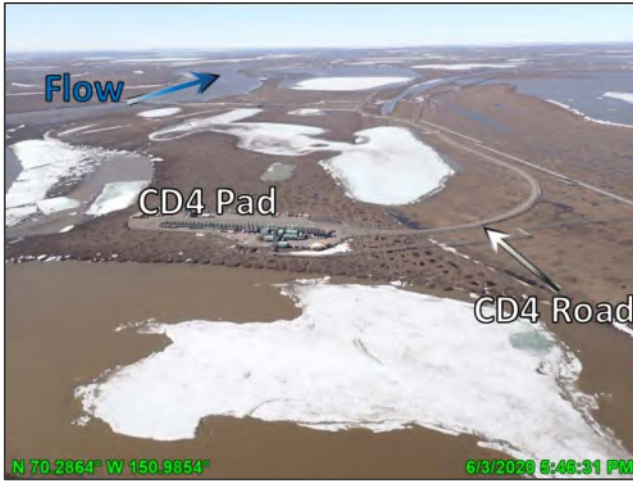
Photo D.13: CD4 pad post-breakup, looking north; June 3, 2020

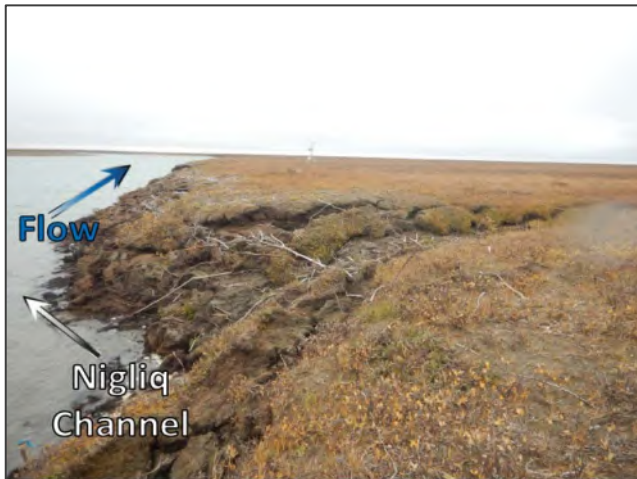
Photo D.23: East bank of Nigliq channel south of CD5 road during fall setup, looking south; September 7, 2020

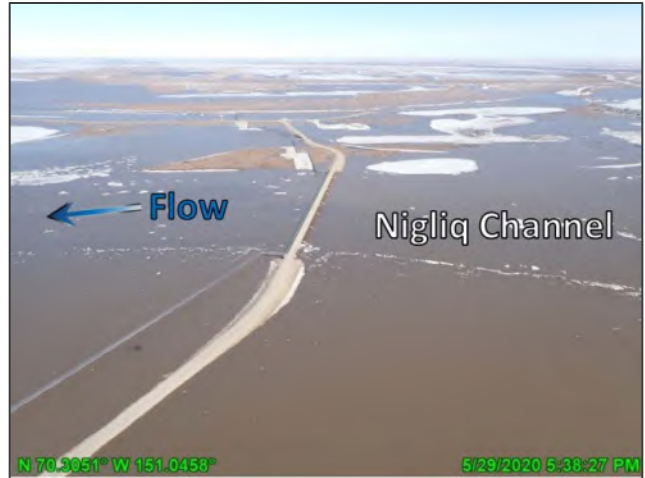
Photo D.30: Peak stage near the Nigliq Channel ice road, looking east; May 29, 2020

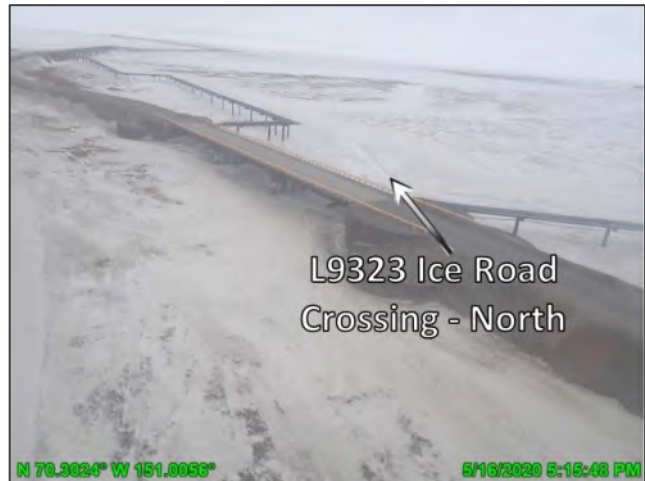
Photo D.32: Pre-breakup near the L9323 ice road crossing-north, looking northwest; May 16, 2020

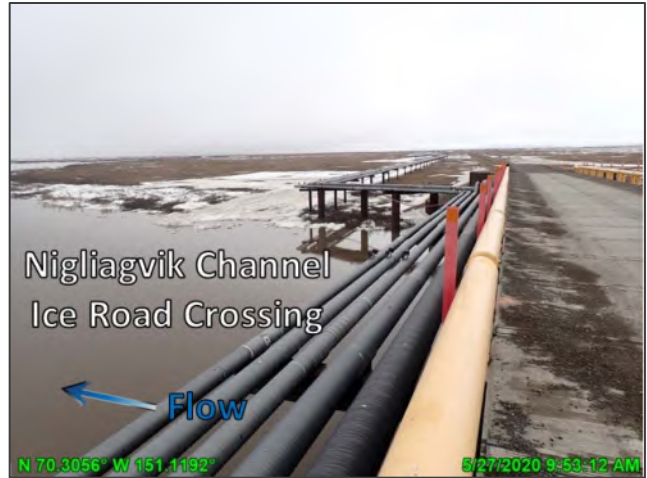
Photo D.35: Meltwater progression at the Nigliagvik ice road crossing, looking east; May 27, 2020

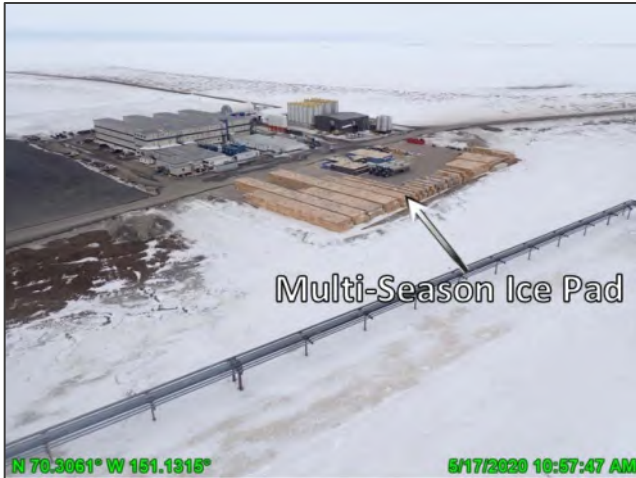
Photo D.38: Pre-breakup conditions at the multi-season ice pad north of K-pad, looking southwest; May 17, 2020

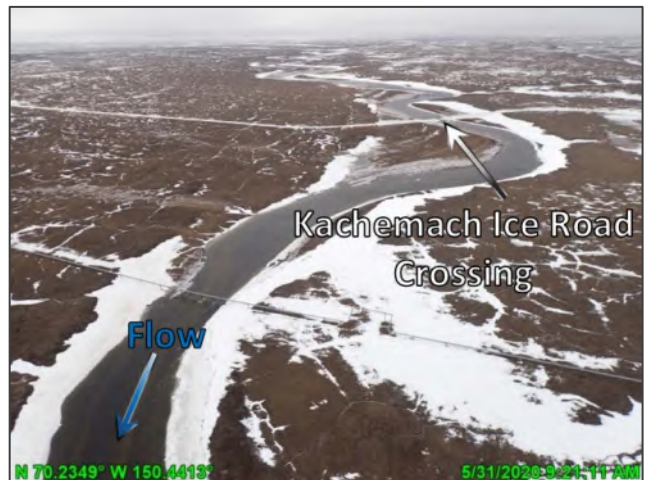
Photo D.41: Peak stage near the slotted Kachemach ice road crossing, looking south (upstream); May 31, 2020

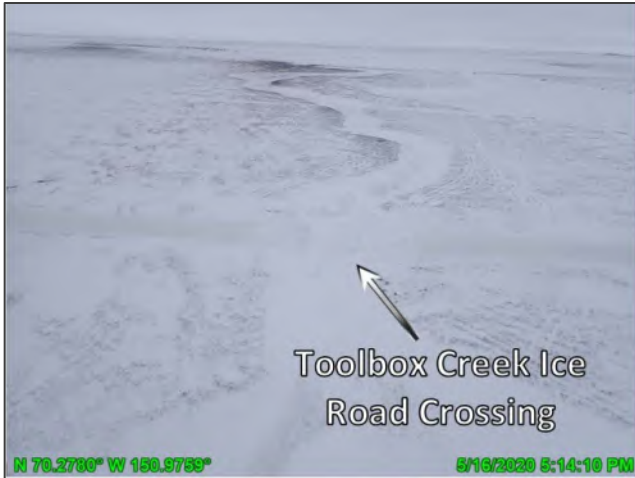
Photo D.45: Pre-breakup conditions at the slotted Toolbox Creek ice road crossing, looking west (downstream); May 16, 2020

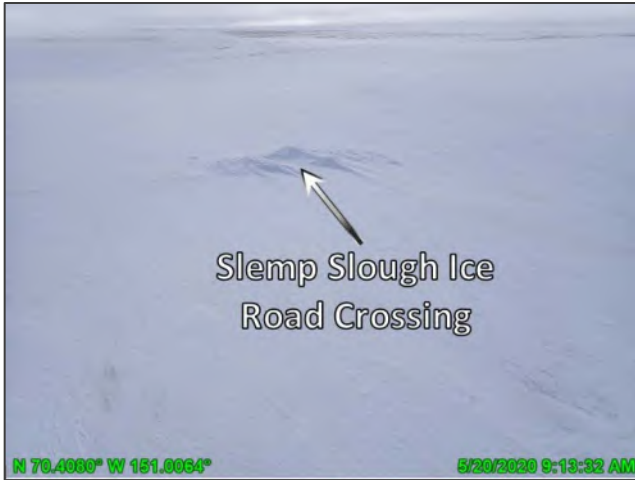
Photo D.48: Pre-breakup conditions at the slotted Slemp Slough ice road crossing, looking north; May 20, 2020

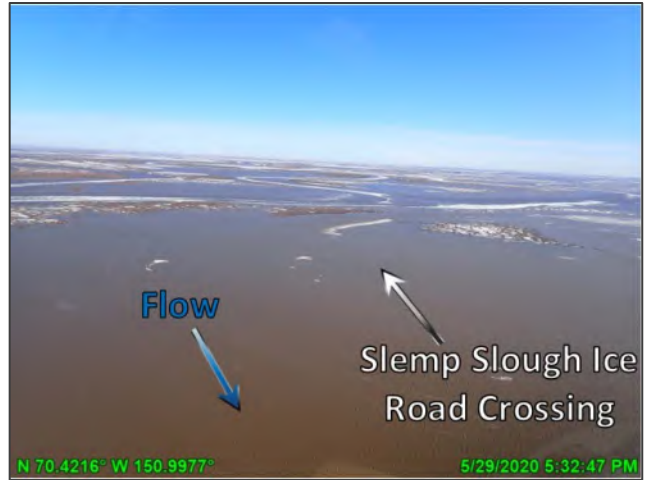
Photo D.49: Peak stage near the Slemp Slough ice road crossing, looking south; May 29, 2020

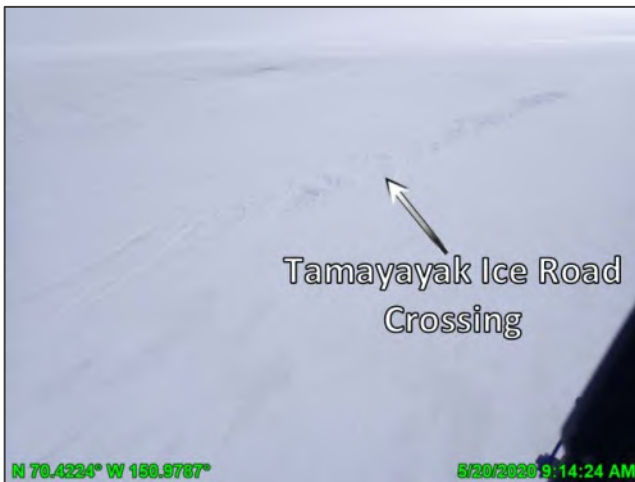
Photo D.50: Pre-breakup conditions at the slotted Tamayayak ice road crossing, looking east; May 20, 2020

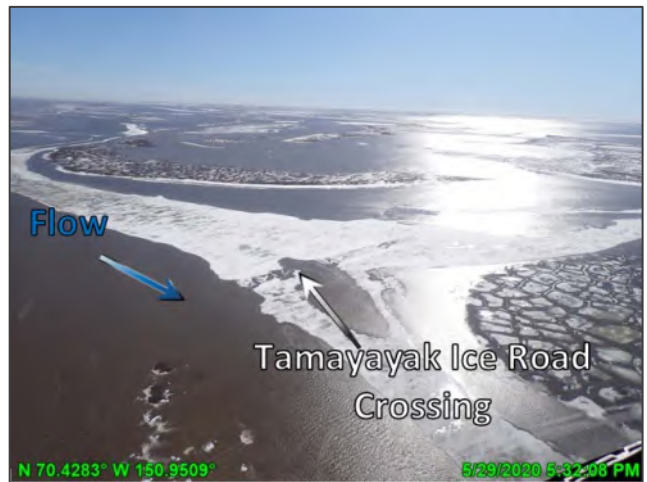
Photo D.51: Peak stage near the slotted Tamayayak ice road crossing, looking southwest (upstream); May 29, 2020

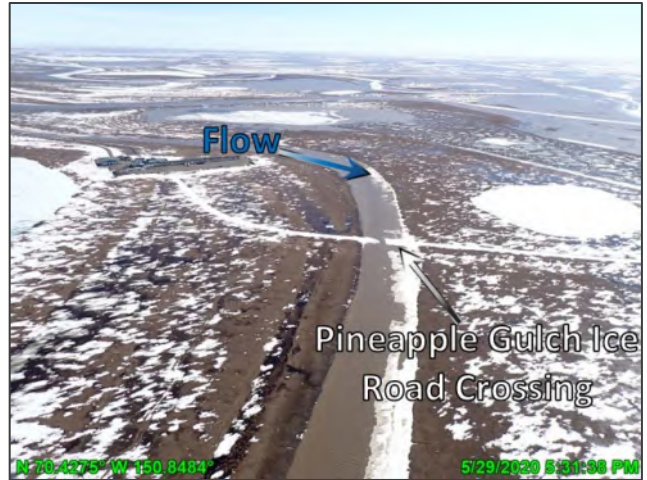
Photo D.53: Peak stage near the Pineapple Gulch (West Ulamniaq Channel) ice road crossing, looking south (upstream); May 29, 2020

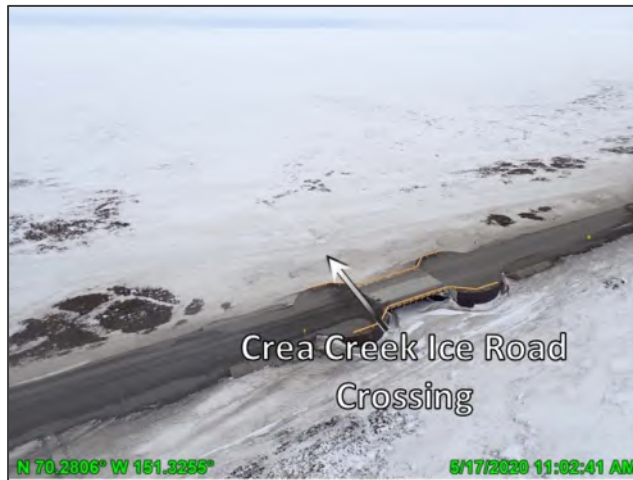
Photo D.54: Pre-breakup conditions at the slotted Crea Creek ice road crossing, looking south; May 17, 2020
