2020 Willow Spring Breakup and Summer Monitoring & Hydrological Assessment - Final

Michael Baker International
3900 C Street Suite 900
Anchorage, AK 99503

ConocoPhillips
Alaska

178179-MBI-HH-RPT-001

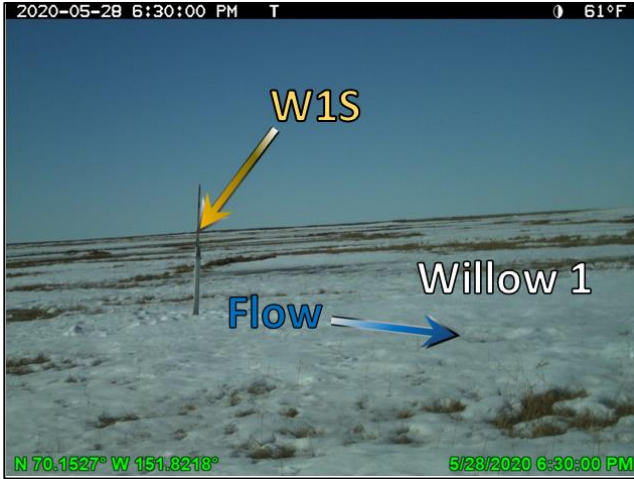
Local melt was first observed through game camera images on May 28 (Photo 4.29). Stage increased until peaking on May 30. During peak, aerial observations show widespread meltwater in the low-lying areas of the drainage system (Photo 4.30). Bottomfast ice and saturated snow were observed in isolated portions of the drainage. The ice road crossing south of the gage station did not appear to impede flow. On May 31, a discharge measurement was attempted but could not be completed due to a lack of measurable flow paths. Direction of flow was south to north (Photo 4.31). After peaking, stage gradually receded. Snow cover on the surrounding tundra was estimated at 10%. By June 4, no flow was observed near the gage station, and local meltwater was confined to pools in low-lying areas (Photo 4.32). Other areas in the drainage not near the gage station appeared to still be hydraulically connected.

Photo 4.29: Initial meltwater at W1S, looking north; May 28, 2020

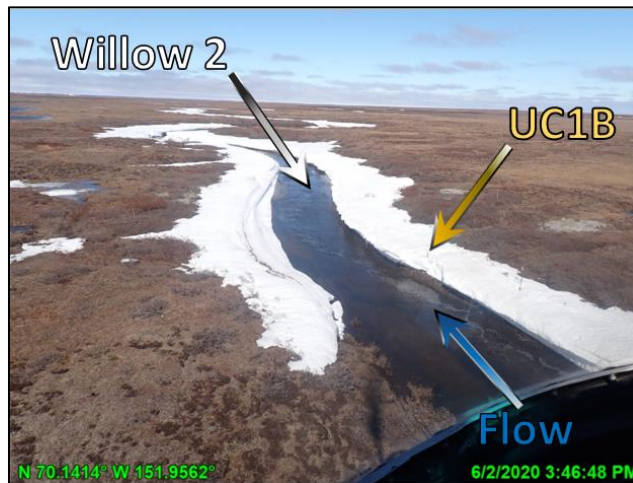
Photo 4.38: Conditions at UC1B on the day of the discharge measurement, looking north (downstream); June 2, 2020

Discharge was measured using a tethered ADCP at UC1B on June 2, approximately 4 days after peak stage. During the measurement, stage was far below bankfull and snow remained along the banks overhanging the channel. The overall quality of the discharge measurement was classified as poor due to the snow and ice in the channel. The moving bed measurement associated with UC1B was negligible and not included as a correction to the overall measurement.

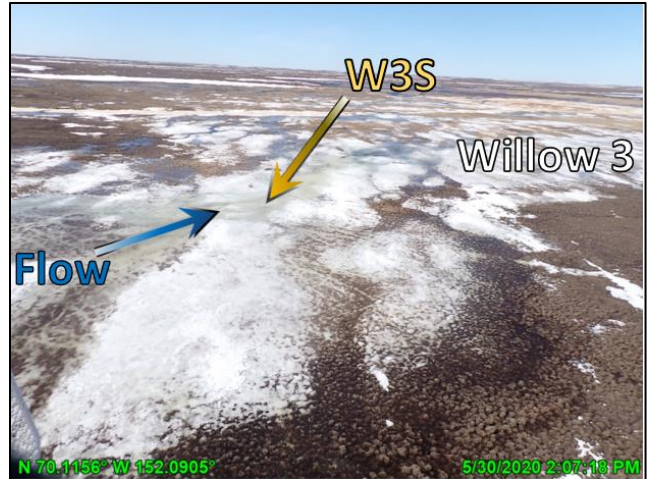
Local melt was first observed in the Willow 3 drainage at W3S on May 27 via game camera images. Peak stage occurred on May 28 and was the result of isolated local melt (Photo 4.40). Local melt increased until May 29 when game camera images suggest flow developed. A site visit on May 30 confirmed S-N flow overtop of saturated snow in the Willow 3 drainage. Aerial observations showed the poorly defined channel filled with saturated snow. Stagnant, local meltwater was accumulating in low-lying pools and polygon troughs near the channel (Photo 4.41). Snow cover on the surrounding tundra was estimated at 10%. On May 31, no flow from Lake M0015/R0056 into W3S was observed. Meltwater in the W3S drainage appeared to be entirely localized (Photo 4.42).

Photo 4.41: Flow overtop of saturated snow at W3S, looking northwest (downstream); May 30, 2020

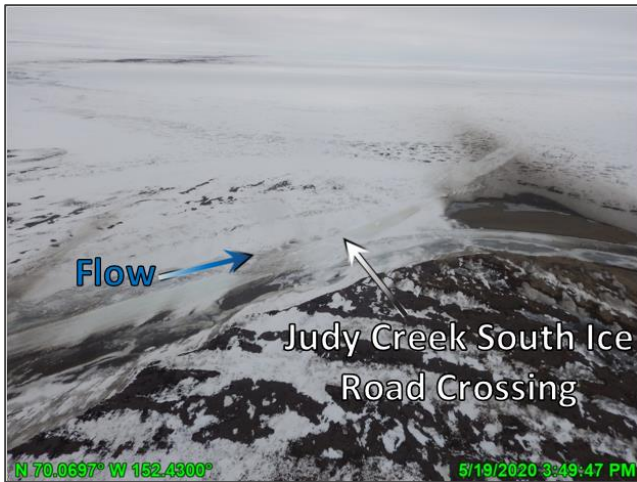
Photo D.3: Pre-breakup conditions at the Judy Creek South ice road crossing, looking west; May 19, 2020

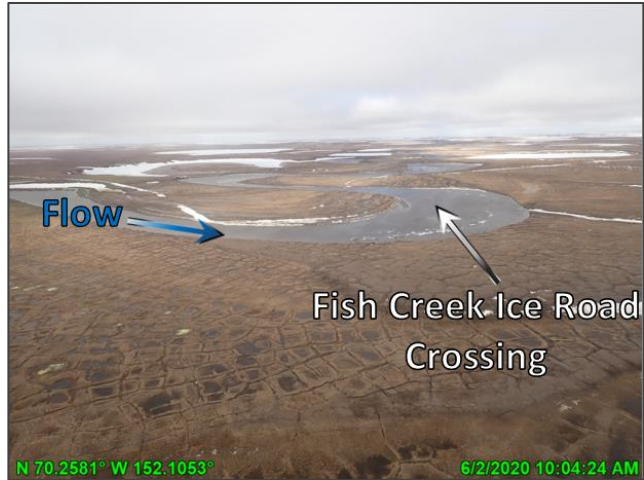
Photo D.6: Post-breakup conditions at the Fish Creek ice road crossing, looking west; June 2, 2020

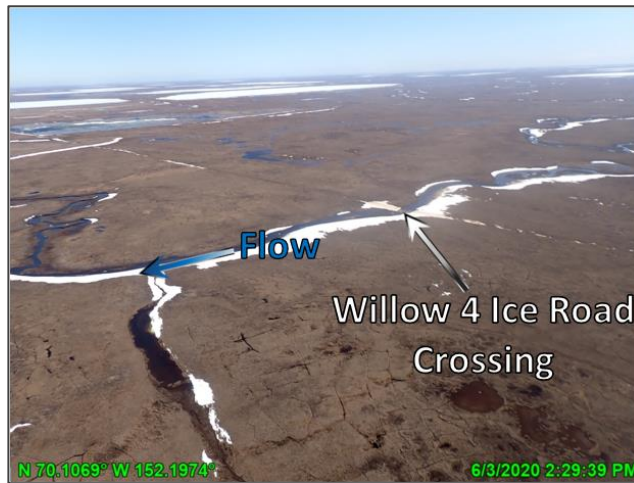
Photo D.11: Post-breakup conditions at the Willow 4 ice road crossing, looking east; June 3, 2020

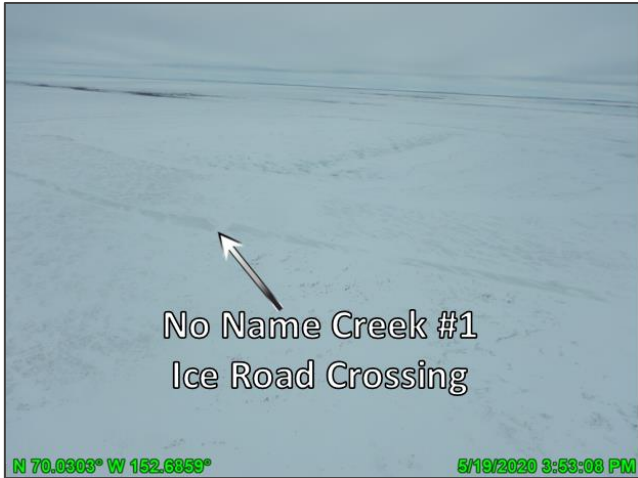
Photo D.12: Pre-breakup conditions at the slotted No Name Creek #1 ice road crossing, looking southeast; May 19, 2020

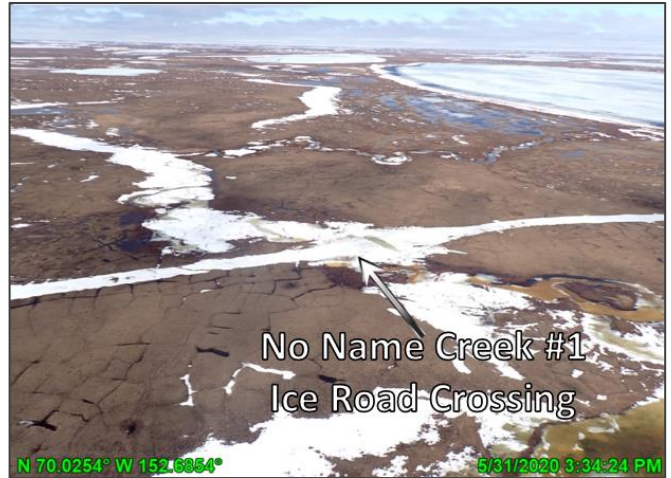
Photo D.13: Breakup conditions at the No Name Creek #1 ice road crossing, looking north (downstream); May 31, 2020

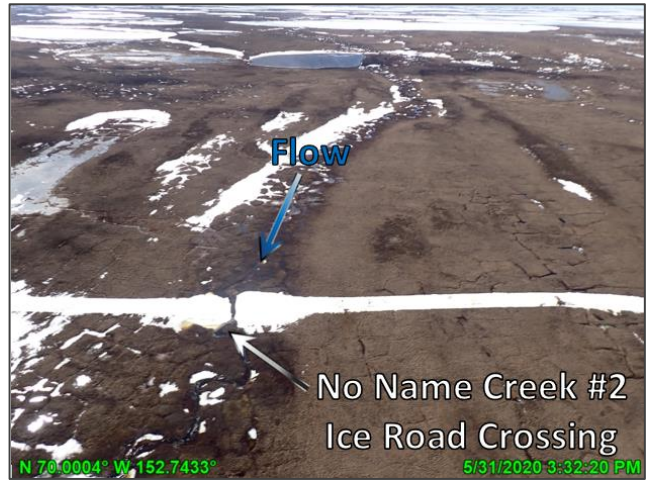
Photo D.15: Breakup conditions at the No Name Creek #2 ice road crossing, looking west (upstream); May 31, 2020

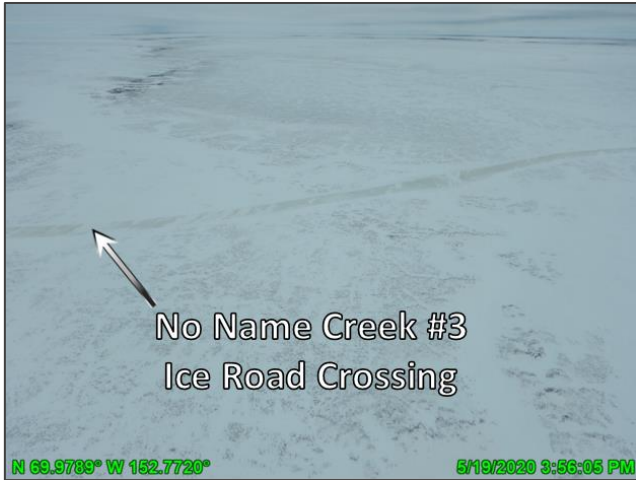
Photo D.16: Pre-breakup conditions at the slotted No Name Creek #3 ice road crossing, looking southeast; May 19, 2020

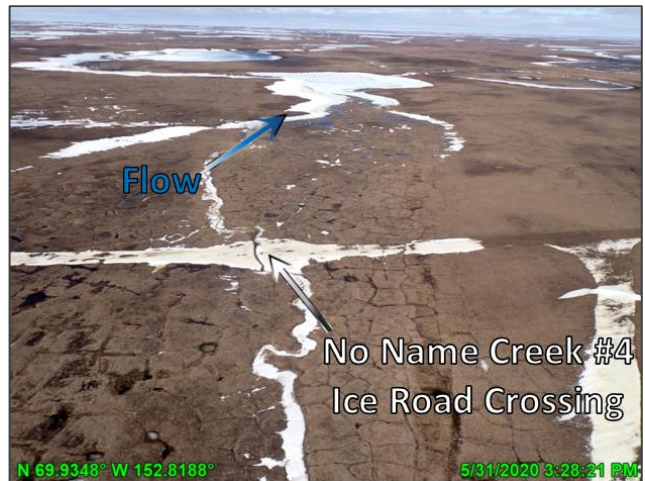
Photo D.19: Breakup conditions at the No Name Creek #4 ice road crossing, looking north (downstream); May 31, 2020

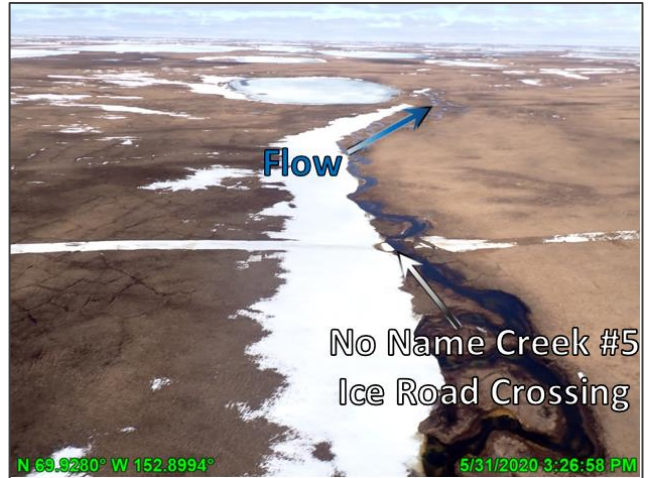
Photo D.21: Breakup conditions at the No Name Creek #5 ice road crossing, looking north (downstream); May 31, 2020

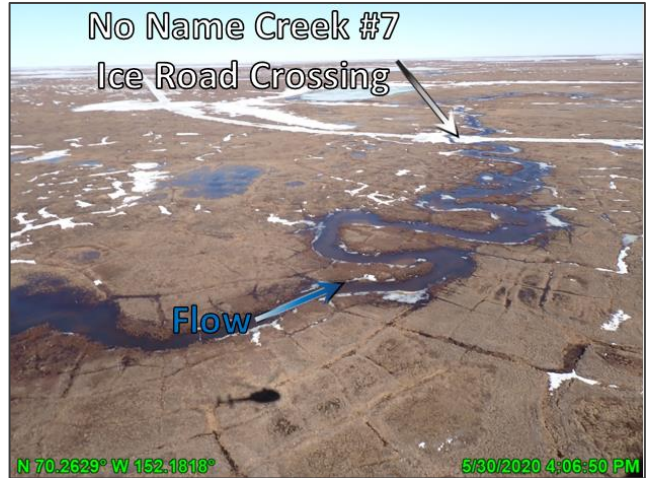
Photo D.25: Breakup progression at the No Name Creek #7 ice road crossing, looking northeast (downstream); May 30, 2020

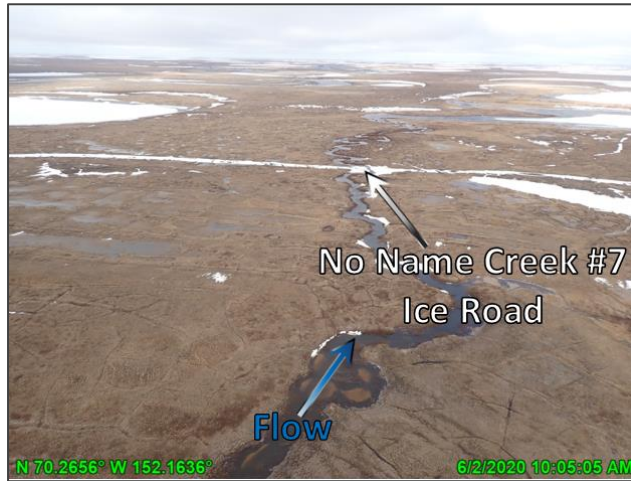
Photo D.26: Post-breakup conditions at the No Name Creek #7 ice road crossing, looking west; June 2, 2020
