# Colville River Delta

Spring Breakup Monitoring &  
Hydrological Assessment

# 2021

**Michael Baker**

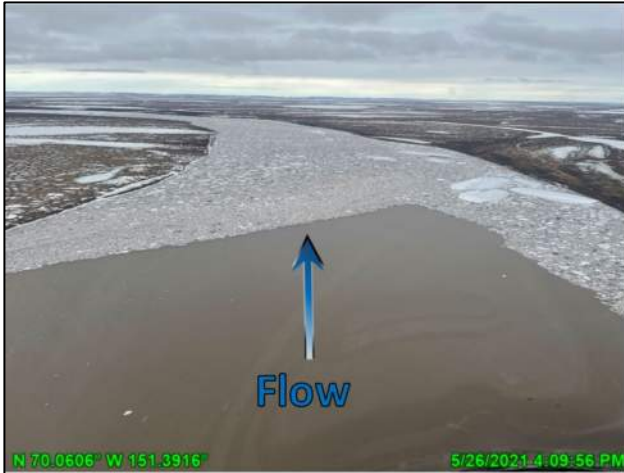
On May 26, an ice jam approximately 4 river miles (RM) long had formed downstream of Ocean Point (Photo 3.3). Adjacent sandbars were submerged but stage remained below bankfull. Downstream of the Ocean Point ice jam, the channel was free of ice until the Horseshoe Bend, where a second small ice jam had formed, approximately 2 RM long (Photo 3.4). This ice jam was held by intact channel ice which continued downstream. Another small ice jam was observed at the Nigliq Channel bifurcation, just upstream of Nuiqsut. The hydraulic connection between the Nigliq and Sakoonang Channels had formed through Lake L9324, south of CD4. By May 27, the initial rise in stage in the CRD and around Alpine facilities crested and began to decrease as temperatures cooled.

Photo 3.3: Colville River ice jam immediately downstream of Ocean Point, looking southeast (downstream); May 26, 2021

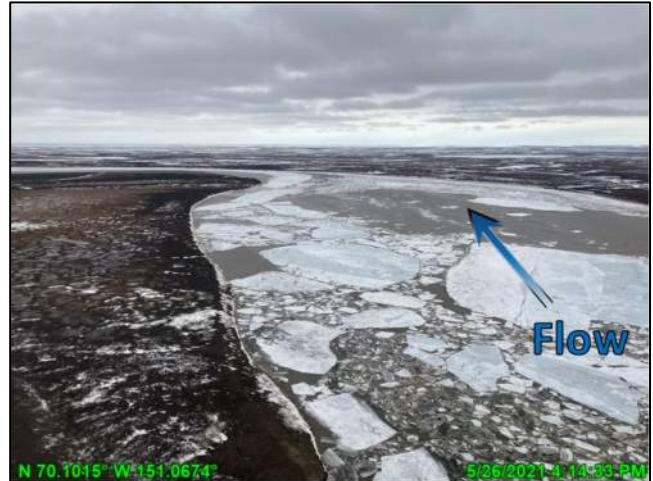
Photo 3.4: Colville River ice jam at the Horseshoe Bend, looking east (downstream); May 26, 2021

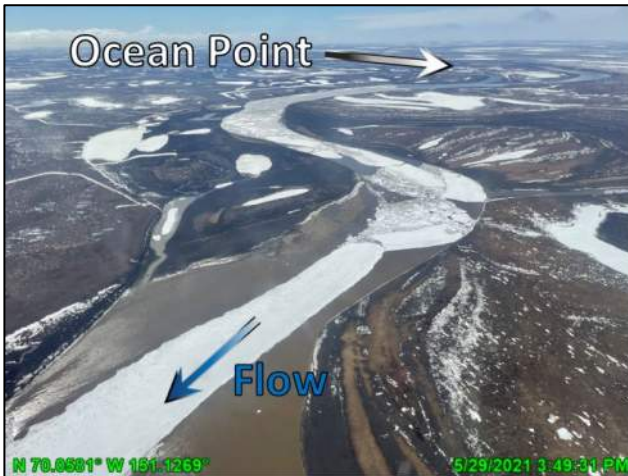
On a May 28 reconnaissance flight approximately 15 RM upstream of Ocean Point, a considerable amount of stranded ice was observed, indicating stage had receded. Water levels in the CRD were also still receding. On May 29, field crews observed the Ocean Point ice jam had not progressed and was now approximately 6 RM long (Photo 3.5). The Horseshoe Bend ice jam remained unchanged from previous days. By May 31, receding stage around Alpine facilities leveled off as floodwater continued to slowly move through the delta. These conditions remained consistent until June 4, when stage began to rise at Umiat. On June 5, both the Ocean Point and Horseshoe Bend ice jams cleared as a result of the rising water levels (Photo 3.6). Periodic ice floes were observed moving through the Horseshoe Bend with intact channel ice generally starting just downstream. By June 6, channel ice had cleared the MON1 reach and stage began to rise around Alpine facilities. Peak stage at MON1 occurred the afternoon of June 6. Intact channel ice was observed at the HDD crossing (Photo 3.7). The gage at Umiat crested in the evening of June 6. Despite rising stage, sandbars were still exposed and water remained below bankfull with no overbank flooding observed (Photo 3.8).

Photo 3.5: Extent of Colville River ice jam immediately downstream of Ocean Point, looking southwest (upstream); May 29, 2021

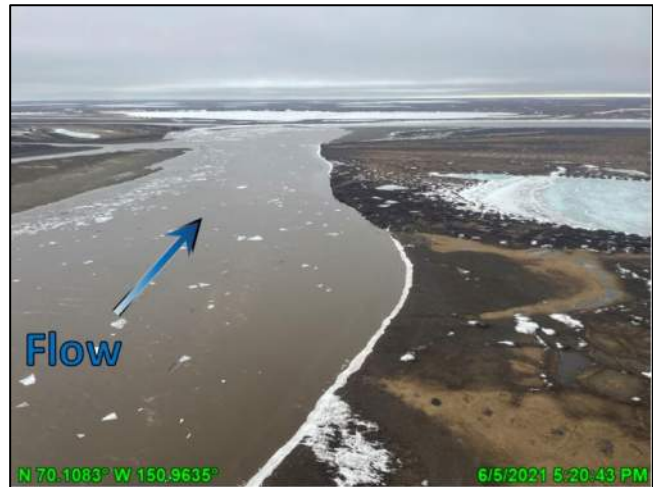
Photo 3.6: Open water conditions with periodic ice floes on the Colville River at Horseshoe Bend after both ice jams cleared, looking northwest (downstream); June 5, 2021

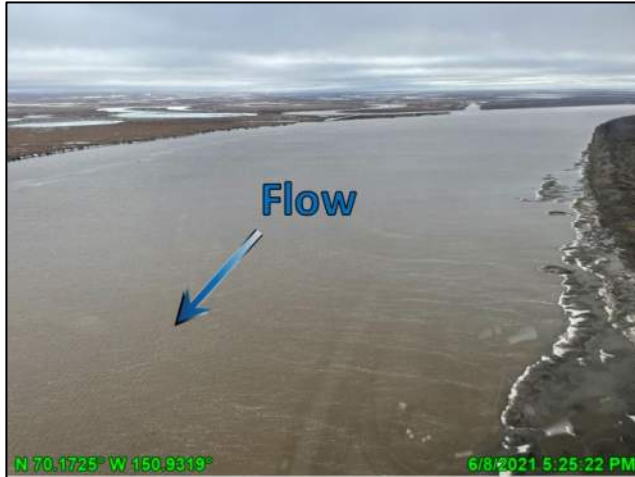
**Photo 3.11: Open water conditions with decreasing stage at the MON1 reach, looking south (upstream); June 8, 2021**

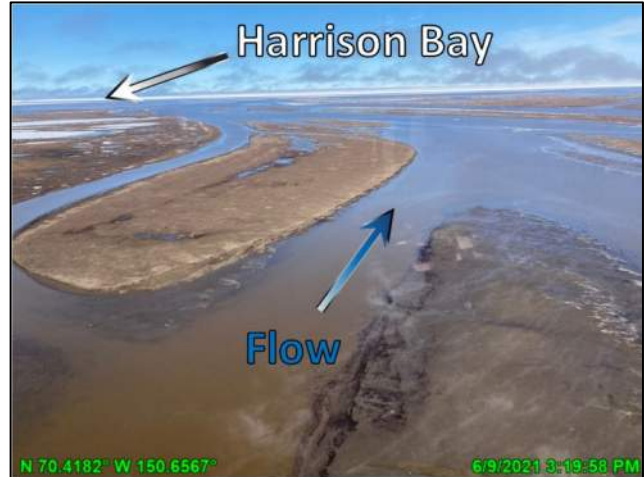
**Photo 3.12: Ice-free channel extending to the coast in the Colville River Delta distributary channels, looking north (downstream); June 9, 2021**

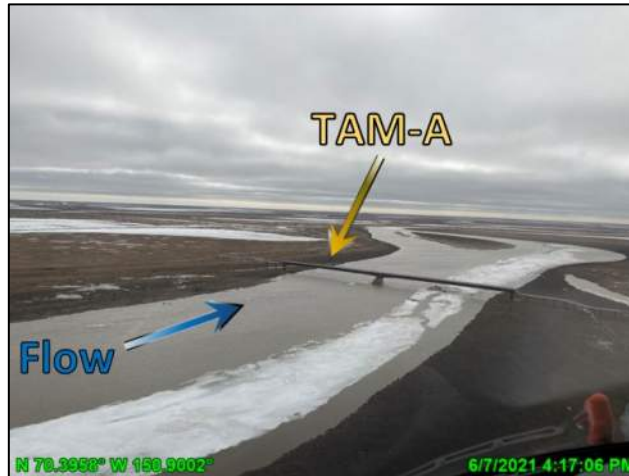
Photo 4.35: Fractured channel ice in the Tamayayak Channel during peak stage, looking northwest; June 7, 2021

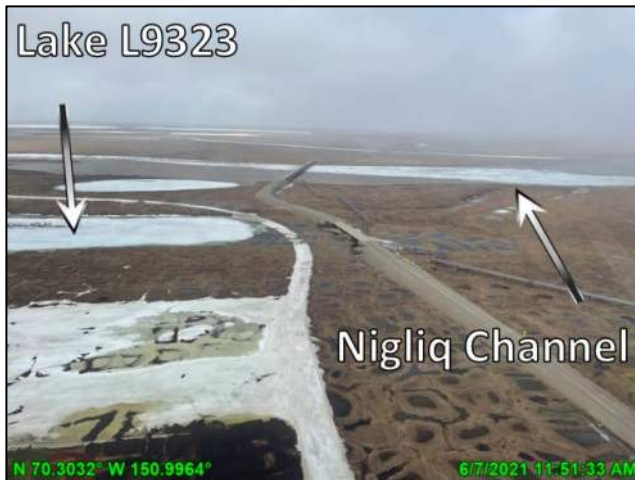
Photo 4.44: Lake L9323 hydraulically disconnected from Nigliq Channel, looking west; June 7, 2021

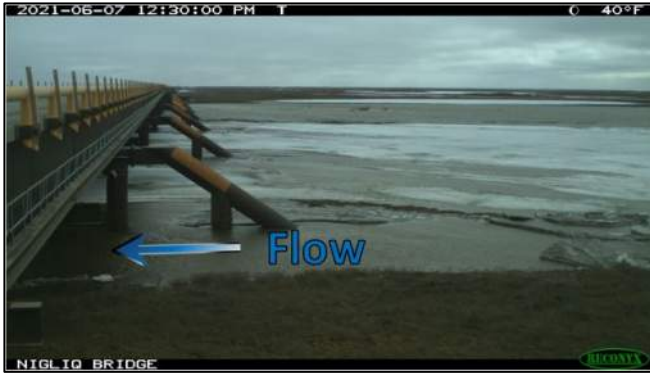
Photo 4.50: Peak conditions from the game camera on the Nigliq Bridge, looking east; June 7, 2021

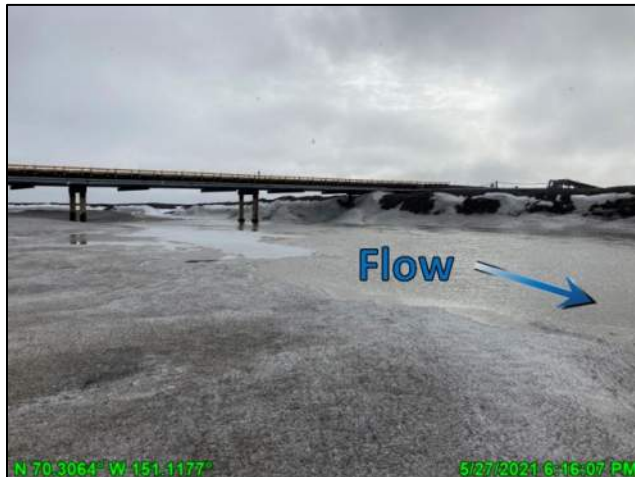
Photo 4.56: Local melt over saturated snow in the Nigliagvik Channel, looking south; May 27, 2021

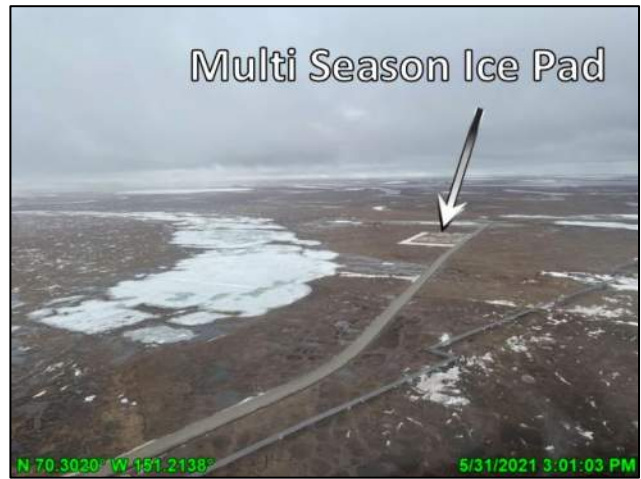
Photo 4.63: CD5 road near multi season ice pad, looking east; May 31, 2021

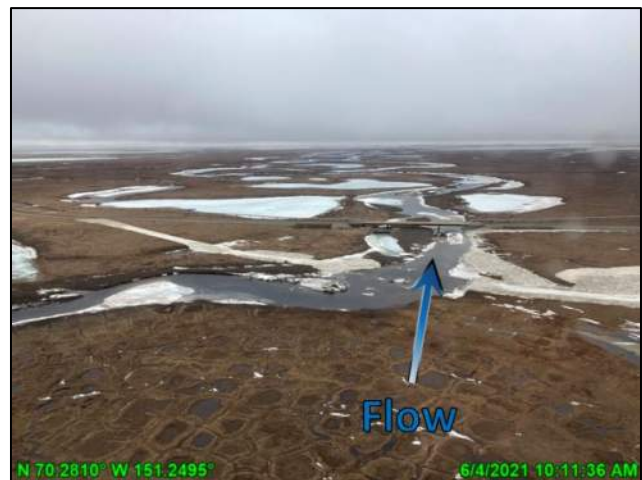
Photo 4.65: Receding stage with saturated snow and ice persisting, looking north (downstream); June 4, 2021

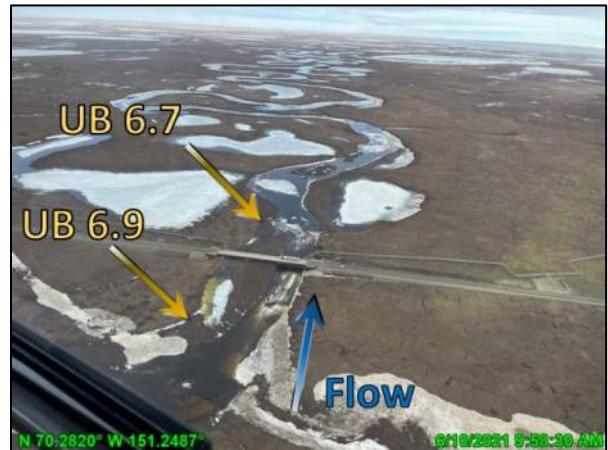
Photo 4.67 Flyover of Tinmiaqsiugvik River showing persisting snow throughout the monitoring period, looking north (downstream); June 10, 2021

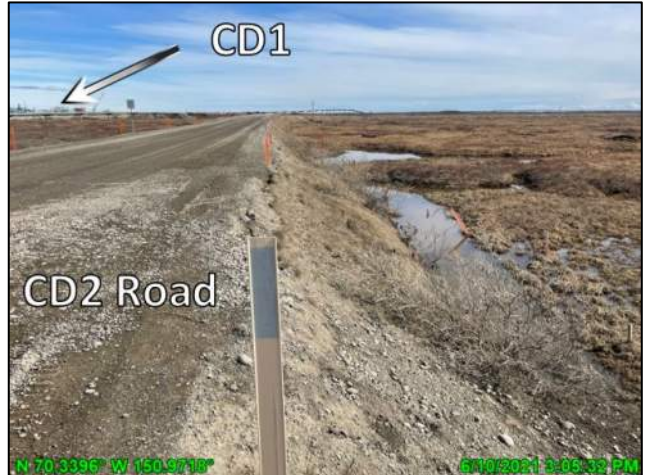
Alpine roads and pads were inspected for erosion on June 9 and June 10. Washlines were noted on the north side of the CD2 road between the long and short swale bridge; however, vegetation under the washlines suggest this was from flood events prior to 2021, likely from 2015. Photo 5.1 through Photo 5.4 shows the CD2 and CD4 road, after stage had receded. No discernable erosion directly attributable to 2021 breakup flooding was observed during aerial and ground reconnaissance of the CD2, CD4, and CD5 roads. Floodwaters did not reach any of the CD5 bridge abutments, and no discernable erosion was observed along the abutments. Washlines from 2015 spring breakup, which was the largest historical flood event to impact Alpine facilities, remain evident along portions of the CD2, CD4, and CD5 roads. There were no signs of sloughing or undermining at drainage structures.

Photo 5.2: CD2 road post-breakup, looking southeast; June 10, 2021

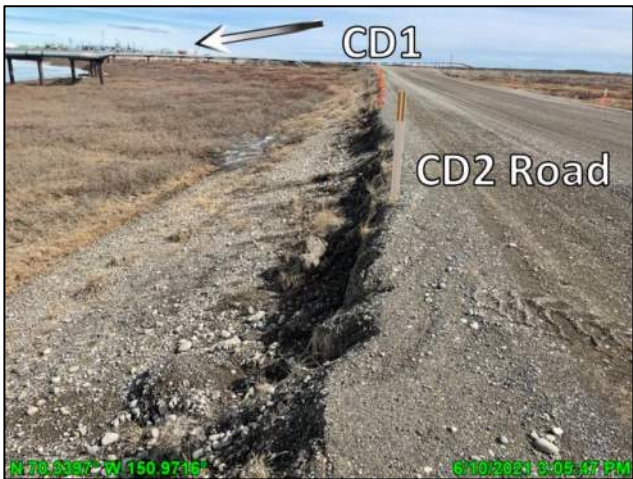
Photo 5.3: CD2 road post-breakup, looking southeast; June 10, 2021

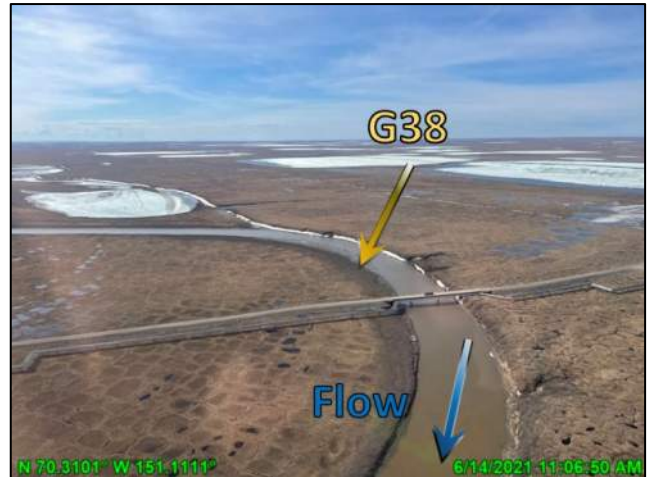
Aerial photos taken post breakup showing no apparent channel migration of the Nigliq and Nigliagvik Channels and are presented in Photo 6.3 and Photo 6.4, respectively. A bank erosion survey upstream and downstream of the Nigliq and Nigliagvik Bridges was performed on August 12. Site conditions during the bank erosion survey at the Nigliq Bridge are presented in Photo 6.5 and Photo 6.6, respectively. Maximum incremental and cumulative erosion at the Nigliq Bridge and Nigliagvik Bridge and maximum incremental, maximum cumulative, and average erosion along the top of bank, upstream and downstream of the bridges, are presented in Table 6.3. Bank erosion tabulated data from the bank erosion survey is presented in Appendix E (UMIAQ 2021).

Photo 6.4: Nigliagvik Channel post breakup showing no channel migration, looking southwest; June 14, 2021

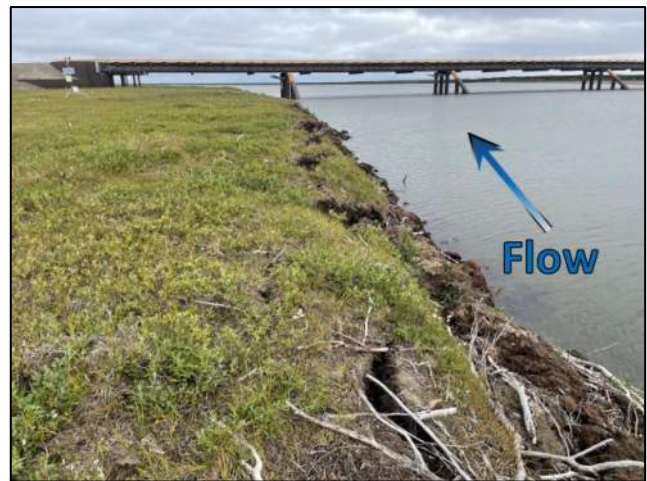
Photo 6.6: West bank of the Nigliq Channel south of the Nigliq Bridge, looking north; August 12, 2021
