# Colville River Delta 2014 Spring Breakup Field Report

**ConocoPhillips**

Michael Baker Jr., Inc.  
3900 C Street, Suite 900  
Anchorage, AK 99503

7/16/2014

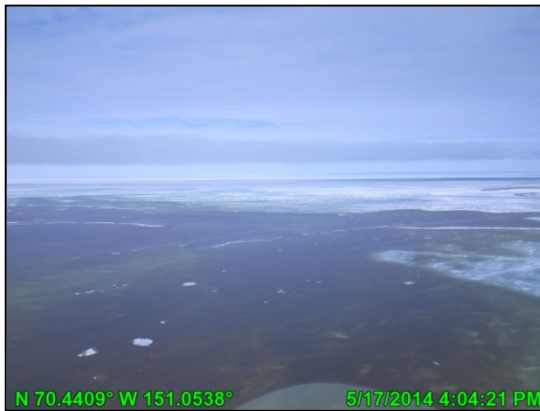
Following gage setup, field personnel initiated reconnaissance flights upstream of MON1 on the Colville River on May 10. On May 13, the leading edge of the melt water in the Colville River was observed approximately 9 miles downstream of Ocean Point. By May 15, the leading edge was in the Colville East Channel between the Sakoonang bifurcation and the Kachemach confluence. On May 17, the Miluveach and Kachemach Rivers had substantial flow and were mostly clear of snow and ice. Water levels were slowly increasing in the Colville East Channel, and the Nigliq Channel was connected to the Nanuq Lake basin. However, no flow was observed through the CD2 road swale bridges. Overflow was observed on the coastal shorefast ice (Photo 3).

**Photo 3: Overflow on coastal shorefast ice; May 17, 2014**

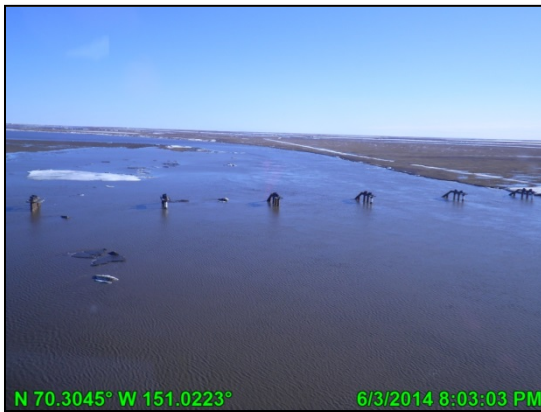
Intact channel ice was present at the Nigliq Channel crossing on May 22 and 31 (Photo 18 and Photo 19), and open water conditions were observed by June 3 (Photo 20 and Photo 21). No flow was observed through the CD5 road culverts; some areas had ponded water. No water was observed around the multi-season ice pad or other CD5 pads throughout the monitoring period (Photo 22). A direct discharge measurement was collected downstream of the Nigliq Channel crossing on June 5.

**Photo 20: Nigliq Channel looking upstream; June 3,  
2014**

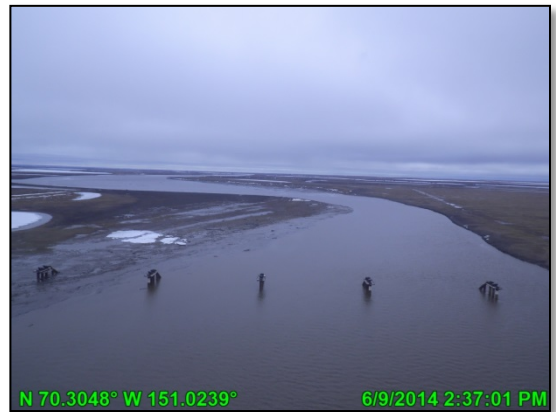
**Photo 21: Nigliq Channel crossing looking  
upstream; June 9, 2014**

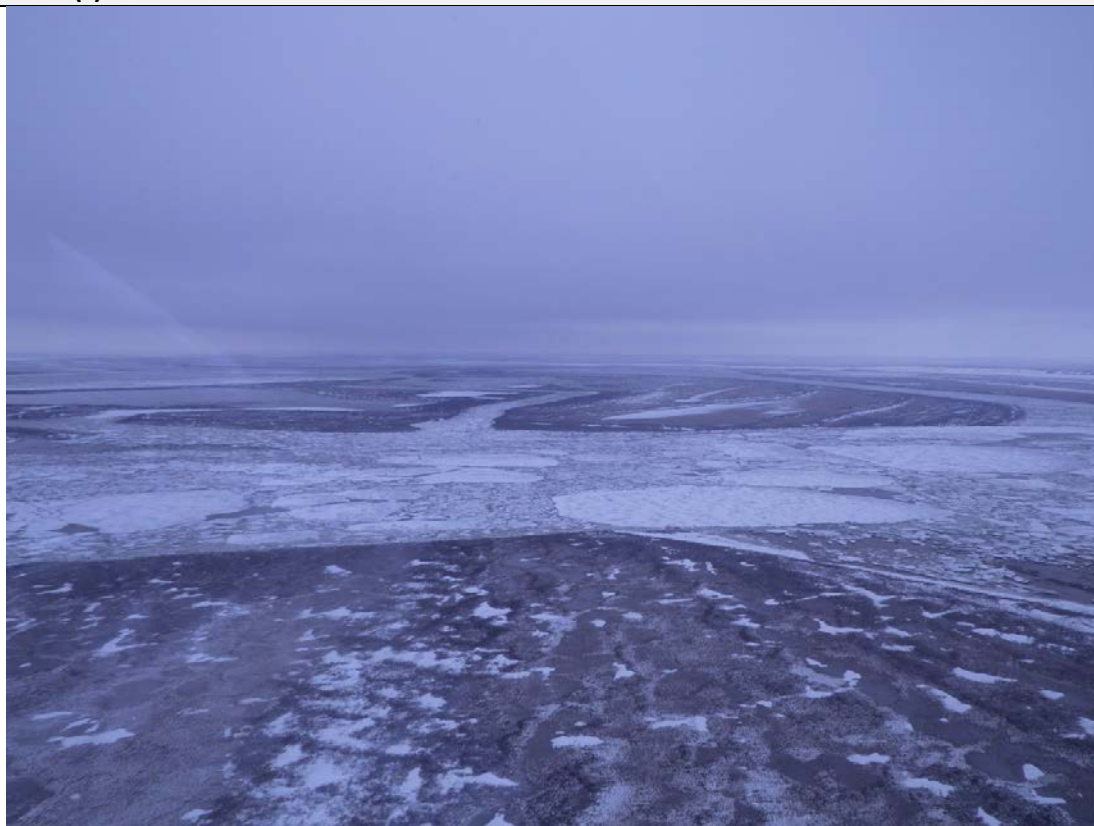
<b>Summary of Events:</b>			
The long swale bridge and a few culverts along the CD2 road are transmitting water with local melt at the short swale bridge. An ice jam was located north of Ocean Point with overbank flooding behind the jam. Intact channel ice was preventing the release of the jam. The Nigliq and East channels were flowing. Readings were collected at the MON1, MON9, MON9D, and MON20 gages. The water surface elevation at MON1 was 14.25 feet BPMSL. Crew member, Garrett Thatcher, arrived at Alpine.			
<b>Challenges:</b>			
None			
<b>Comments:</b>			
The Nigliq Channel flow continues to enter the Nanuq Lake basin. Competent channel ice remains in all channels at this time.			
<b>Planned for Next Field Day:</b>			
The crew plans to continue monitoring gages throughout the delta and around facilities.

Photo 1: Ice jam downstream of Ocean Point looking upstream; May 19, 2014

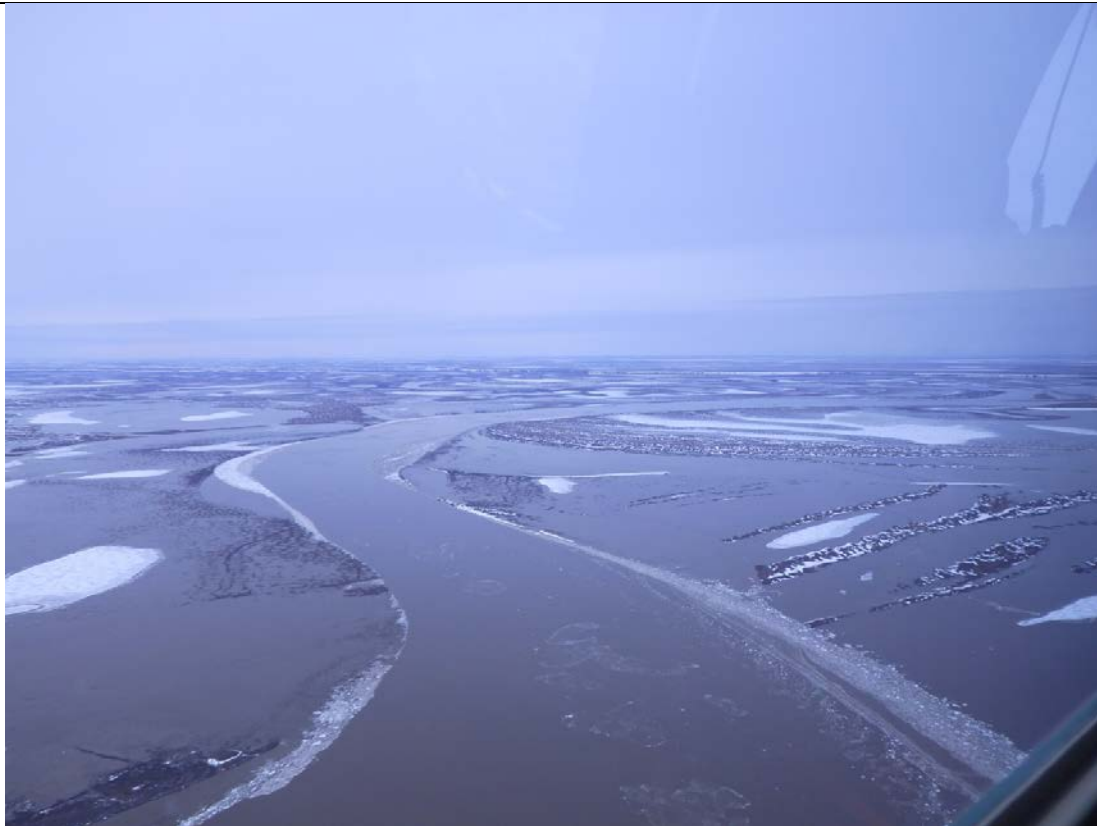
**Photo 3: Overbank flooding upstream of ice jam; May 20, 2014**

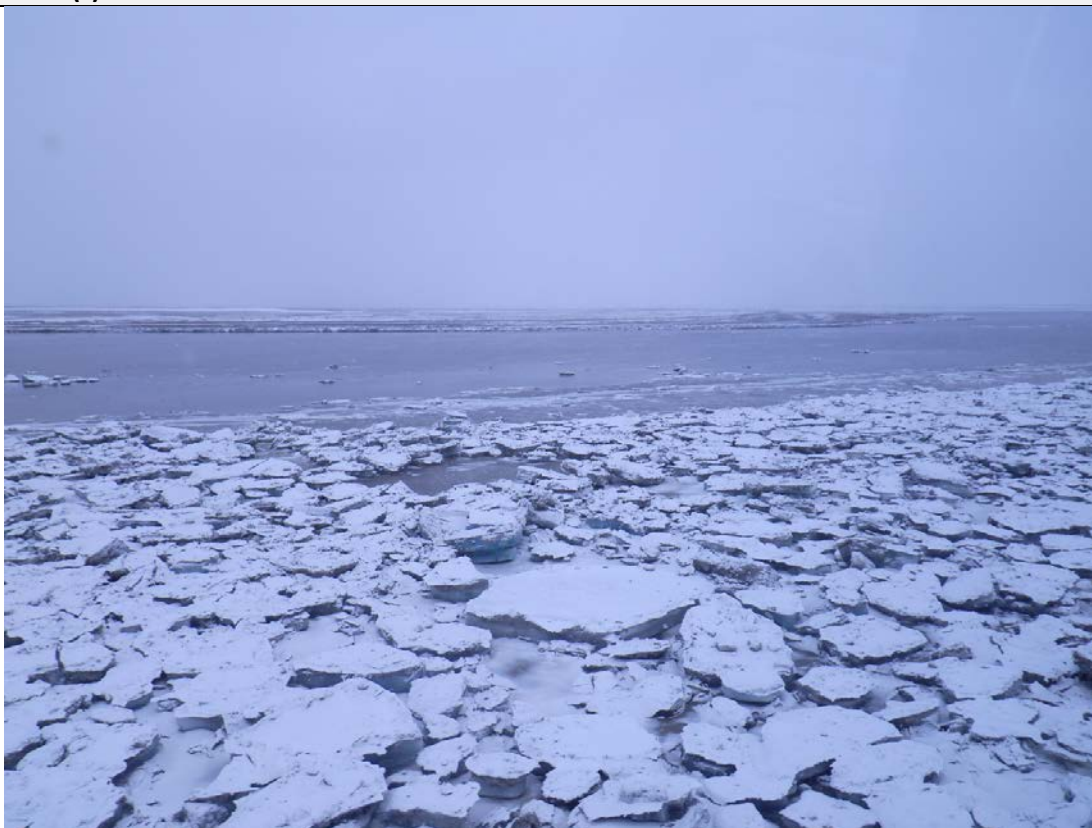
Photo 1: Stranded and rafted ice on shoals within ice jam upstream of MON1; May 23, 2014

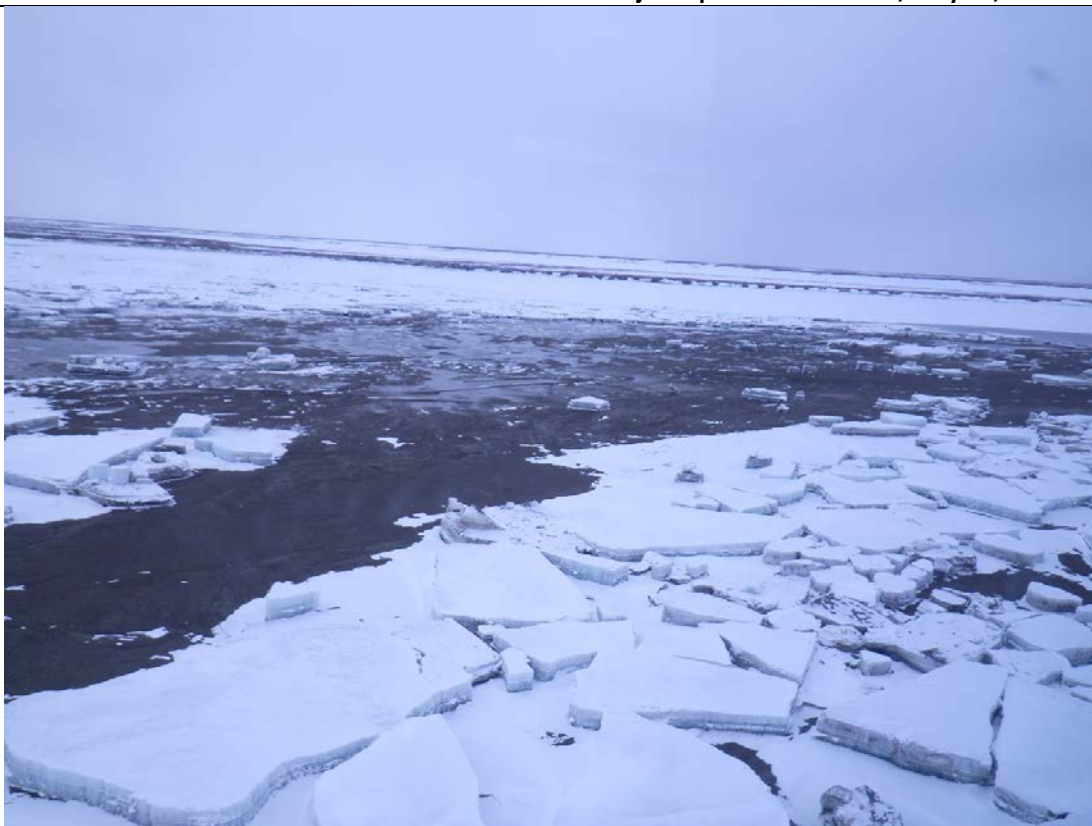
Photo 2: Stranded ice on shoals within ice jam upstream of MON1; May 23, 2014

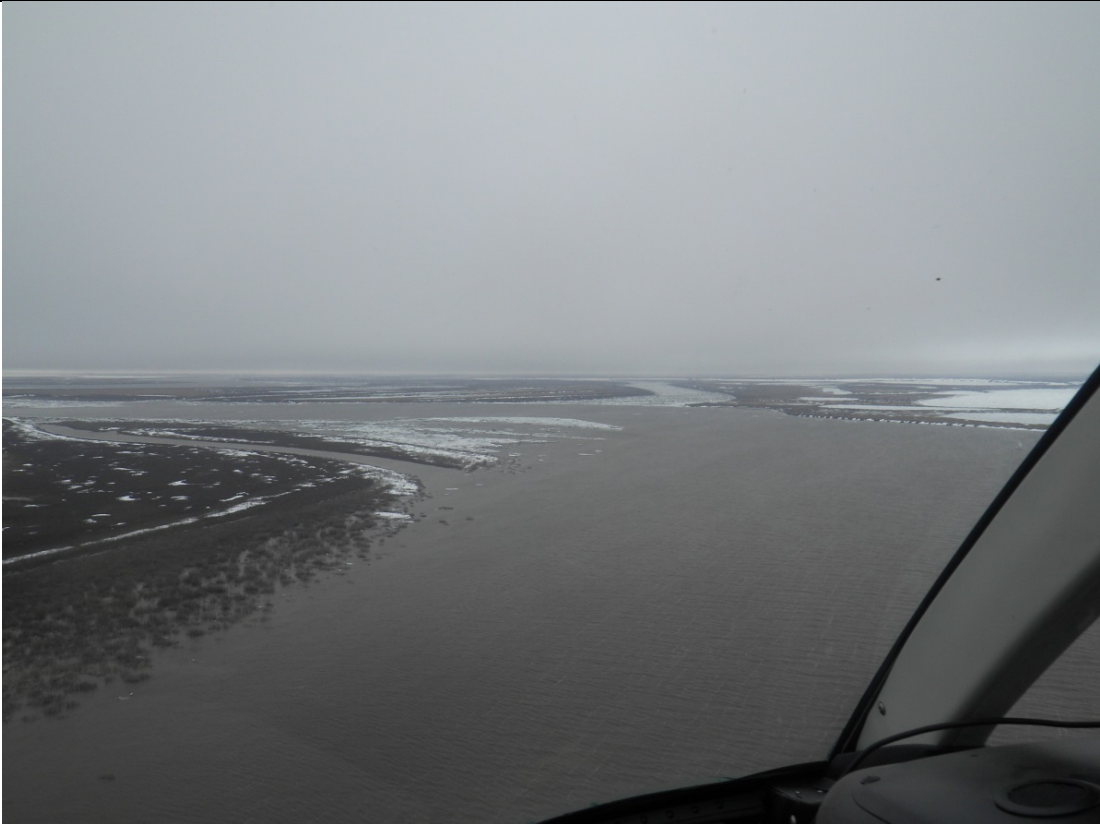
Photo 3: Previous location of ice jam upstream of MON1; May 30, 2014

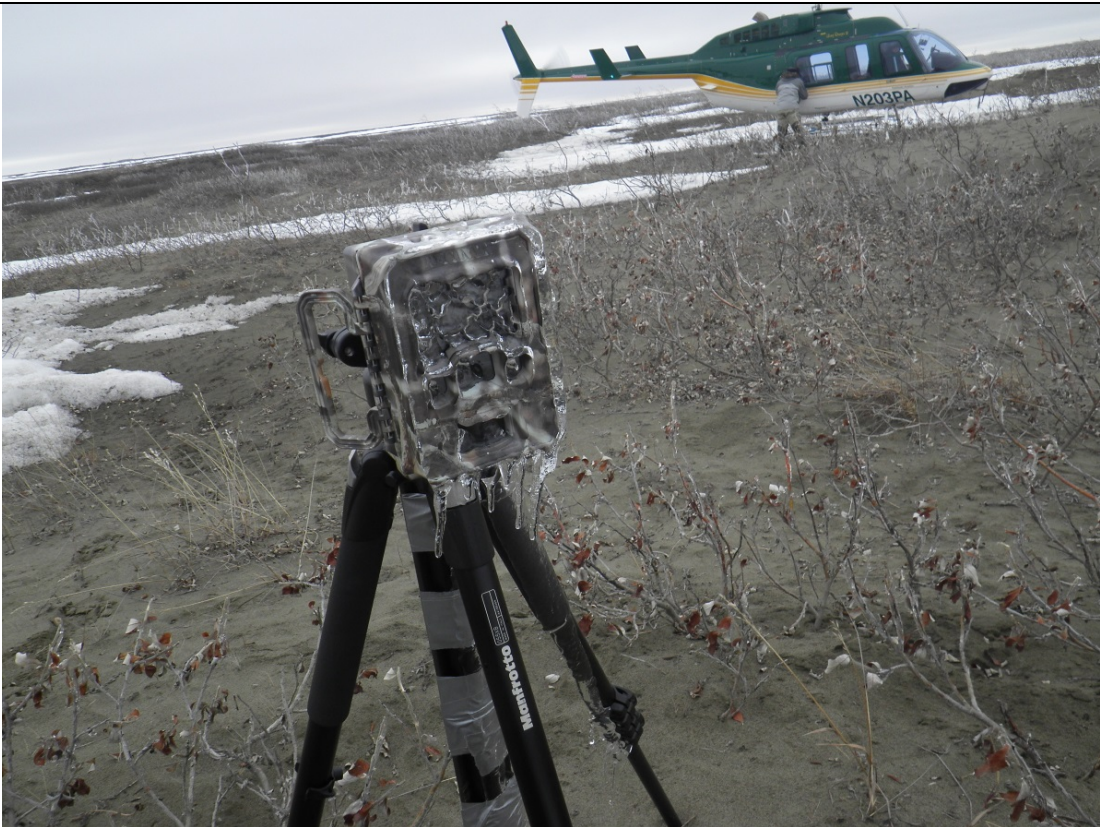
Photo 4: Frozen rain on time lapse camera at MON1; May 30, 2014

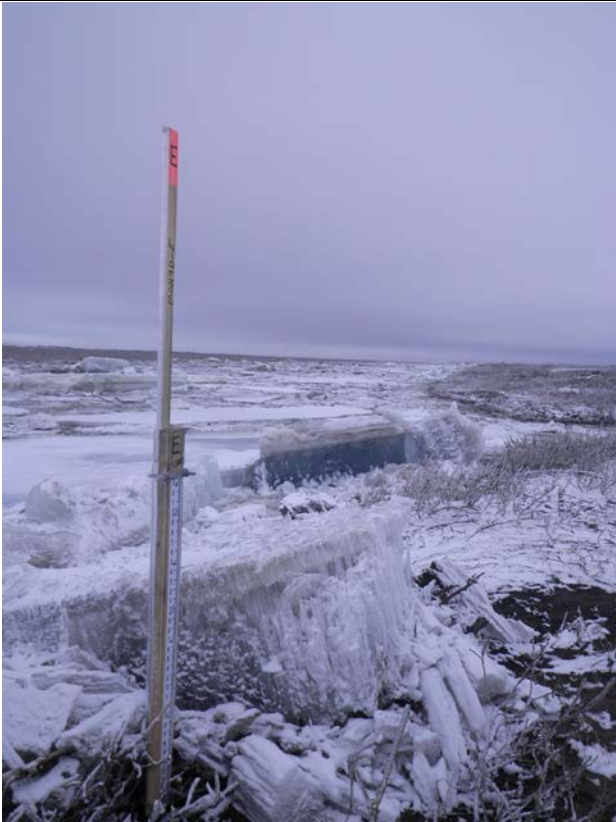
Photo 2: Ice build up along bank at MON9D; May 31, 2014

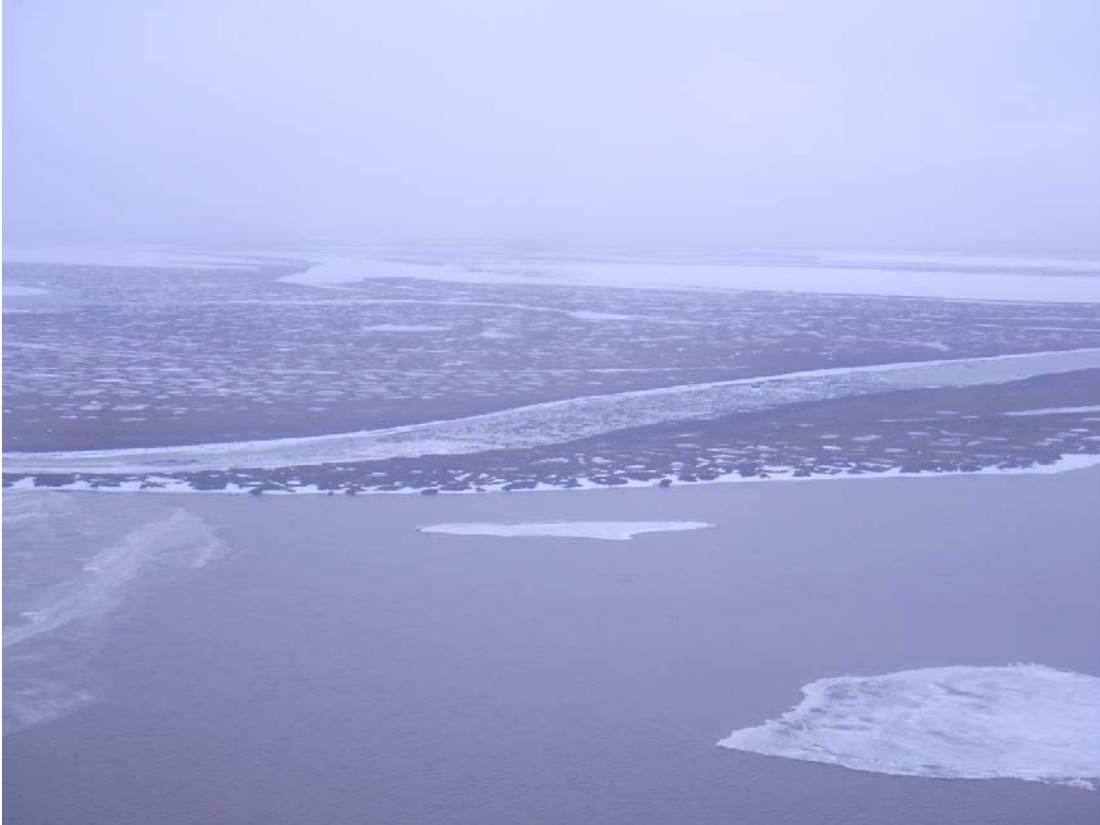
**Photo 3: Small ice jam on the Sagoonang Channel; June 2, 2014**

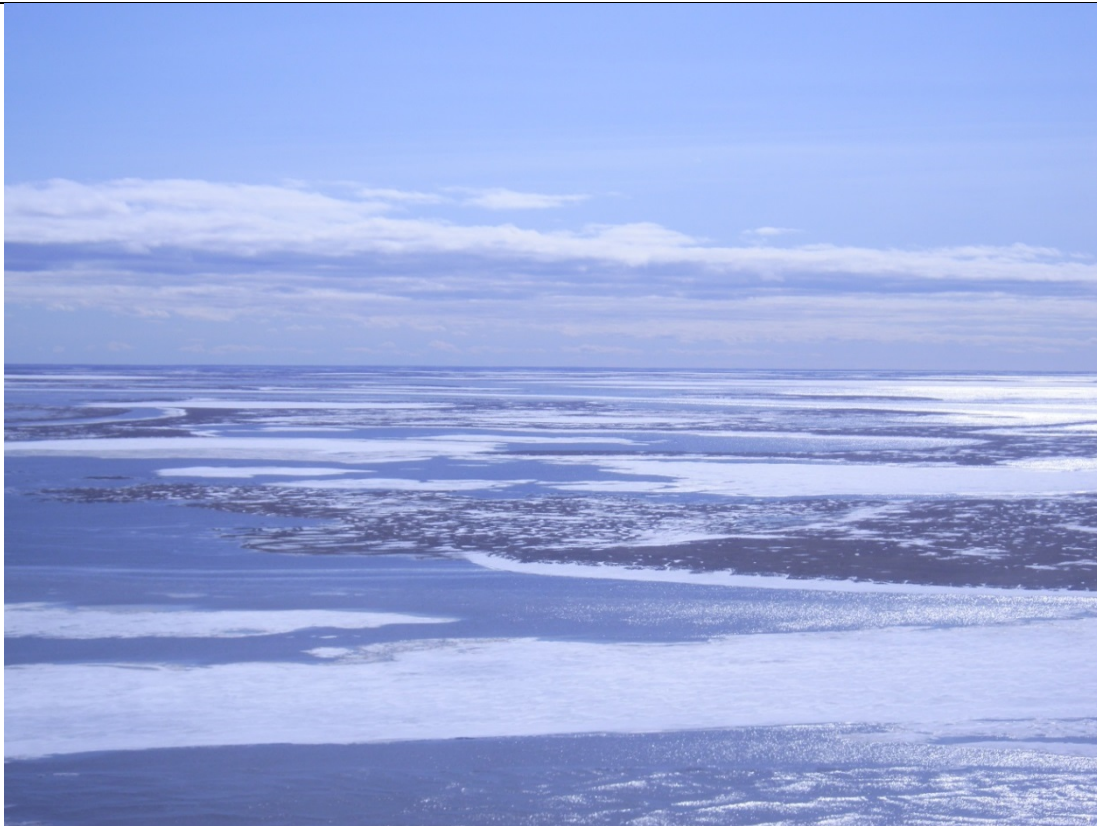
**Photo 3: Coastal flooding near Slemph Slough, looking south; June 3, 2014**

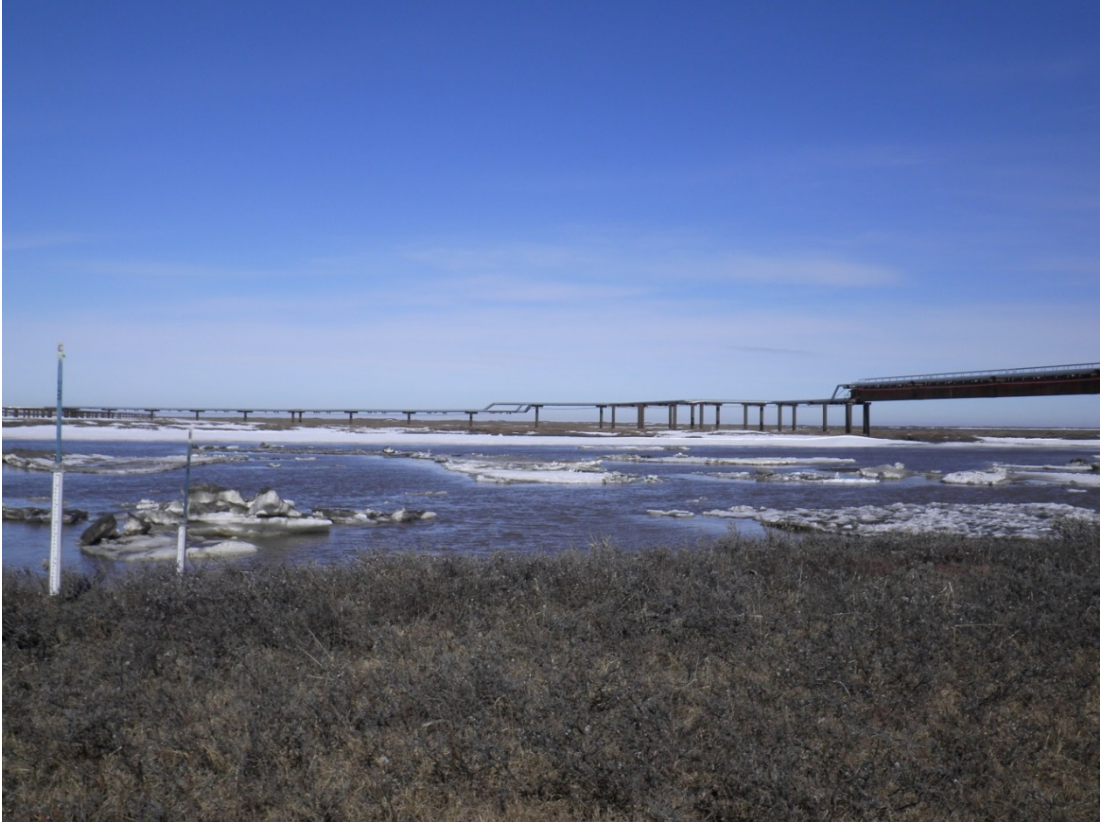
Photo 1: Ice jam moving downstream on the Sakoonang Channel, looking northeast; June 4, 2014

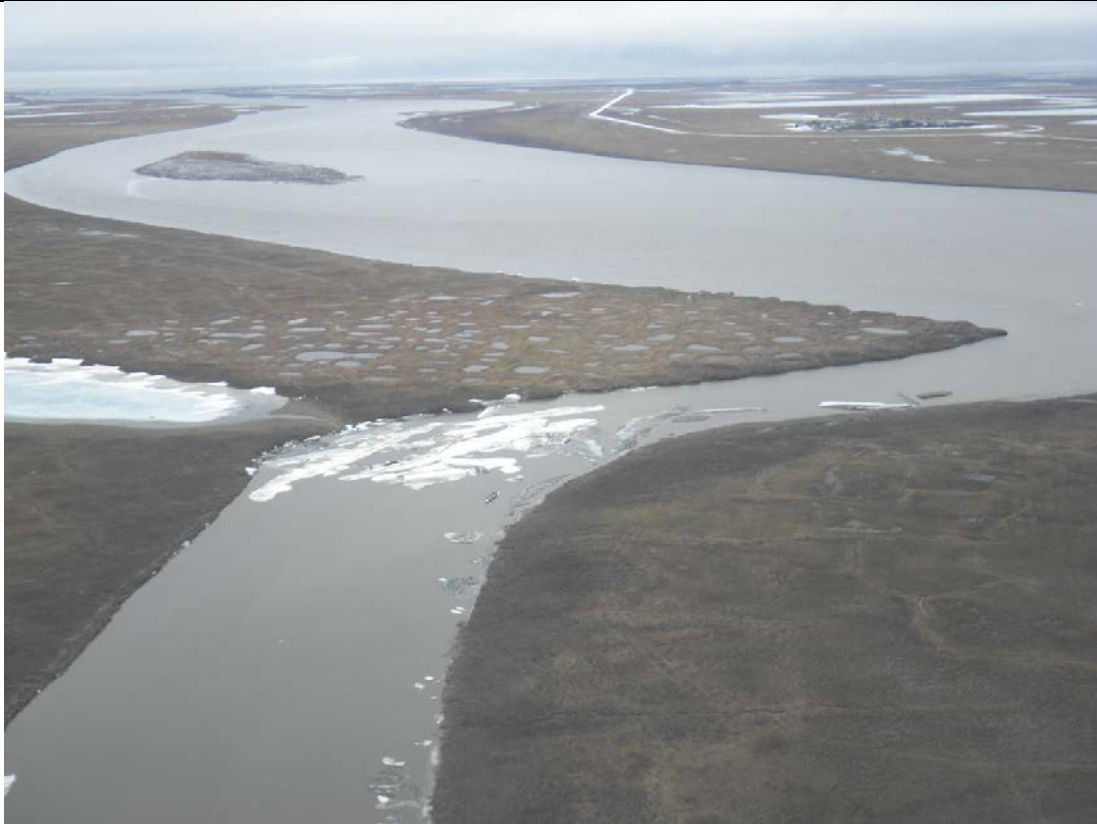
**Photo 5: Small ice jam at the mouth of the Nigliagvik Channel at the confluence with the Nigliq Channel;  
June 5, 2014**

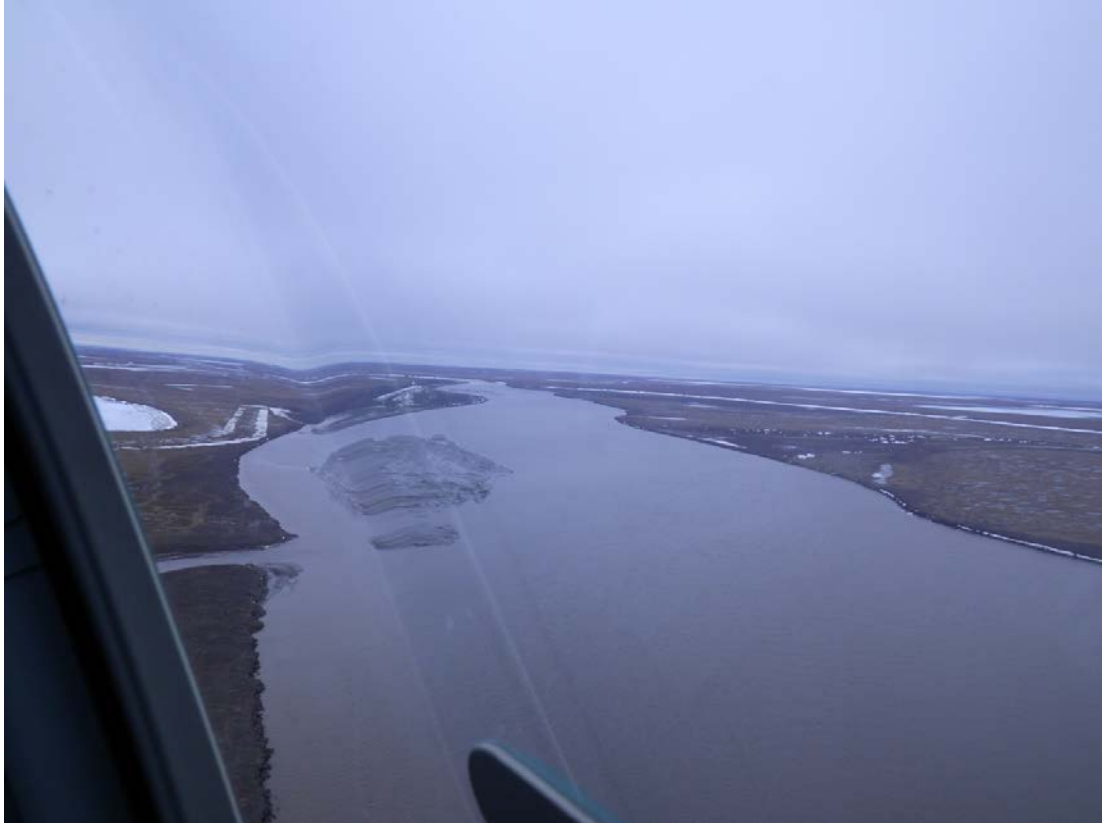
**Photo 4: Nigliq Channel, looking upstream; June 9, 2014.**
