# 2014

# Colville River Delta Spring Breakup

## Monitoring and Hydrological Assessment

Michael Baker Jr., Inc.  
3900 C Street, Suite 900  
Anchorage, Alaska 99503  
907-273-1600  
November 2014

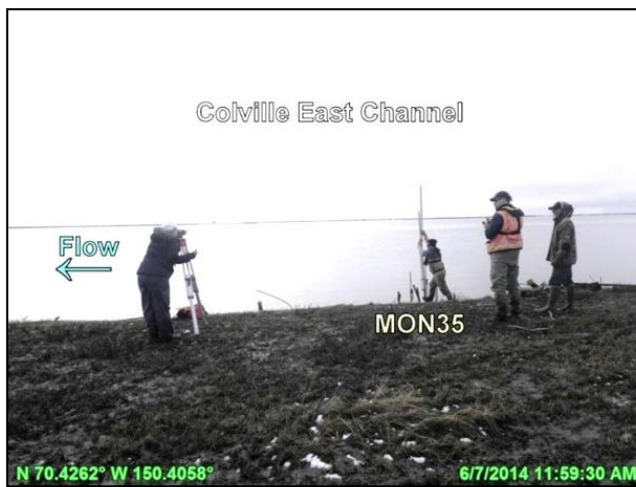
**Photo 1.1: Surveying and reinstalling gages at MON35, Helmericks Homestead, looking east; June 7, 2014**

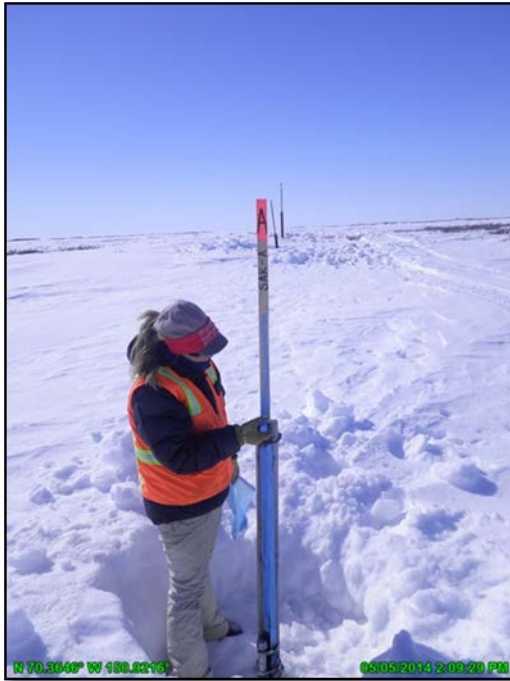
**Photo 1.2: Setting up and chalking gages at the Sakoonang Channel adjacent to the pipeline bridge, looking southwest; May 5, 2014**

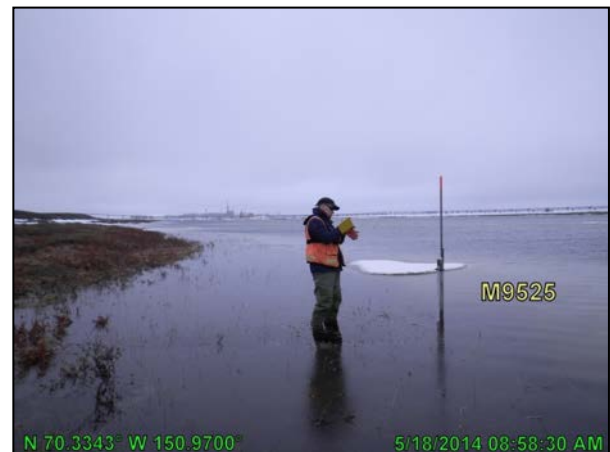
**Photo 2.1: Lake M9525 gage reading, looking northeast; May 18, 2014**

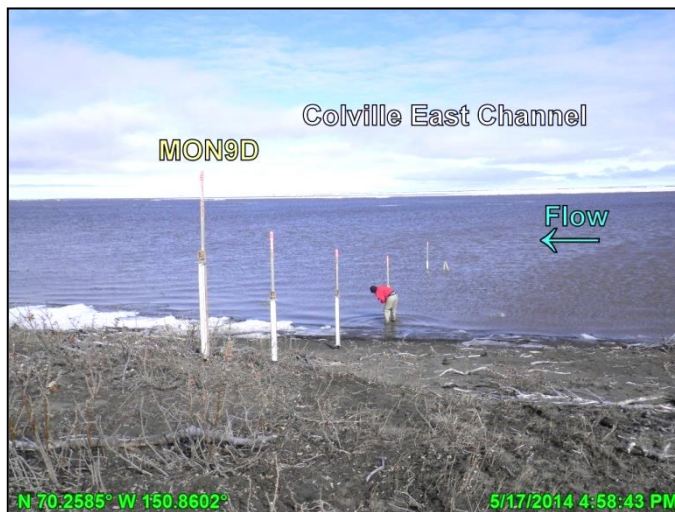
gages from ice impacts was considered to be likely, multiple gages were installed linearly from the edge of the low water channel up to the overbank (Photo 2.2). The elevations overlapped by approximately one foot. Individual gage assemblies were identified with alphabetical designations beginning with A representing the location nearest to the stream centerline.

Photo 2.2: MON9D gage setup; May 17, 2014

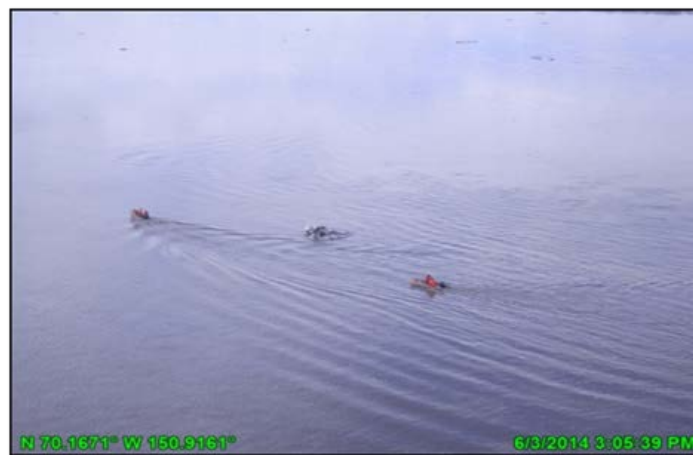
Photo 2.6: Collecting discharge measurements on the Colville River near MON1; June 3, 2014

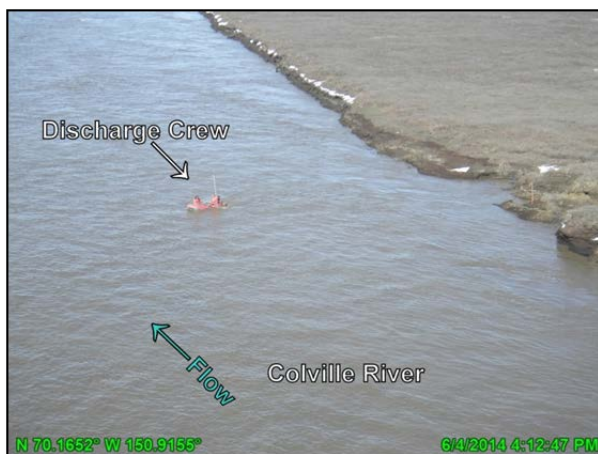
**Photo 3.5: MON1 Discharge measurements on the Colville River; June 4, 2014**

On June 4, a discharge measurement was completed at MON1 (Photo 3.5). Some small ice floes were present along the west bank. The Nigliq Channel was mostly

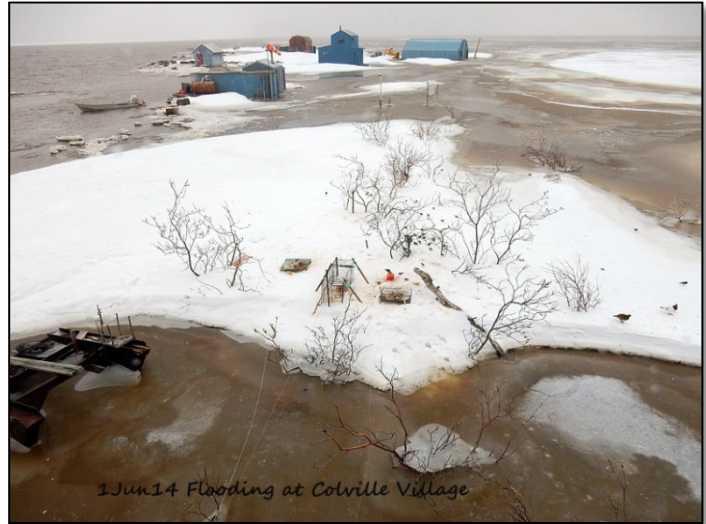
Coastal floodwaters reached the MON35 gages on May 16. Overflow was observed on coastal shore fast ice on May 17. Water levels crested on May 20. Water receded at the gage locations and below freezing temperatures persisted between May 25 and May 30. On May 28, floodwaters from the Colville East Channel caused a rise in WSE, and peak stage occurred on June 1 at MON35 with Colville Village reporting most of the island underwater (Photo 3.7).

According to Jim Helmericks, it was the second highest flood level in recent history, similar to the breakup flood in 2000.

**Photo 3.7: MON35 Peak stage, Helmericks Homestead, looking south; June 1, 2014**

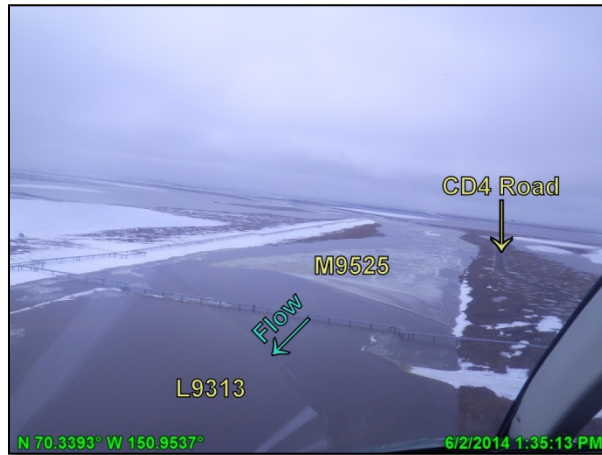
Lake L9313 received overland flow from the Sakoonang Channel via Lake M9525. The peak WSE of 8.59 feet BPMSL was recorded on June 3 at gage G10 (Photo 3.9); the lake fully recharged. Lake L9312 was recharged via precipitation and snowmelt within the lake's basin. The peak WSE of 7.94 feet BPMSL was recorded on

Photo 3.9: Lake L9313 receiving over land flow from Lake M9525; looking southwest; June 2, 2014

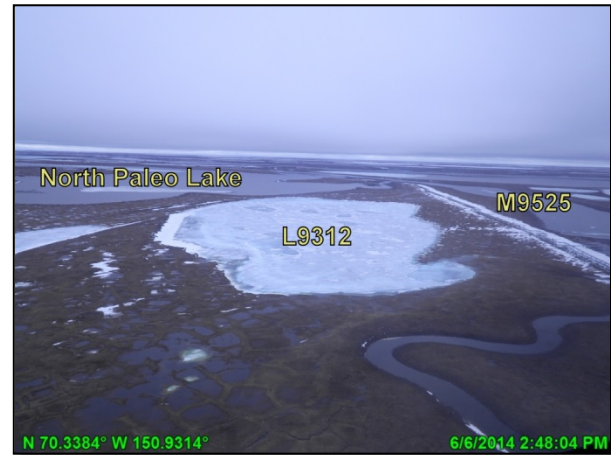
June 6 at gage G9 (Photo 3.10). While the lake did recharge, based on aerial observations and WSE, bankfull recharge was not observed.

Photo 3.10: Lake L9312 at peak WSE, looking south, June 6, 2014.

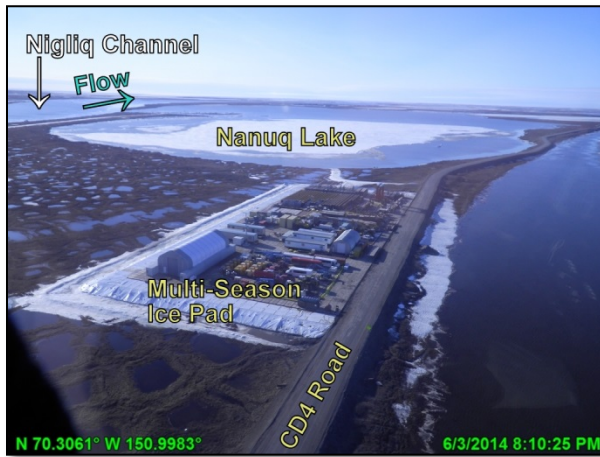
Some culverts along the CD4 road were conveying minimal flood flows on May 21. CD4 road culverts, with the exception of the CD4-20 and CD4-23 batteries; remained dry throughout breakup. On May 22, discharge measurements were collected at the culverts, but flow was not measurable along the CD4 road. On June 1 and 2, minimal flow was observed through the culverts and floodwaters equalized rapidly. No flow was recorded during direct discharge measurements collected on June 2 at the culverts (Photo 3.13).

Photo 3.13: CD4 Road and multi-season ice pad, looking north; June 3, 2014

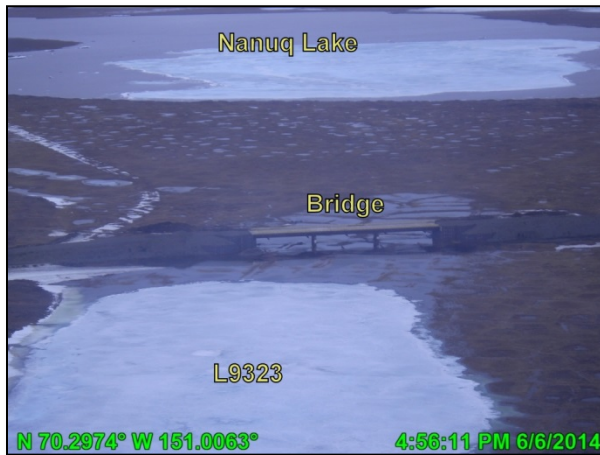
Local melt was evident on gages G24/G25 along the CD5 road crossing at Lake L9323 throughout the monitoring period. On June 1 and 2 during peak stage on the Nigliq Channel, Lake L9323 was not connected by floodwaters, and wet tundra polygons were evident (Photo 3.15).

Photo 3.15: Lake L9323 Local melt , looking north, June 6, 2014

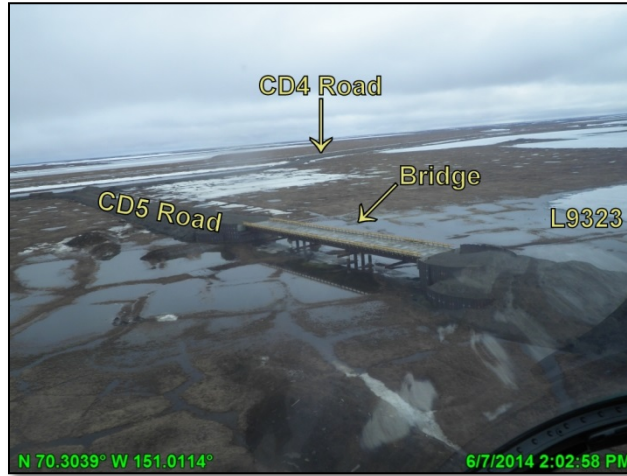
Photo C.1: CD5 Road between Lake L9323 and CD4 Road, local melt water, looking southeast; June 7, 2014

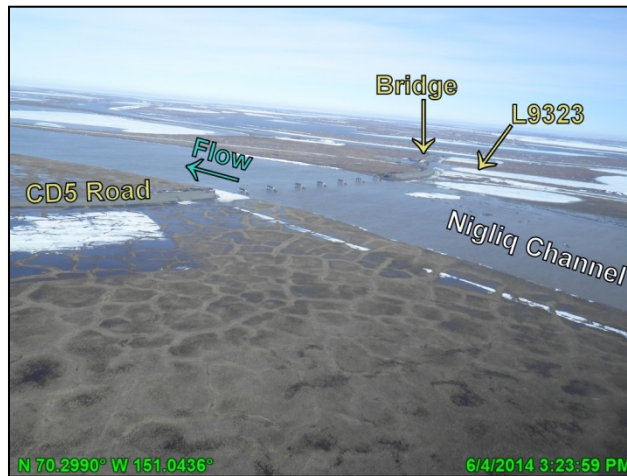
Photo C.2: CD5 Road between Nigliq Channel and L9323, no overland flow along road, looking northeast; June 4, 2014

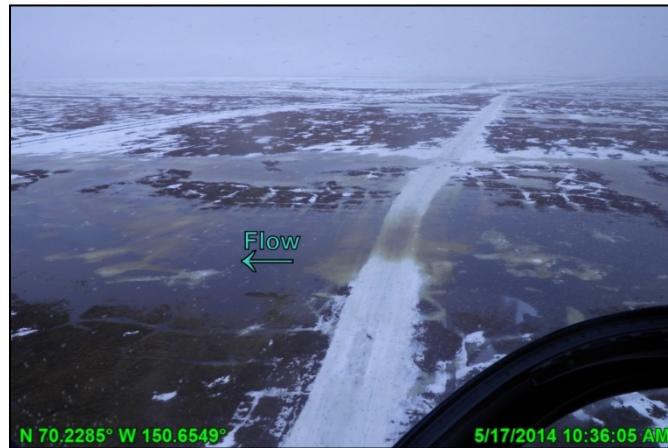
Photo C.17: Flow over the No Name Creek ice road crossing, looking northeast; May 17, 2014

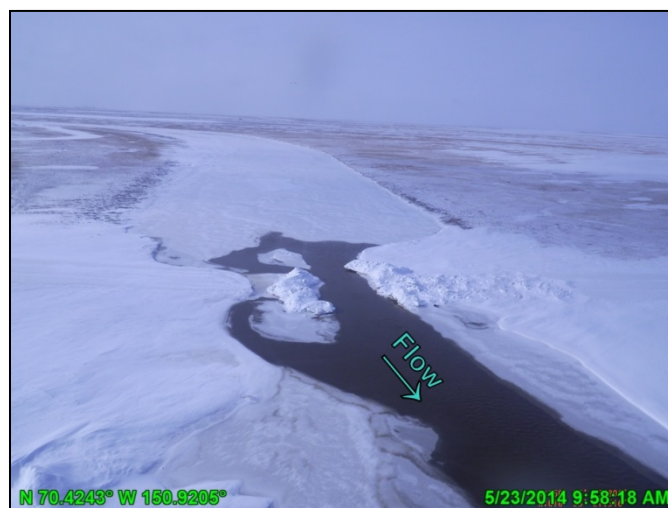
Photo C.18: Flow through slotted Pineapple Gulch ice road crossing, looking southwest; May 23, 2014

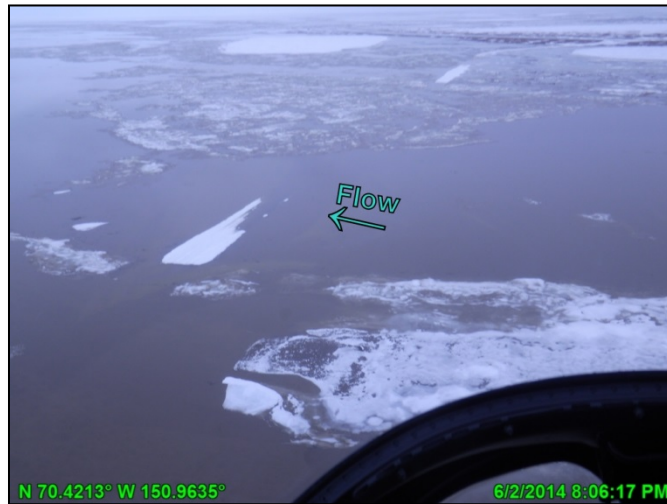
Photo C.23: Remnant of the Tamayyak ice road crossing, looking east; June 2, 2014
