2015 COLVILLE RIVER DELTA SPRING BREAKUP MONITORING AND HYDROLOGICAL ASSESSMENT

148414-MBJ-RPT-001 | November 2015

EXECUTIVE SUMMARY

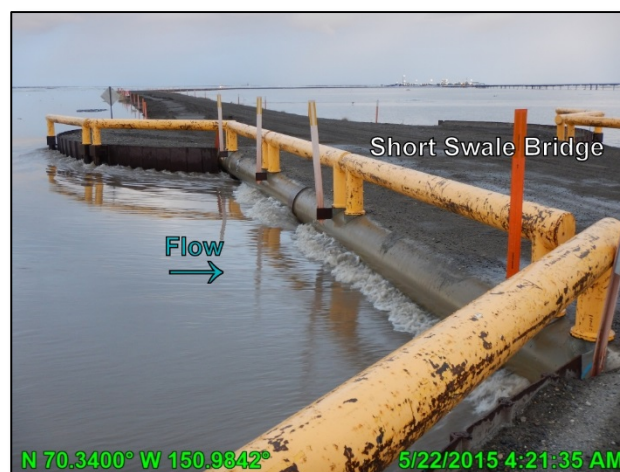
Photo 3.14: Flow through the CD2 road Short Swale Bridge following peak WSE, looking west, May 22, 2015

At the the swale bridges, PT data shows the maximum WSE differential between upstream gage G3 and downstream gage G4 was 1.73 feet, one hour before the time of peak WSE upstream (Table 3.6). Peak WSE on the downstream side occurred two hours later and the differential equalized within about 24 hours (Graph 3.5). By May 24, flow through the swale bridges had ceased.

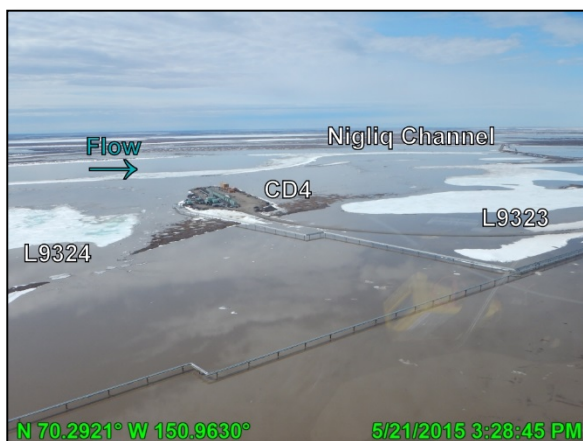
Local melt was accumulating in polygon depressions and low lying areas around the CD4 road and pad on May 19 and May 20. On May 21, floodwater began to inundate the surrounding area (Photo 3.19). Stage increased rapidly during the day as backwater water behind the East Channel and the Nigliq Channel ice jams was diverted through the lake basins between the Sakoongang and Nigliq Channels.

Photo 3.19: Flooding around the CD4 pad, looking northwest prior to peak WSE in the area; May 21, 2015

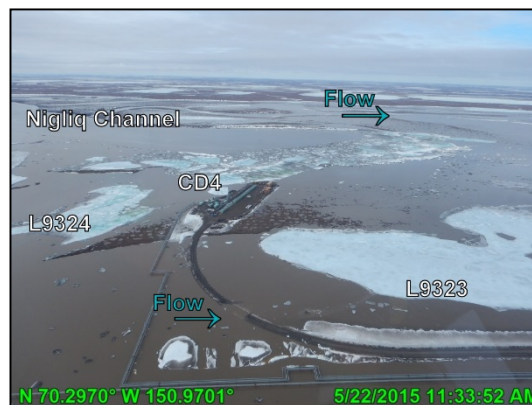
Photo 3.22: CD4 road and pad following peak stage, looking west; May 22, 2015

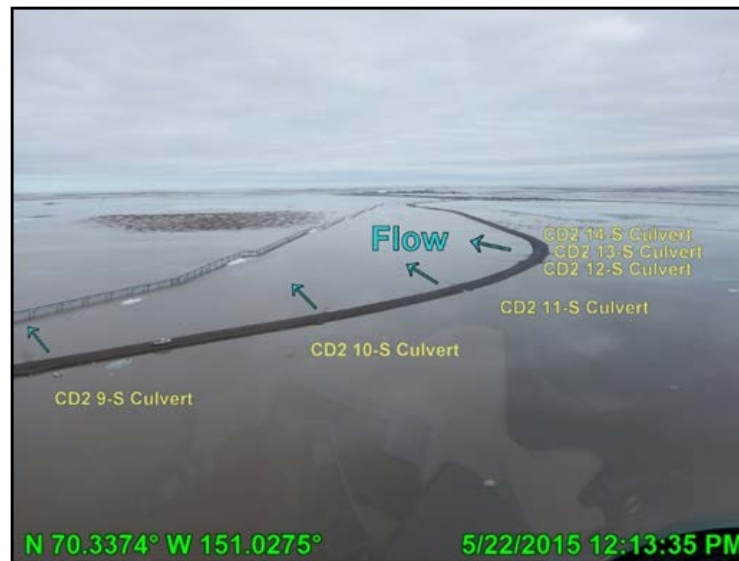
Visual observations of flow conditions at each CD2 road culvert are summarized in Table 4.1 below. Photo 4.1 shows culverts along the CD2 road conveying flow at peak conditions. CD2 road culvert peak discharge was calculated using WSE data from the gages located in the vicinity of the culverts. The WSE differential for the CD2 road gages is presented in Graph 4.7.

Photo 4.1: CD2 road culverts during peak conditions, looking northeast; May 22, 2015

Total peak discharge of the CD2 road culverts was approximately 2,300 cfs at 4:15 AM on May 22. At the time of peak discharge, culverts CD2-1 through CD2-8, CD2-9 through CD2-18 and CD2-19 through CD2-26 were conveying 30%, 45%, and 25%, respectively, of the total discharge. Culverts CD2-9 through CD2-18 had the highest average velocity of 7.5 fps.

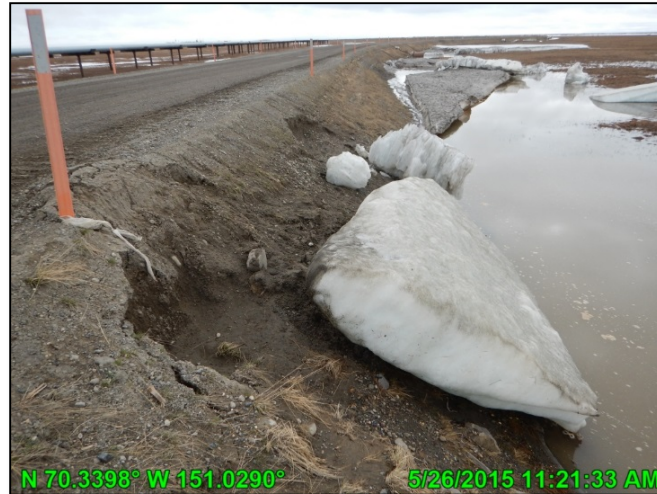
Photo C.6: Scarp from ice on the south side of CD2 road at gage G6, looking east; May 26, 2015

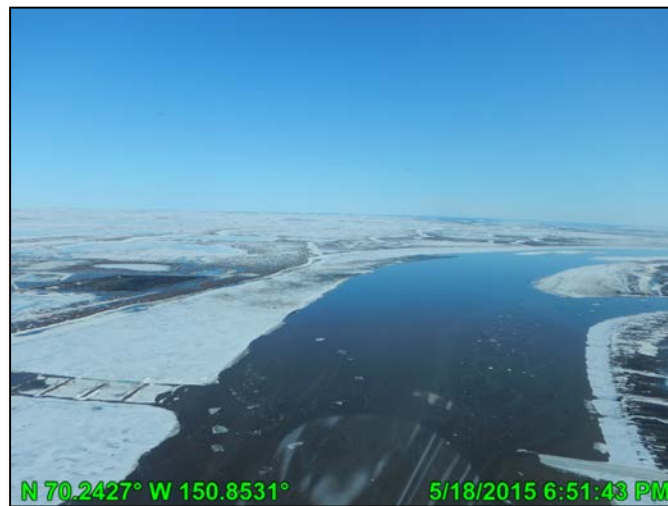
Photo C.32: Colville River ice road crossing during breakup, looking south; May 18, 2015

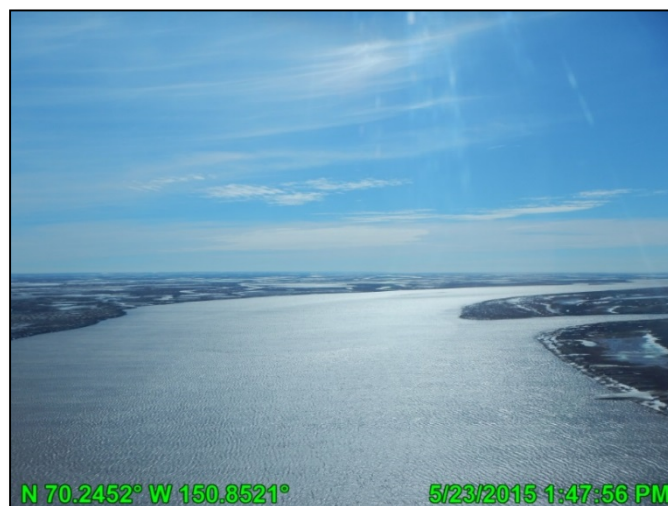
Photo C.33: Colville River ice road crossing following breakup, looking south; May 23, 2015

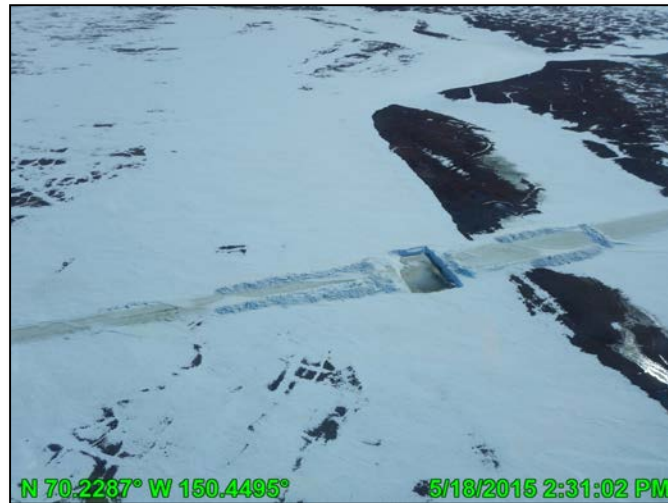
Photo C.34: Kachemach River ice road crossing prior to breakup, looking south; May 18, 2015

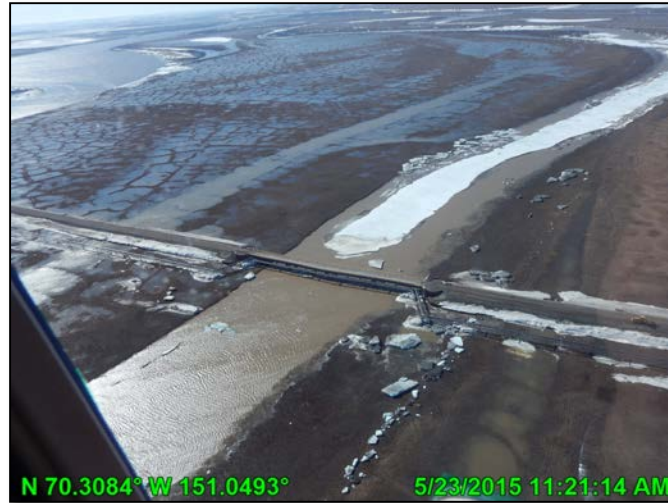
Photo C.37: Lake L9341 ice road crossing at CD5 road during breakup, looking south; May 23, 2015

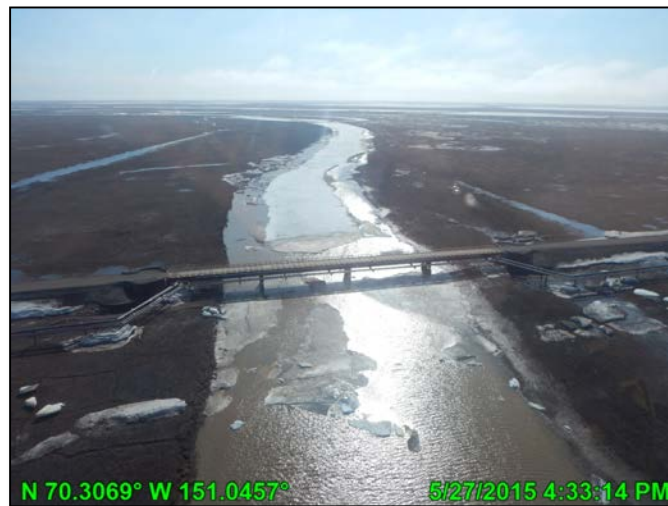
Photo C.38: Lake L9341 ice road crossing at CD5 road following breakup, looking south; May 27, 2015

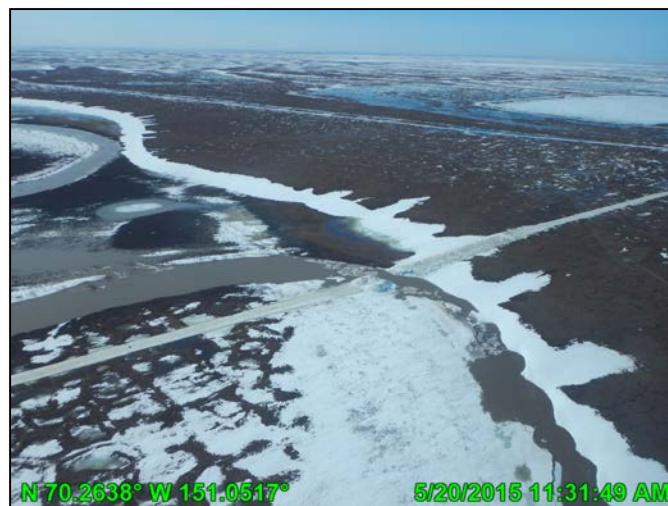
Photo C.39: Nigliagvik Channel ice road crossing south of CD5 road during breakup, looking west; May 20, 2015

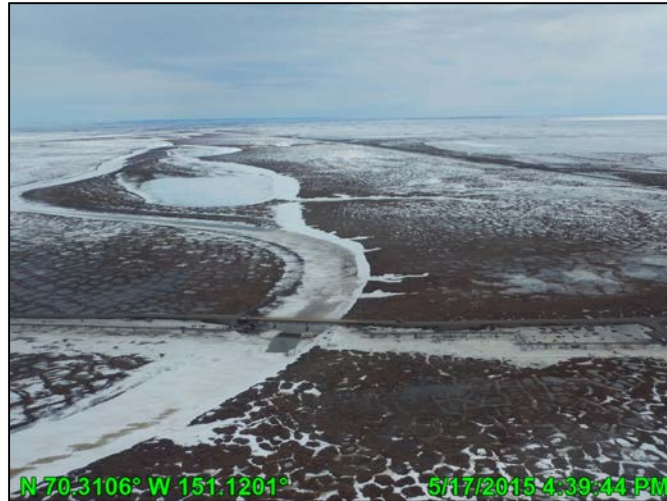
Photo C.40: Nigliagvik ice road crossing at CD5 road prior to breakup, looking south; May 17, 2015

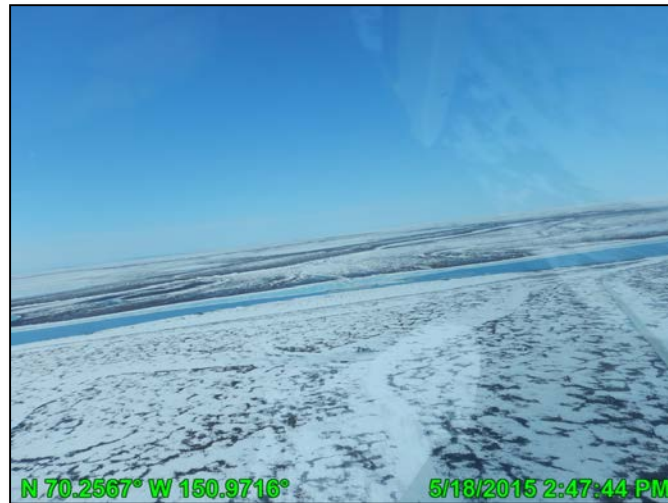
Photo C.43: Nigliq Channel ice road crossing south of CD5 road prior to breakup, looking west; May 18, 2015

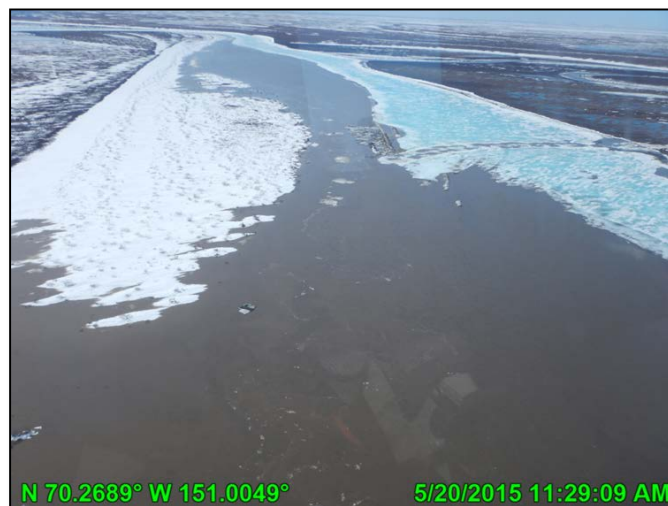
Photo C.44: Nigliq Channel ice road crossing south of CD5 road during breakup, looking south; May 20, 2015

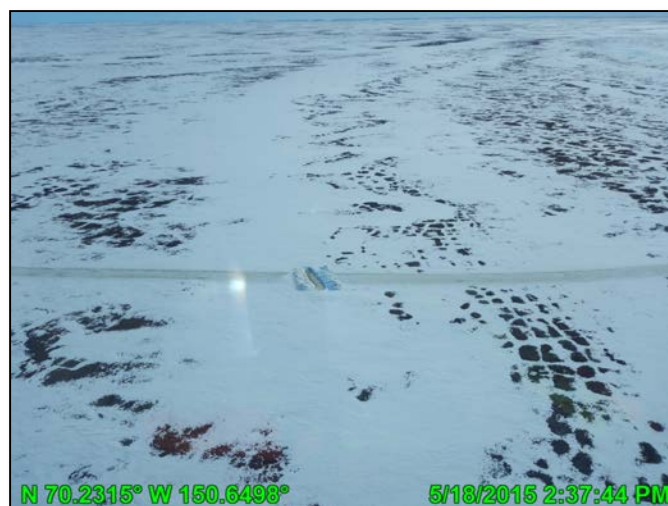
Photo C.48: No Name Creek ice road crossing, prior to breakup, looking west; May 18, 2015

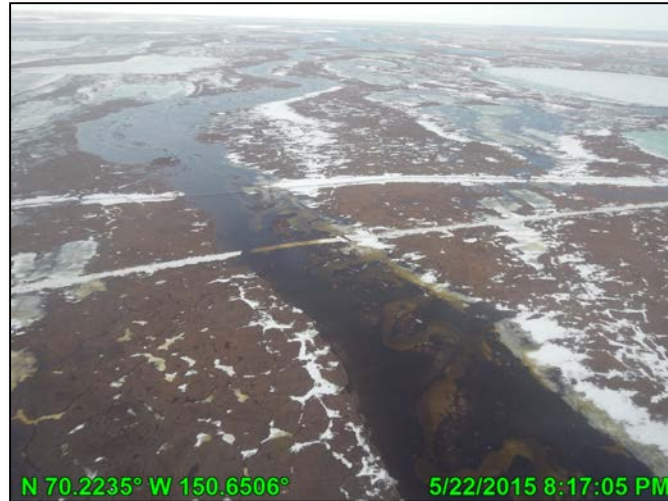
Photo C.49: No Name Creek ice road crossing, during breakup, looking north; May 22, 2015

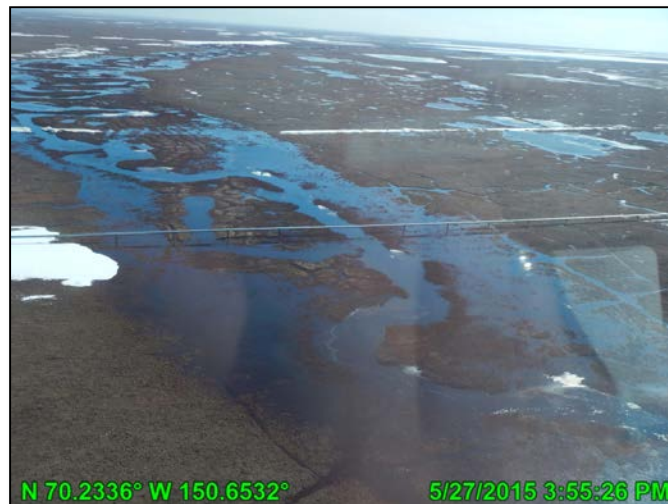
Photo C.50: No Name Creek ice road crossing, following breakup, looking south; May 27, 2015

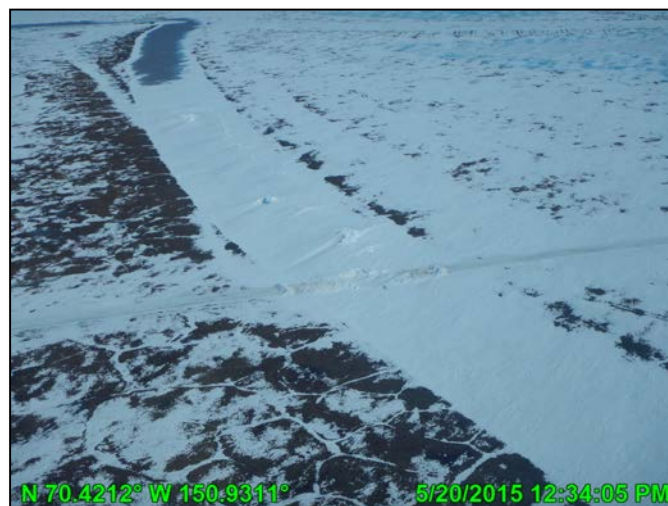
Photo C.51: Pineapple Gulch ice road crossing prior to breakup, looking south; May 20, 2015

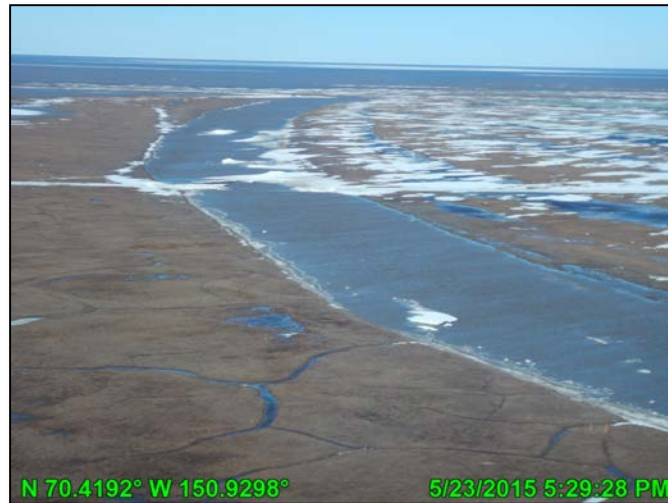
Photo C.52: Pineapple Gulch ice road crossing during breakup, looking north; May 23, 2015

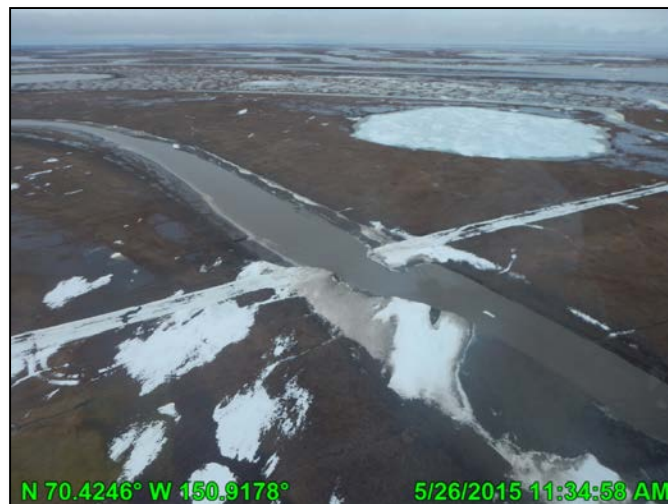
Photo C.53: Pineapple Gulch ice road crossing following breakup, looking north; May 26, 2015

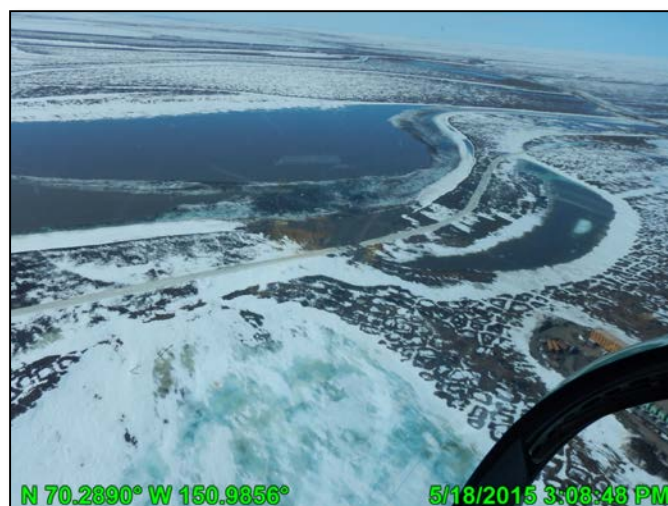
Photo C.54: Silas Slough ice road crossing during breakup, looking northwest; May 18, 2015

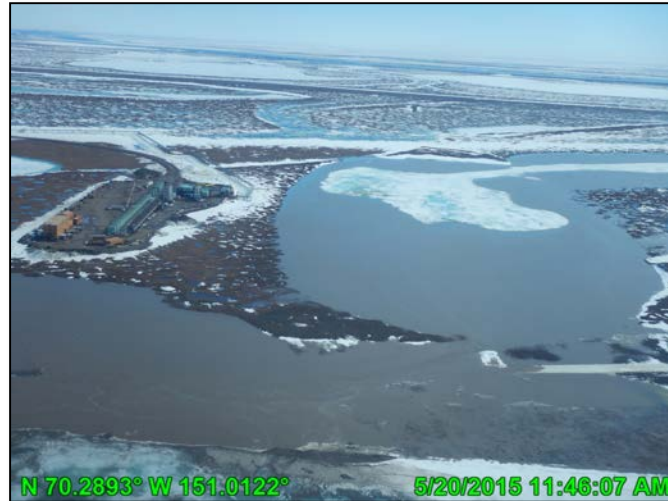
Photo C.55: Silas Slough ice road crossing during breakup, looking east; May 20, 2015

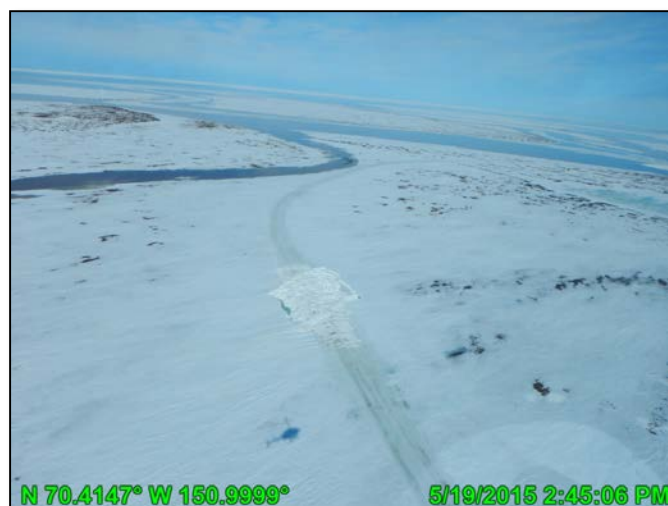
Photo C.57: Slep Slough ice road crossing prior to breakup, looking north; May 19, 2015

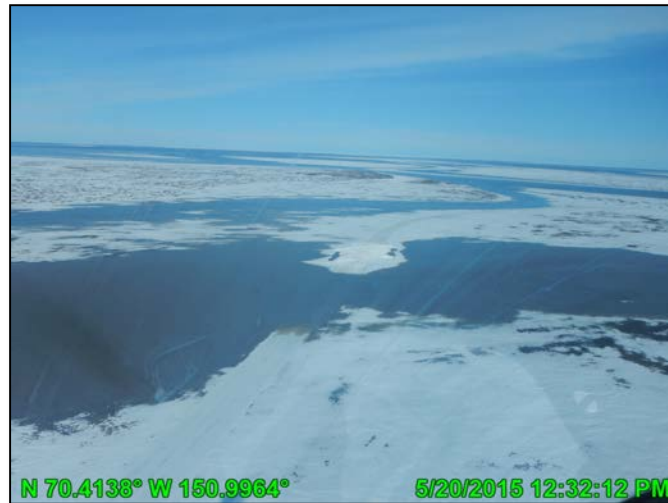
Photo C.58: Slemp Slough ice road crossing during breakup, looking north; May 20, 2015

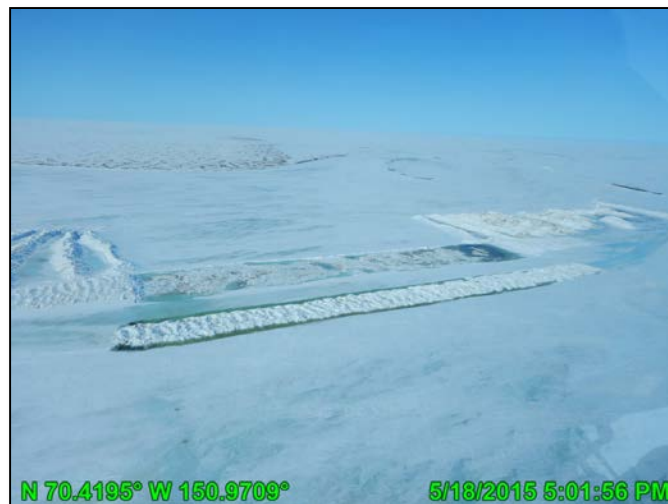
Photo C.59: Tamayayak ice road crossing prior to breakup, looking north; May 18, 2015

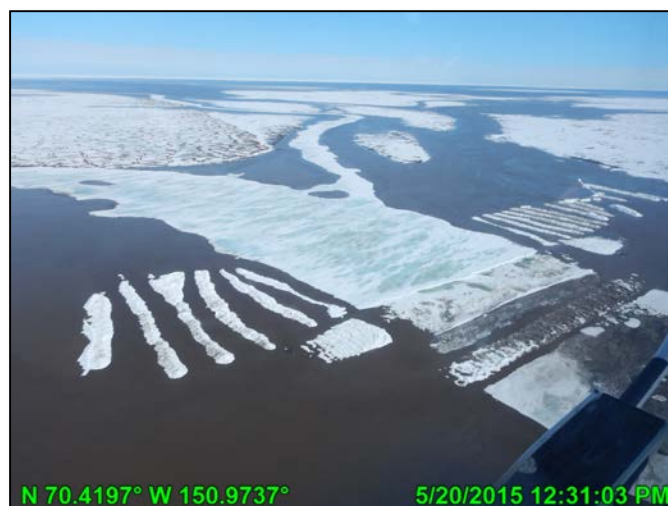
Photo C.60: Tamayayak ice road crossing during breakup, looking north; May 20, 2015

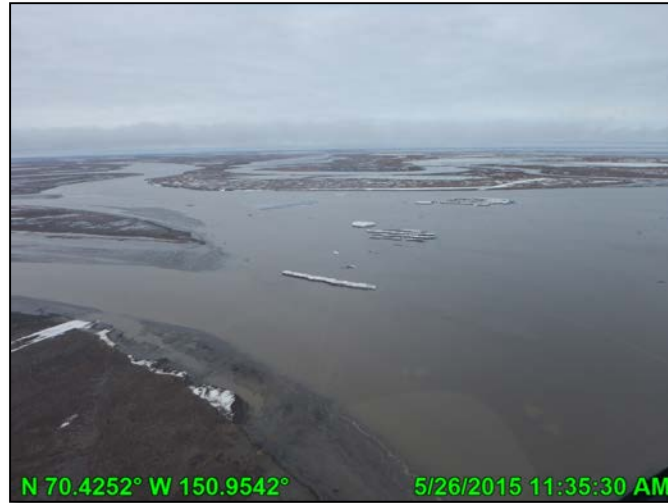
Photo C.61: Tamayyak ice road crossing following breakup, looking south; May 26, 2015
