2016 COLVILLE RIVER DELTA

SPRING BREAKUP MONITORING & HYDROLOGICAL ASSESSMENT

MICHAEL BAKER INTERNATIONAL

ConocoPhillips
Alaska

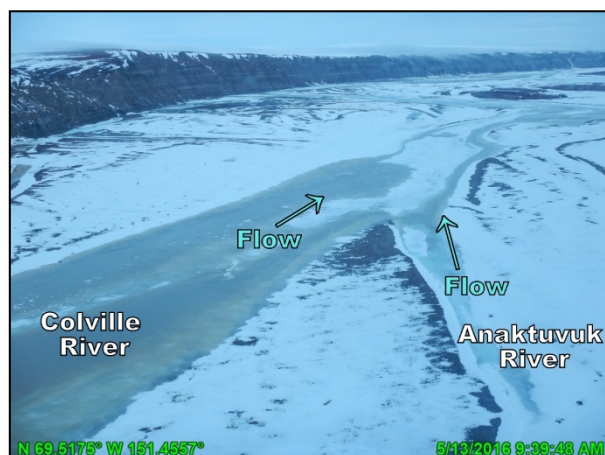
Photo 3.1: Leading edge of floodwater downstream of the Anaktuvuk River confluence, looking northwest; May 13, 2016

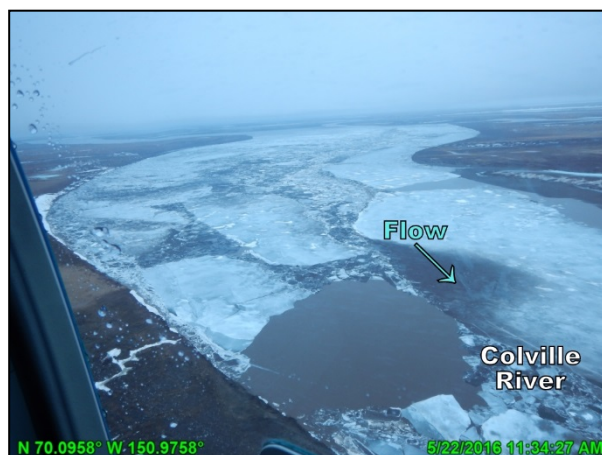
Photo 3.4: Ice jam on the Colville River upstream of MON1, looking southwest; May 22, 2016

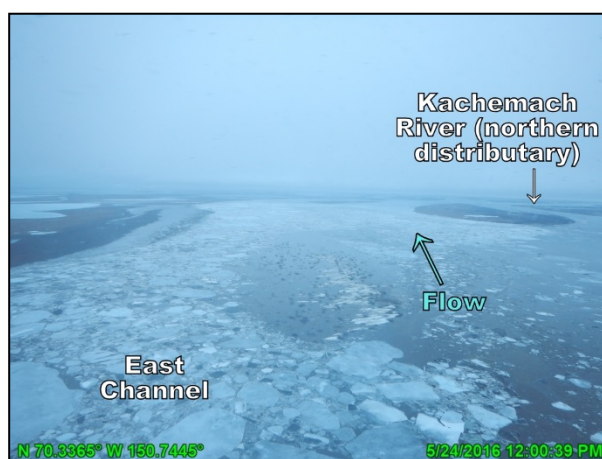
Photo 3.6: Ice jam moving toward the Kachemach and Miluveach River confluences, looking northeast; May 24, 2016

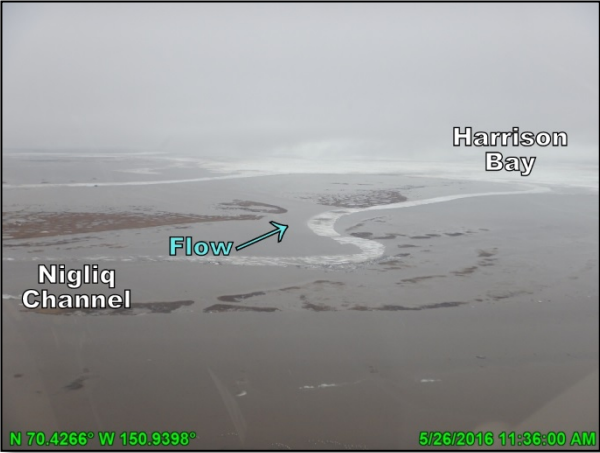
Photo 3.7: Intact channel ice at the mouth of the Nigliq Channel, looking northwest; May 26, 2016

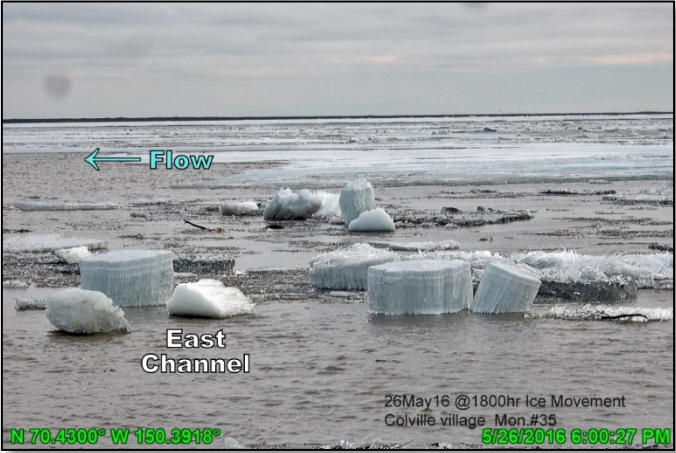
Photo 3.8: Ice floes at MON35 moving down the East Channel toward the ocean, looking east; May 26, 2016

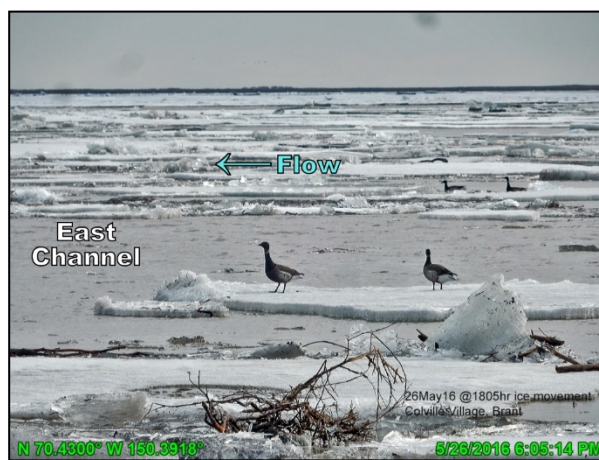
Photo 3.11: Conditions during the approximate time of peak stage at MON35, looking east; May 26, 2016

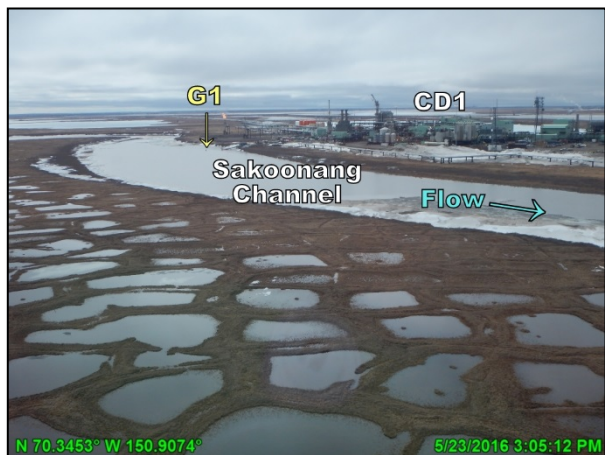
Photo 3.13: Sakoonang Channel, looking southwest; May 23, 2016

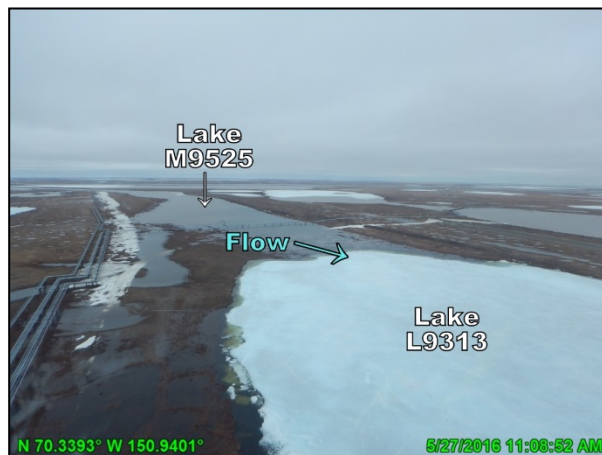
Sakoonang Channel floodwater reached Lake L9313 (gage G10) on the afternoon of May 25 when conditions were nearing peak stage at gage G1. Peak stage was observed in Lake L9313 (gage G10), approximately 8 hours after stage peaked at gage G1, at approximately 7:00am on May 26, cresting at 8.38 feet BPMSL (Table 3.5). Lake L9312 (gage G9) remained hydraulically isolated from Sakoonang Channel floodwater; however, gage G9 PT recorded a slow steady rise in stage attributed to local snowmelt in the lake basin and peaked at 7.48 feet BPMSL at approximately 3:15pm on May 26 (Photo 3.15, Table 3.5, and Graph 3.9).

Photo 3.14: Sakoonang Channel floodwater via Lake M9525 recharge at Lake L9313 (Gage G10), looking southwest; May 27, 2016

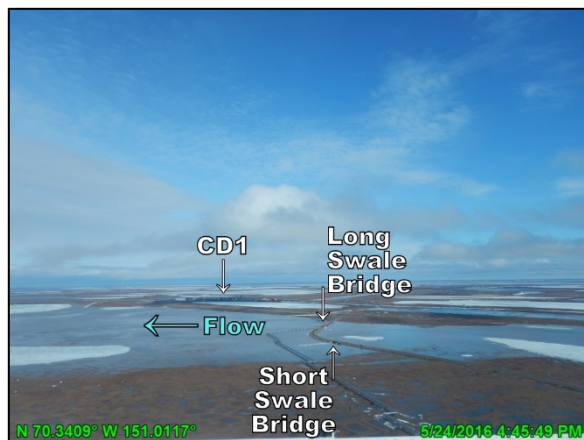
Photo 3.16: Floodwater at the CD2 road swale bridges prior to peak stage, looking west; May 24, 2016

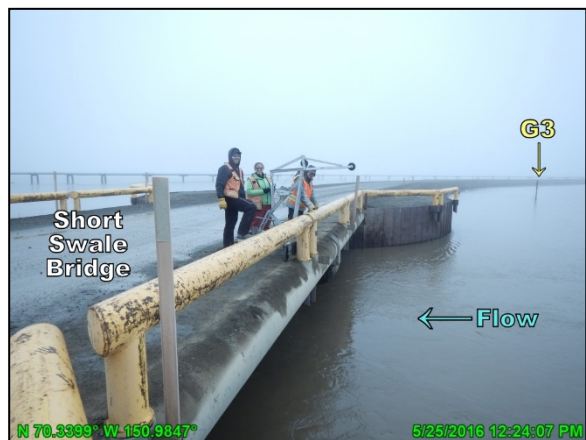
Photo 3.17: Floodwater at the Short Swale Bridge just prior to peak stage, looking northeast; May 25, 2016

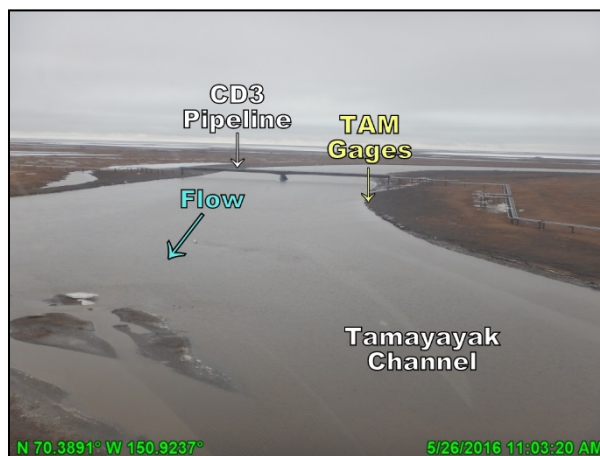
Photo 3.20: Tamayayak Channel at CD3 pipeline crossing, looking northeast; May 26, 2016

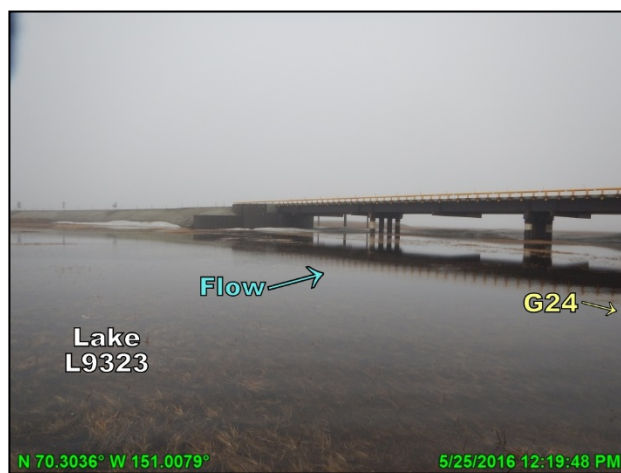
Photo 3.24: Lake L9323 Bridge approximately 4.5 hours after peak stage, looking northwest; May 25, 2016

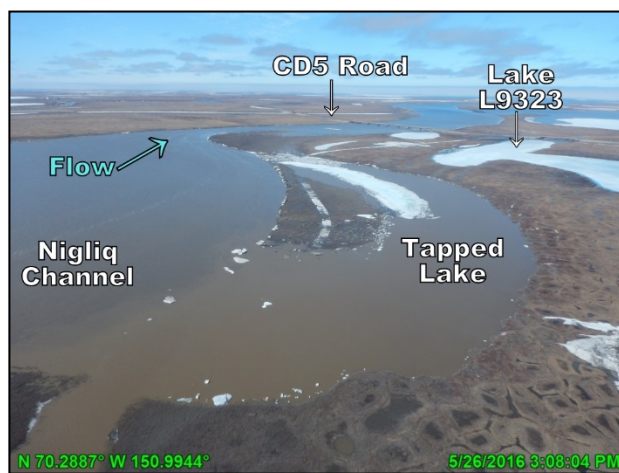
Photo 3.25: Nigliq Channel upstream of Lake L9323, looking northwest; May 26, 2016

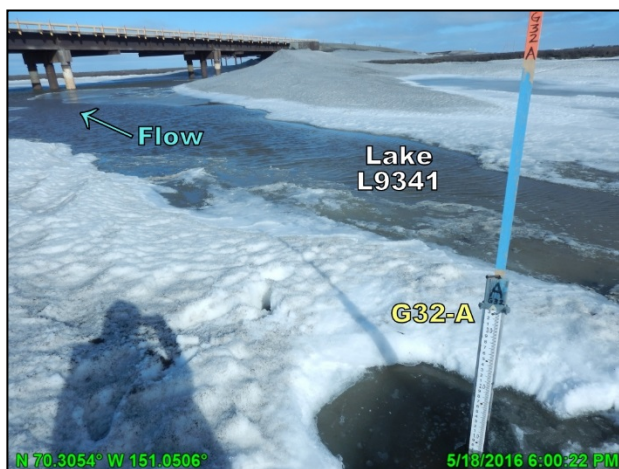
Photo 3.26: Intact ice and snow drift at Lake L9341 Bridge, looking northeast; May 18, 2016

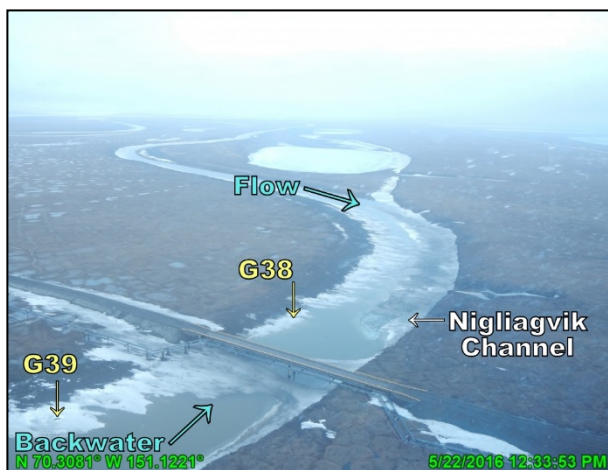
By May 22, stage in the Nigliq Channel was on the rise and Nigliq Channel floodwater and backwater reached the Nigliagvik Bridge (Photo 3.28). Stage at gage G38 began to rise from the rising floodwater and stage at gage G39 began to rise again from the rising backwater. On the morning of May 23, the snow drift breached and the Nigliagvik Channel began flowing downstream at the bridge. On May 25, stage peaked at gages G38 and G39 at 12:00pm, cresting at 8.35 feet BPMSL and 8.14 feet BPMSL, respectively (Table 3.14 and Graph 3.18).

Photo 3.28: Floodwater and backwater from the Nigliq Channel at the Nigliagvik Bridge, looking southeast; May 22, 2016

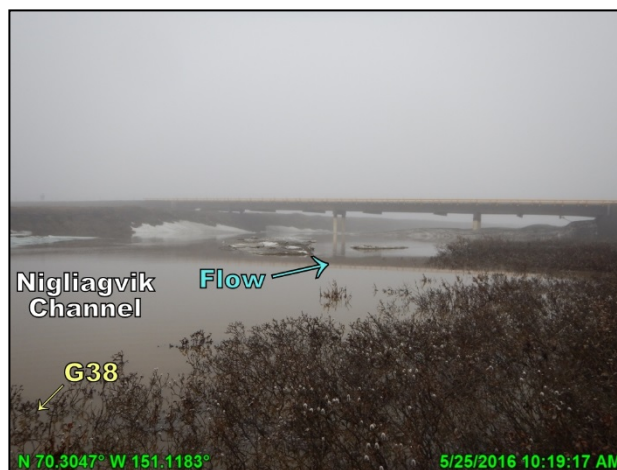
At peak stage, the snow drift partially remained in the channel causing contracted flow through the bridge opening (Photo 3.29). By May 29, the presence of the snow drift was only limited to the east bank and was no longer causing contracted flow within the channel (Photo 3.30).

The highest WSE differential between gages G38 and G39 was 0.80 feet and occurred at 5:00pm on May 24. At this time, the elevated stage at the gage G38 compared to gage G39 suggests the snow drift or an ice jam was impeding flow at the bridge opening.

Photo 3.29: Nigliagvik Bridge just prior to peak stage, looking west; May 25, 2016

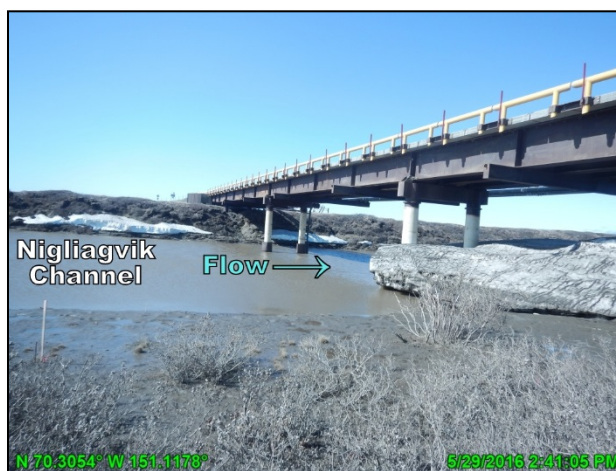
Photo 3.30: Remaining snow drift at the Nigliagvik Bridge, looking northwest; May 29, 2016

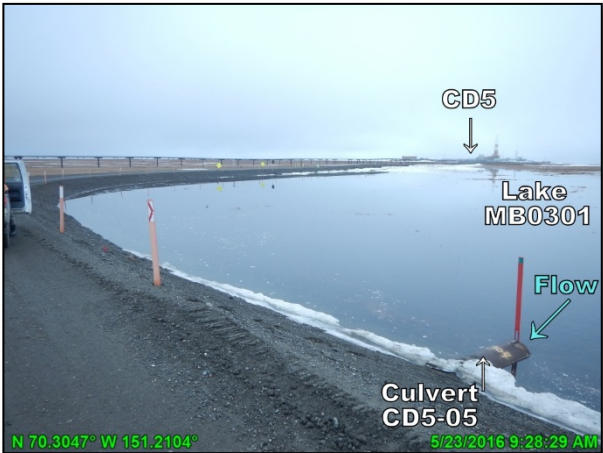
Photo 3.31: Culvert CD5-05, looking northwest; May 23, 2016

Floodwater did not contact the portion of the CD5 road within in the CRD and all culverts remained dry. Three culverts along drainages west of the Nigliagvik Channel, outside of the CRD, were observed flowing. Visual observations of flow conditions at each CD5 road culvert are summarized in Table 4.7. Photo 3.31 and Photo 3.32 in Section 3.6.D of this report show culverts CD5-5, CD5-8, and CD5-9 conveying flow during peak conditions.

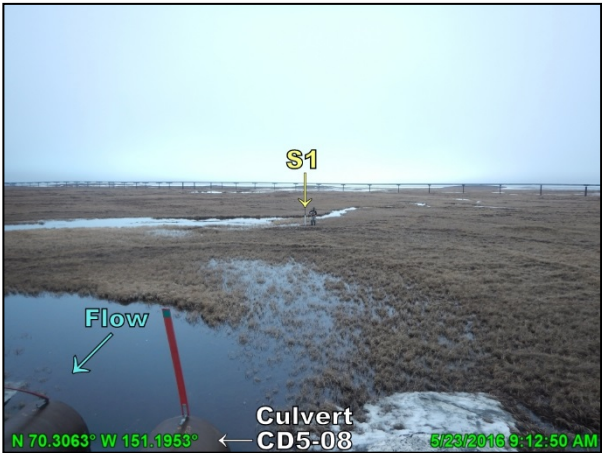
Photo 3.32: Culverts CD5-08 and CD5-09, looking southeast; May 23, 2016

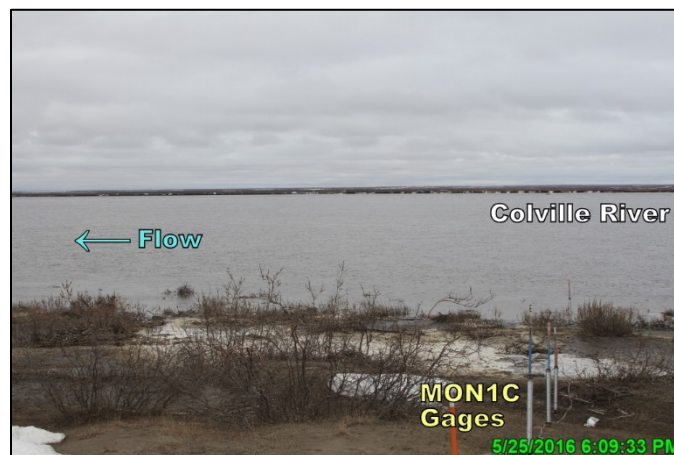
On May 25, discharge was measured on the Colville River adjacent to MON1C using an ADCP mounted on an inflatable boat (Appendix B). At the time of the measurement the channel was clear of snow and ice (Photo 4.1). Four transects and one loop test were completed during the discharge measurement. The loop test revealed a moving bed. Measured discharge, accounting for moving bed conditions, was approximately 253,000 cubic feet per second (cfs) with a corresponding stage of 14.17 feet BPMSL at MON1C. The average velocity was 5.29 feet per second (fps) and the maximum measured velocity was 10.0 fps. The measurement quality was rated fair because of intermittent data gaps in the loop test. A summary of the discharge measurement and the WinRiver II output for each transect are presented in Appendix D.1.

Photo 4.1: Colville River at MON1 during discharge measurement, looking east; May 25, 2016

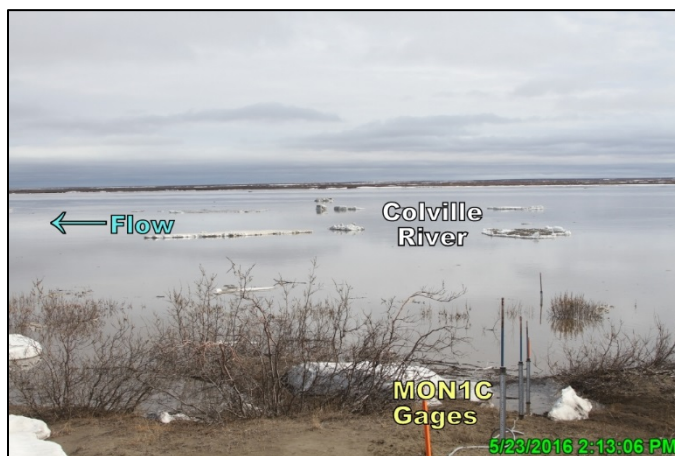
Photo 4.2: Colville River at MON1C at time of calculated peak discharge, looking east; May 23, 2016

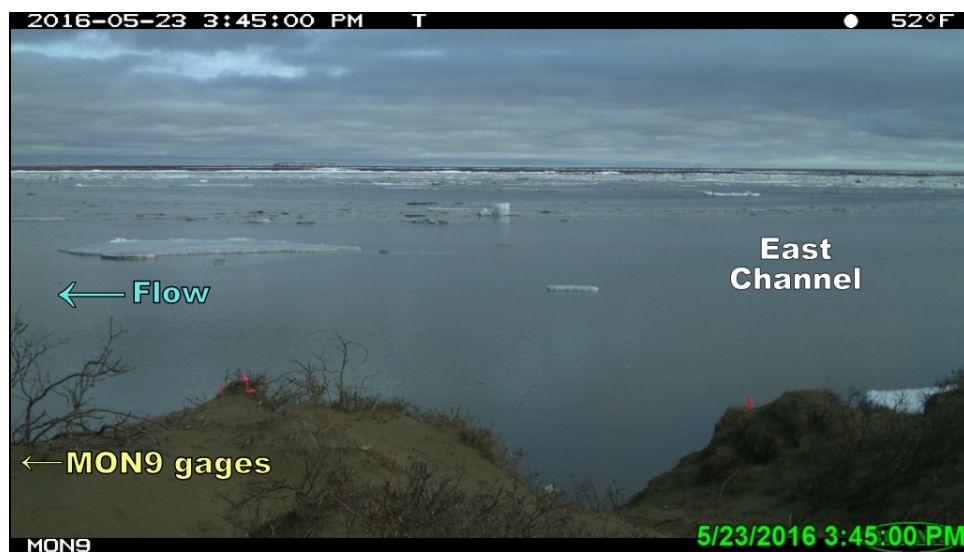
Peak discharge occurred at 3:45pm on May 23, 3 hours and 15 minutes before peak stage. Peak discharge followed the release of the ice jam upstream of MON1 and the passage of accompanying flood wave and ice floes and was approximately 218,000 cfs with a corresponding WSE of 13.45 feet BPMSL. Peak discharge was likely influenced by backwater and ice floes in the channel and therefore was assigned a fair-poor quality rating (Table 2.1) (Photo 4.3). Graph 4.2 shows the results from the discharge calculations and the WSEs versus time.

Photo 4.3: East Channel at MON9 at the time of peak discharge, looking east; May 23, 2016

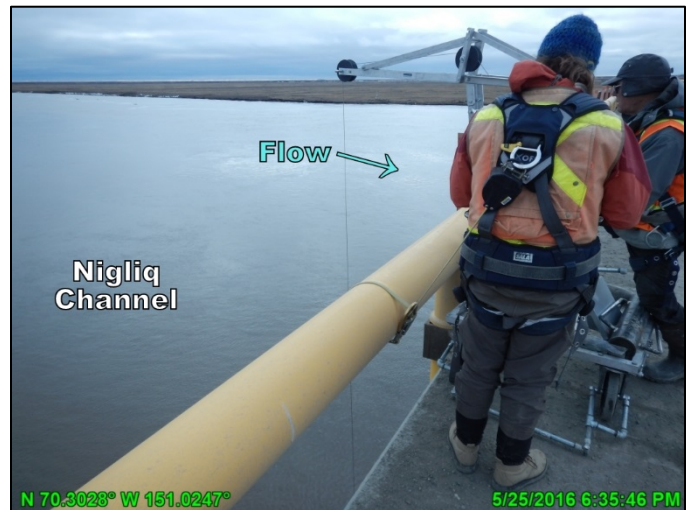
On the evening of May 25, Nigliq Channel discharge was measured at the upstream side of the Nigliq Bridge using a USGS Type AA Current Meter and the USGS midsection technique (Appendix B.1.1). At the time of the measurement, the channel was mostly clear of snow and ice and conditions were considered steady and uniform (Photo 4.4). Measured discharge was approximately 46,300 cfs with a corresponding stage of 8.08 feet BPMSL at gage G26. The average velocity was 2.4 fps and the highest depth-averaged velocity within a particular section was 3.9 fps. The quality of the measurement was classified as good-fair based on the remaining snow drifts and grounded ice along the mud bar on the east side of the channel. The plan and cross-section profile at gage G26 is presented in Appendix B.2.2.3. A summary of the discharge measurement is presented in Appendix D.2.

Photo 4.4: Conditions at the Nigliq Bridge during discharge measurement, looking southwest; May 25, 2016

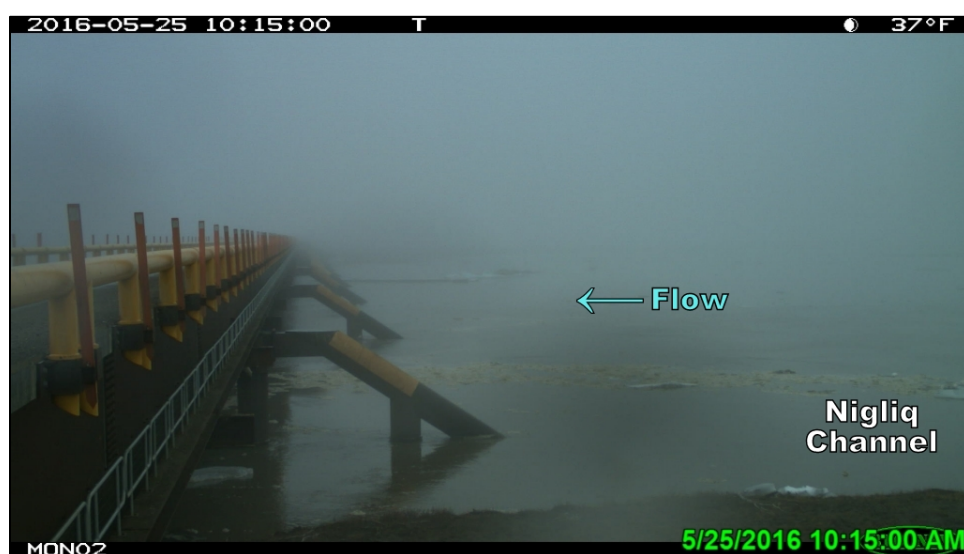
Peak discharge occurred at 10:15am on May 25, 1 hour and 15 minutes before peak stage. Peak discharge followed the release of an upstream ice jam and the passage of the accompanying flood wave and ice floes and was 65,000 cfs with a corresponding WSE of 8.69 feet BPMSL. Minor ice floes were present at the time of peak discharge and no backwater effects were observed, therefore the computation was assigned a quality rating of fair (Photo 4.5). In addition, the computed peak discharge was within 8 hours of the measured discharge, adding to the confidence in the computation. Graph 4.3 shows the results from the discharge calculations and the WSEs versus time.

**Photo 4.5: Conditions at the Nigliq Bridge at the time of peak discharge, upstream looking east
May 25, 2016**

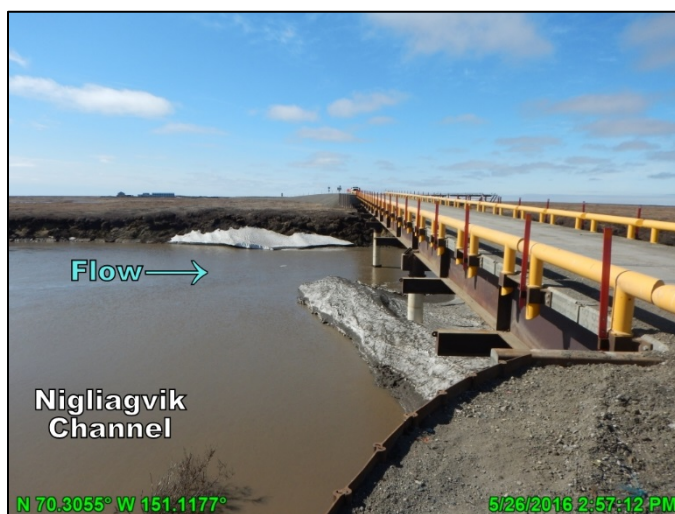
On the afternoon of May 26, discharge was measured in the Nigliagvik Channel at the upstream side of the Nigliagvik Bridge using an USGS Type AA Current Meter and the USGS midsection technique (Appendix B.1.1). At the time of measurement, there was a snow drift along the right (east) bank immediately upstream of the bridge contracting flow along the left (west) bank and creating eddies on the downstream side of the snow drift (Photo 4.6). The measured discharge was approximately 1,500 cfs with a corresponding stage of 6.58 feet BPMSL at gage G38.

Photo 4.6: Nigliagvik Bridge conditions during direct discharge measurement, looking west; May 26, 2016

The large snow drift under the east side of the bridge was present during peak conditions and was observed contracting flow through the bridge opening. To account for the energy losses through the contracted section, the USGS width contraction method was used to estimate peak discharge (Appendix B.1.3). The approach section channel geometry was from Transect 28 surveyed for the *Monitoring Plan with an Adaptive Management Strategy* in July 2016 (LCMF 2016b). The bridge section channel geometry was from the direct discharge measurement on May 26. WSEs at Transect 28 were from gage G38 and WSEs at the bridge section were interpolated between gages G38 and G39. The channel roughness was calibrated from the measured discharge and corresponding WSEs.

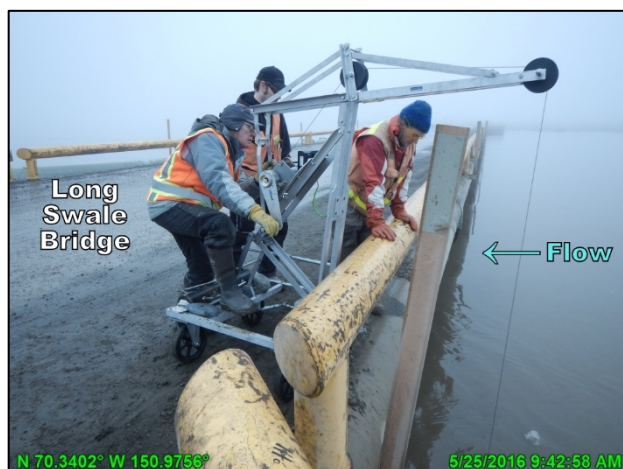
At the time of the measurements, the bridges were ice free with small ice floes periodically passing under the bridges (Photo 4.7). At the downstream side of the Short Swale Bridge, a long snow drift (approximately 13 feet) was protruding from the left bank (Photo 4.8). The quality of the measurements at the Long Swale Bridge and Short Swale Bridge were rated good/fair and fair, respectively.

Photo 4.7: Long Swale Bridge during direct discharge measurement, looking east; May 25, 2016

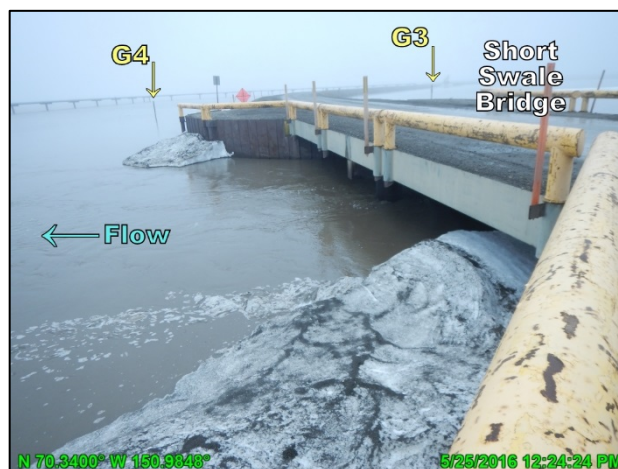
Photo 4.8: Snow drift on the downstream side of the Short Swale Bridge during discharge measurement, looking east; May 25, 2016

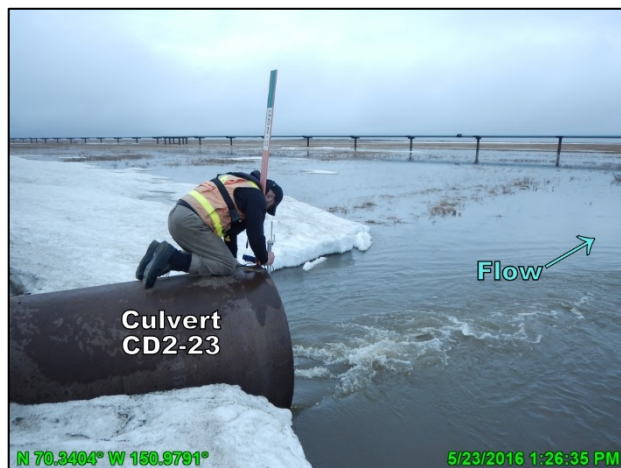
Photo 4.9: Culvert CD2-23 direct discharge measurement, looking northwest; May 23, 2016

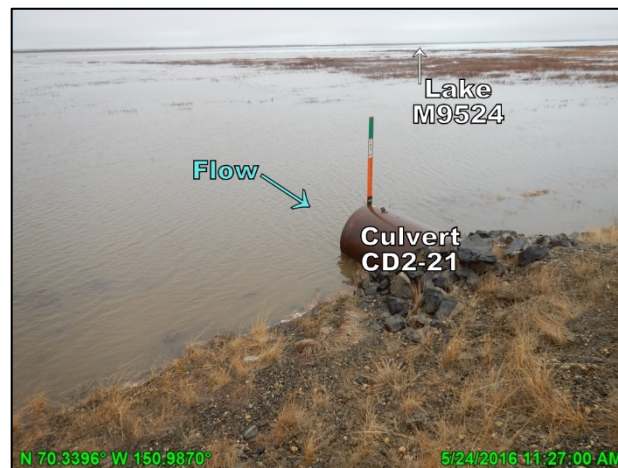
Photo 4.10: Culvert CD2-21 within 24 hours of peak conditions, looking southwest; May 24, 2016

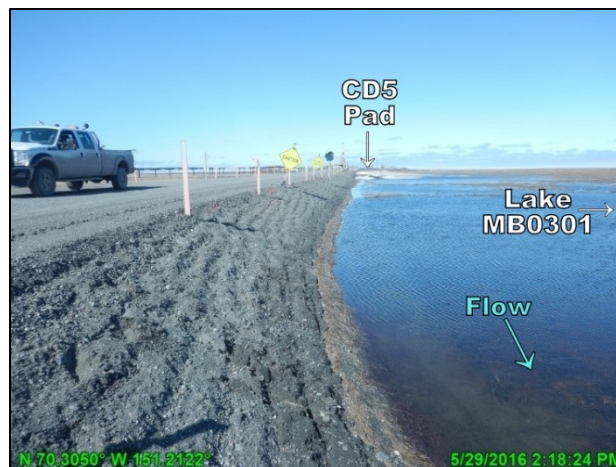
Alpine gravel pads and access roads were inspected for erosion on May 28 and May 29. Other than washlines, no discernable erosion was observed during aerial and ground reconnaissance of the CD2 (Photo 5.1), CD4 (Photo 5.2), and CD5 (Photo 5.3) roads. Floodwaters did not reach the CD5 bridge abutments or road within the CRD. A prominent washline from 2015 spring breakup was evident along portions of the CD2, CD4, and CD5 roads. There were no signs of sloughing or undermining at drainage structures. Additional photo documentation of erosion surveys and breakup conditions along the Alpine facilities roads and pads are shown in Appendix C.1.

Photo 5.3: CD5 road near CD5 pad, looking west; May 29, 2016

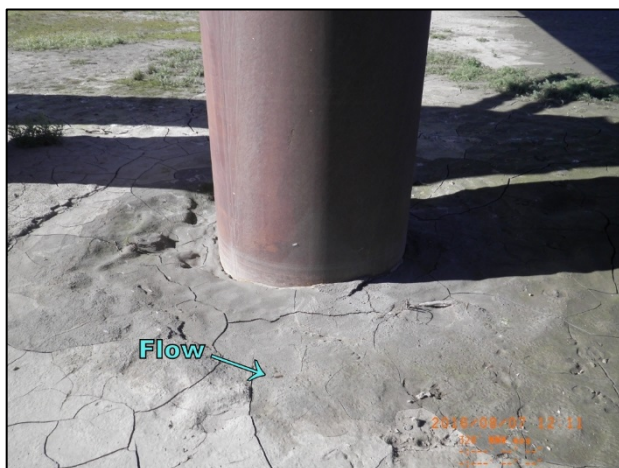
Photo 6.1: Nigliq Bridge pier 7, pile D post-breakup; August 7, 2016

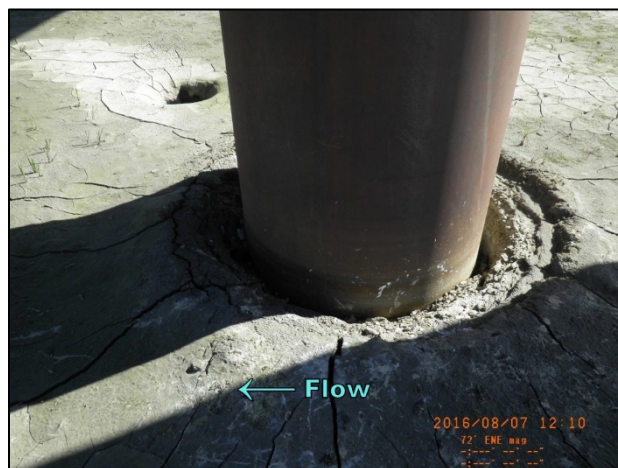
Photo 6.2: Nigliq Bridge pier 8, pile D post-breakup; August 7, 2016

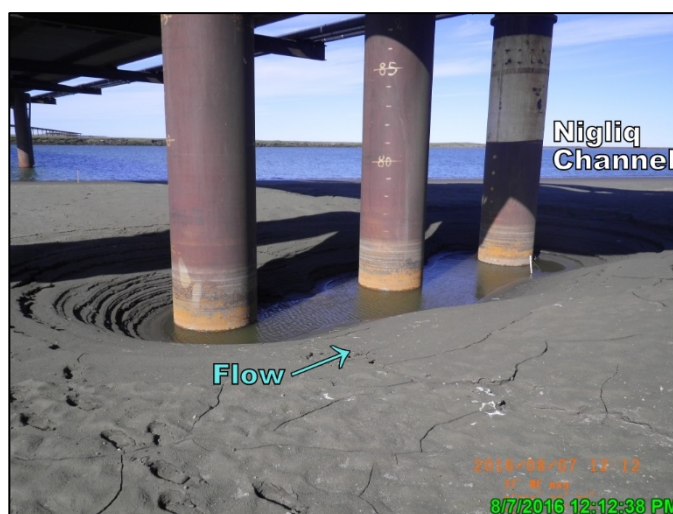
Photo 6.3: Small scour hole around Nigliq Bridge pier 6, piles C, D, & E post-breakup; August 7, 2016

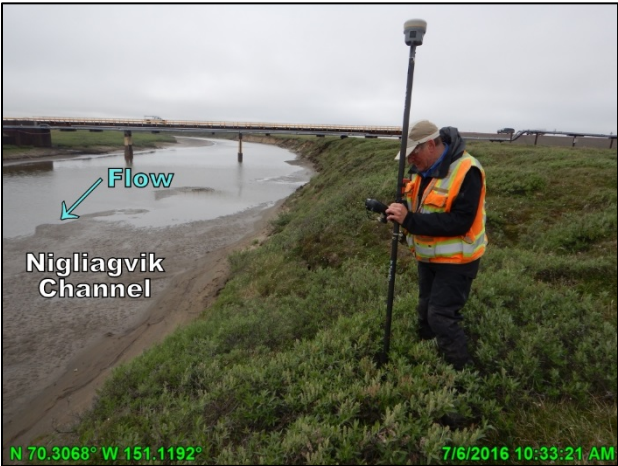
The greatest bank erosion observed between 2013 and 2016 along the west bank was 9.3 feet occurring at station 0+00, approximately 480 feet upstream (south) of the Nigliagvik Bridge. The average rate of erosion at station 0+00 is 3.1 ft/yr. The average rate of change for all

Photo 6.7: West bank downstream of the Nigliagvik Bridge, looking south; July 6, 2016

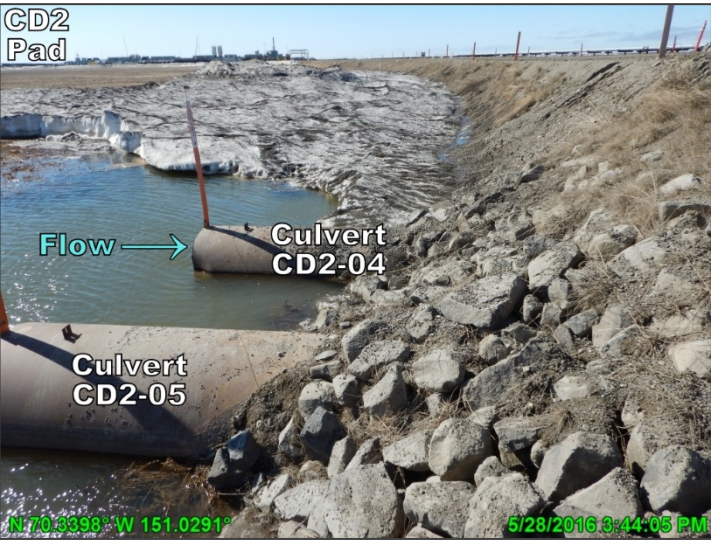
Photo C.1: South side of CD2 road east of CD2 pad, looking west; May 28, 2016

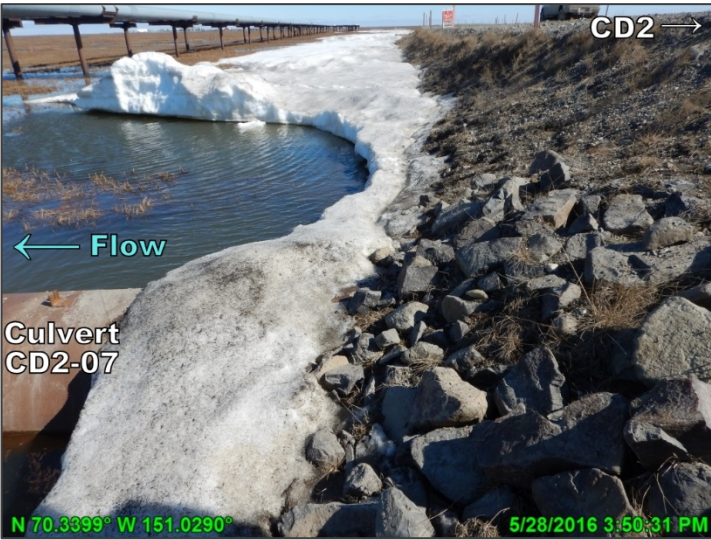
Photo C.2: North side of CD2 road east of CD2 pad, looking east; May 28, 2016

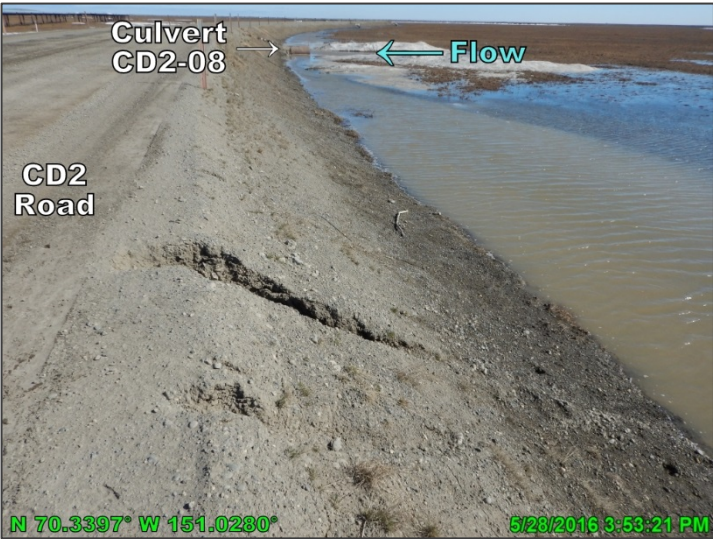
Photo C.4: South side of CD2 road west of CD2 pad, looking east; May 28, 2016

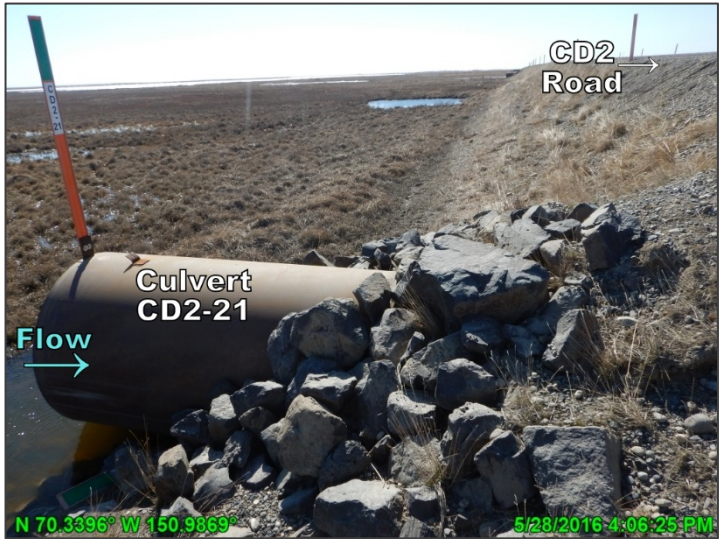
Photo C.5: South side of CD2 road west of the Short Swale Bridge, looking west; May 28, 2016

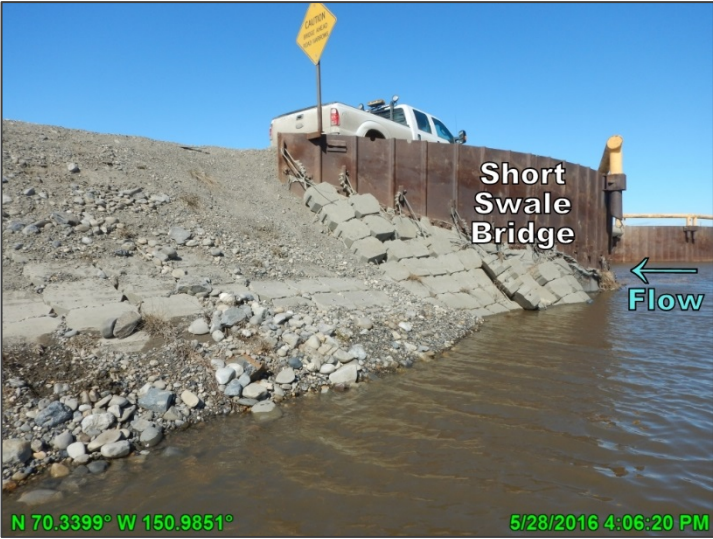
Photo C.6: South side of CD2 road west of the Short Swale Bridge, looking northeast; May 28, 2016

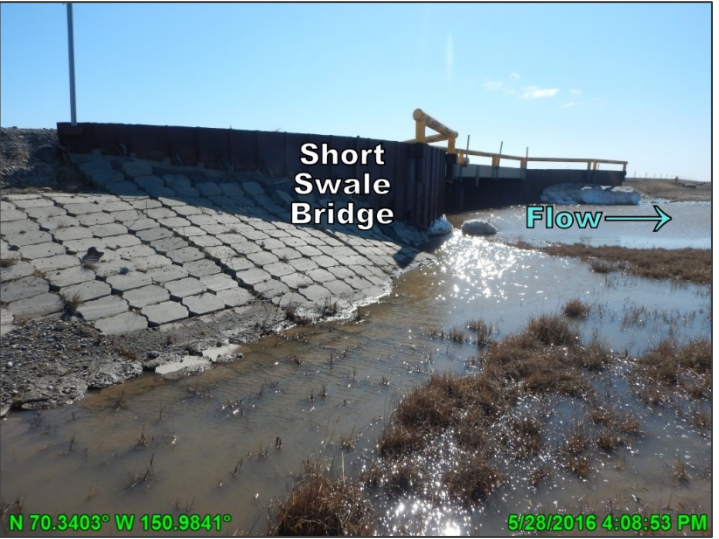
Photo C.7: North side of CD2 road east of the Short Swale Bridge, looking southwest; May 28, 2016

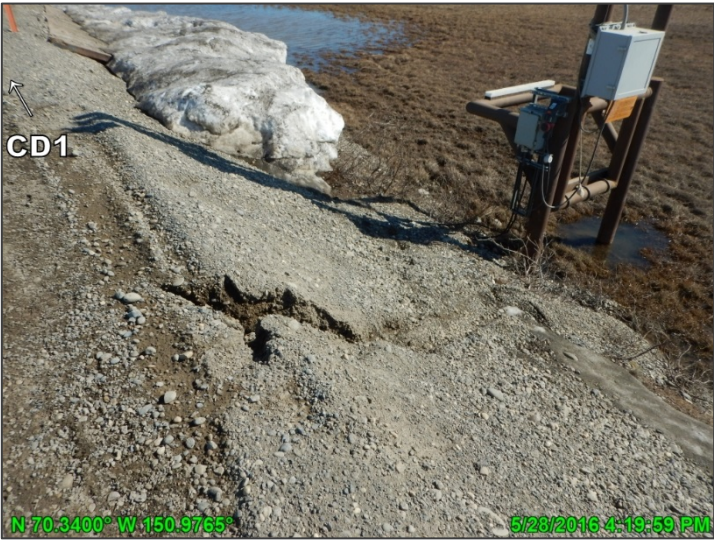
Photo C.8: South side of CD2 road west of the Long Swale Bridge, looking southwest; May 28, 2016

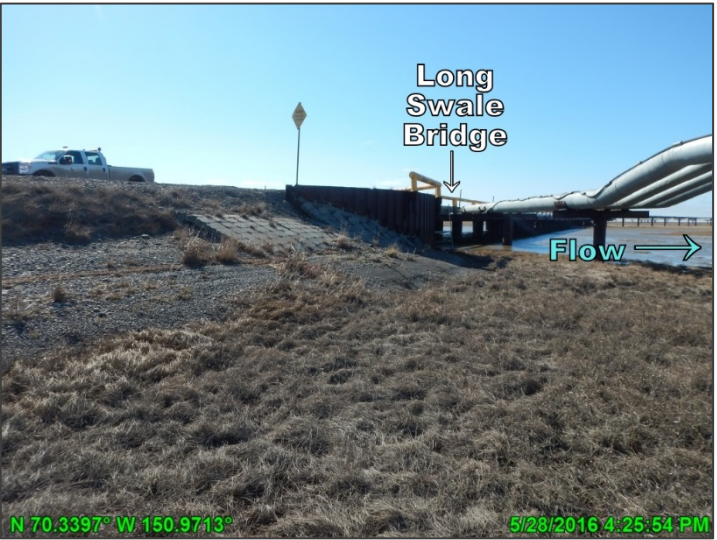
Photo C.9: North side of CD2 road east of the Long Swale Bridge, looking west; May 28, 2016

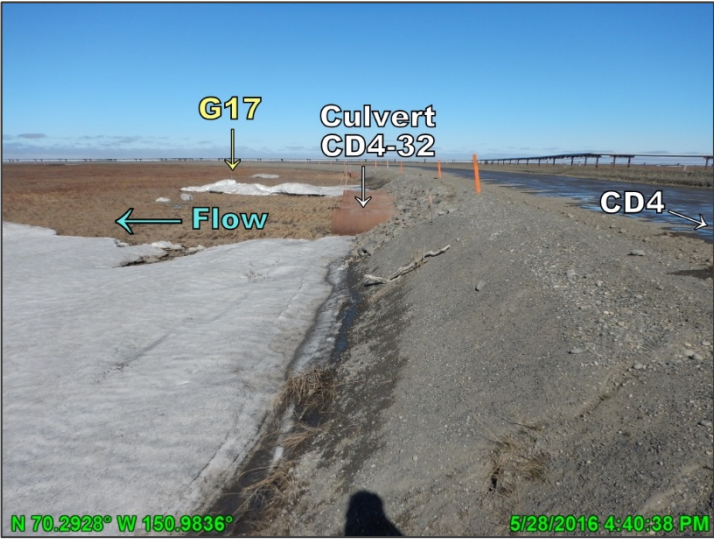
Photo C.10: North side of CD4 road east of CD4 pad, looking northeast; May 28, 2016

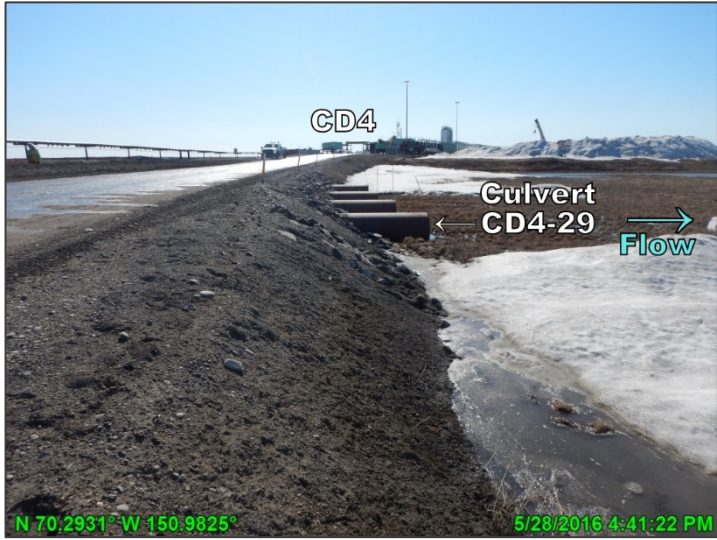
Photo C.11: North side of CD4 road east of CD4 pad, looking southwest; May 28, 2016

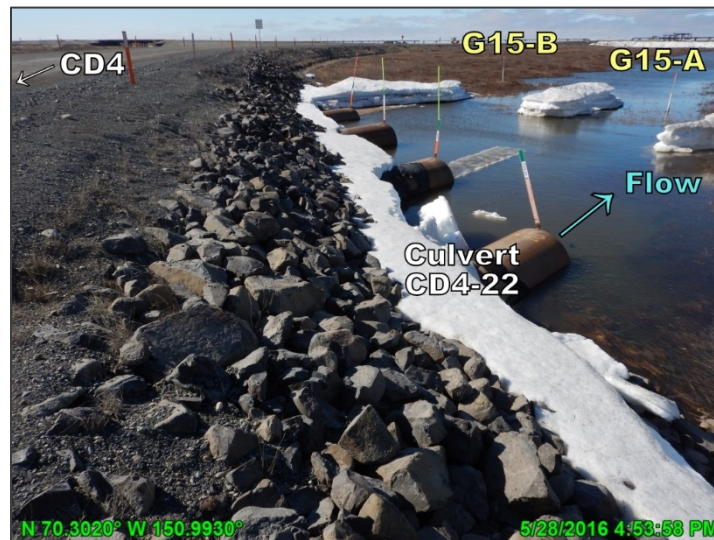
Photo C.12: East side of CD4 road south of CD5 road, looking northwest; May 28, 2016

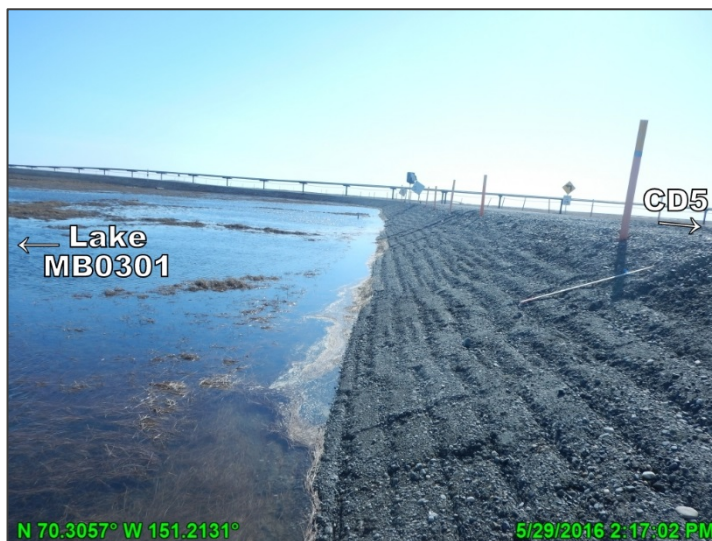
Photo C.13: East side of CD5 road south of CD5 pad, looking southeast; May 29, 2016

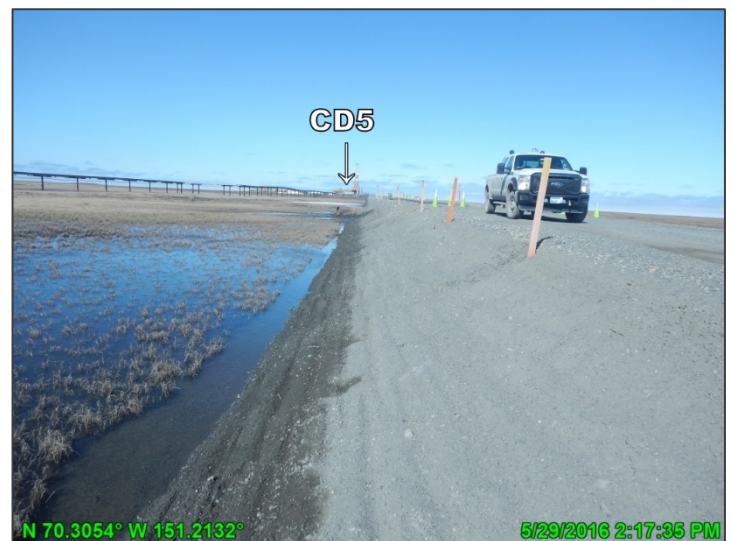
Photo C.14: West side of CD5 road south of CD5 pad, looking northwest; May 29, 2016

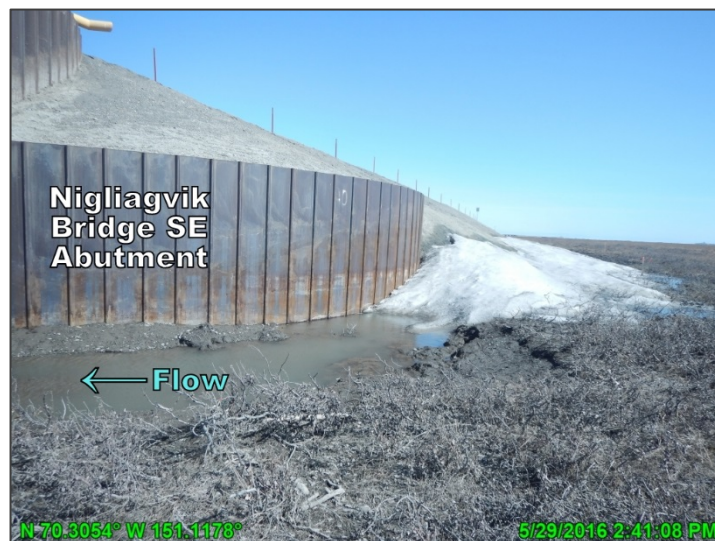
Photo C.16: South side of CD5 road at the Nigliagvik Bridge, looking east; May 29, 2016

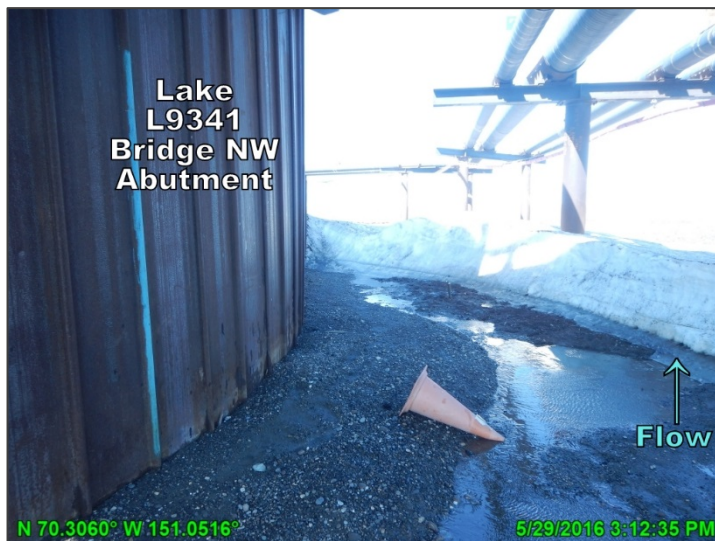
Photo C.17: North side of CD5 road at the Lake L9341 Bridge, looking north; May 29, 2016

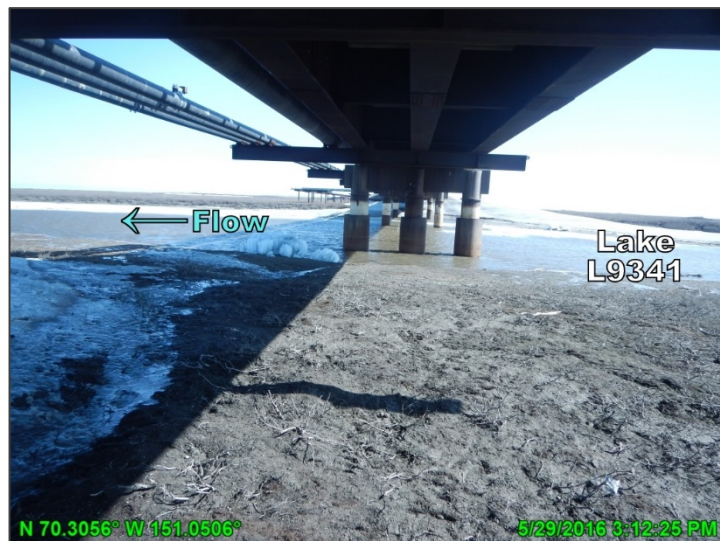
Photo C.18: Under the Lake L9341 Bridge, looking east; May 29, 2016

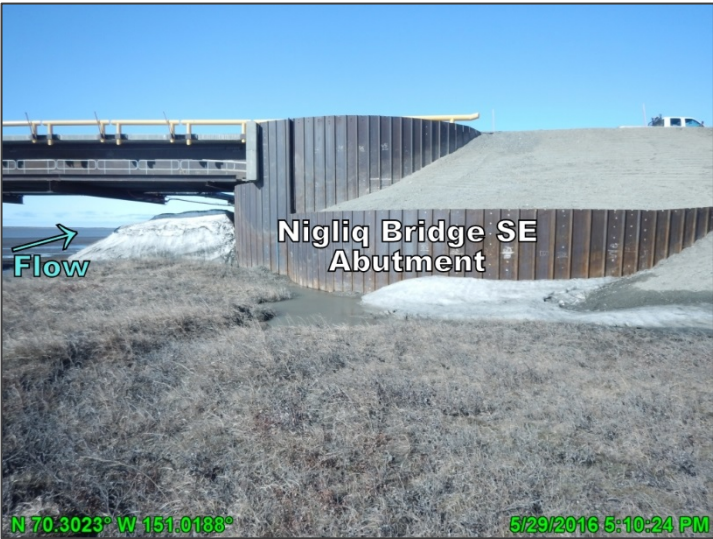
Photo C.19: South side of CD5 road at the Nigliq Bridge, looking north; May 29, 2016

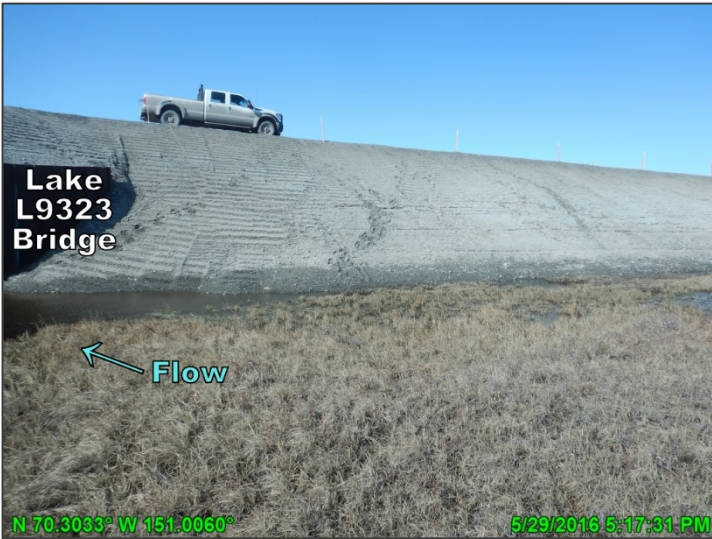
Photo C.20: South side of CD5 road east of Lake L9323 Bridge, looking north; May 29, 2016

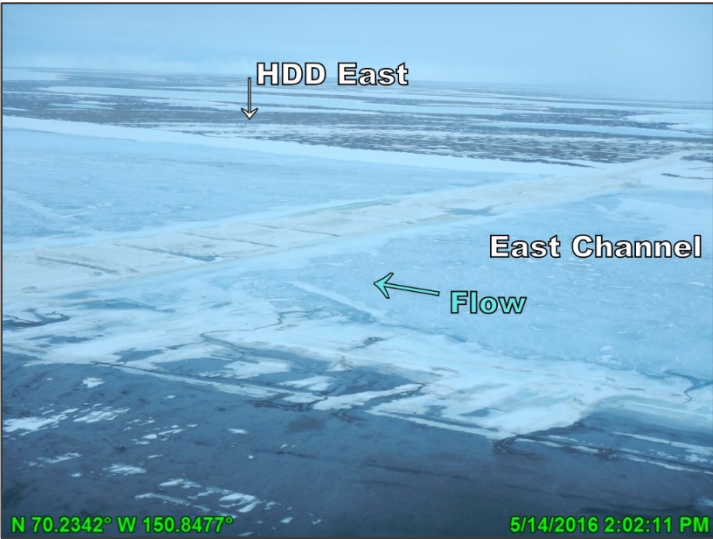
Photo C.21: Colville River pre-breakup, looking northeast.; May 14, 2016

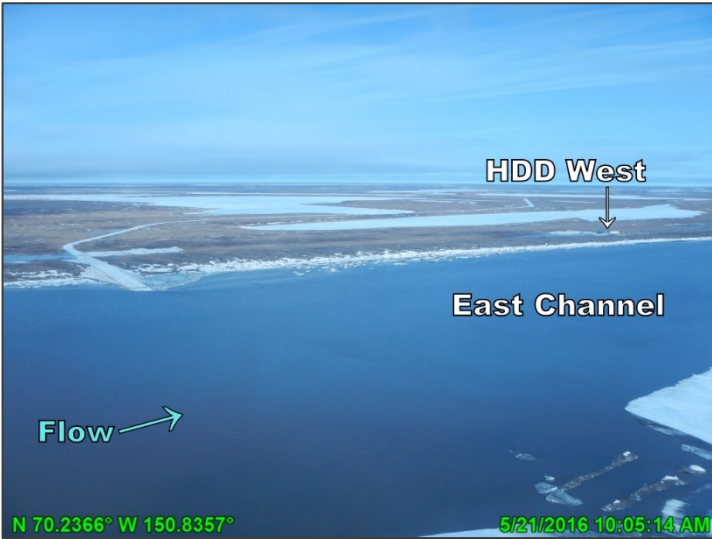
Photo C.22: Colville River during breakup, looking west; May 21, 2016

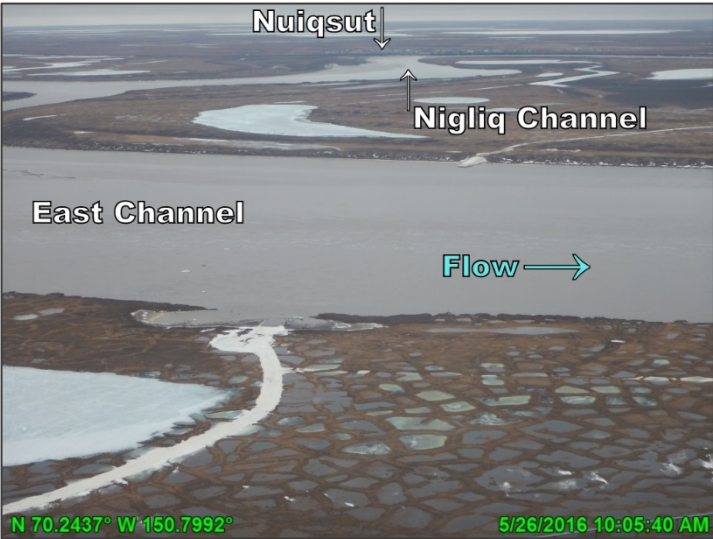
Photo C.23: Colville River post breakup, looking southwest; May 26, 2016

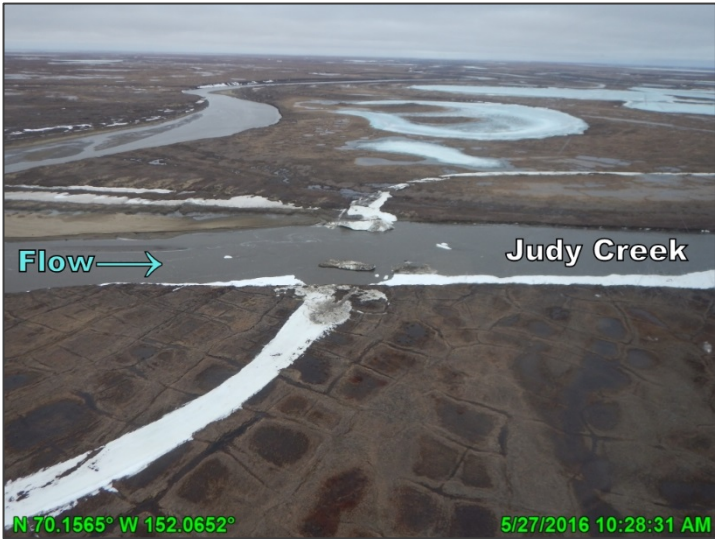
Photo C.24: Judy Creek post breakup, looking southwest; May 27, 2016
