2019 Colville River Delta Spring Breakup Monitoring & Hydrological Assessment

Michael Baker International 3900 C Street Suite 900 Anchorage, AK 99503

MSA Contract No. 296937

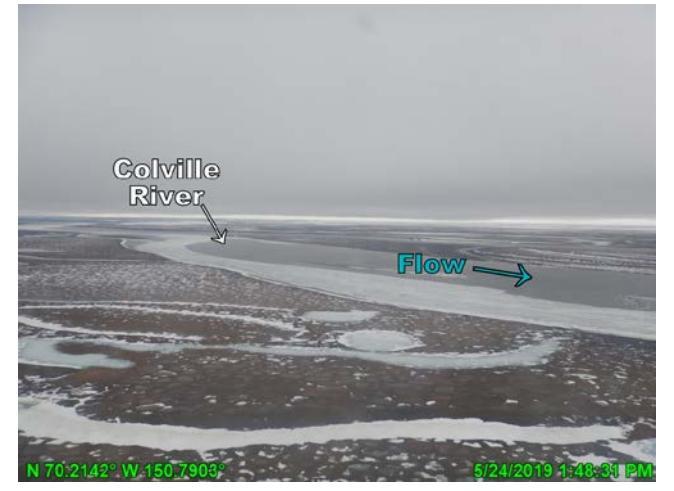
Photo 4.1: Intact channel ice through MON1 reach just prior to release, looking southwest (upstream); May 24, 2019

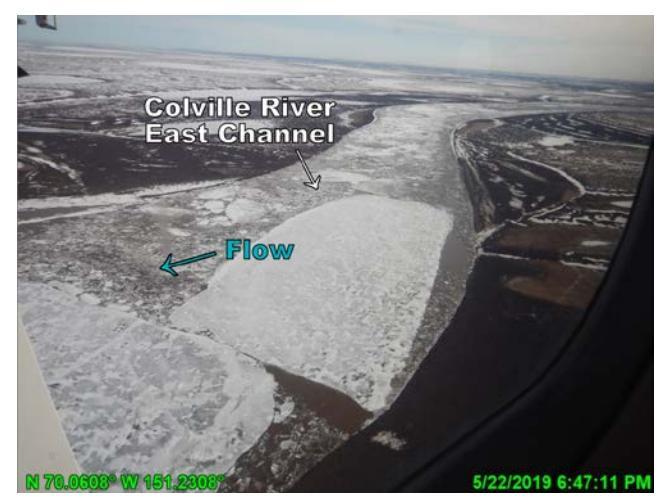
Photo 4.2: Ice jam upstream of horseshoe bends upstream of MON1, looking southwest (upstream); May 22, 2019

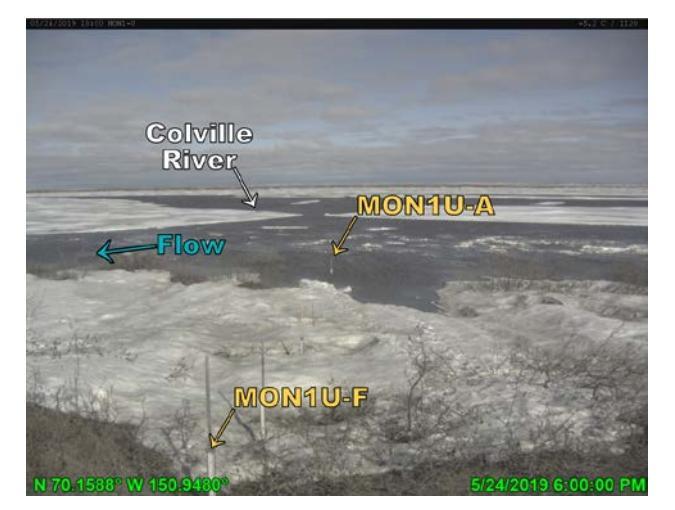
Photo 4.3: Ice jam release through the MON1 reach the day of peak stage, at MON1U looking east; May 24, 2019

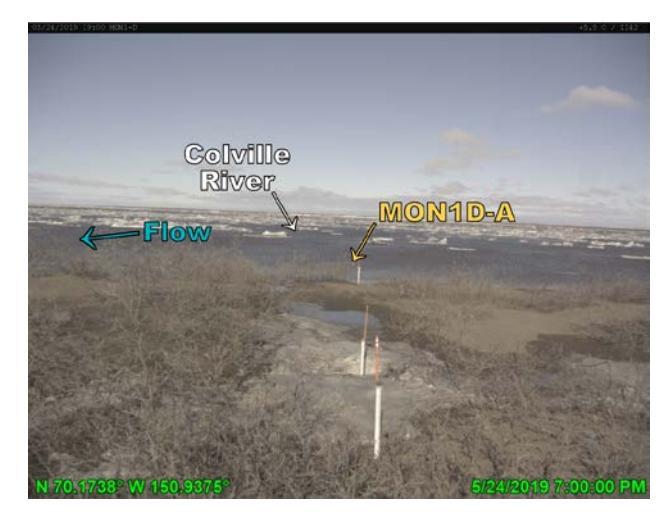
Photo 4.4: Ice jam release through the MON1 reach the day of peak stage, at MON1D looking east; May 24, 2019

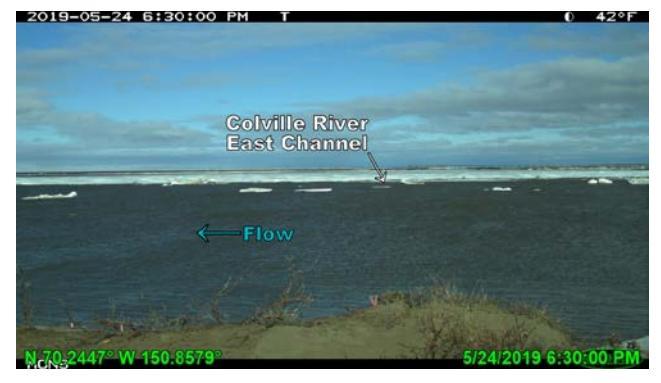
Photo 4.6: Ice jam release moving through MON9 reach and influencing peak discharge, looking east; May 24 2018

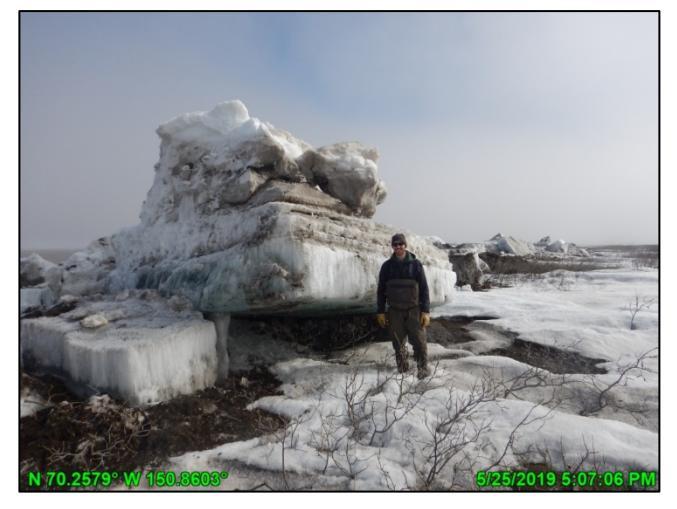
Photo 4.7: Rafted ice floes post ice jam release stranded on the bank at MON9D; May 25, 2019

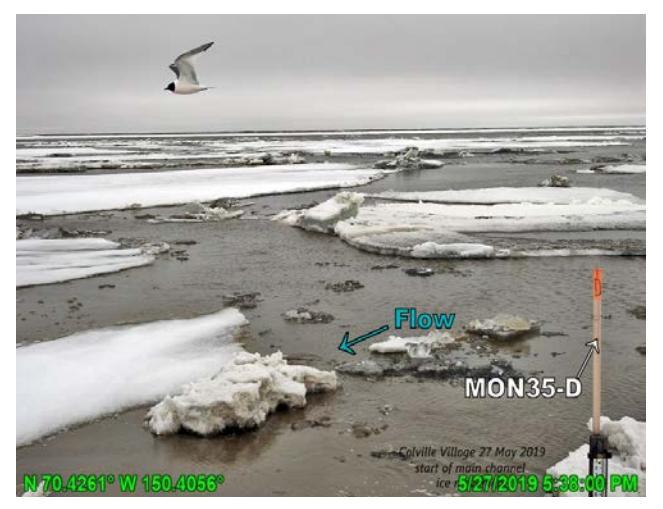
Photo 4.8: Break up of channel ice at MON35/Helmericks Homestead; May 27, 2019

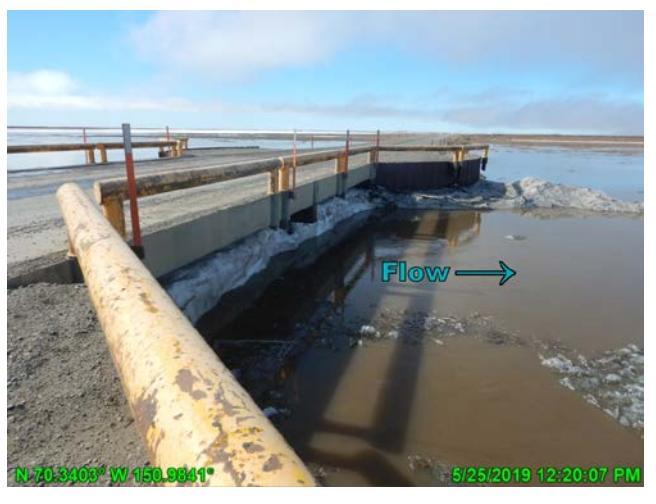
Drainage structures are kept free of ice, snow accumulation, and blockages through regular maintenance by CPAI. Plywood covers are installed at the culvert inlets and outlets during the winter and removed prior to breakup. Snow is also mechanically removed from the immediate upstream and downstream areas of all culverts and the CD2 swale bridges prior to breakup flooding. Snow was cleared from the entrances and exits of CD2 swale bridges prior to the arrival of floodwater, though drifted snow remained immediately beneath the swale bridges at the onset of breakup flow (Photo 4.15 and Photo 4.16).

Photo 4.16: Drifted snow downstream of the CD2 short swale bridge, looking west; May 25, 2019

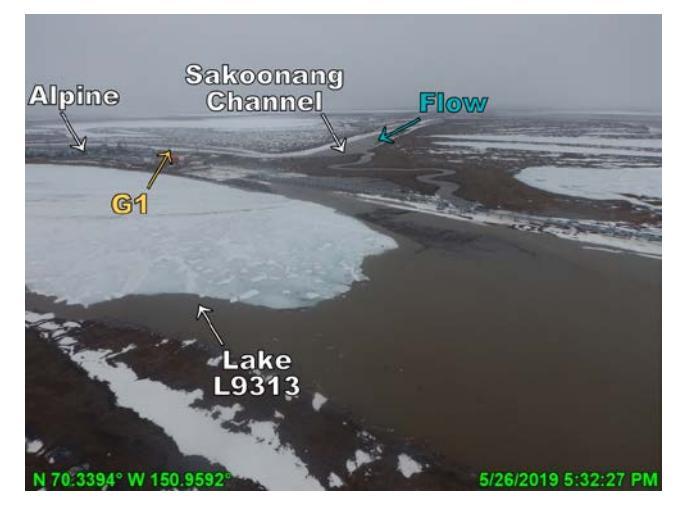
Photo 4.17: Peak stage at G1 under the influence of channel ice in the Sakoonang, looking east; May 26, 2019

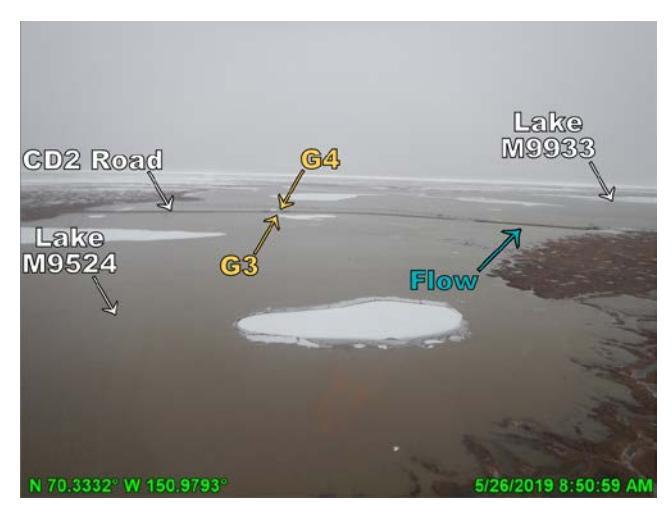
Floodwater along the CD2 road was only present around gages G3/G4. Monitoring locations G6/G7, G12/G13, and G8 were either dry or only had local melt. The long swale bridge, the short swale bridge, and four adjacent culverts conveyed flow from the Nigliq Channel (via Nanuq Lake then Lake M9524) across the CD2 road north toward lakes L9316 and M9933 (Photo 4.20). Peak stage occurred at G3 and G4 on May 25 and May 26. Discharge was measured at the long swale bridge and area culverts on May 25, within a few hours of peak; discharge was measured at the short swale bridge on May 26.

Photo 4.20: Flood extents along the CD2 road during peak stage conditions, looking north (downstream); May 26, 2019

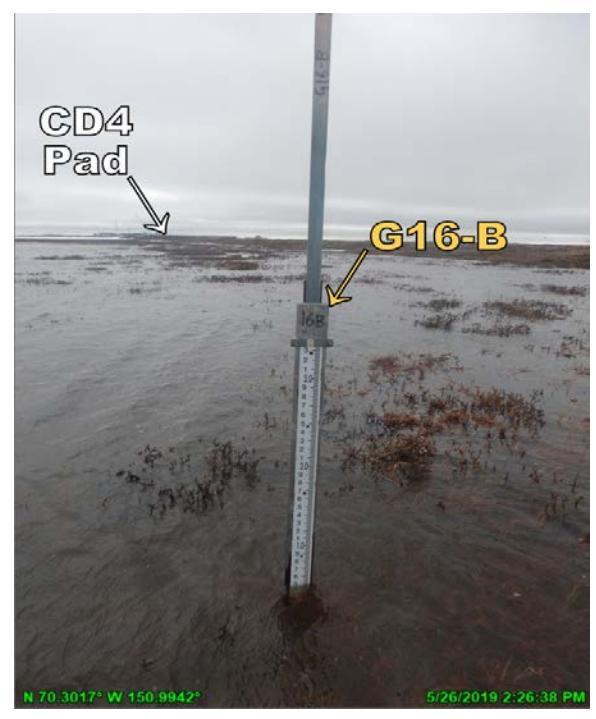
Initial melt was observed at road gages G15/G16 on March 26 (Photo 4.28 and Photo 4.29). The PT stage indicates that connectivity through the road culverts at the G15/G16 gages. These drainage structures, however, were not accessible because of ice and snow blockages. Discharge was not measured, and peak discharge was not calculated for culverts at this location.

Photo 4.28: Peak stage at gage G16, looking north; May 26, 2019

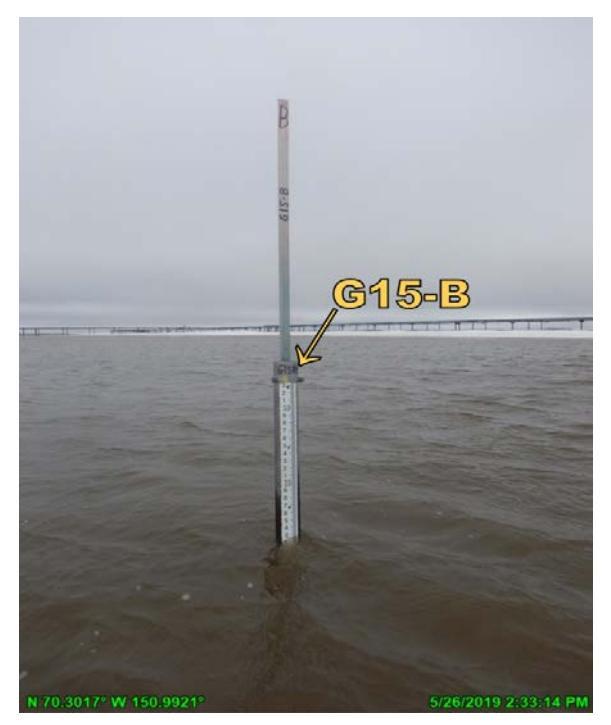
Photo 4.29: Peak stage at gage G15, looking north; May 26, 2019

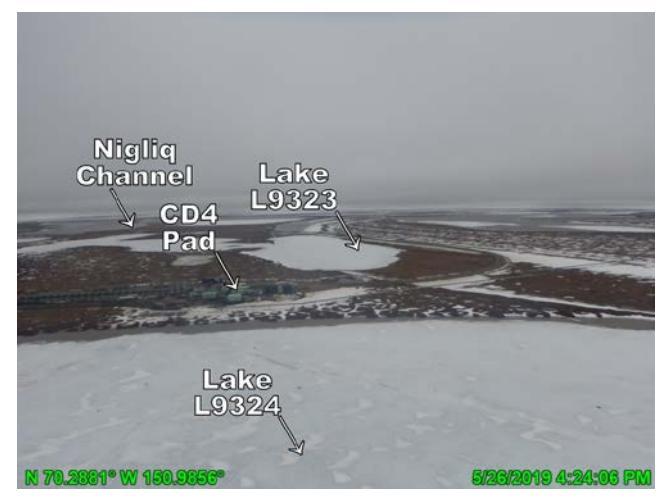
Initial melt was observed at road gages G17 and G18 on May 25. Stage increased sufficiently to cause a brief hydraulic connection through the culverts on this day which was, based on the lack of evidence of overland flooding in the area (Photo 4.30), attributed to local melt. Discharge was measured at culverts CD4-25, 26, 27, and 28 on May 25 (Photo 4.31), which performed as designed to equalize flow across the CD4 road. Peak discharge was calculated for these culverts. The timing of peak discharge, however, nearly coincides with the measured discharge, suggesting that the peak value is too high. This is likely influenced by ice and snow inside the culverts and variation in the culvert invert elevations since the date of last survey (UMIAQ 2017).

Photo 4.30: Lack of evidence of overland flooding at CD4 road near gages G17/G18, looking north; May 26, 2019

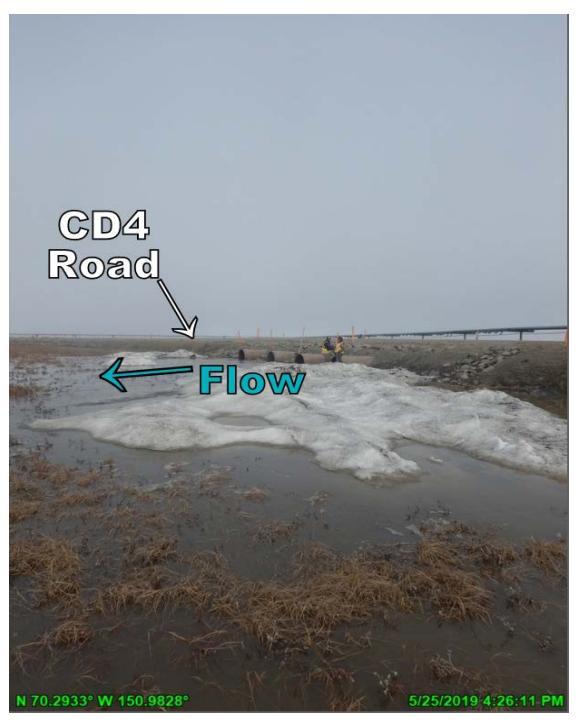
Photo 4.31: Local melt at CD4 road culverts near gages G17/G18; May 25, 2019

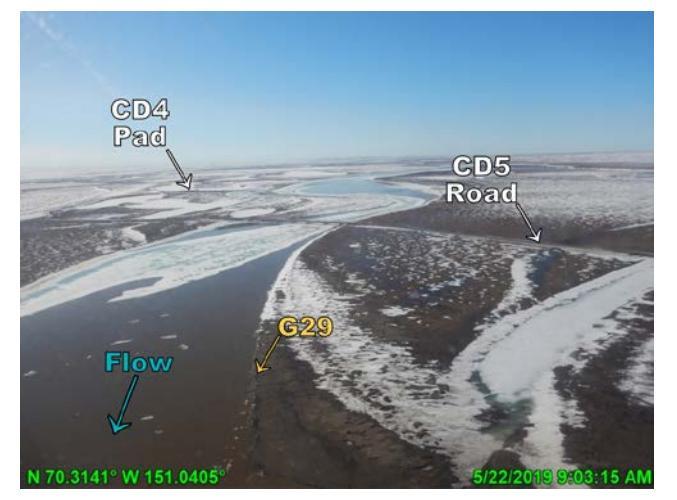
Photo 4.33: Channel ice at Nigliq Bridge, looking south (upstream); May 22, 2019

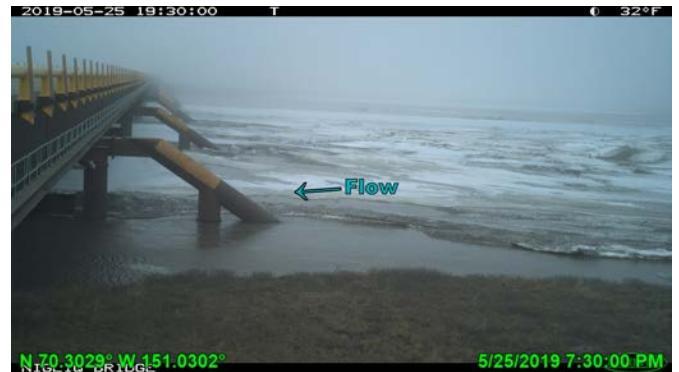
Photo 4.34: Channel ice intact at Nigliq Bridge at 7:30pm, looking east; May 25, 2019

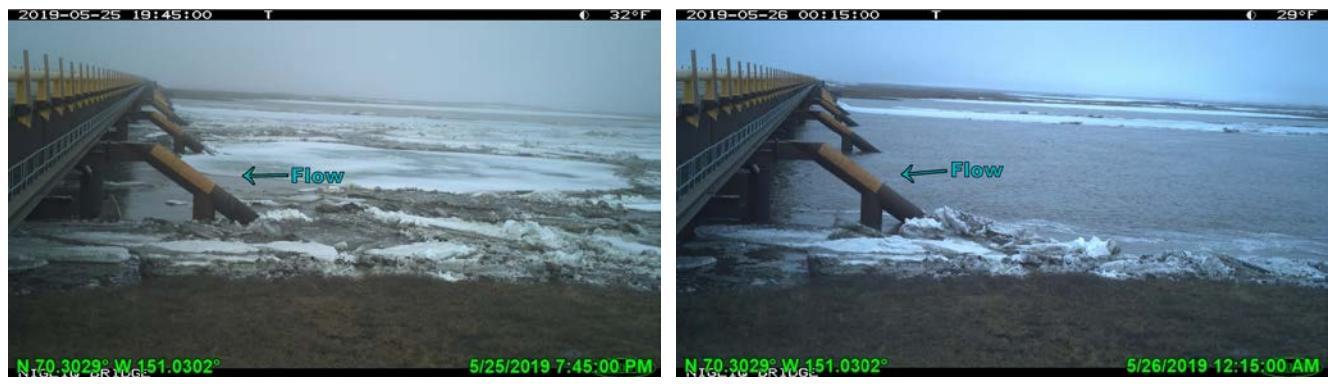
The leading edge of floodwater in the Nigliq Channel passed under the bridge on May 21. Channel ice remained intact through the reach (Photo 4.33) until cleared by the progression of ice jamming and release through the bridge on May 25 (Photo 4.34 and Photo 4.35). Stage through the reach peaked after the channel ice moved downstream (Photo 4.36), potentially the result of backwater created by jams further downstream. Some floes remained caught or grounded on the upstream side of the bridge on May 26 (Photo 4.37).

Photo 4.35: Channel ice being broken and pushed downstream at 7:45pm by upstream ice jam release, looking east; May 25, 2019 Photo 4.36: Peak conditions at the Nigliq Bridge, looking east; May 26, 2019

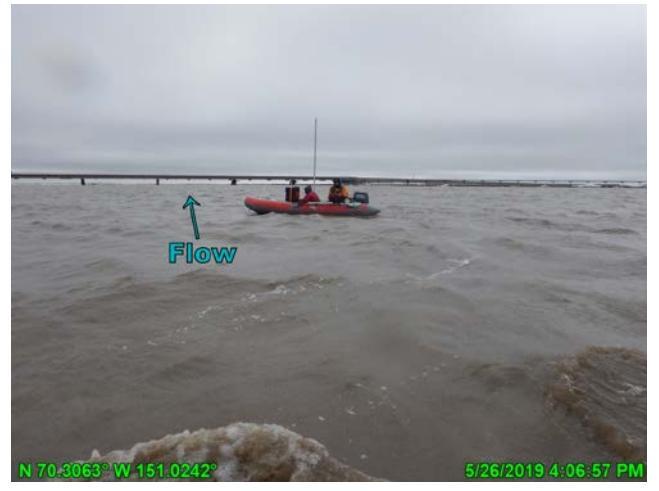
Discharge was measured on May 26 downstream of the Nigliq Bridge. At the time of the measurement, large pans were still situated upstream of the bridge but the channel, where the measurement was performed, was mostly clear of snow and ice and conditions were considered steady and uniform (Photo 4.38). The average velocity was 2.57 fps. The quality of the measurement was classified as good. Indirect discharge calculated at the time of direct measurement was 0.67 percent higher than the measured discharge.

Photo 4.38: Measuring discharge downstream from the Nigliq Bridge, looking south; May 26, 2019

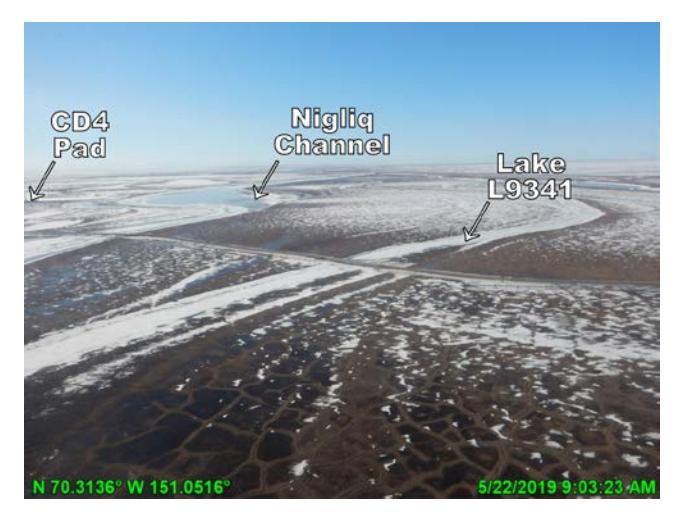
Competent ice was present and visible throughout the paleochannel including at the Lake L9341 surface throughout breakup (Photo 4.39) including during peak conditions. Peak breakup stage at the Lake L9341 bridge was the result of backwater from the Nigliq Channel (Photo 4.40). Nigliq Channel water levels were not sufficient to enter the upstream end of the paleochannel; therefore, no flow was observed through the Lake L9341 bridge.

Photo 4.39: Competent ice in Lake L9341 as breakup initiates, looking south; May 22, 2019

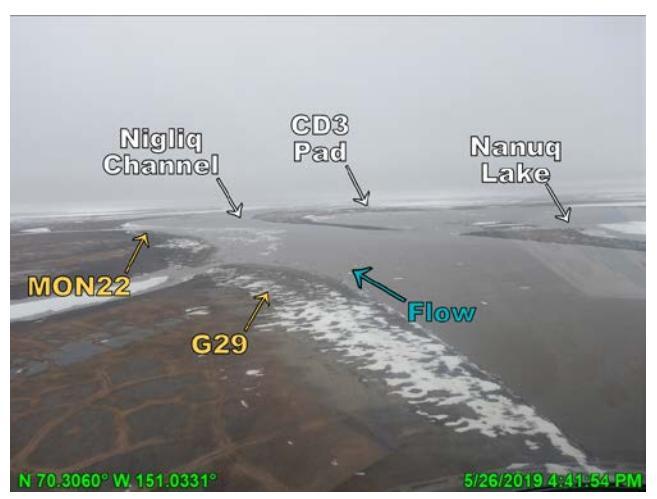
Photo 4.40: Nigliq Channel backwater influence at the north end of Lake L9341 the day of peak stage, looking southeast (downstream); May 26, 2019

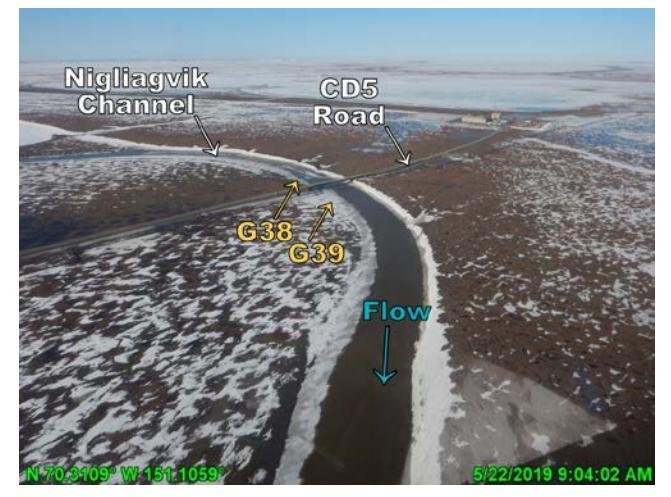
Channel ice was present upstream of the bridge throughout breakup (Photo 4.41) including during peak conditions (Photo 4.42) and floes remained in the vicinity of the bridge after peak. This ice prevented measuring discharge during peak conditions. Peak discharge could not be calculated due to a lack of data from the equipment malfunction.

Photo 4.41: Conditions in the Nigliagvik Channel, looking southwest (upstream); May 22, 2019

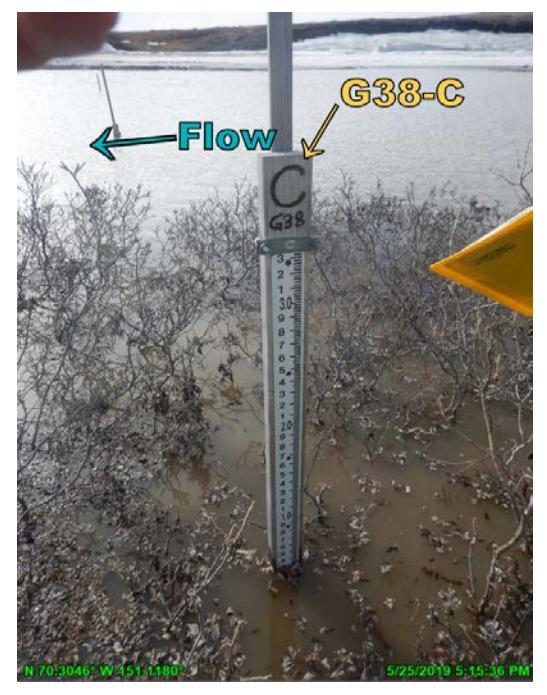
Photo 4.42: Nigliagvik Channel one day prior to peak stage, looking west; May 25, 2019

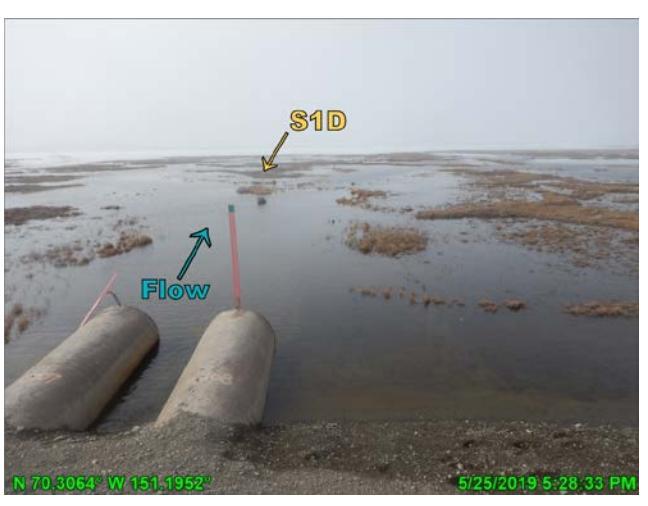
Stage remained below the PT elevation at gages S1/S1D throughout breakup. Flow was observed (Photo 4.43) and measured at two culverts along the CD5 road west of the Nigliagvik Channel twice during breakup monitoring. Peak discharge was not calculated for either location; there are no gages at the CD5-04 vicinity and stage at S1/S1D was too low for PT recordings at the CD5-07 vicinity. Gages S1/S1D stage and discharge data is provided in Graph 4.17. Measured discharge at CD5 road culverts conveying flow is summarized in Table 4.4. Additional culvert discharge data is provided in Appendix C.

Photo 4.44: South to north (downstream) flow through culverts at S1/S1D gages, looking north; May 25, 2019

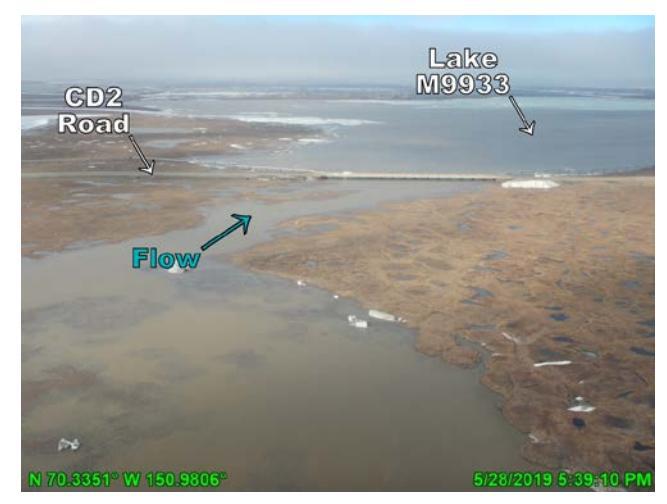
Alpine road and pads were inspected for erosion between June 3 and June 4. Photo 5.1 through Photo 5.4 show major drainage structures that passed breakup flow as stage is subsiding. No discernable erosion attributable to 2019 breakup flooding was observed during aerial and ground reconnaissance of the CD2, CD4, and CD5 roads. Floodwaters did not reach CD5 bridge abutments or the CD5 road within the CRD. Washlines from 2015 spring breakup, which was the largest historical flood event to impact Alpine facilities, remain evident along portions of the CD2, CD4, and CD5 roads. There were no signs of sloughing or undermining at drainage structures. Additional photo documentation of erosion surveys and breakup conditions along the Alpine facilities roads and pads are shown in Appendix D.

Photo 5.1: CD2 road long swale bridge as breakup ebbs, looking north; May 28, 2019

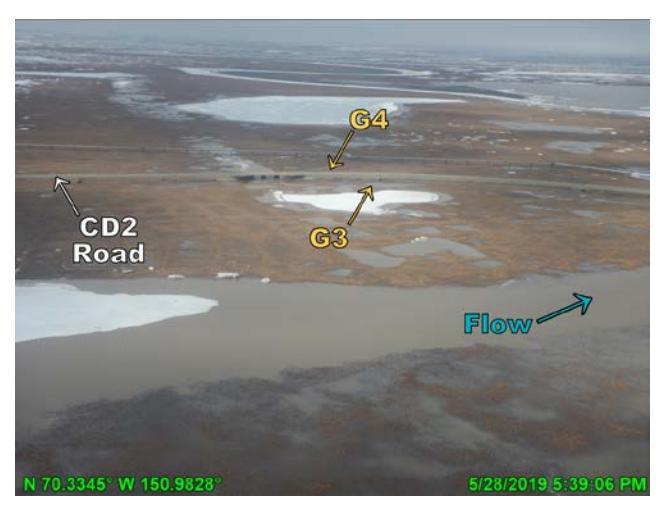
Photo 5.2: CD2 road short swale bridge as breakup ebbs, looking north; May 28, 2019

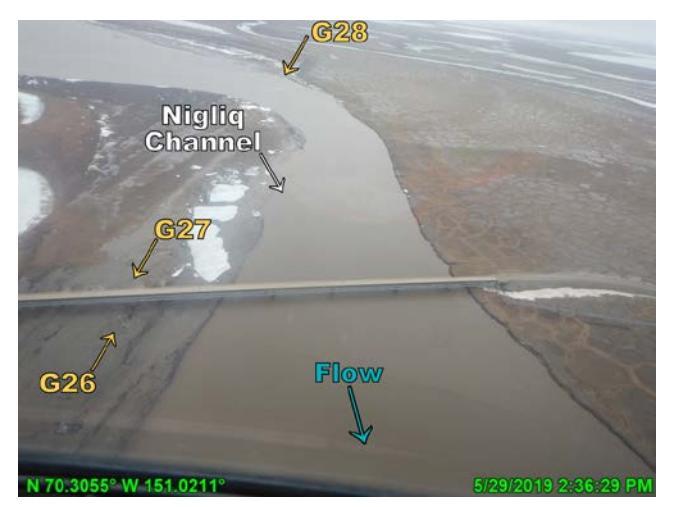
Photo 5.3: CD5 road Nigliq Bridge #2 as breakup ebbs, looking south (upstream); May 29, 2019

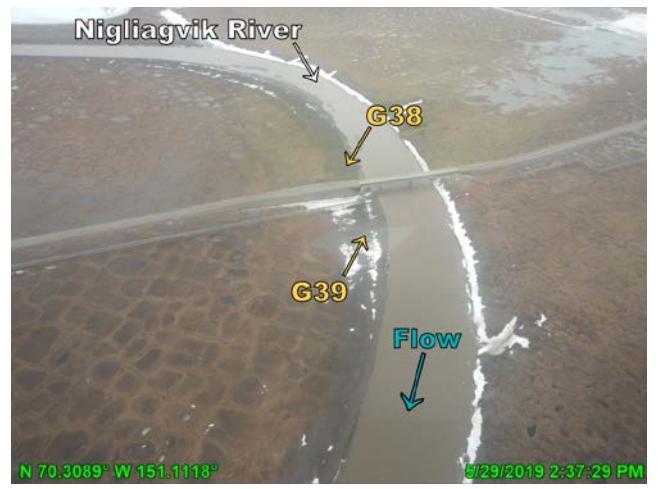
Photo 5.4: CD5 road Nigliagvik Bridge #4 as breakup ebbs, looking south (upstream); May 29, 2019

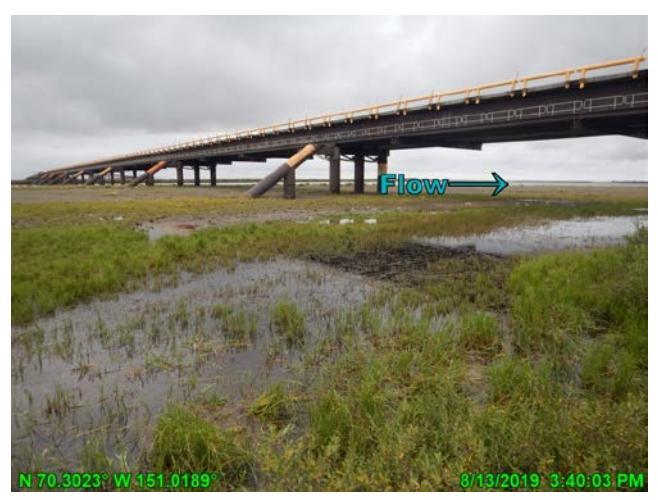
Site conditions during the bank erosion survey at the Nigliq Bridge and Nigliagvik Bridge are presented in Photo 6.1 through Photo 6.4. Maximum incremental and cumulative erosion at the Nigliq Bridge and Nigliagvik Bridge and maximum incremental, maximum cumulative, and average erosion along the top of bank, upstream and downstream of the bridges, is presented in Table 6.3. Bank erosion tabulated data is presented in Appendix E (UMIAQ 2019b).

Photo 6.2: East bank of the Nigliq Channel near the Nigliq Bridge, looking northwest; August 13, 2019

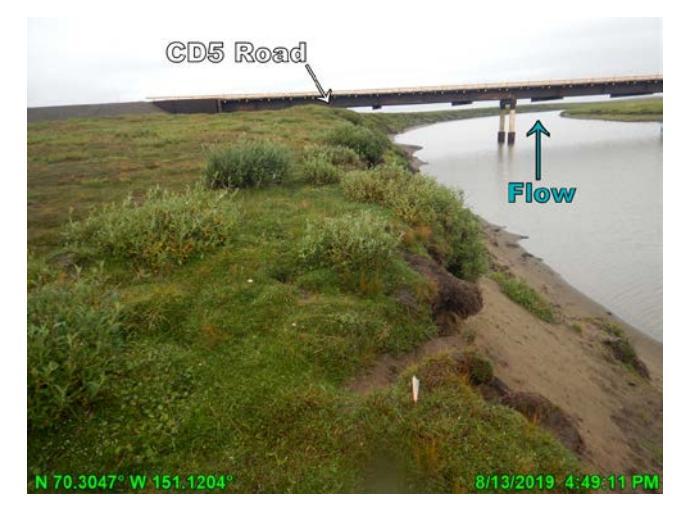
Photo 6.3: West bank of the Nigliagvik Channel near the Nigliagvik Bridge, looking north (downstream); August 13, 2019

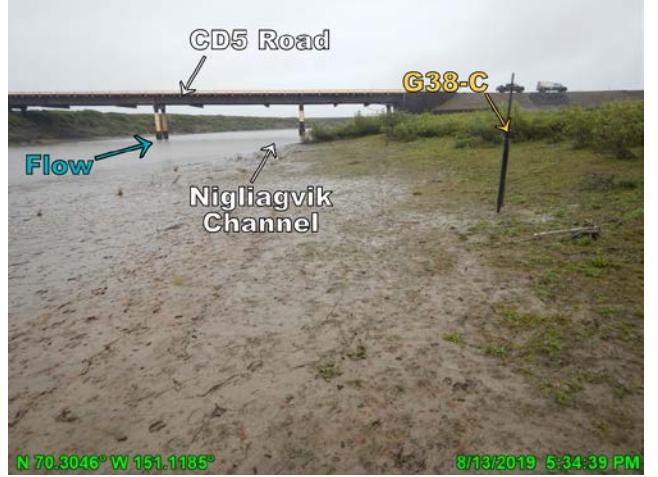
Photo 6.4: East bank of the Nigliagvik Channel, looking north (downstream); August 13, 2019

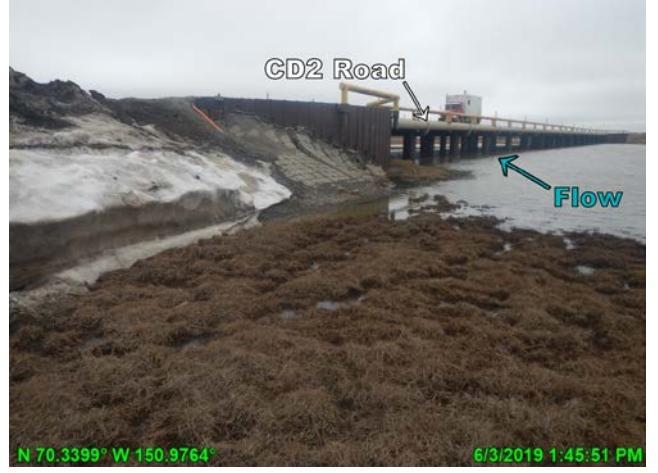
Photo D.1: CD2 road long swale bridge SW abutment, looking east; June 3, 2019

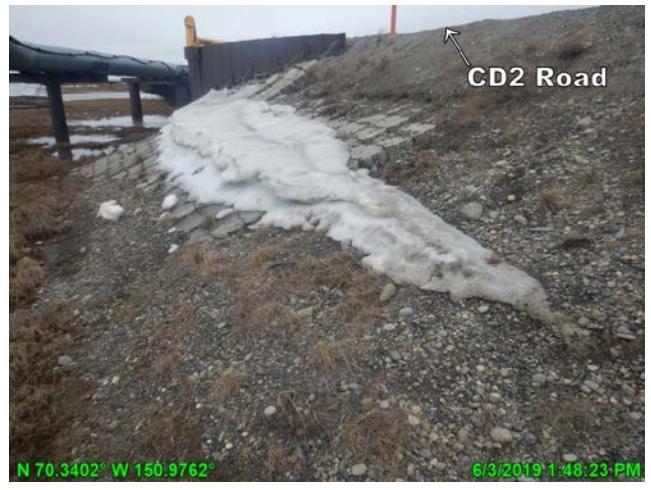
Photo D.2: CD2 road long swale bridge NW abutment, looking east; June 3, 2019

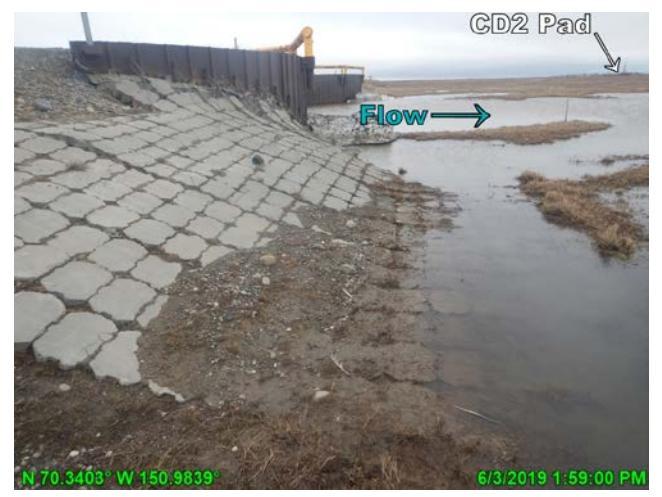
Photo D.3: CD2 road short swale bridge SW abutment, looking west; June 3, 2019

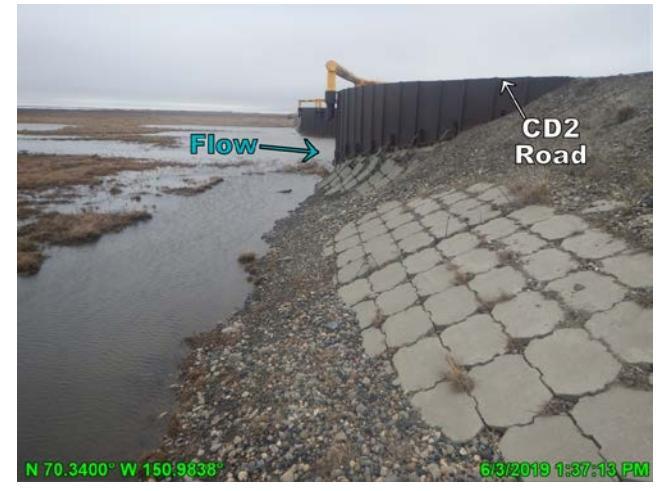
Photo D.4: CD2 road short swale bridge NW abutment, looking east; June 3, 2019

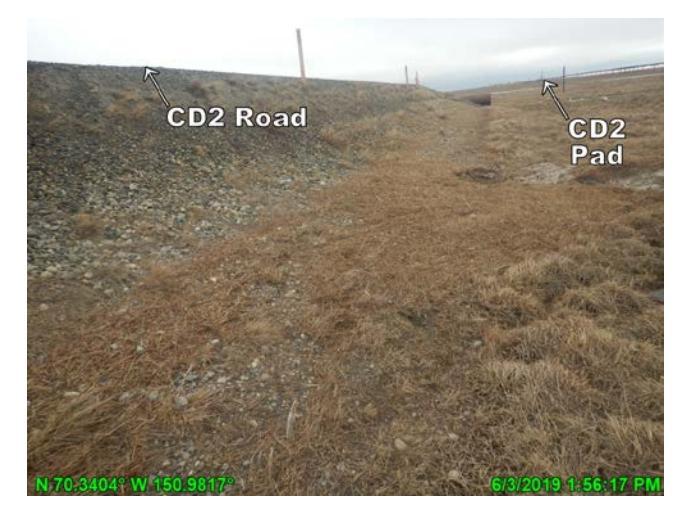
Photo D.5: Road in vicinity of culvert CD2-21N post-breakup, looking west; June 3, 2019

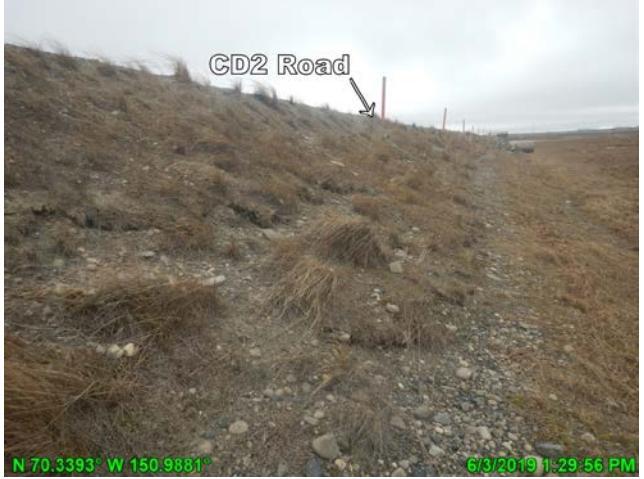
Photo D.6: Road in vicinity of culvert CD2-21S post-breakup, looking east; June 3, 2019

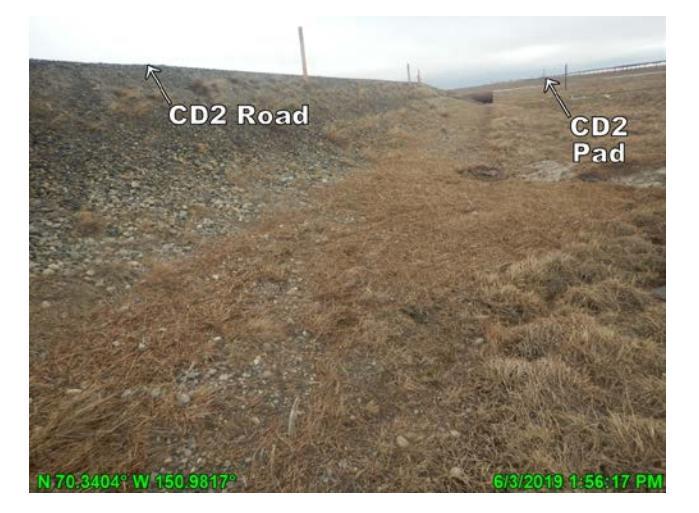
Photo D.7: Road in vicinity of culvert CD2-22N post-breakup, looking west; June 3, 2019

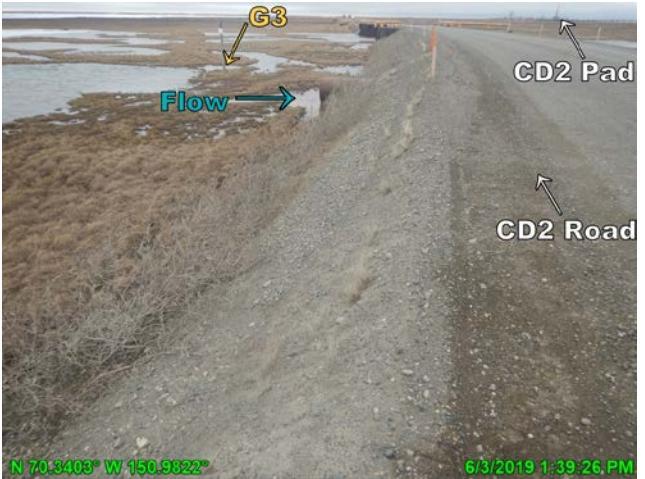
Photo D.8: Road in vicinity of culvert CD2-22S post-breakup, looking west; June 3, 2019

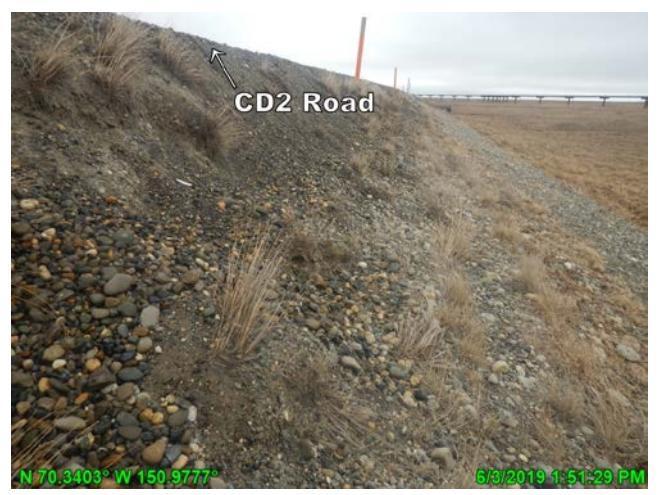
Photo D.9: Road in vicinity of culvert CD2-23N post-breakup, looking west; June 3, 2019

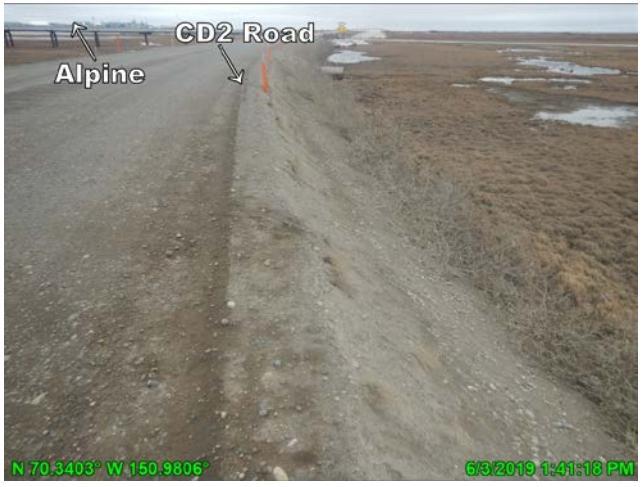
Photo D.10: Road in vicinity of culvert CD2-23S post-breakup, looking east; June 3, 2019

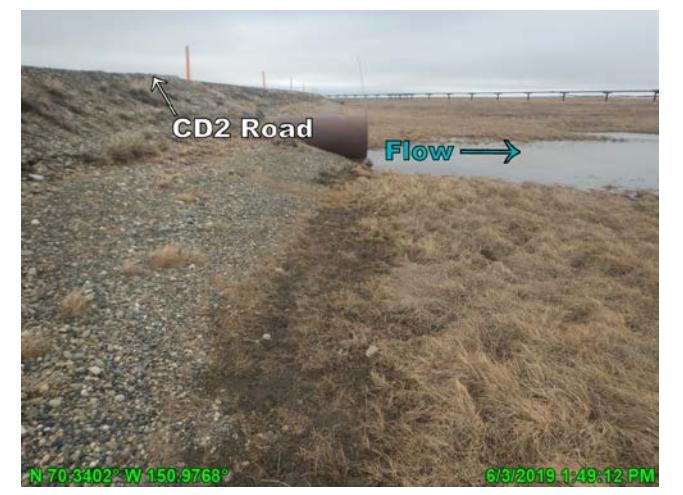
Photo D.11: Road in vicinity of culvert CD2-24N post-breakup, looking west; June 3, 2019

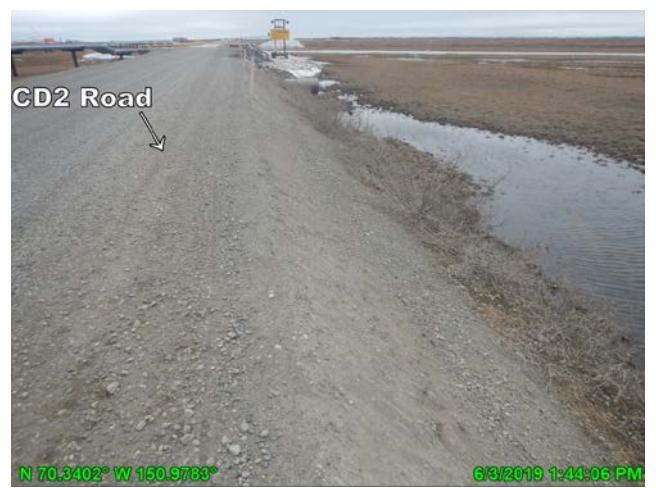
Photo D.12: Road in vicinity of culvert CD2-24S post-breakup, looking east; June 3, 2019

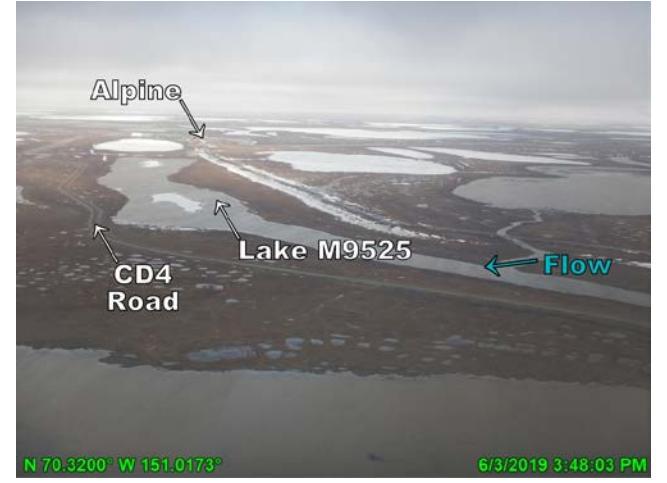
Photo D.13: CD4 road post-breakup, looking northeast; June 3, 2019

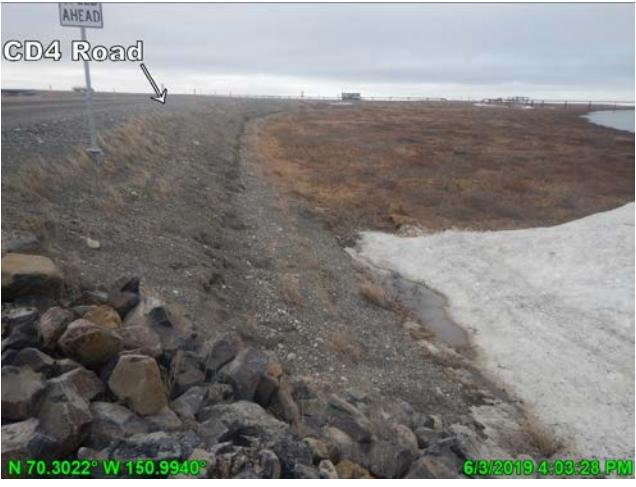
Photo D.14: CD4 road in vicinity of G15 culverts post-breakup, looking northwest; June 3, 2019

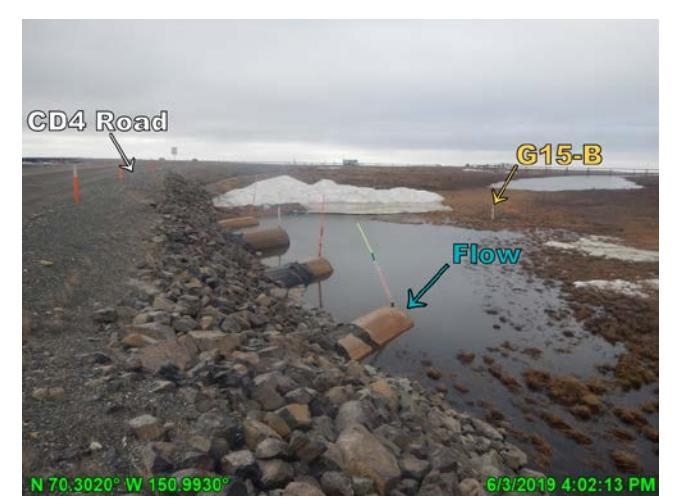
Photo D.15: CD4 road in vicinity of G15 culverts post-breakup, looking northwest; June 3, 2019

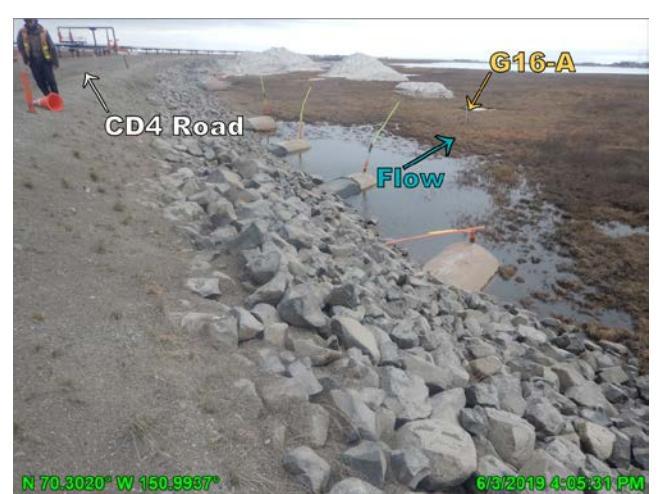
Photo D.16: CD4 road in vicinity of G16 culverts post-breakup, looking southwest; June 3, 2019

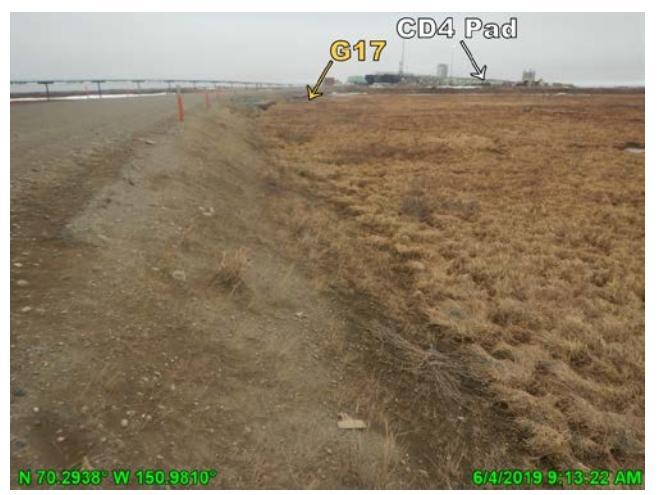
Photo D.17: CD4 road in vicinity of G17 culverts post-breakup, looking west; June 4, 2019

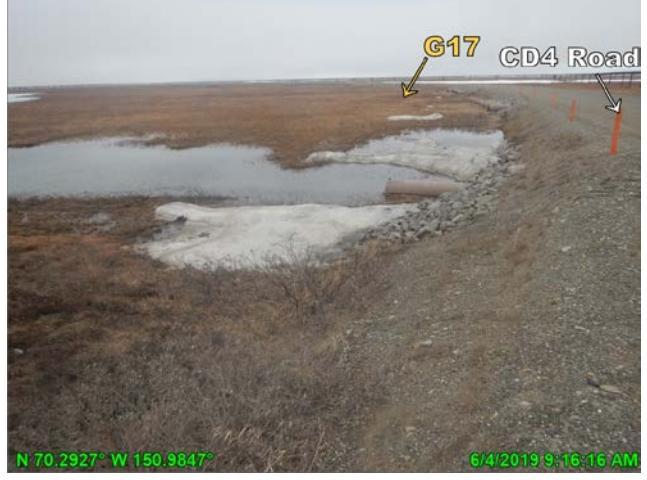
Photo D.18: CD4 road in vicinity of G17 culverts post-breakup, looking east; June 4, 2019

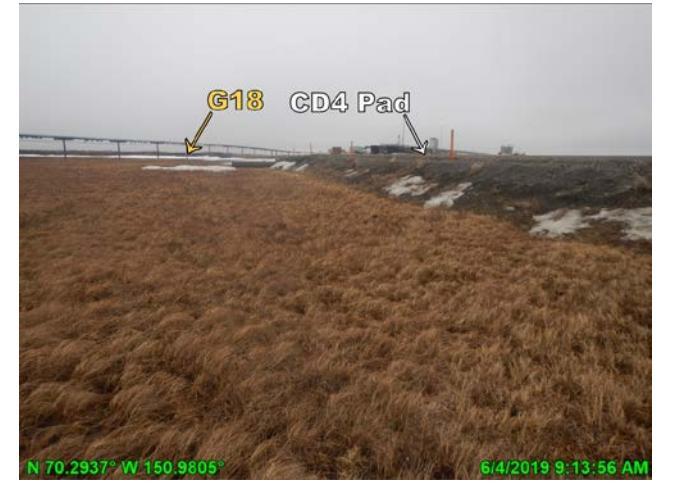
Photo D.19: CD4 road in vicinity of G18 culverts post-breakup, looking west; June 4, 2019

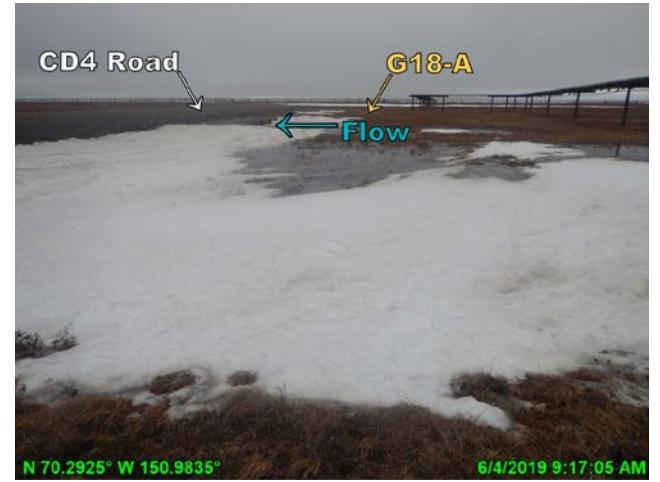
Photo D.20: CD4 road in vicinity of G18 culverts post-breakup, looking east; June 4, 2019

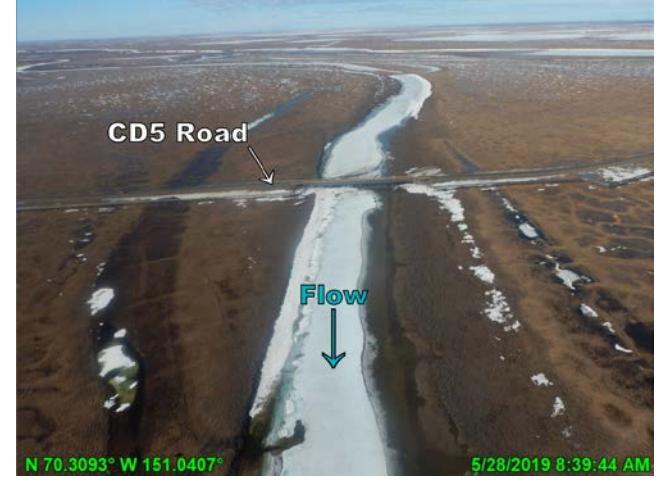
Photo D.21: CD5 road Lake L9341 Bridge #3 as breakup subsides, looking south (upstream); May 28, 2019

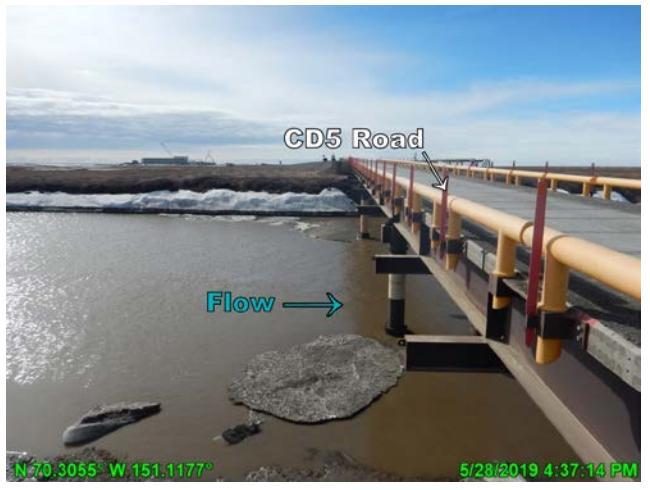
Discharge was not measured at the Nigliagvik Bridge because of the presence of ice in the channel just upstream of the bridge during peak conditions.

Photo D.22: CD5 road Nigliagvik Bridge #4 as breakup subsides, looking west; May 28, 2019

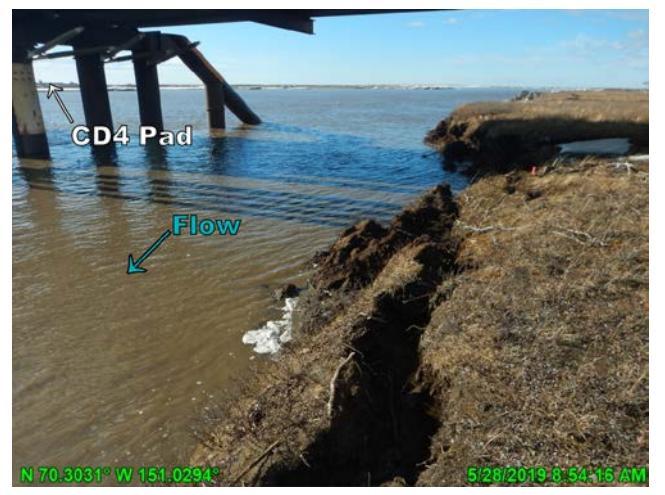
Photo D.23: CD5 road Nigliq Bridge #2 bank sloughing at west abutment, looking south (upstream); May 28, 2019

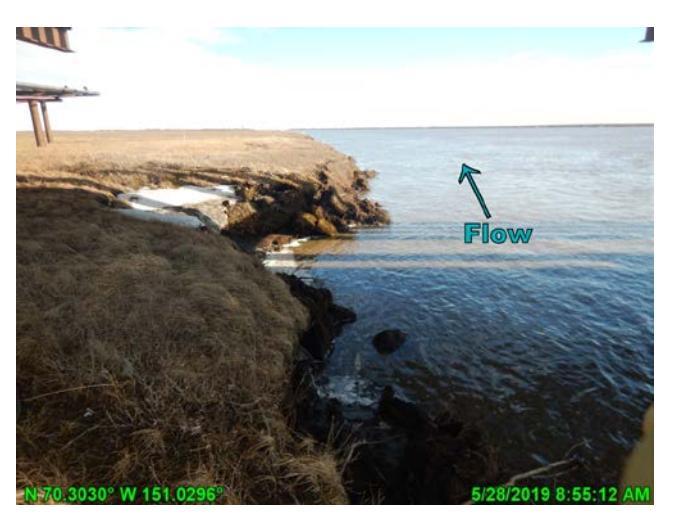
Photo D.24: CD5 road Nigliq Bridge #2 bank sloughing at west abutment, looking north (downstream); May 28, 2019

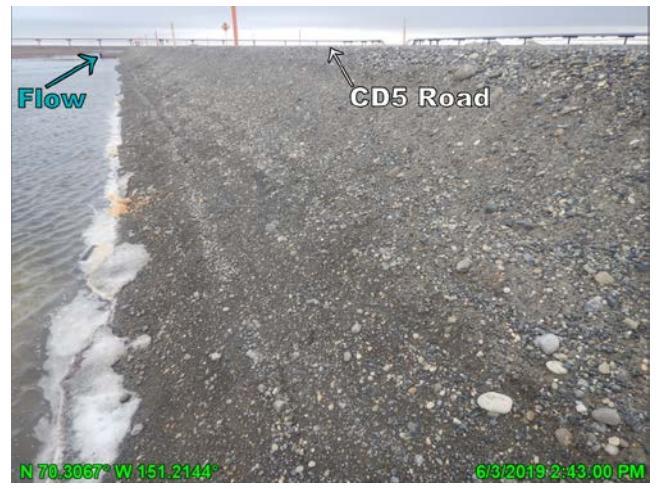
Photo D.25: Road in vicinity of culvert CD5-04N post-breakup, looking south; June 3, 2019

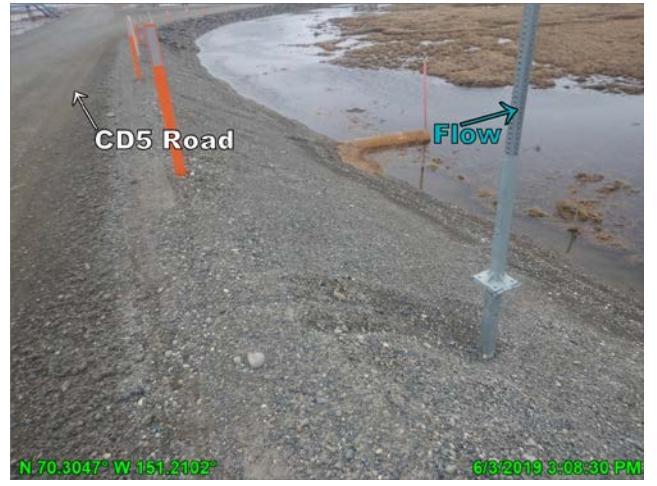
Photo D.27: Road in vicinity of culvert CD5-05N post-breakup, looking west; June 3, 2019

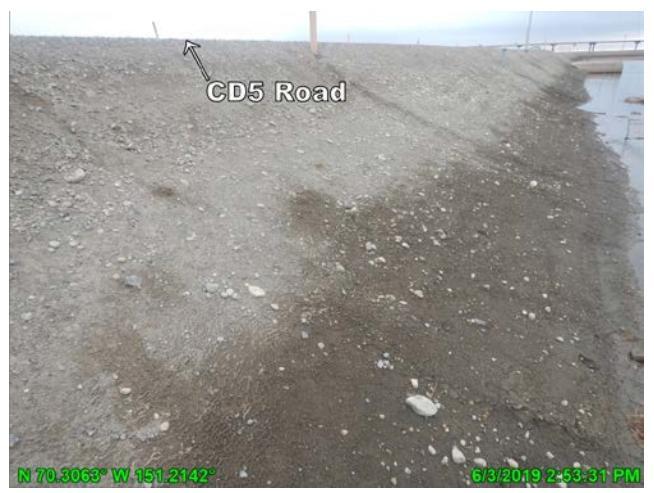
Photo D.26: Road in vicinity of culvert CD5-04S post-breakup, looking south; June 3, 2019

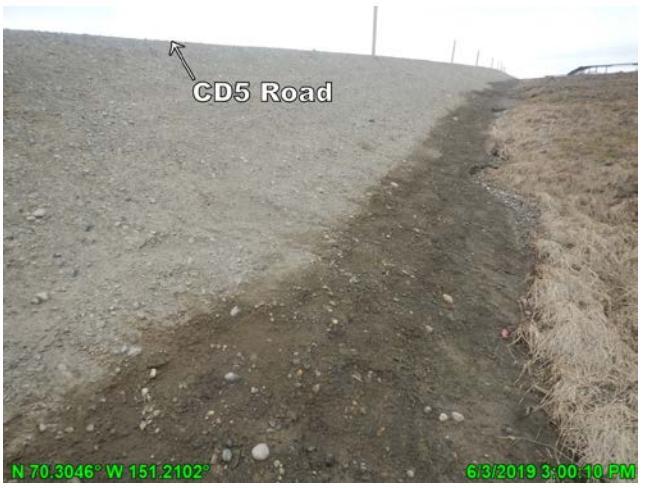
Photo D.28: Road in vicinity of culvert CD5-04S post-breakup, looking west; June 3, 2019
