2019 Colville River Delta Spring Breakup Monitoring & Hydrological Assessment

Michael Baker International 3900 C Street Suite 900 Anchorage, AK 99503

MSA Contract No. 296937

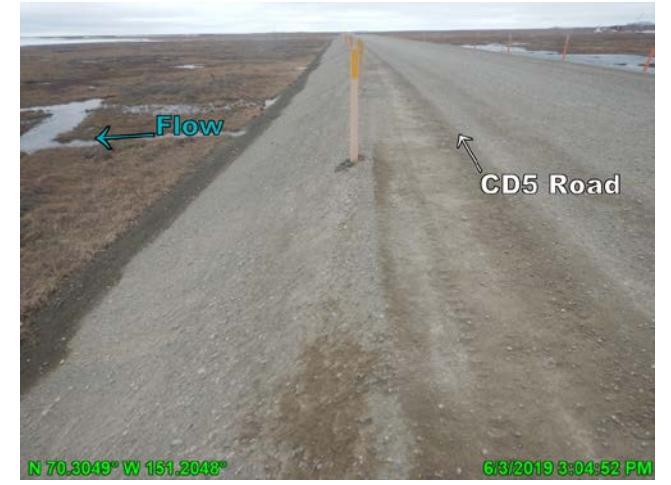
Photo D.29: Road in vicinity of culvert CD5-06N post-breakup, looking east; June 3, 2019

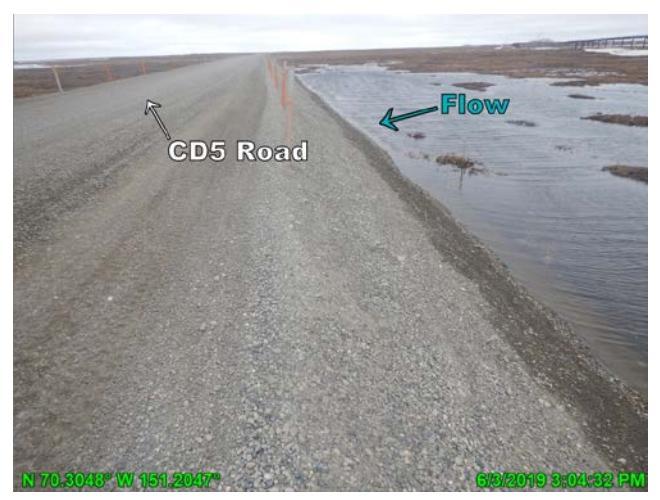
Photo D.30: Road in vicinity of culvert CD5-06S post-breakup, looking east; June 3, 2019

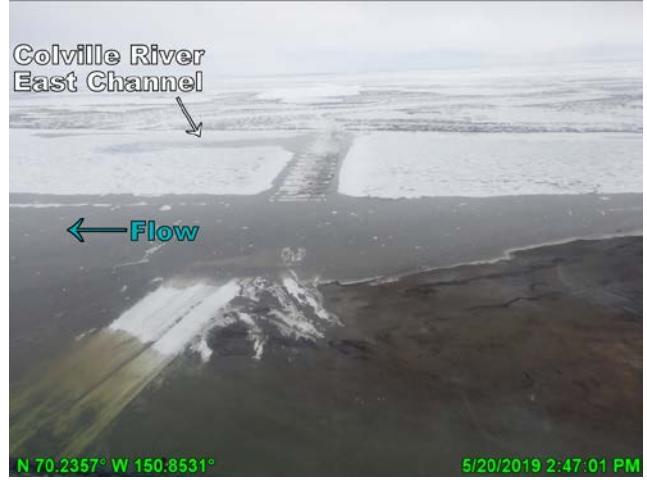
Photo D.31: Initial flow through slotted Colville River Ice Bridge, looking east; May 20, 2019

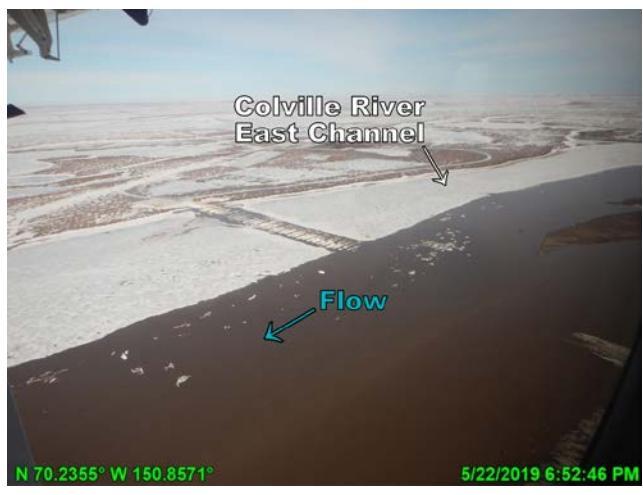
Photo D.32: Breakup progression at Colville River Ice Bridge, looking southeast (upstream); May 22, 2019

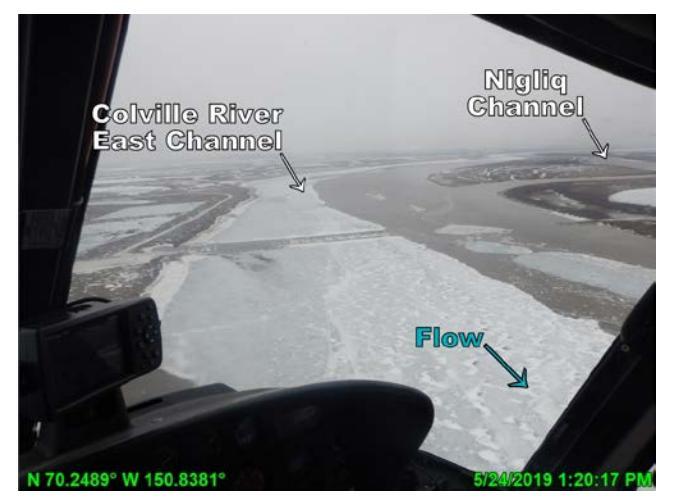
Photo D.33: Peak conditions at Colville River Ice Bridge, looking south (upstream); May 24, 2019

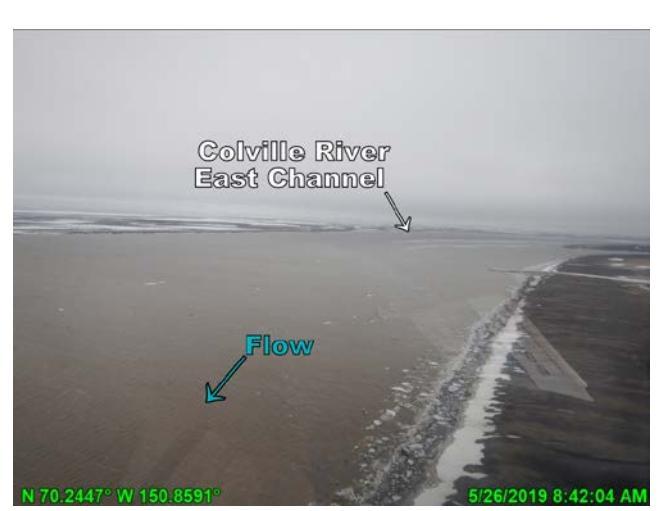
Photo D.34: Open channel at Colville River Ice Bridge, looking south (upstream); May 26, 2019

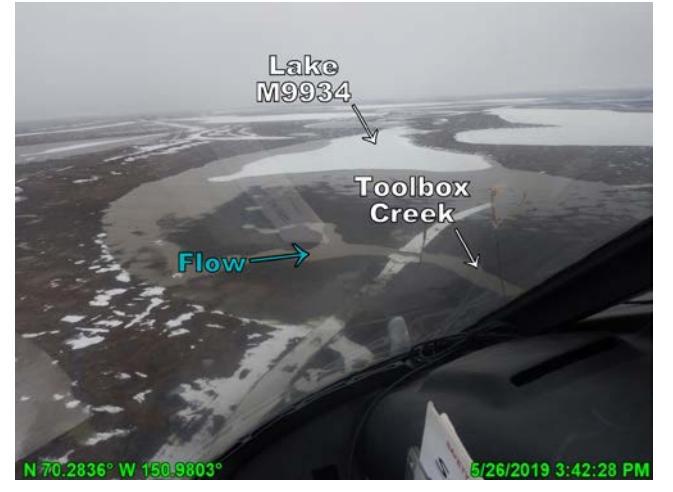
Photo D.35: Peak conditions at Toolbox Creek ice road crossing, looking south; May 26, 2019

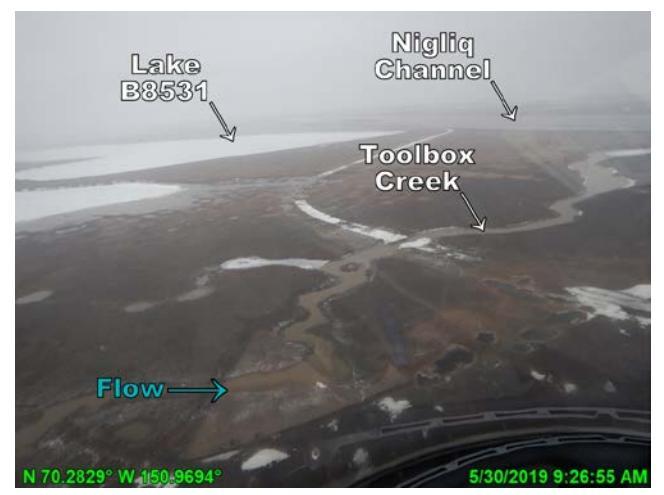
Photo D.36: Post-breakup at Toolbox Creek ice road crossing, looking southwest; May 30, 2019

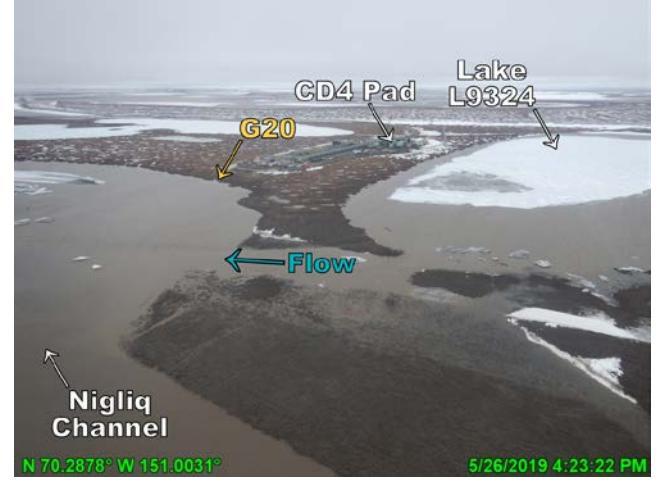
Photo D.37: Peak conditions at Slias Slough ice road crossing, looking northeast; May 26, 2019

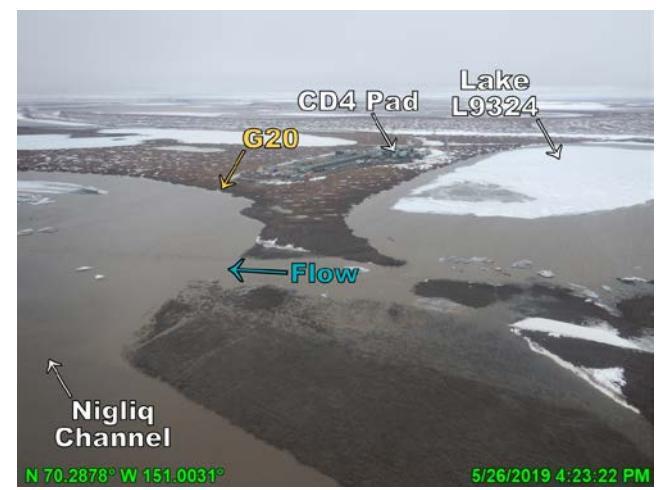
Photo D.38: Peak conditions at Slias Slough ice road crossing, looking northeast; May 26, 2019

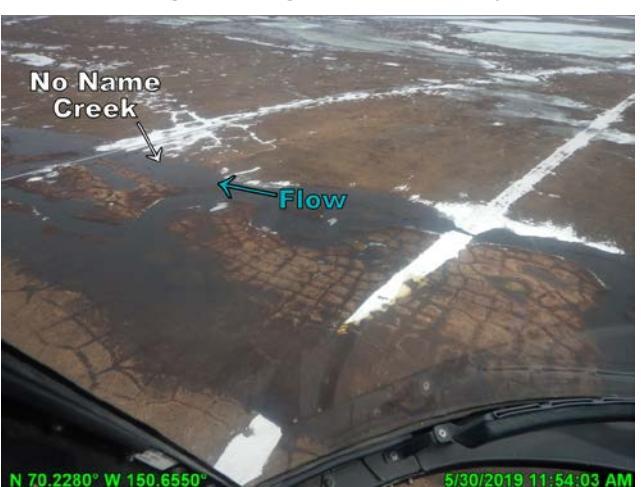
Photo D.39: Peak conditions at No Name Creek ice road crossing; May 30, 2019

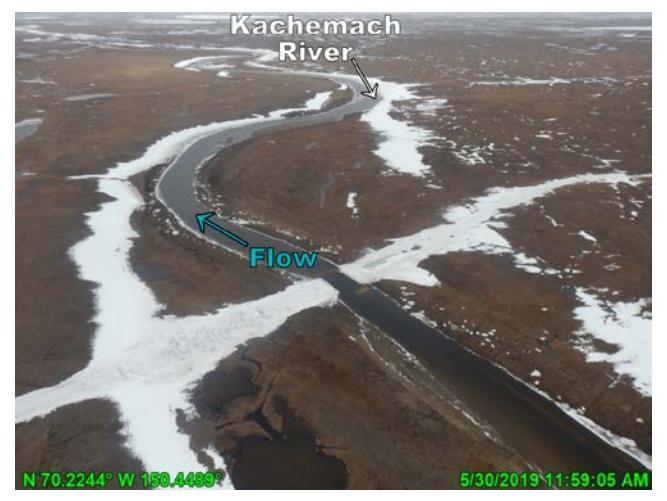
Photo D.41: Peak conditions at Kachemach ice road crossing, looking north; May 30, 2019

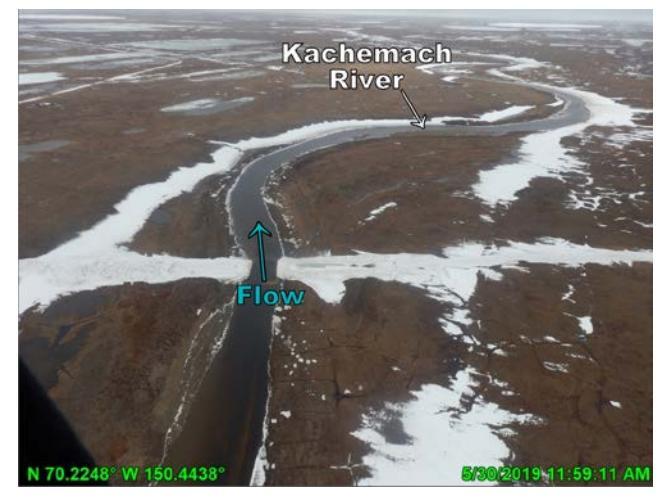
Photo D.42: Peak conditions at Kachemach ice road crossing, looking northwest; May 30, 2019

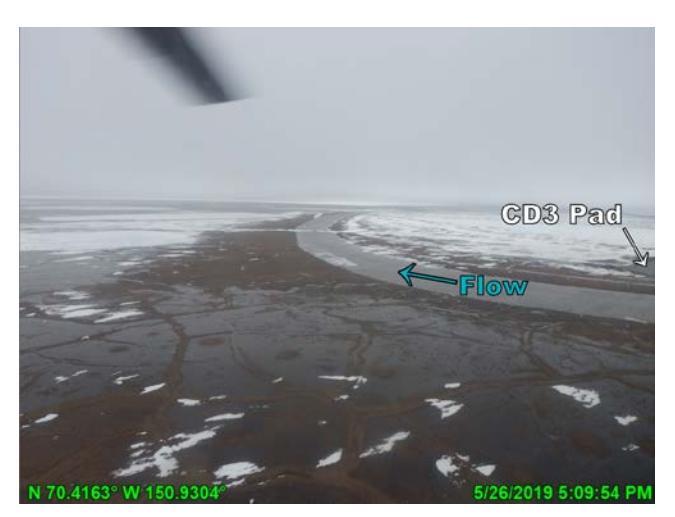
Photo D.44: Peak conditions at Pineapple Creek ice road crossing, looking north; May 26, 2019

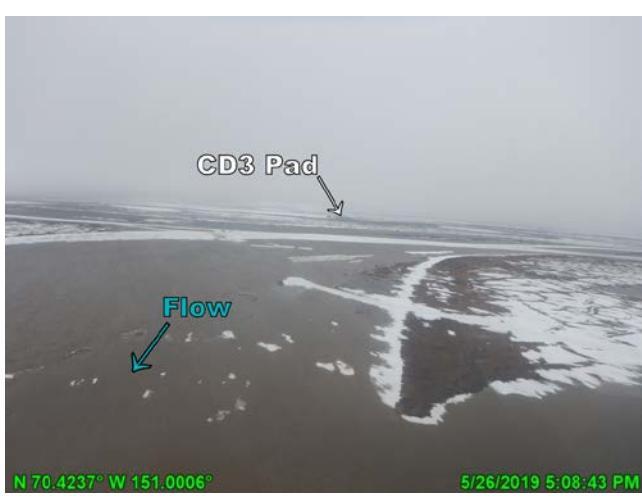
Photo D.46: Peak conditions at Tamayayak ice road crossing #1, looking south; May 26, 2019

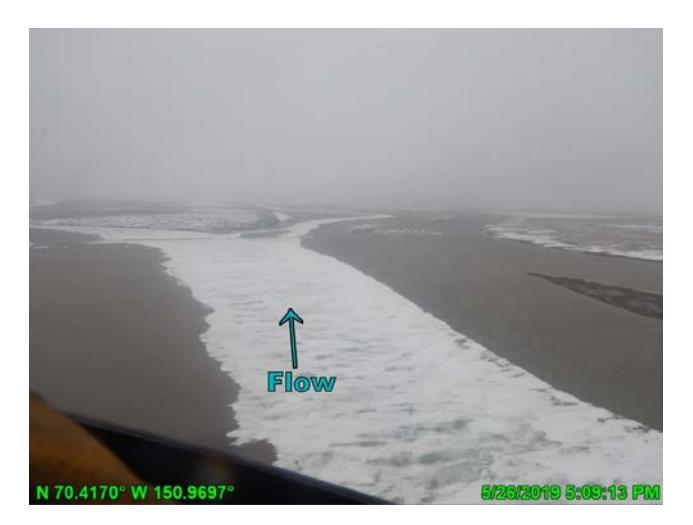
Photo D.47: Peak conditions at Tamayayak ice road crossing #1, looking north; May 26, 2019
