2019 GMT1 /MT6 Spring Breakup & Summer Monitoring & Hydrological Assessment

Prepared for:

ConocoPhillips
Alaska

MSA Contract No. 296937

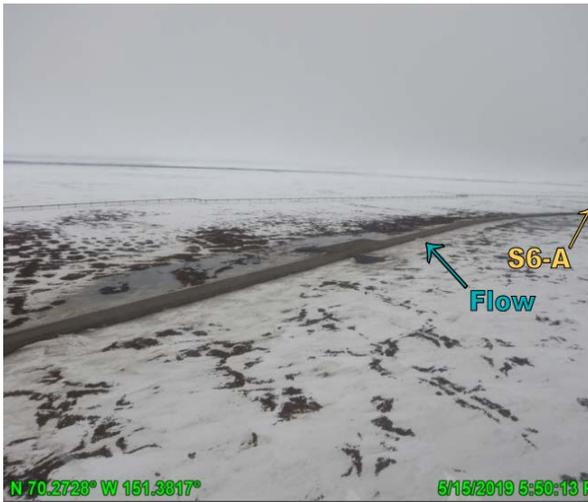
On May 15, local melt was observed in isolated areas around the GMT1/MT6 access road (Photo 3.1). By May 22, increasing local meltwater was accumulating in and around natural drainage areas, including the Tinmiaqsiugvik and Crea Bridges (Photo 3.2). Meltwater was observed meeting the GMT1/MT6 road embankment at limited locations along the alignment, particularly around the drainage areas associated with the S2 and S6 monitoring stations. Snow cover on the surrounding tundra was approximately 70 percent. The historical average date of peak stage conditions in the GMT1/MT6 area is May 25.

Photo 3.1: Local melt near S6, looking northeast; May 15, 2019

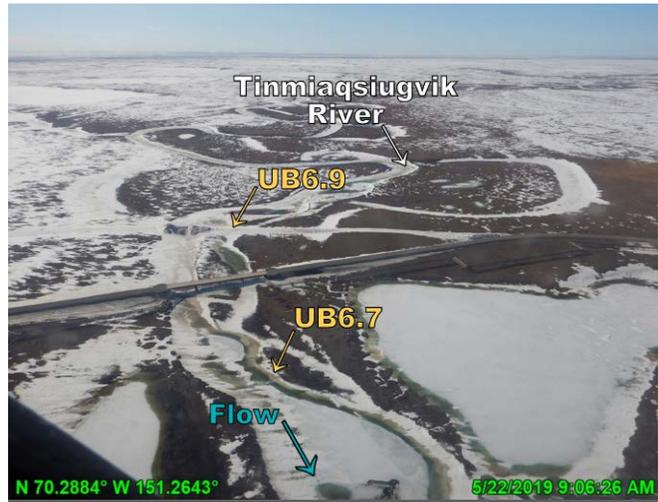
Photo 3.2: Tinmiaqsiugvik River, looking south (upstream); May 22, 2019

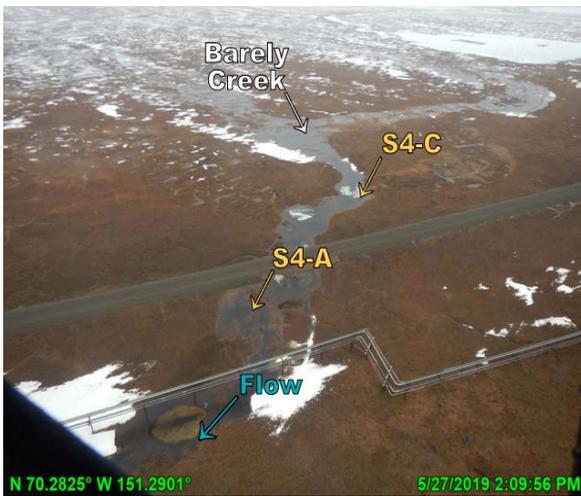
On May 27, discharge measurements were performed at the Crea Bridge, Tinmiaqsiugvik Bridge and Barely Creek Culvert Battery. At the time of measurements, increased meltwater had elevated stage to near peak conditions throughout most of the GMT1/MT6 area (Photo 3.3). By May 29, aerial observations suggest meltwater was hydraulically connected through drainage structures at most GMT1/MT6 monitoring locations (Photo 3.4).

Photo 3.3: Minor overbank flooding at Barely Creek, looking south (upstream); May 27, 2019

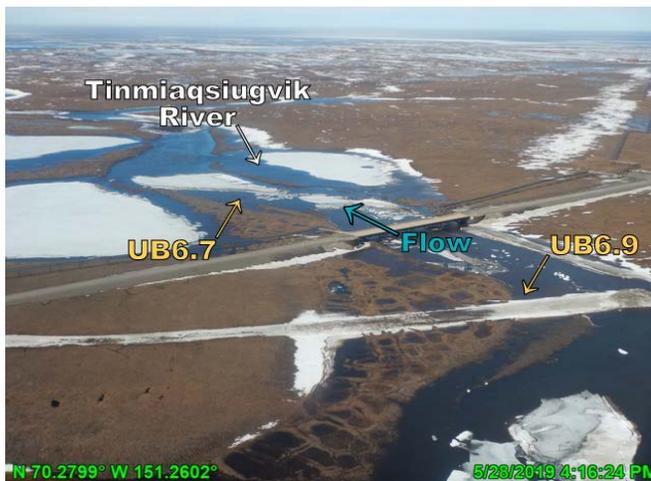
Photo 4.3: Tinmiaqsiugvik River, looking northeast (downstream); May 28, 2019

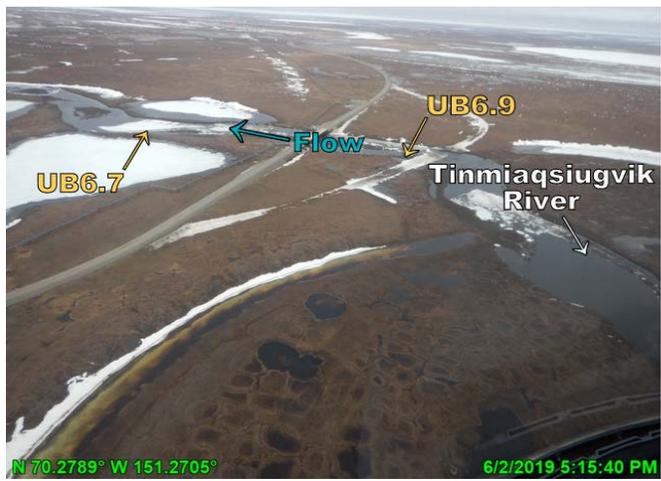
Photo 4.4: Tinmiaqsiugvik River, looking northeast; June 2, 2019

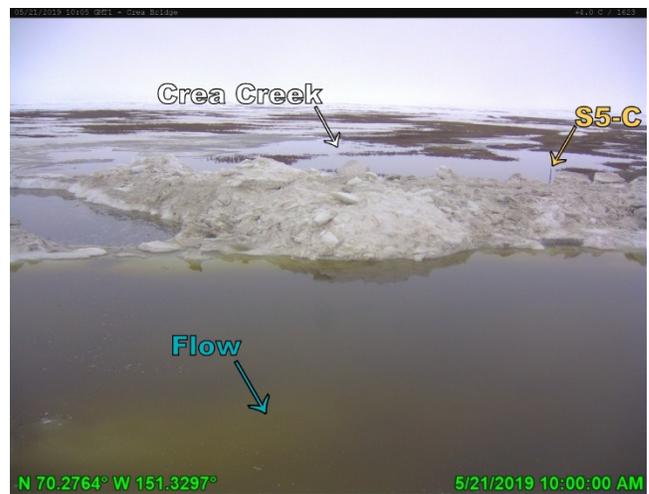
Photo 4.8: RTFM image at Crea Bridge on the day of peak stage at S5-C, looking south (upstream); May 21, 2019

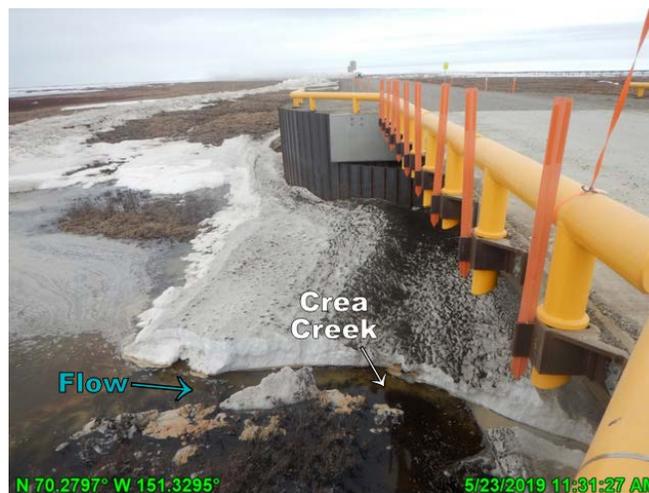
Photo 4.9: Crea Creek after peak stage, looking west; May 23, 2019

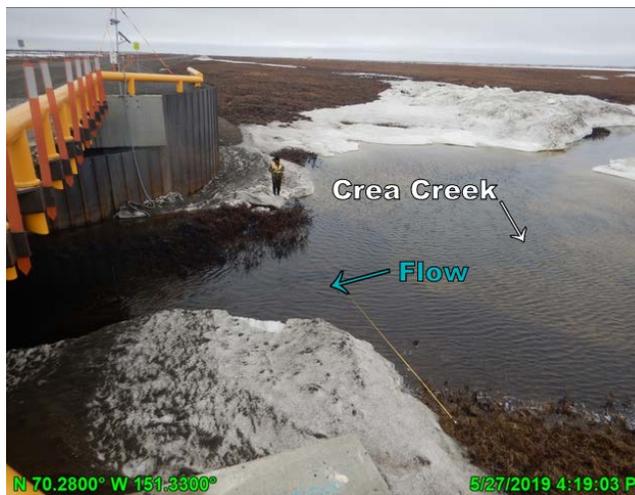
Discharge was measured on May 27 and May 29 (Photo 4.10 and Photo 4.11) upstream of the bridge near the abutments. Large amounts of snow and bottomfast ice were still present around the bridge during the May 27 measurement. Most snow and ice at the bridge had cleared by the second measurement on May 29. The overall quality of both discharge measurements was classified as fair based on the conditions at the time of the measurements.

Photo 4.10: Crea Creek during the first discharge measurement, looking southeast (upstream); May 27, 2019

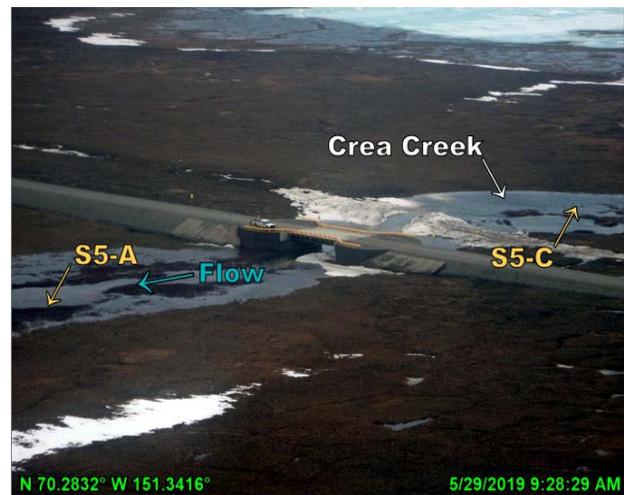
Photo 4.11: Crea Creek the day of second discharge measurement, looking southeast (downstream); May 29, 2019

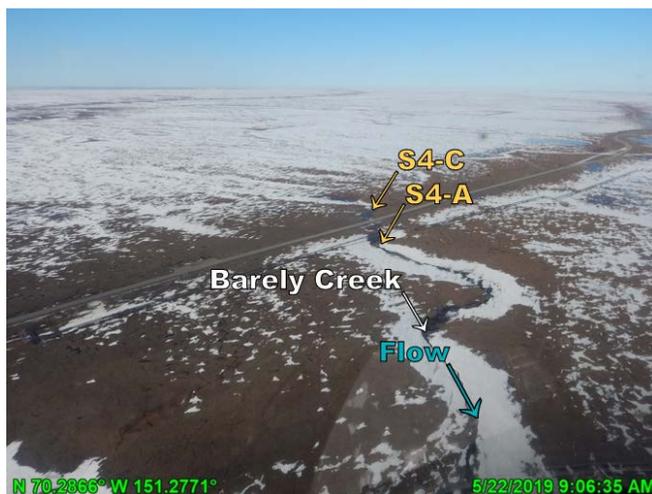
Isolated meltwater was initially observed at the S4 gages on May 19. Snow cover on the surrounding tundra was approximately 70 percent. Peak stage occurred on May 22. Aerial observations from May 22 show flow paths forming through the drifted snowpack in the drainage on both sides of the GMT1/MT6 road, suggesting hydraulic connection had been initiated (Photo 4.14). With the exception of temporary blockage from a bladder frozen in place, all culverts were observed to be functioning as designed and natural drainage patterns in the area were maintained.

Photo 4.14: Barely Creek, looking southwest (upstream); May 22, 2019

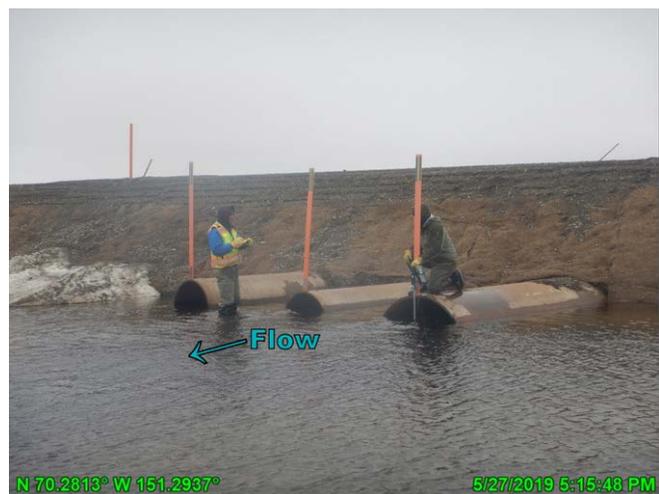
On May 25 stage began to gradually increase until reaching a second crest on May 27. On May 27, flow was observed through all three culverts and minimal snow cover remained in the channel and along the downstream banks (Photo 4.15). Discharge through the culverts was measured and minor overbank flooding in the drainage was observed. On the south (upstream) side of the GMT1/MT6 road, meltwater from two flow paths was flowing unimpeded through the culverts. On May 28, snow was observed on the north (downstream) side of the GMT1/MT6 access road along the channel banks and meltwater was hydraulically connected to the Tinmiaqsiugvik River (Photo 4.16). Conditions remained consistent and stage remained elevated through May 29 (Photo 4.17) until gradually dropping on June 3.

Photo 4.15: Barely Creek on the day of the discharge measurement, looking south (upstream); May 27, 2019

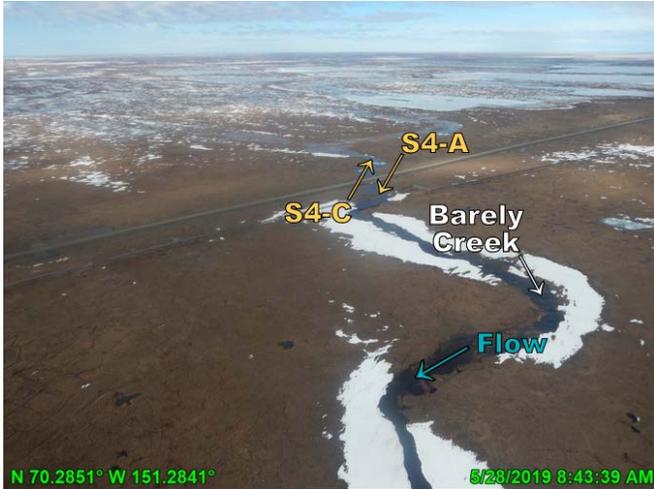
Photo 4.16: Barely Creek, looking southwest (upstream); May 28, 2019

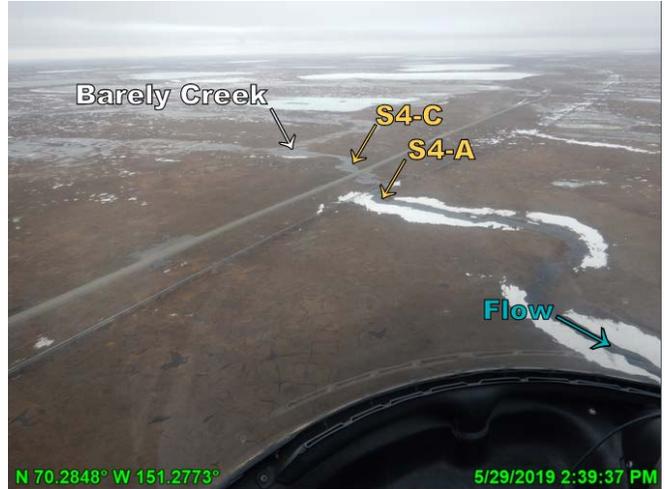
Photo 4.17: Barely Creek, looking southwest (upstream); May 29, 2019

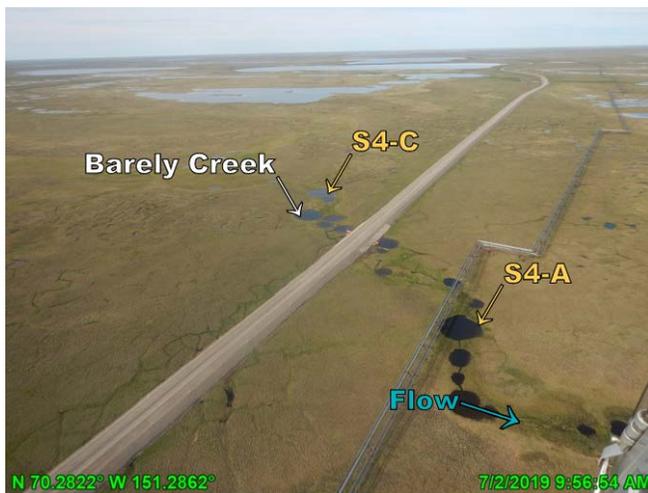
Aerial observations from July 2 show hydraulic connection were maintained through the Barely Creek culverts. The upstream stage hydrograph and observations on July 3 indicate that water was present with minimal discernable flow in the early summer (Photo 4.18 and Photo 4.19). Barely Creek culvert battery summer stage and discharge data is provided in Graph 4.10.

Photo 4.18: Barely Creek, looking southwest (upstream); July 2, 2019

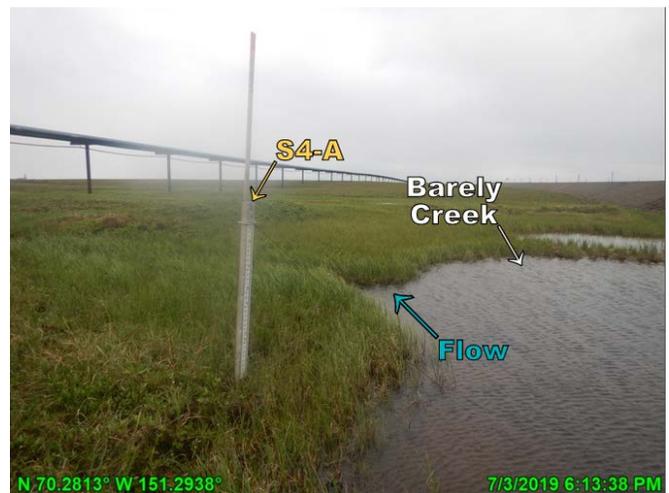
Photo 4.19: Barely Creek gage S4-A, looking east; July 3, 2019

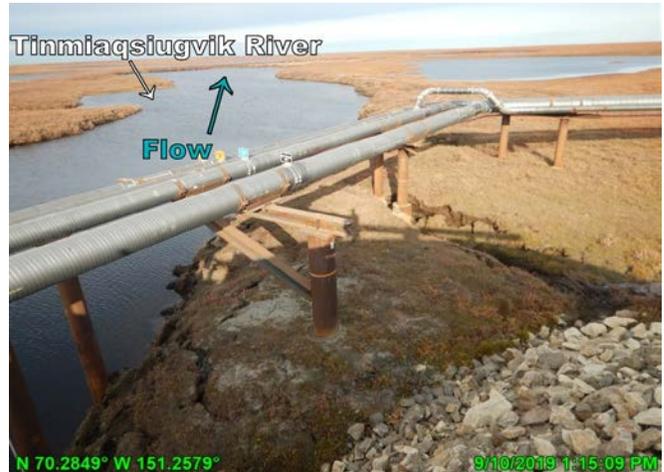
Post-breakup conditions were assessed to evaluate erosion and scour at the Tinmiaqsiugvik Bridge and Crea Bridge abutments, Barely Creek culvert inlets and outlets, and along the banks upstream and downstream of all GMT1/MT6 access road crossings. In addition, the access road and pad were inspected for erosion and any displaced gravel fill onto the tundra. At the Tinmiaqsiugvik Bridge, bank erosion was first observed at the east abutment and along the east bank immediately downstream of the bridge in 2018. During the 2018-19 winter, the two VSMs most threatened by the bank erosion were abandoned and replaced with a single VSM with a cantilevered horizontal support. The 2019 observations show continued erosion along the bank at the abandoned VSMs (Photo 7.1 and Photo 7.2). Similar to 2018, thermo-erosional niching and subsequent riverbank block failure continue to occur. This is caused when moving water undercuts an ice-rich bank through thermal and mechanical processes forming a “niche.” At a point the niche is deep enough that the overhanging block collapses and further erodes at the toe of the bank. A gully, also downstream of the Tinmiaqsiugvik Bridge on the east bank, has deepened since 2018. The gully, that now encompasses both VSMs of the support downstream (pipeline flow direction) of the new VSM, appears to be a thermokarst feature with exposed ice wedges (Photo 7.3 and Photo 7.4). The gully is approximately 4 feet deep at the VSMs.

Photo 7.2: East bank downstream of Tinmiaqsiugvik Bridge, looking north (downstream); July 3, 2019

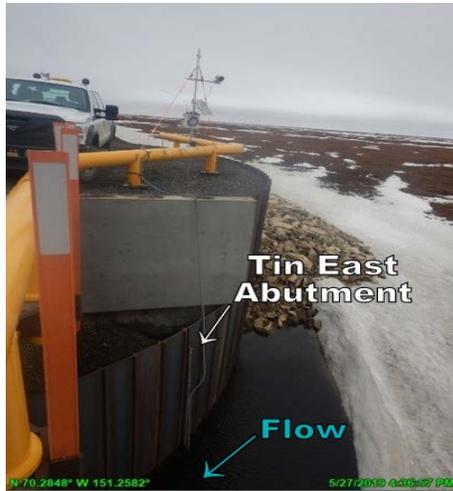
No displaced gravel fill attributed with spring breakup flooding was observed along the road embankment, around culvert inlets and outlets, or around bridge abutments (Photo 7.5 through Photo 7.19). Other than at the Tinmiaqsiugvik Bridge, there were no signs of sloughing or undermining at drainage structures and no channel changes were observed at the crossings. Additional photo documentation of post-breakup conditions is provided in Appendix E.

Photo 7.5: Tinmiaqsiugvik River east abutment, upstream, looking east; May 27, 2019

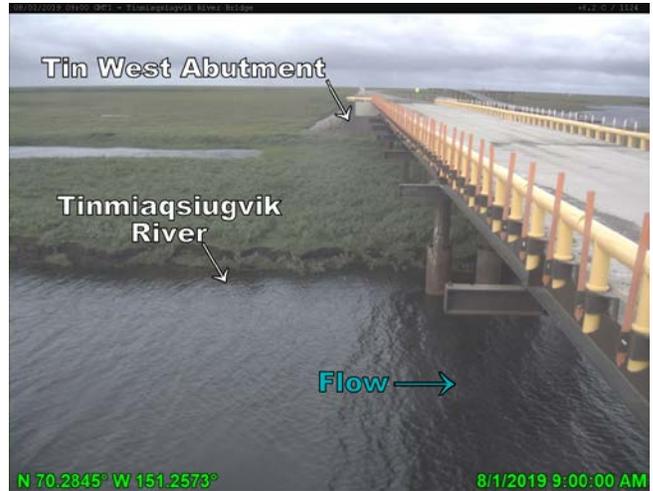
Photo 7.6: Tinmiaqsiugvik River west abutment, upstream, looking west (upstream); August 1, 2019

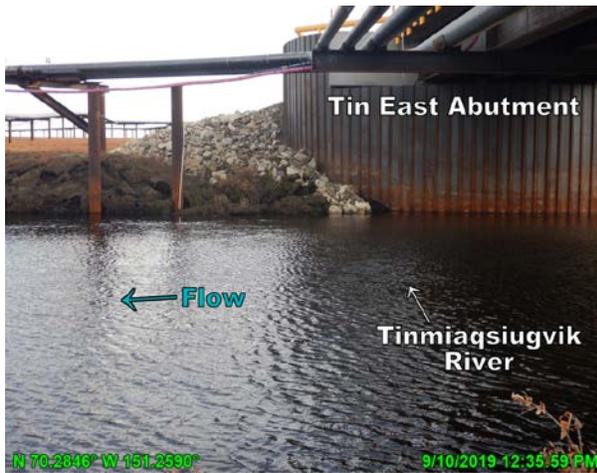
Photo 7.7: Tinmiaqsiugvik River east abutment, downstream, looking east; September 10, 2019

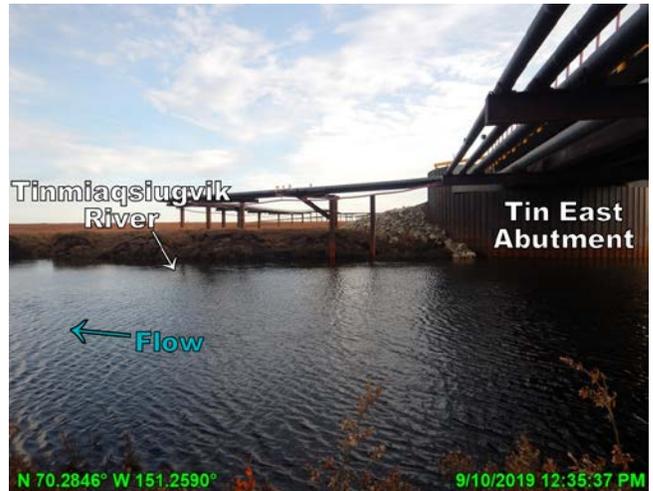
Photo 7.8: Tinmiaqsiugvik River east bank downstream, looking east (downstream); September 10, 2019

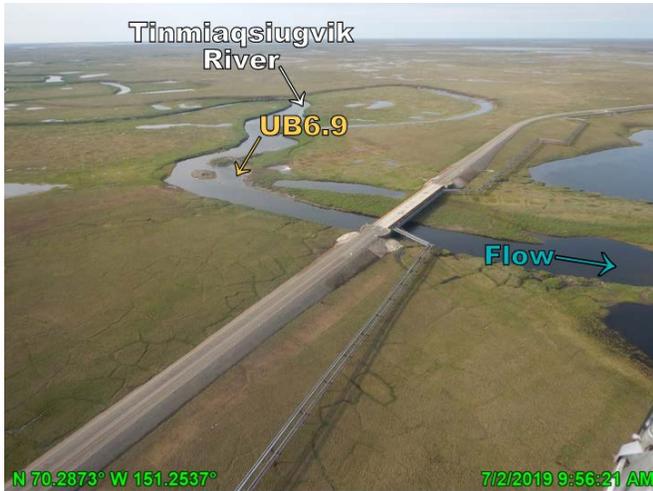
Photo 7.9: Tinmiaqsiugvik River west bank downstream, looking southwest (upstream); July 2, 2019

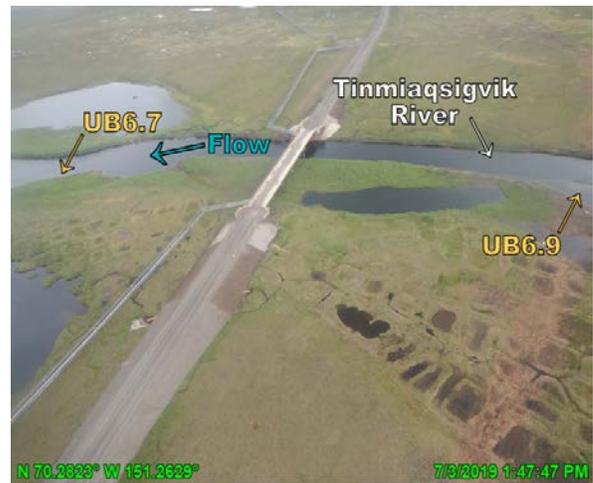
Photo 7.10: Tinmiaqsiugvik River east bank upstream, looking northeast (downstream); July 3, 2019

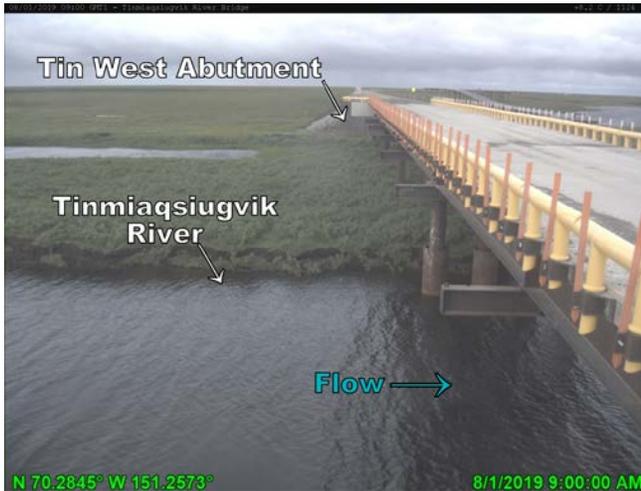
Photo 7.11: Tinmiaqsiugvik River west bank upstream, looking west; August 1, 2019

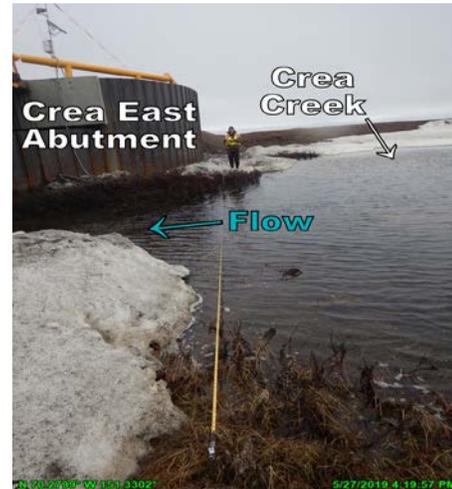
Photo 7.12: Crea Creek east abutment upstream, looking northeast (upstream); May 27, 2019

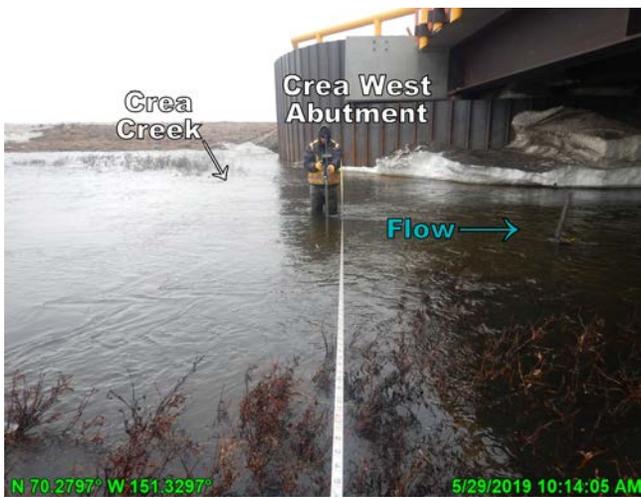
Photo 7.13: Crea Creek west abutment upstream, looking west (upstream); May 29, 2019

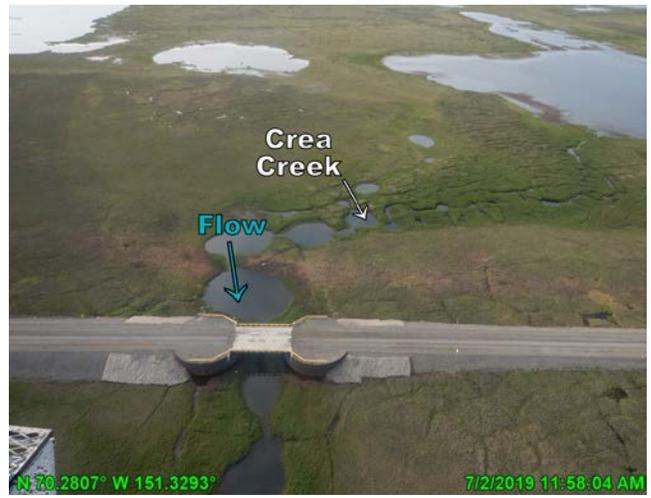
Photo 7.14: Crea Creek east abutment downstream, looking south (upstream); July 2, 2019

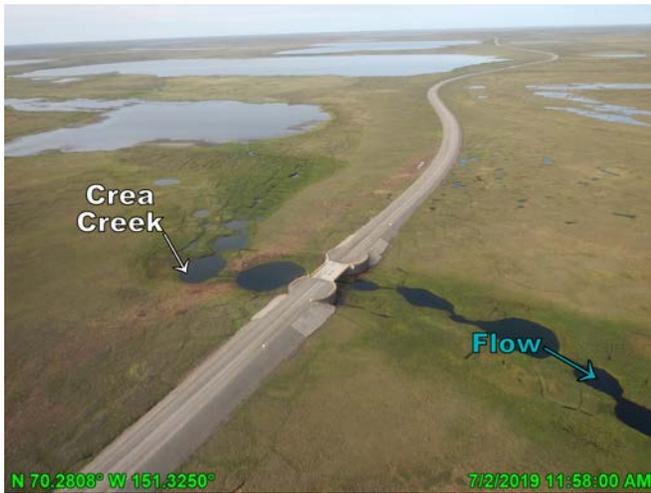
Photo 7.15: Crea Creek west abutment downstream, looking southwest (upstream); July 2, 2019

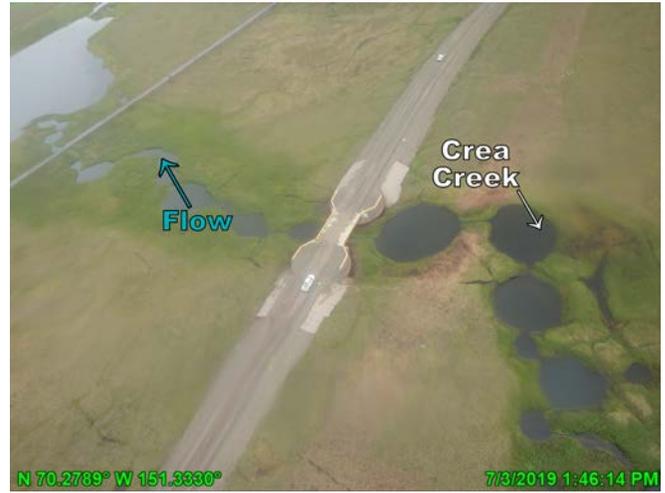
Photo 7.16: Crea Creek bank conditions, looking southwest (upstream); July 3, 2019

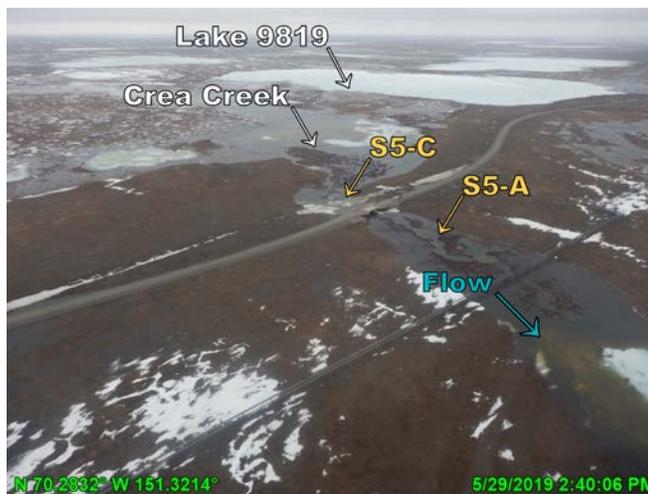
Photo E.12: Crea Creek during high flow conditions, looking south (upstream); May 29, 2019

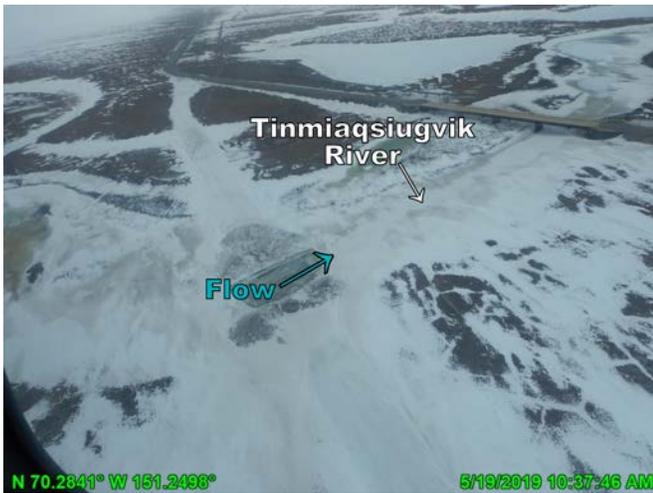
Photo E.13: Tinmiaqsiugvik River with slotted ice road pre-breakup, looking east; May 29, 2019

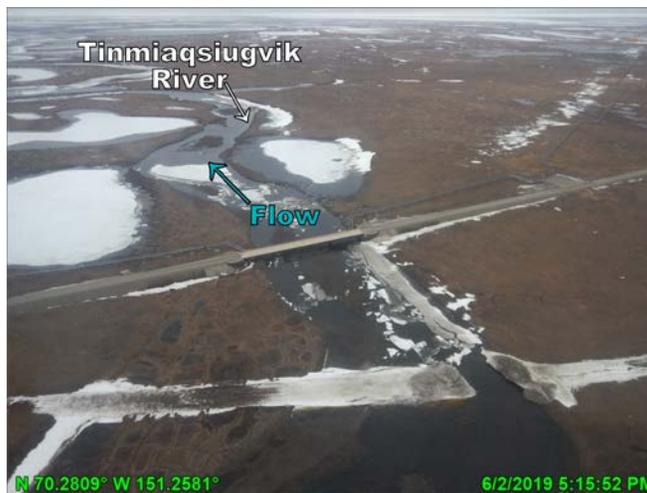
Photo E.15: Tinmiaqsiugvik River post-breakup, looking southwest (upstream); June 2, 2019
