Colville River Delta Spring Breakup 2013 Field Report

ConocoPhillips
Alaska

Michael Baker, Jr., Inc.
1400 West Benson Blvd., Suite 200
Anchorage, Alaska 99503

July 18, 2013
Project Number: 135141

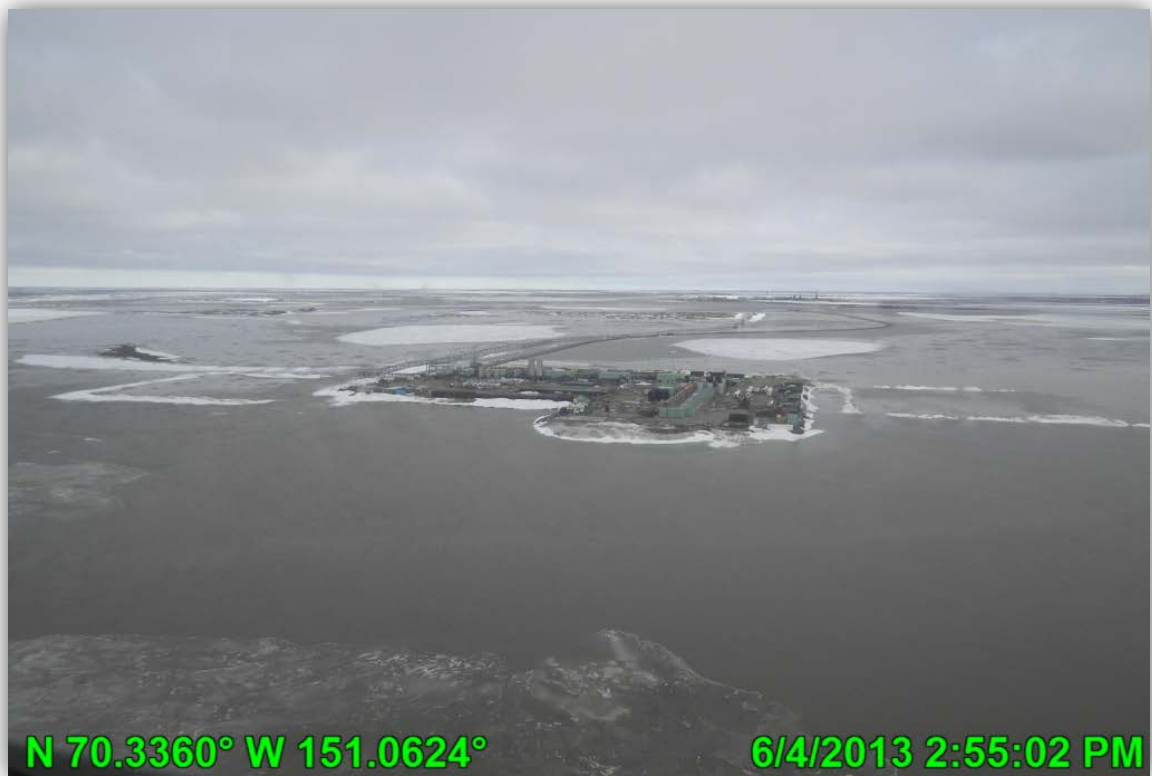
Photo 1: CD2 Pad; June 4, 2013

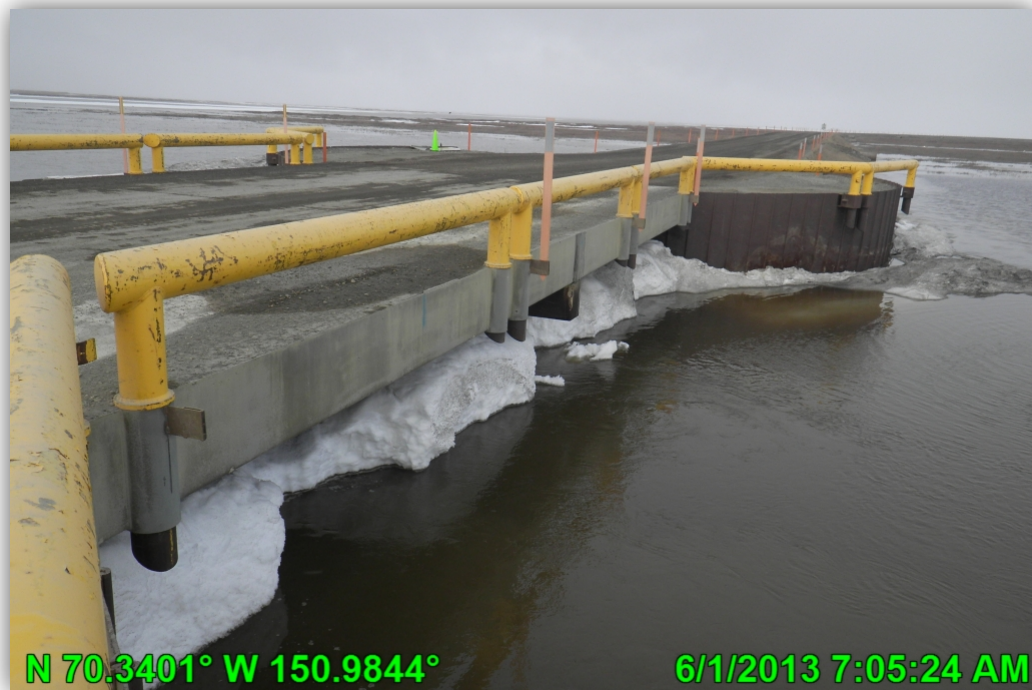
Photo 5: Small Swale bridge conveying flow thru snow blockage; June 1, 2013

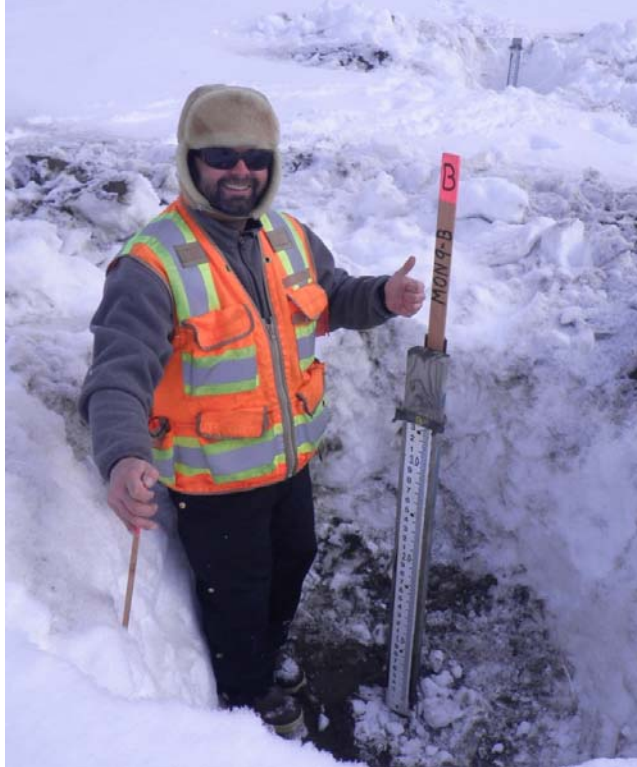
Photo 1: Gage dug out and rehabilitated at Mon 9 (HDD); May 8, 2013

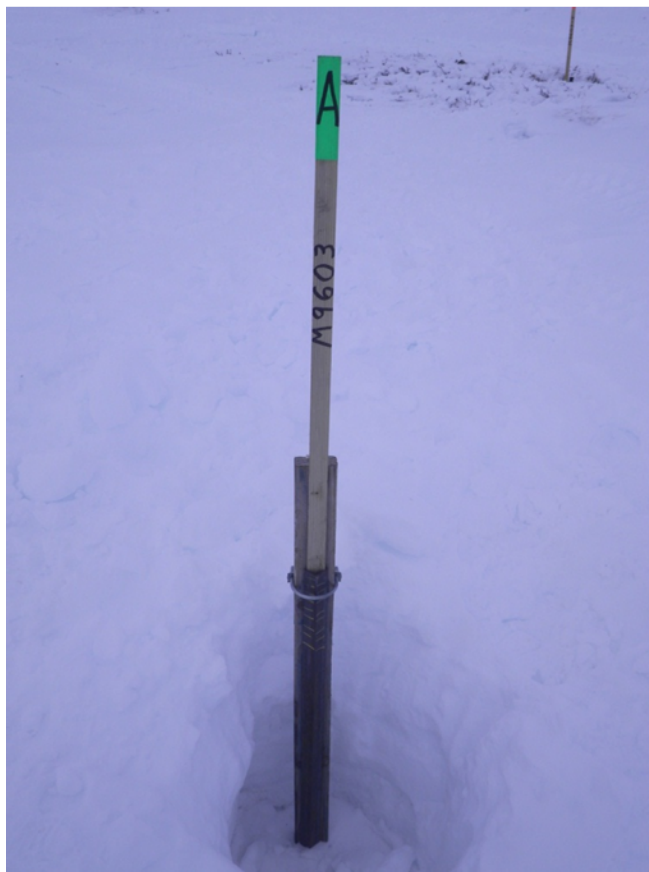
Photo 2: Back of gage at lake M9603 showing safety stripes used during installation; May 14, 2013

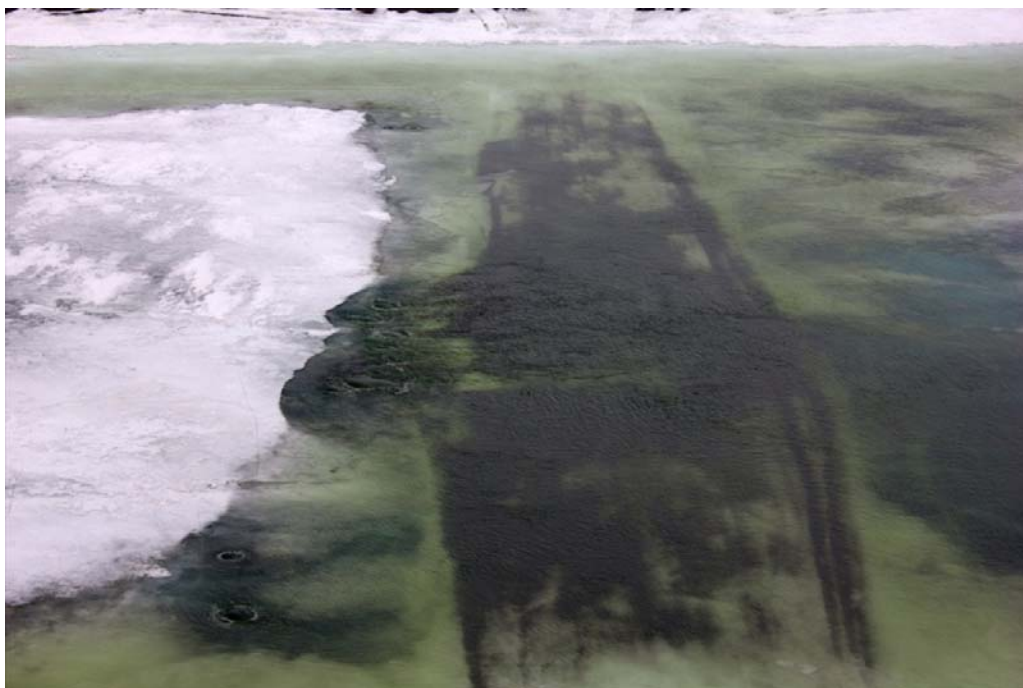
Photo 2: Melt water emerging from below the ice cover and flowing over remnants of an ice bridge near Ocean Point; May 27, 2013

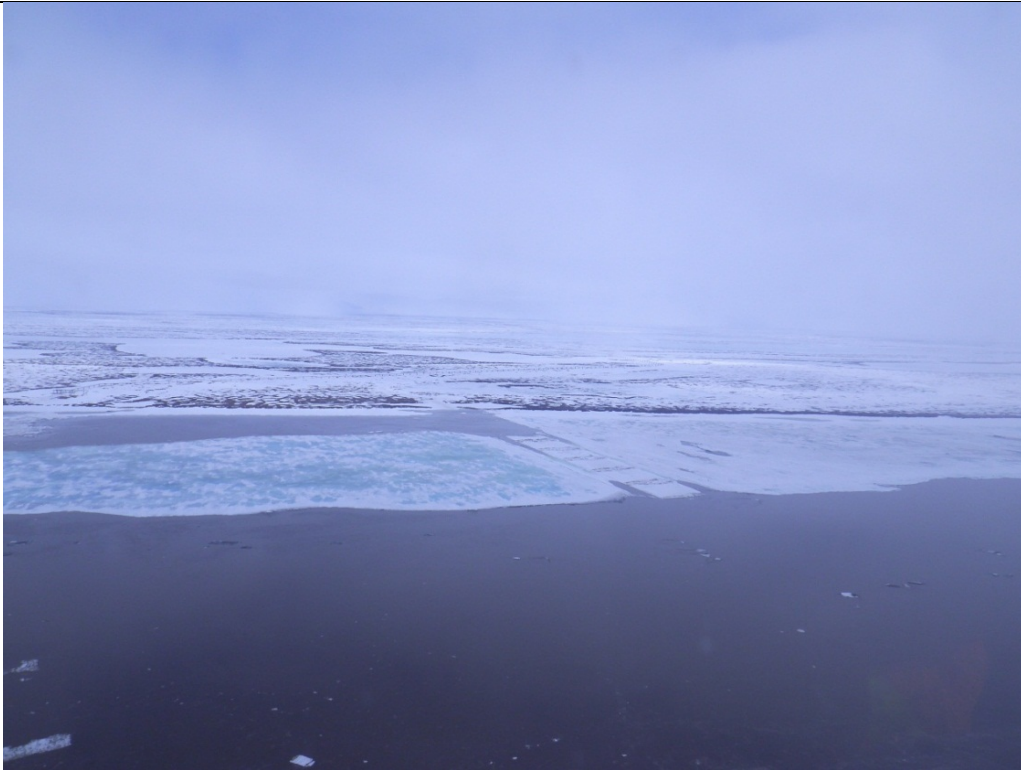
Photo 2: Water flowing around the slotted Colville River ice bridge; May 30, 2013

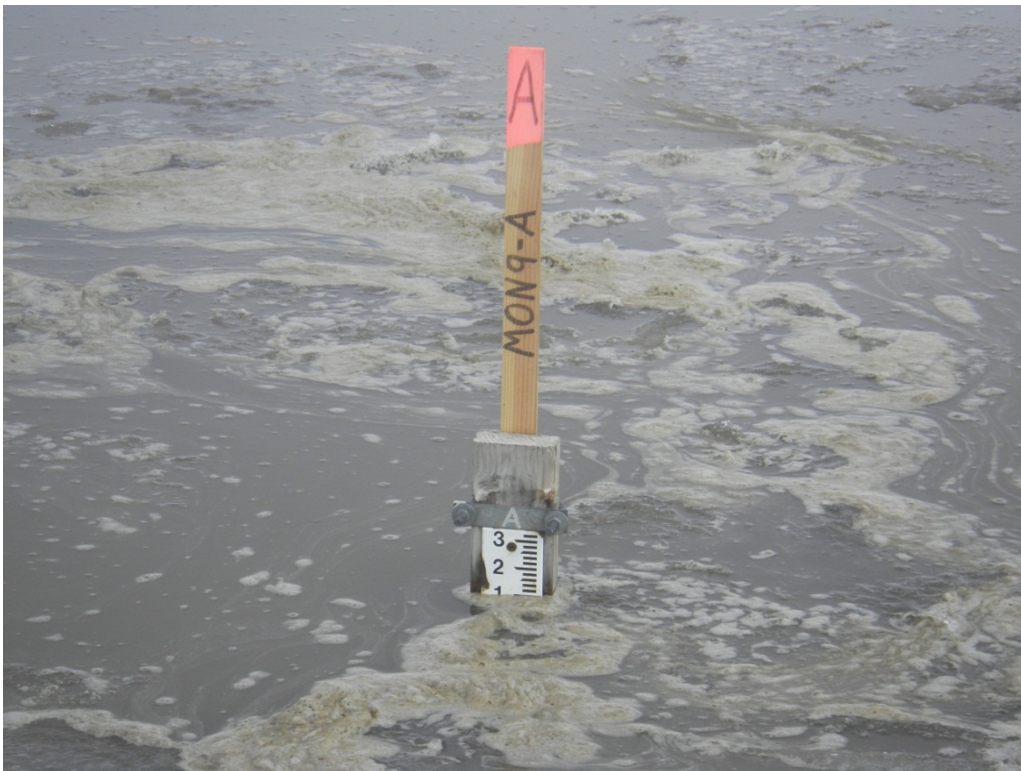
Photo 3: Water has arrived on gages at MON9 near HDD; May 30, 2013

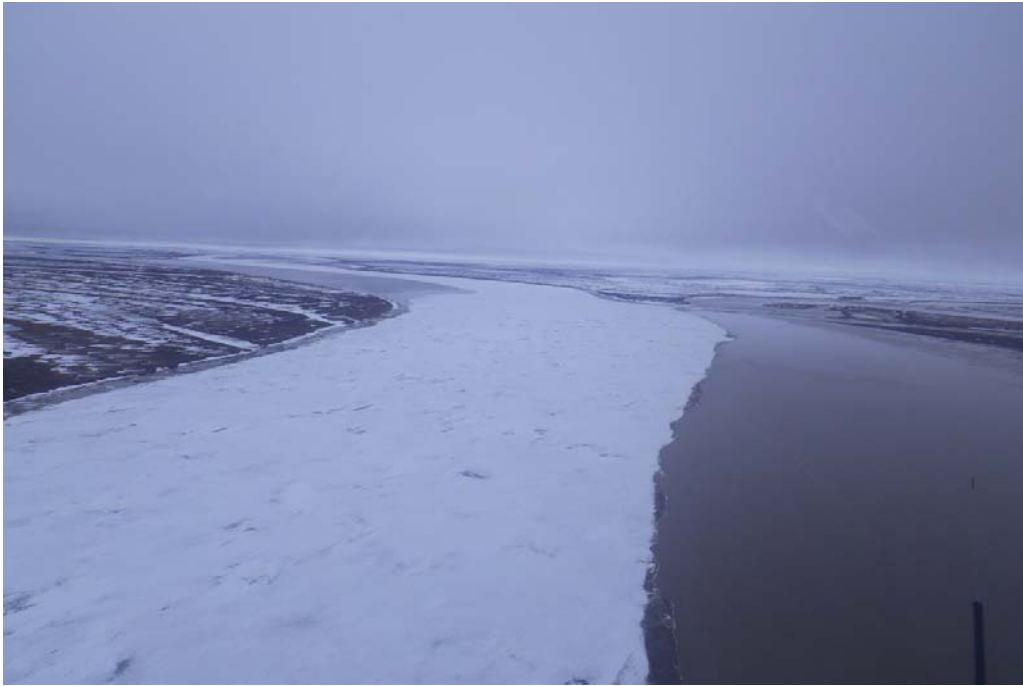
Photo 1: Intact channel ice in the Colville River upstream of MON1, looking north ; June 1, 2013

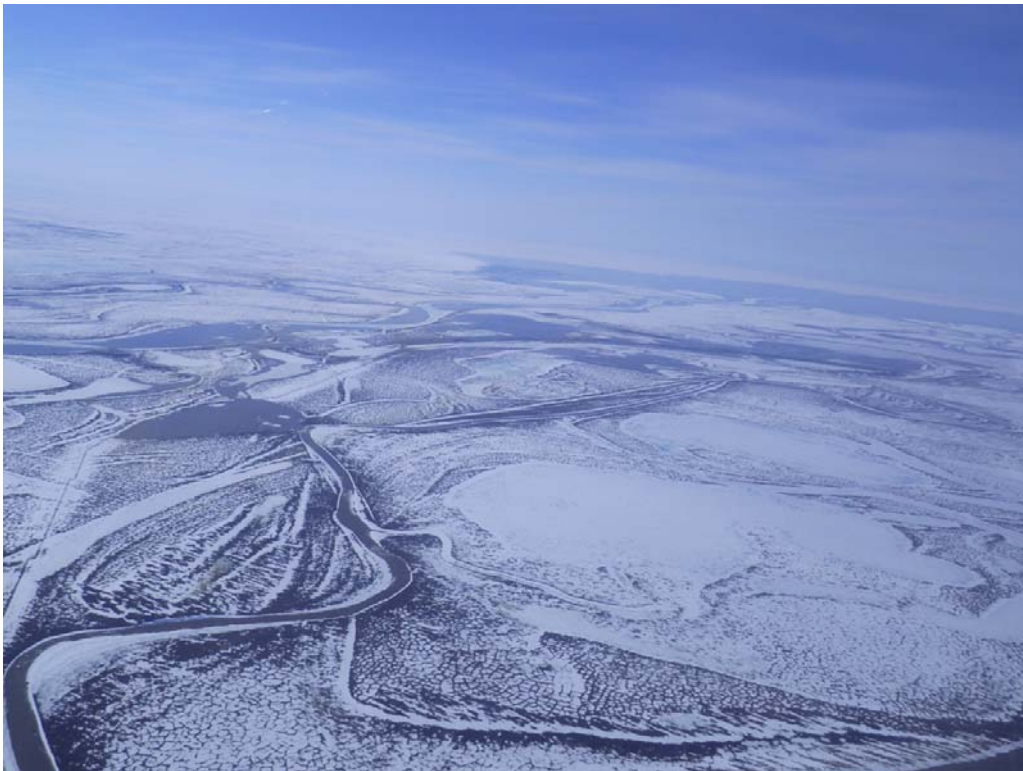
Photo 2: Nigiq Channel and Sakoonang Channel looking north towards Alpine facilities; June 1, 2013

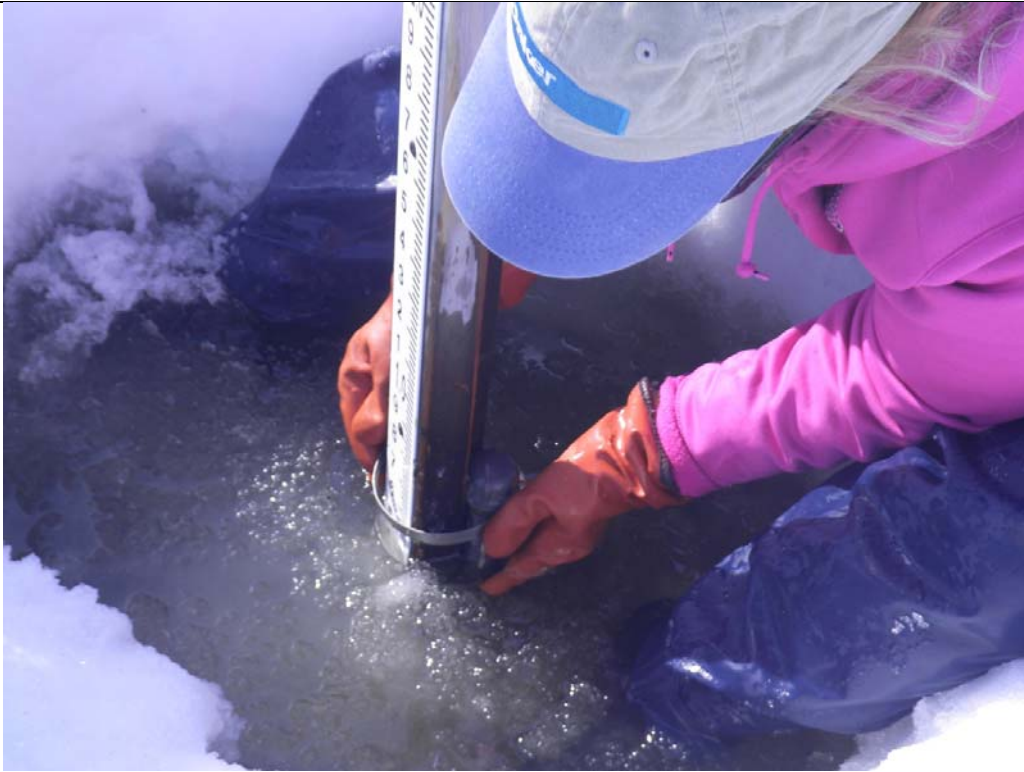
Photo 3: Installing a pressure transducer at Clover Material Source C1; June 1, 2013

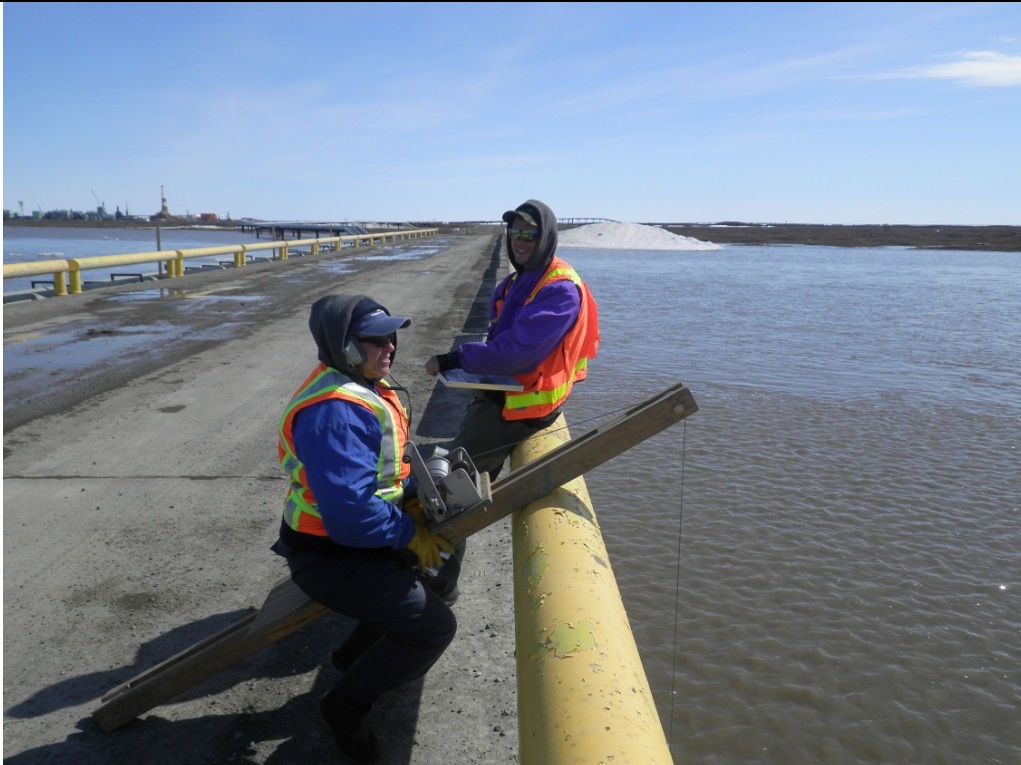
Photo 2: Discharge measurements on the Large Swale bridge; June 2, 2013

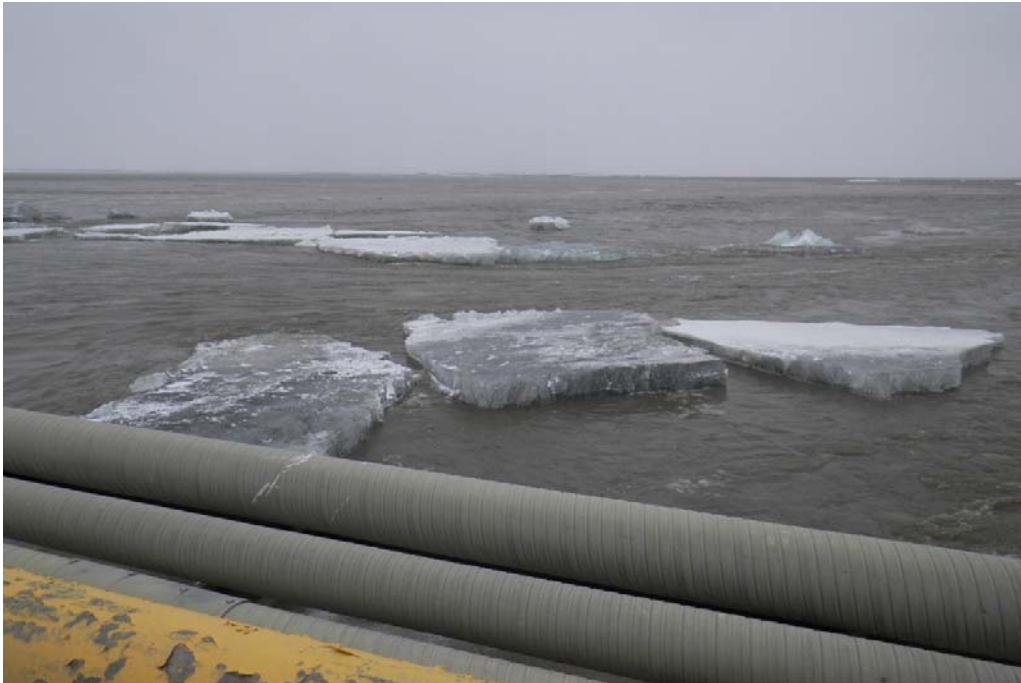
Photo 1: Grounded ice downstream of the Large Swale bridge, looking north; June 3, 2013

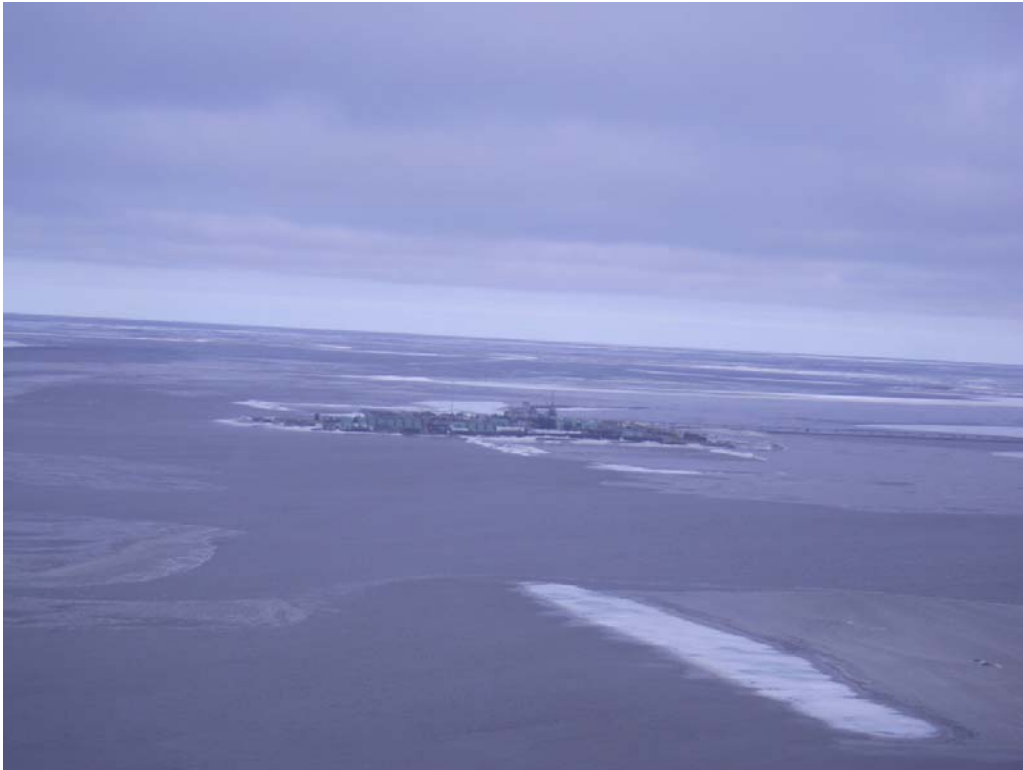
Photo 1: CD2 pad looking north; June 4, 2013

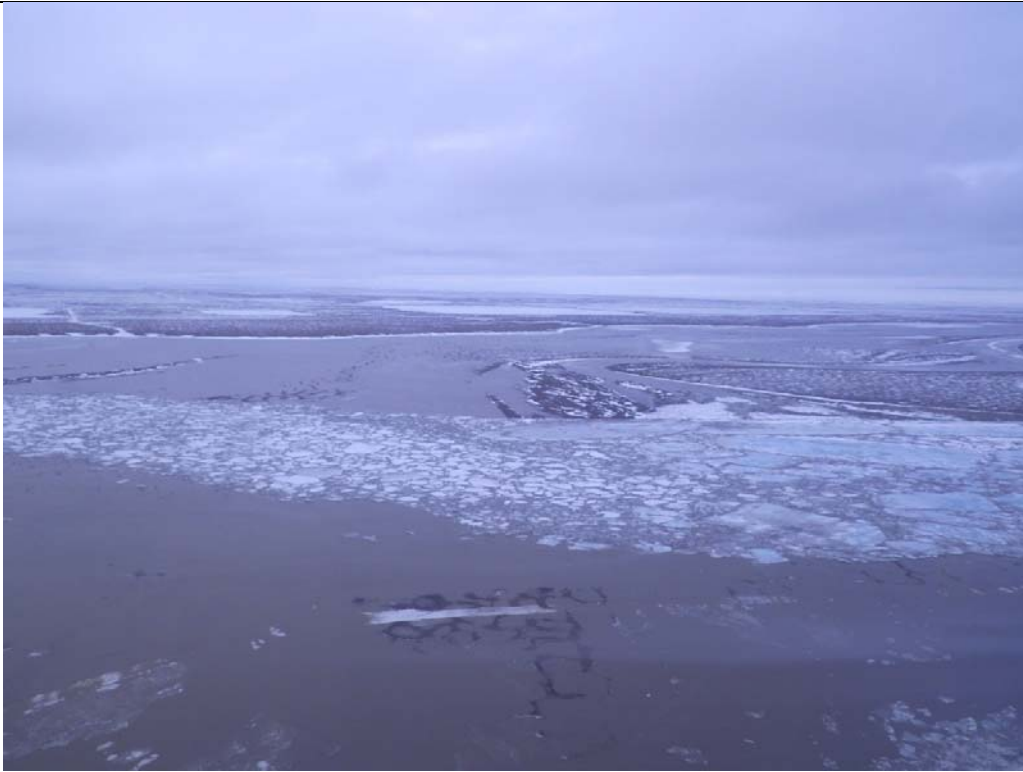
Photo 2: Nigliq channel ice jam upstream of CD4; June 4, 2013

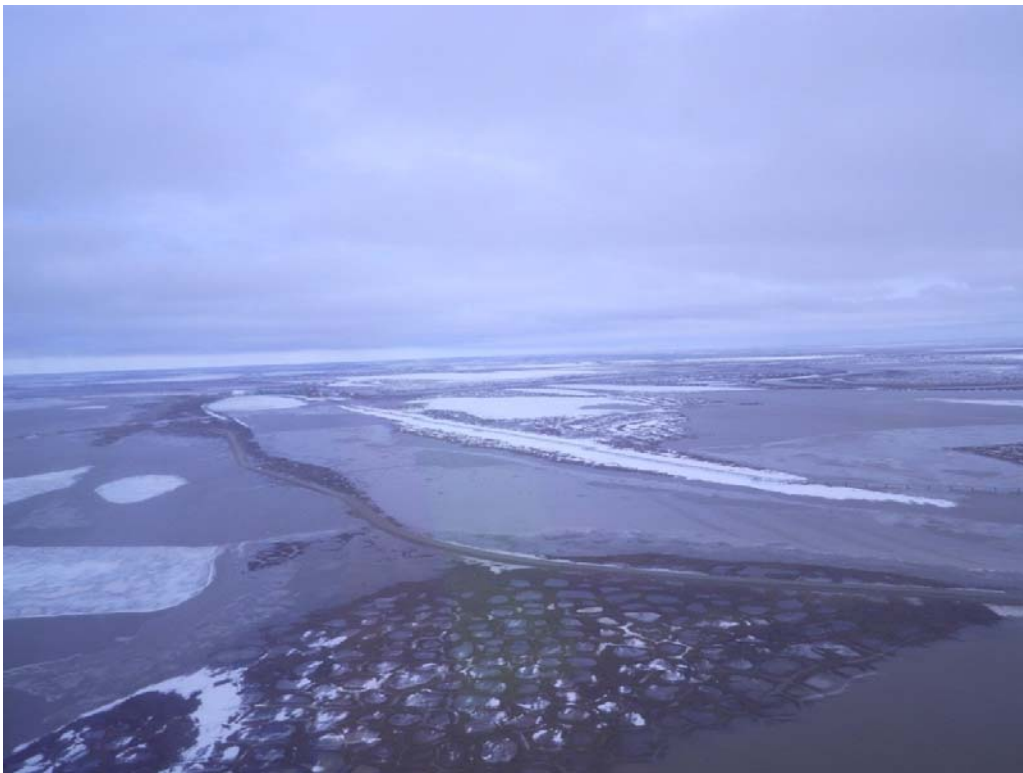
Photo 3: CD4 road and Lake M9525 looking northeast; June 4, 2013

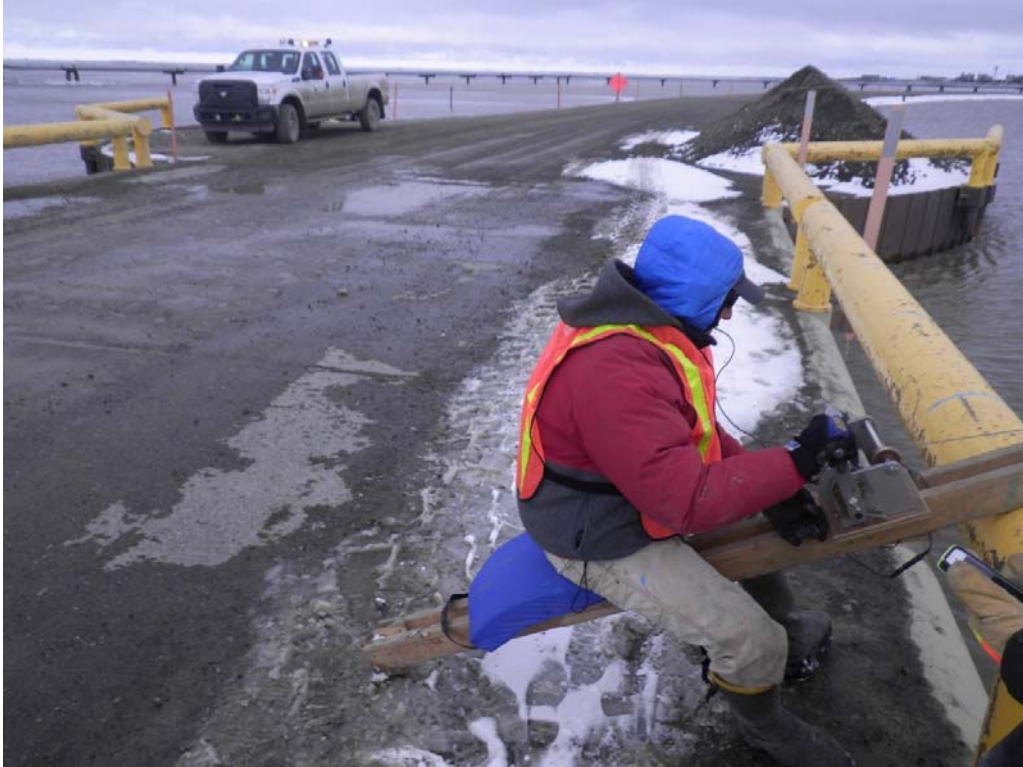
Photo 3: Measuring discharge along the long swale bridge, looking east; June 5, 2013

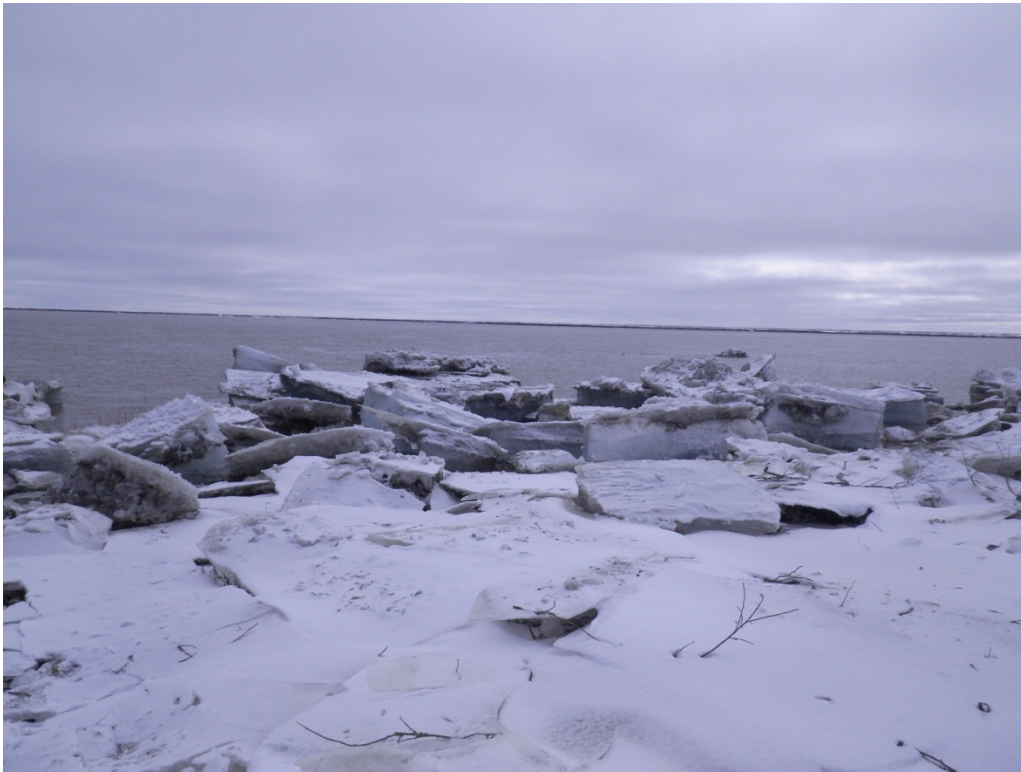
Photo1: Grounded ice at MON1-D, looking east; June 6, 2013

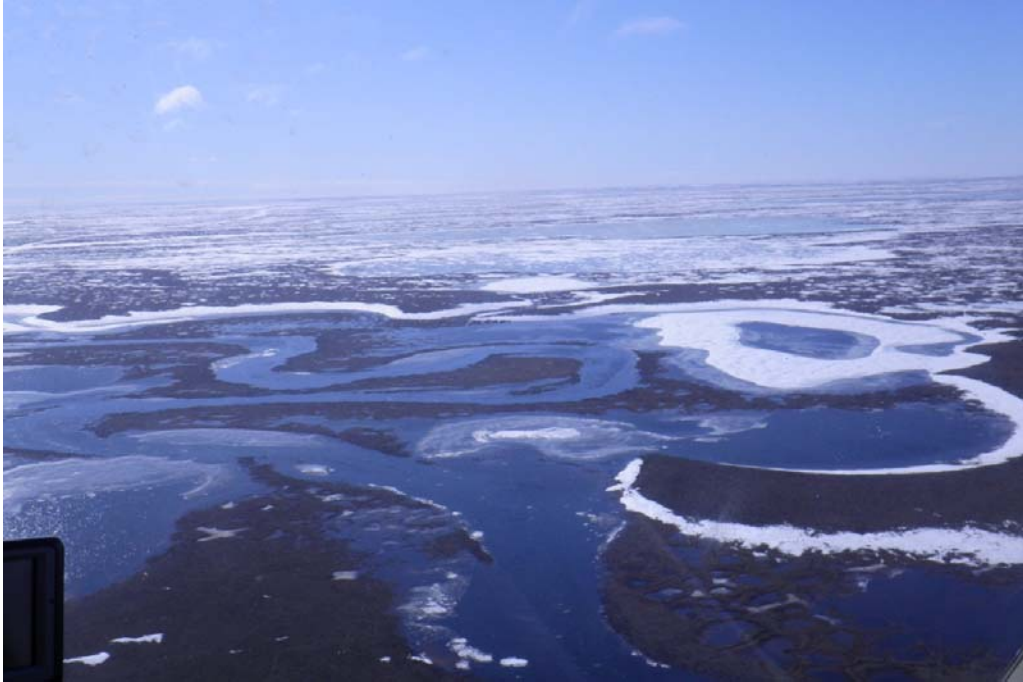
Photo 3: Flooding on the Ublutuoch River, looking west; June 6, 2013

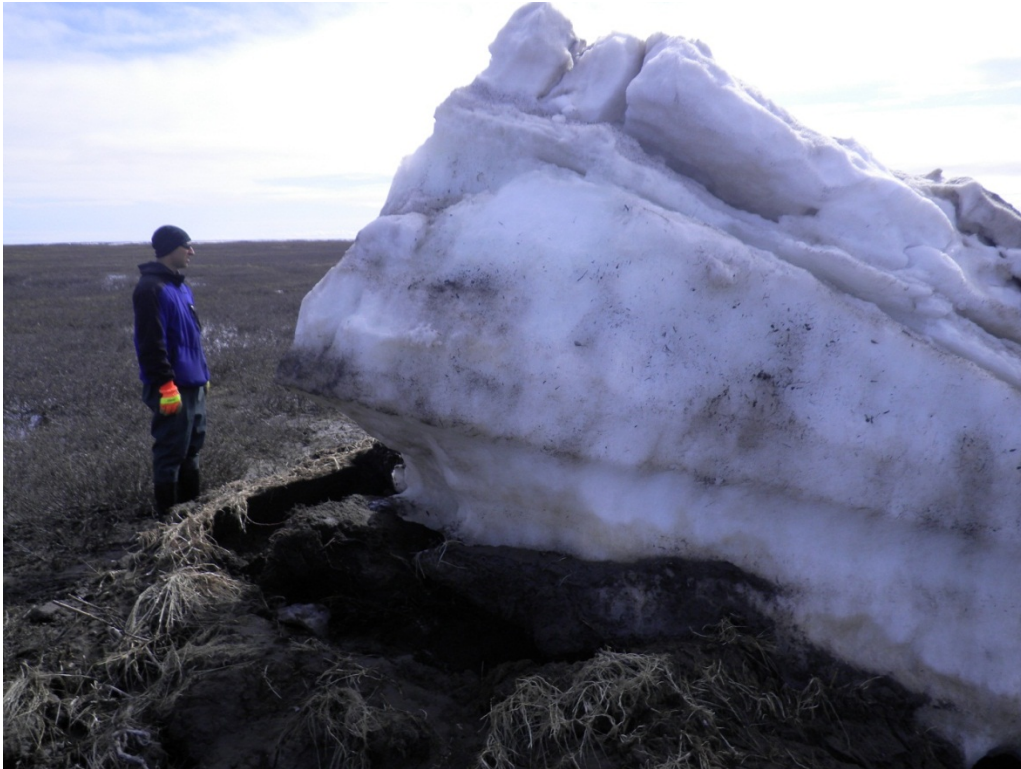
Photo 1: Grounded ice on Nigliq Channel at the proposed CD5 crossing; June 7, 2013

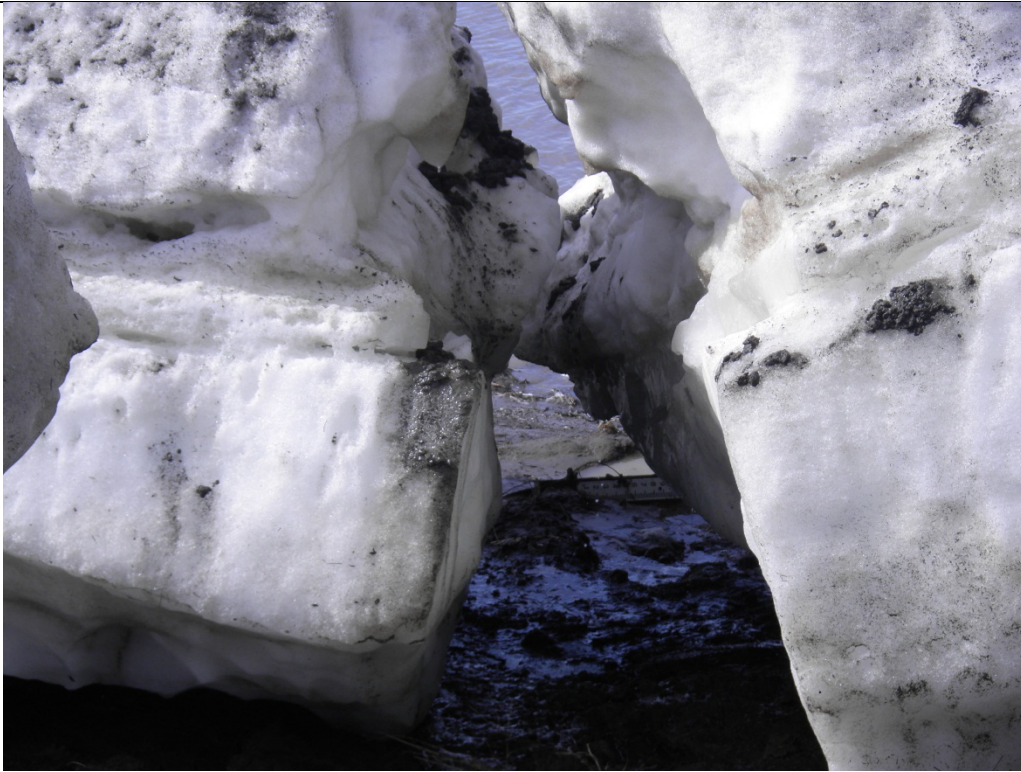
Photo 2: Gage C at MON20 between grounded ice floes; June 7, 2013

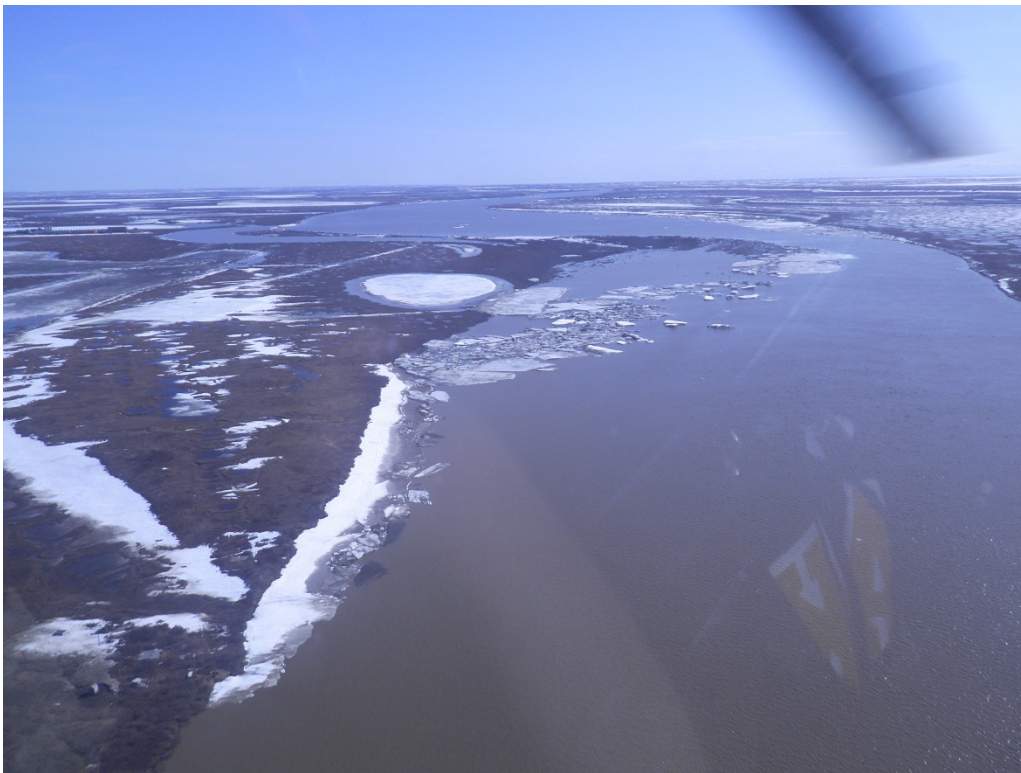
Photo 3: Proposed CD5 Nigliq crossing, looking south; June 7, 2013

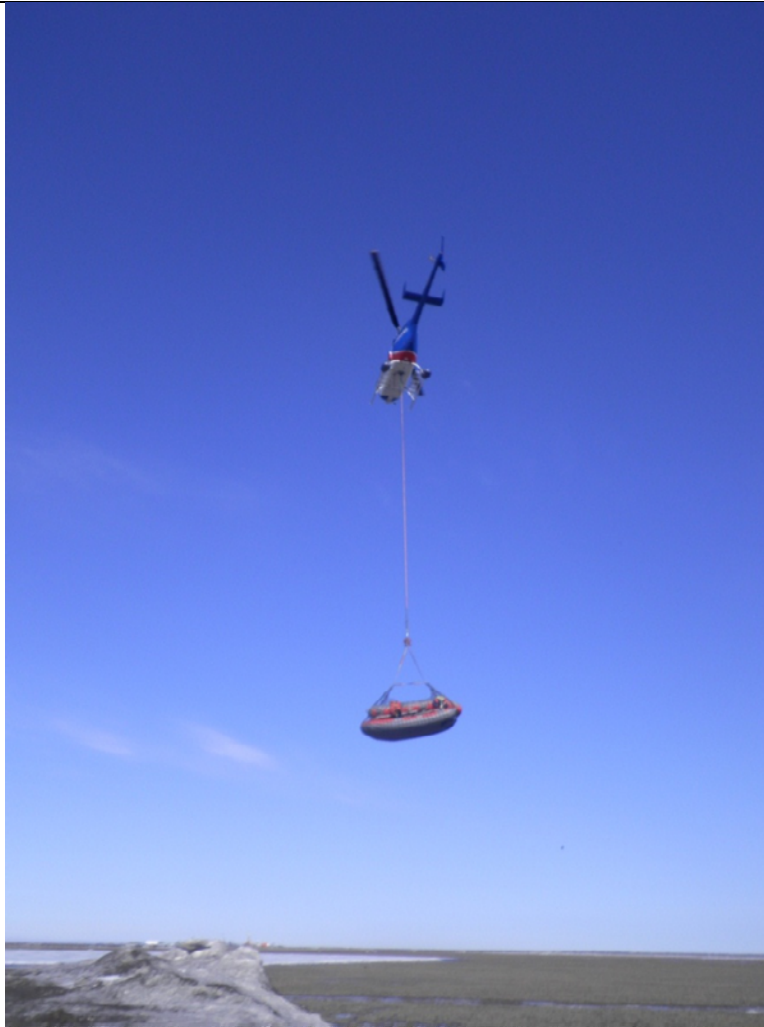
Photo 4: Sling load departing for MON1 discharge measurement; June 7, 2013

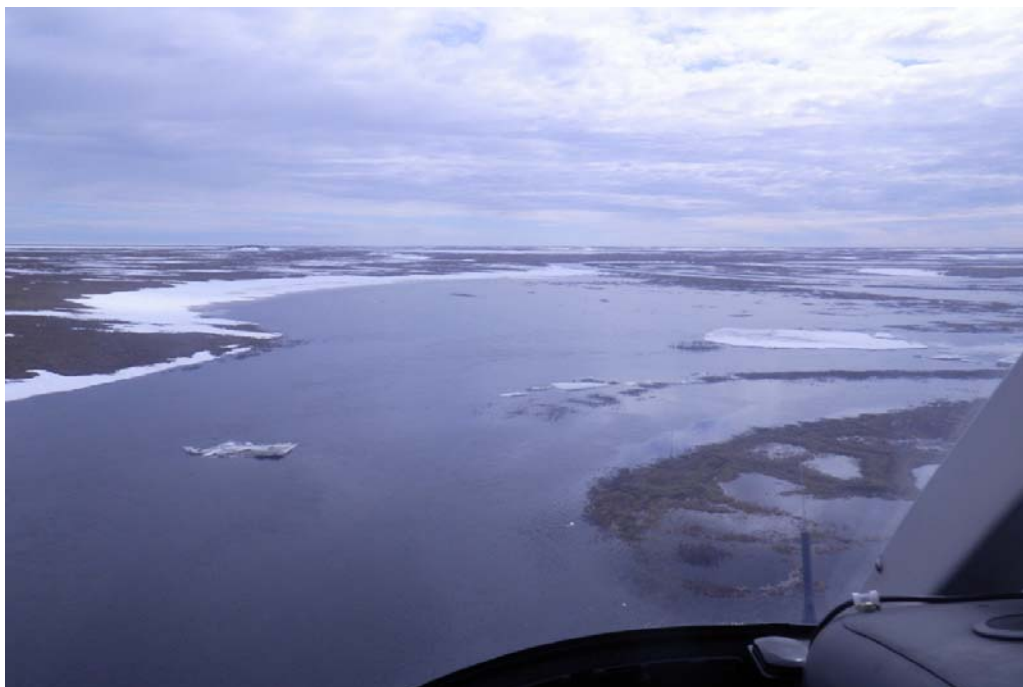
Photo 1: Ublutuoch River gage sites, looking east; June 8, 2013

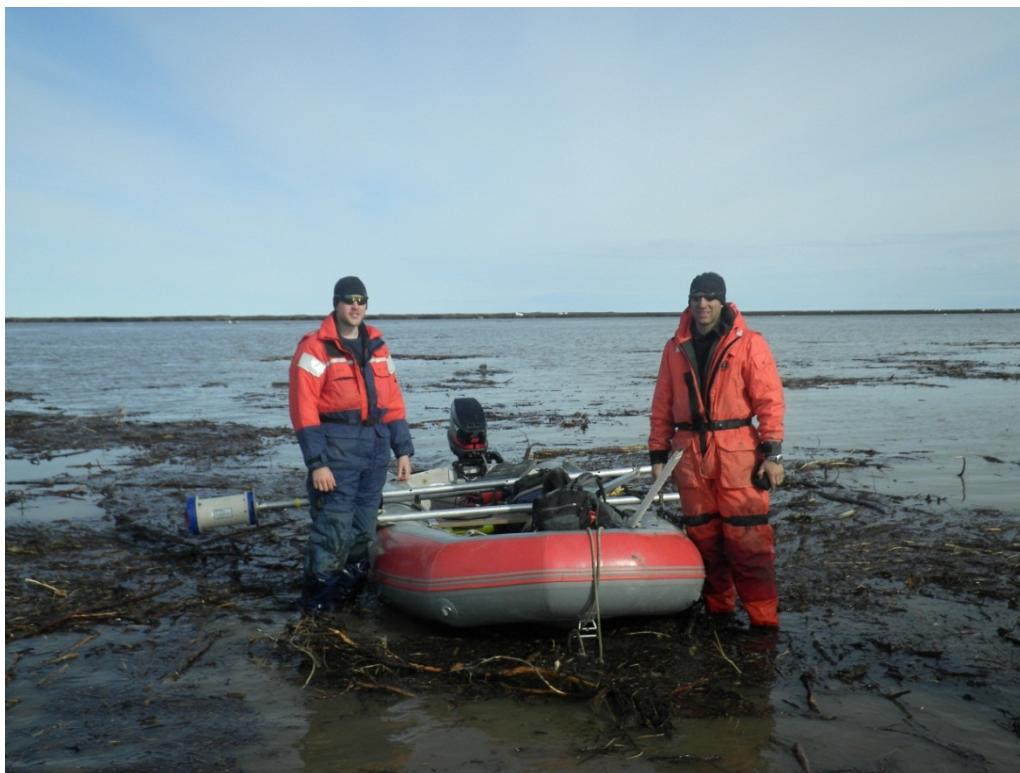
Photo 2: Acoustic Doppler Current Profiler (ADCP) mounted on inflatable boat for discharge measurements at MON1; June 8, 2013

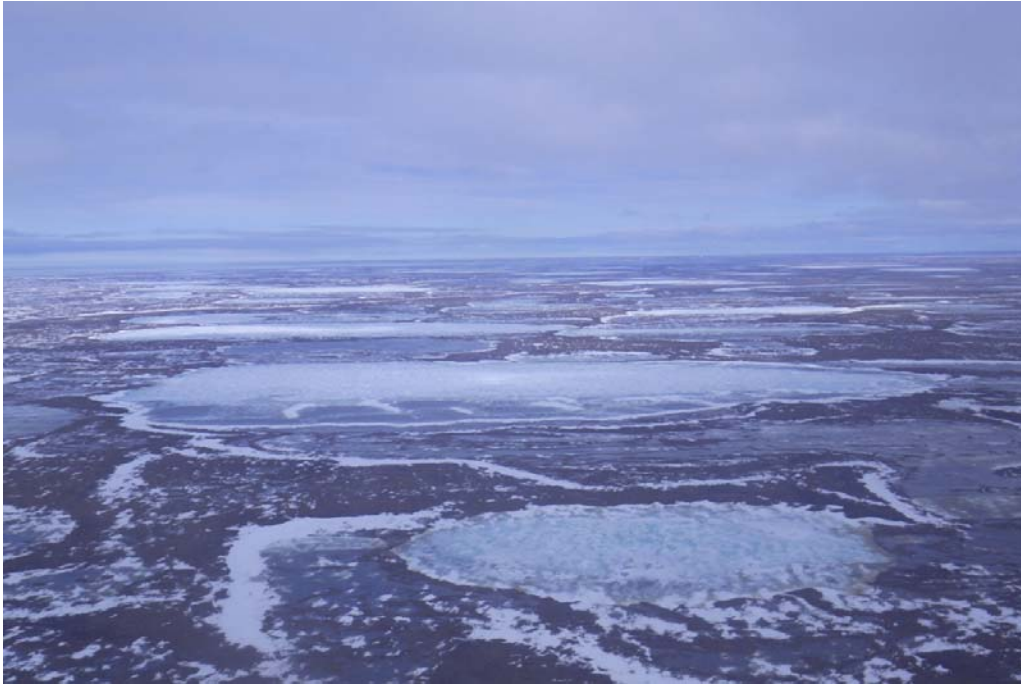
Photo 1: Lake R0076 looking east; June 9, 2013

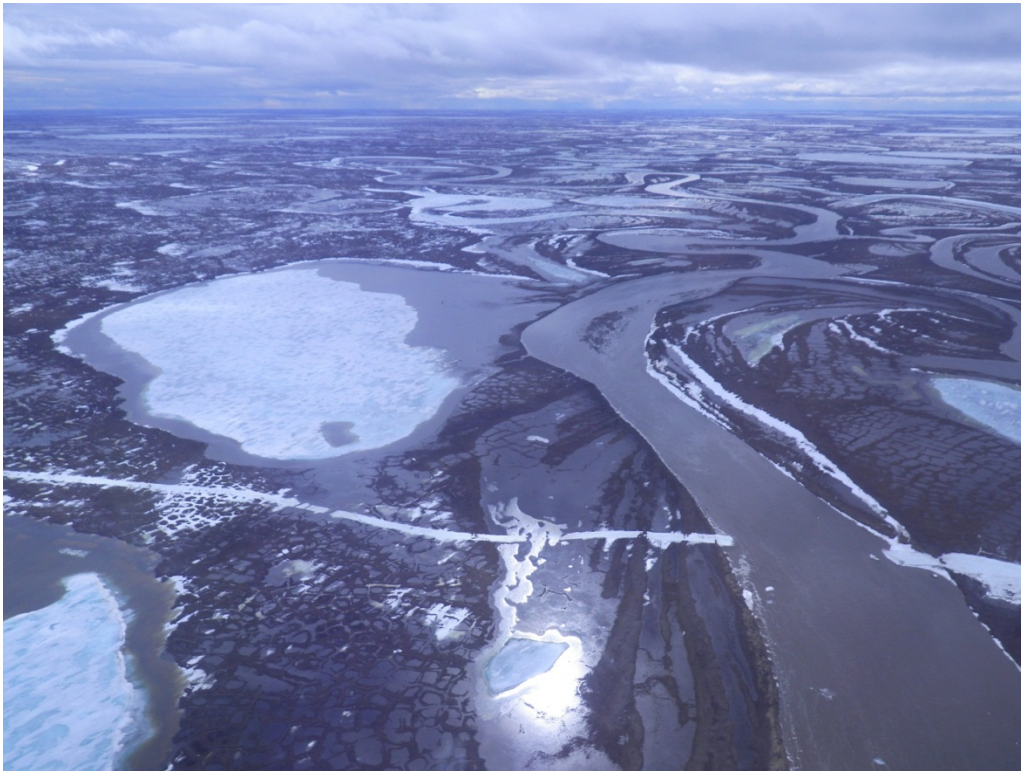
Photo 2: Cassin ice road crossing at Fish Creek, looking upstream; June 9, 2013

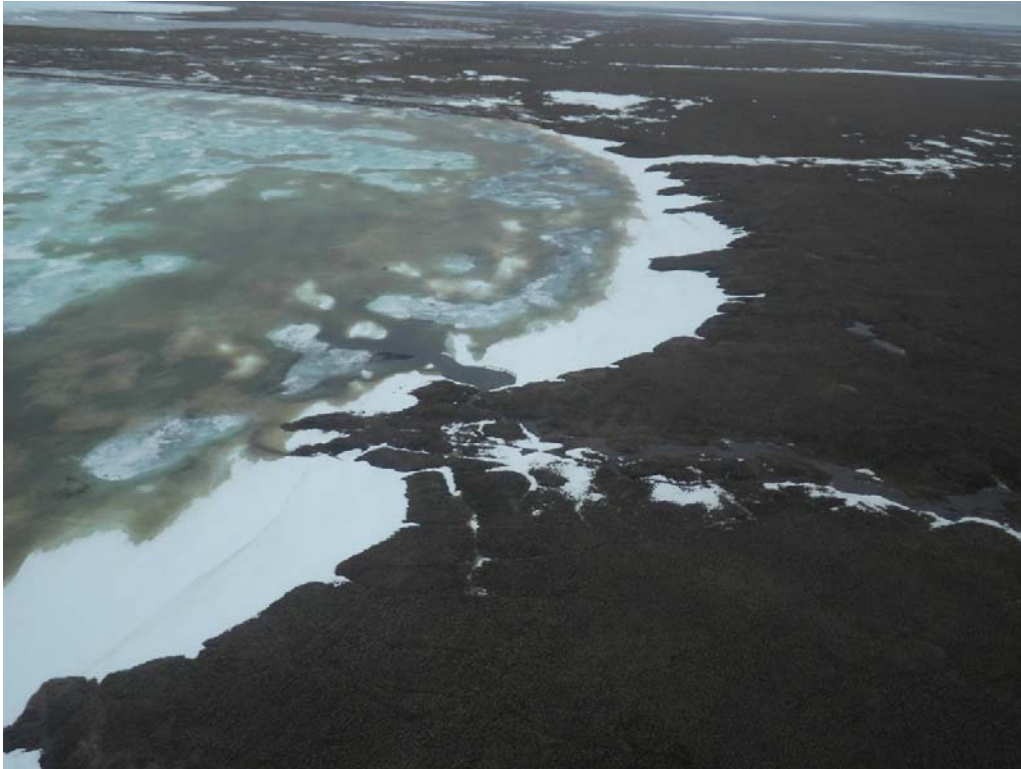
Photo 1: Inflow to lake L9805, looking east; June 10, 2013
